Your Ref: 22/23/23/VC05/027650
Our Ref : CS4/LPC23006887/N

13 July 2023

**TECHNICAL INVESTIGATION REPORT OF FIRE INCIDENT INVOLVING THE
INSURED VEHICLE GBC 1782E ON 24 JUNE 2023**

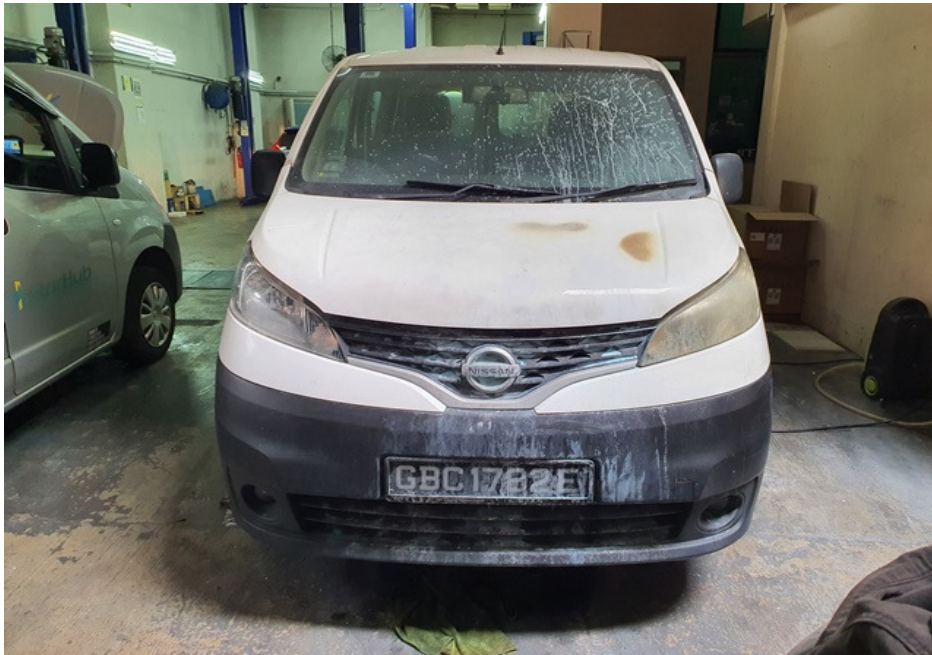
5. The fire had resulted in the body parts at the frontal portion of the Insured Vehicle to be burnt. This had included its front bonnet and front windscreen, amongst others. The interior compartment was observed to be relatively unaffected by the fire.
6. The fire had resulted in the components in the engine compartment of the Insured Vehicle to be burnt. Affected parts had included the battery and engine block, amongst others. See photos 1 – 6 below.

Photo 1 shows the general view of the frontal portion of the Insured Vehicle at the time of our inspection. The fire damage to the Insured Vehicle was confined to its frontal portion. Its front windscreen, front bonnet, front bumper and left front headlamp were amongst the body parts that were found to have been affected as a result of the fire.

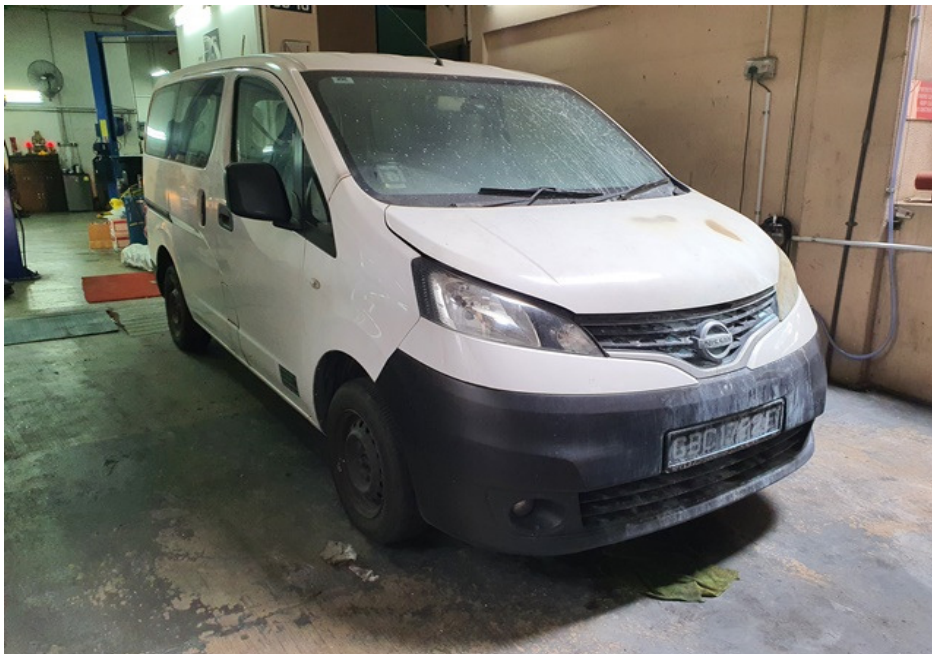
Photo 2 shows the general view of the right body of the Insured Vehicle at the time of our inspection. The fire damage to the Insured Vehicle was confined to its frontal portion. The right body was found to have been relatively unaffected by the fire.

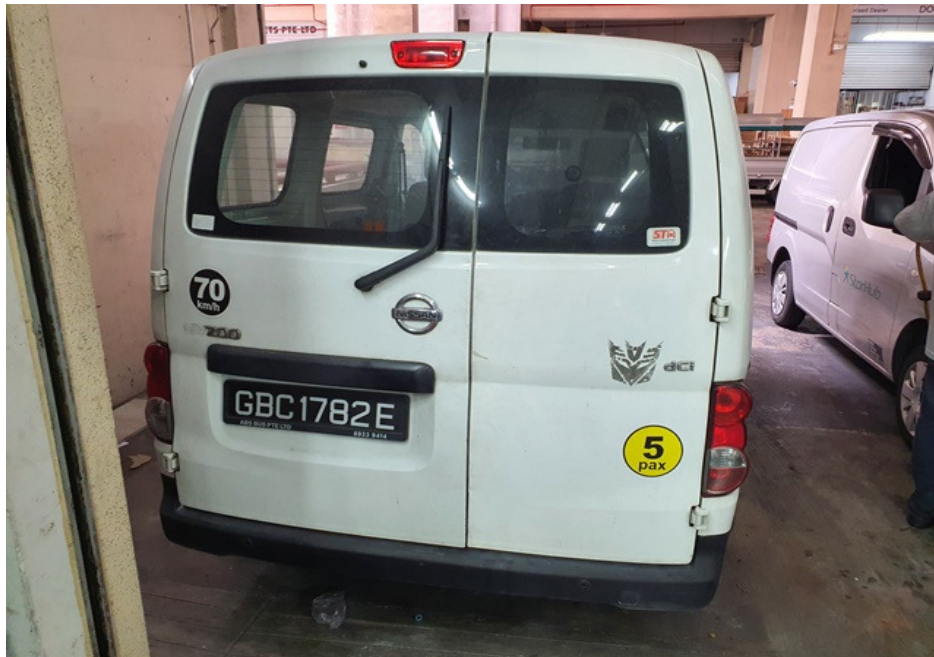
Photo 3 shows the general view of the rear portion of the Insured Vehicle at the time of our inspection. The fire damage to the Insured Vehicle was confined to its frontal portion. The rear portion was found to have been relatively unaffected by the fire.

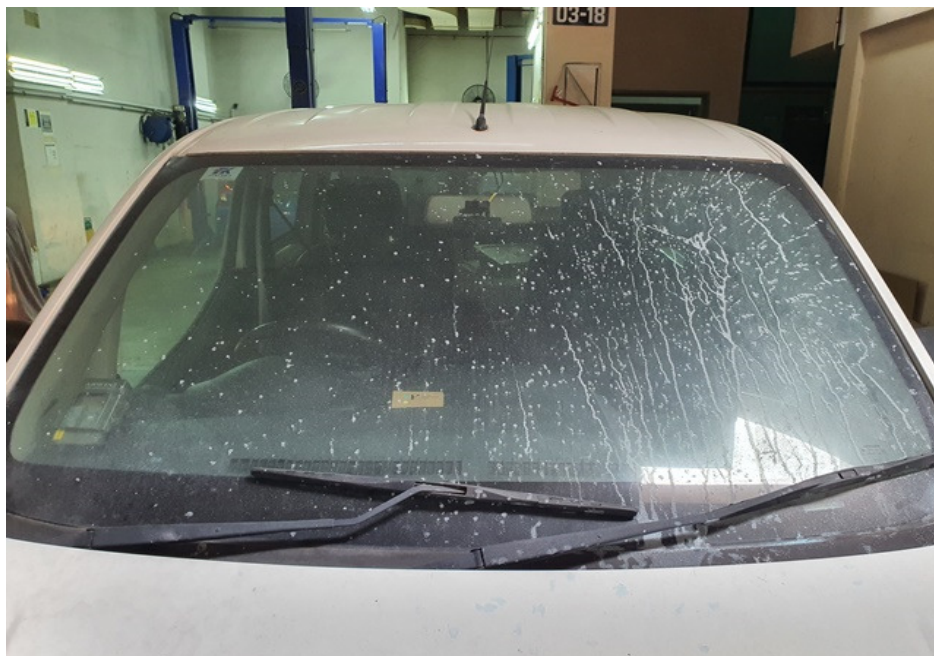
Photo 4 shows the general view of the front windscreen of the Insured Vehicle at the time of our inspection. The fire damage to the front windscreen of the Insured Vehicle was minimal.

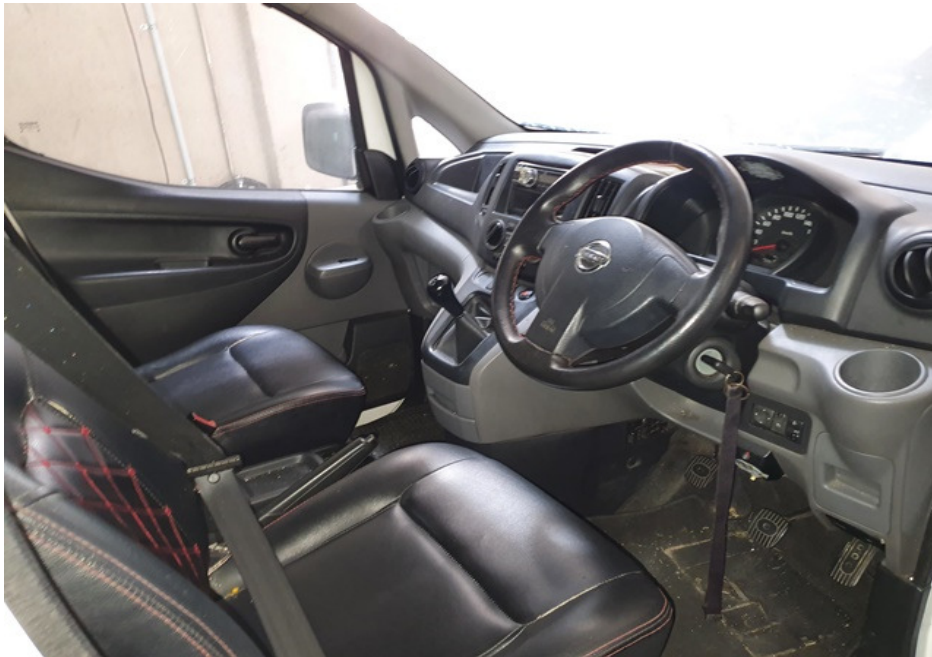
Photo 5 shows the interior compartment of the Insured Vehicle, which was observed to be relatively unaffected by the fire.

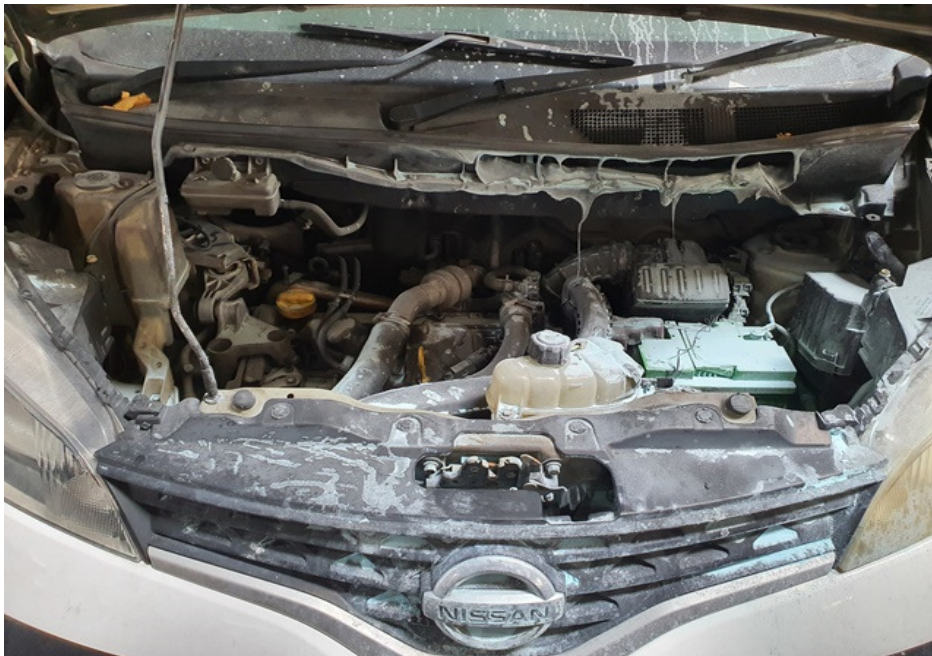
Photo 6 shows a general view of the engine compartment of the Insured Vehicle which was covered in fire extinguisher residue at the time of our inspection. Most of its engine components were found to have been affected as a result of the fire.

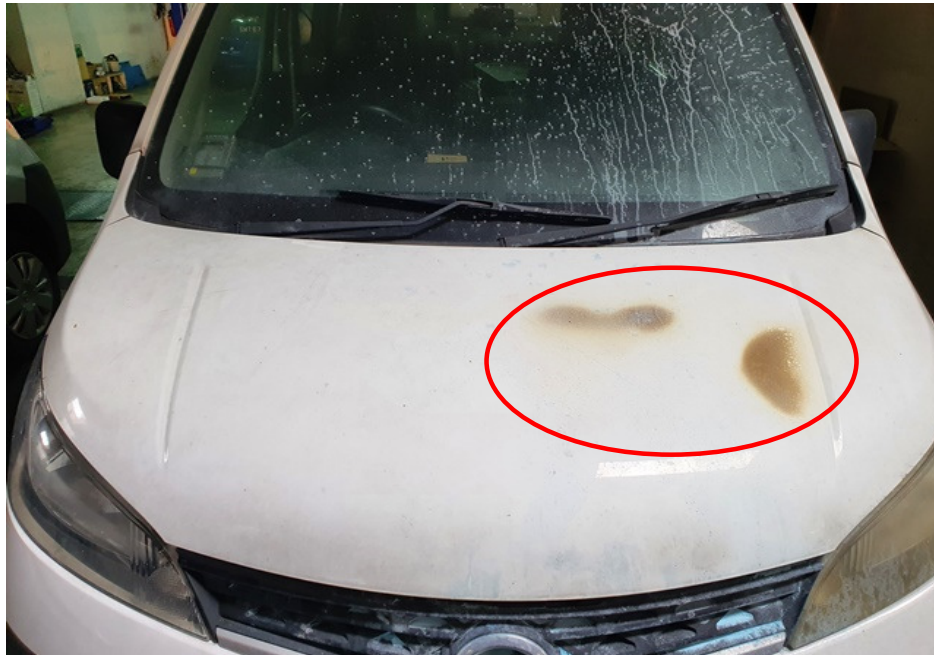
8. For this particular case, the fire appears to have originated within the engine compartment of the Insured Vehicle, somewhere around the left centre portion of the engine compartment. This can be determined from the burn pattern and the high heat intensity burn marks (whitish burn marks) found on the left centre portion of the front bonnet of the Insured Vehicle and also the rust that had developed on the underside of the front bonnet, at the left bottom portion.

9. The whitish burn marks are a result of exposure to prolonged heat intensity. Rust would normally start to develop around these areas soon after a fire as prolonged exposure to high heat intensity usually causes steel/metal material body parts to be exposed to natural environmental condition. The rust that had developed on the underside of the front bonnet, around the left bottom portion, is an indication that the left centre portion of the engine compartment had sustained exposure to prolonged high heat intensity. See photos 7 & 8 below.

Photo 7 shows the burn pattern and whitish burn marks (circled) that were found on the left centre portion of the front bonnet of the Insured Vehicle. Such whitish burn marks are a result of exposure to prolonged heat intensity, which may indicate where the fire had started. Rust would also begin to develop on these areas soon after the fire.

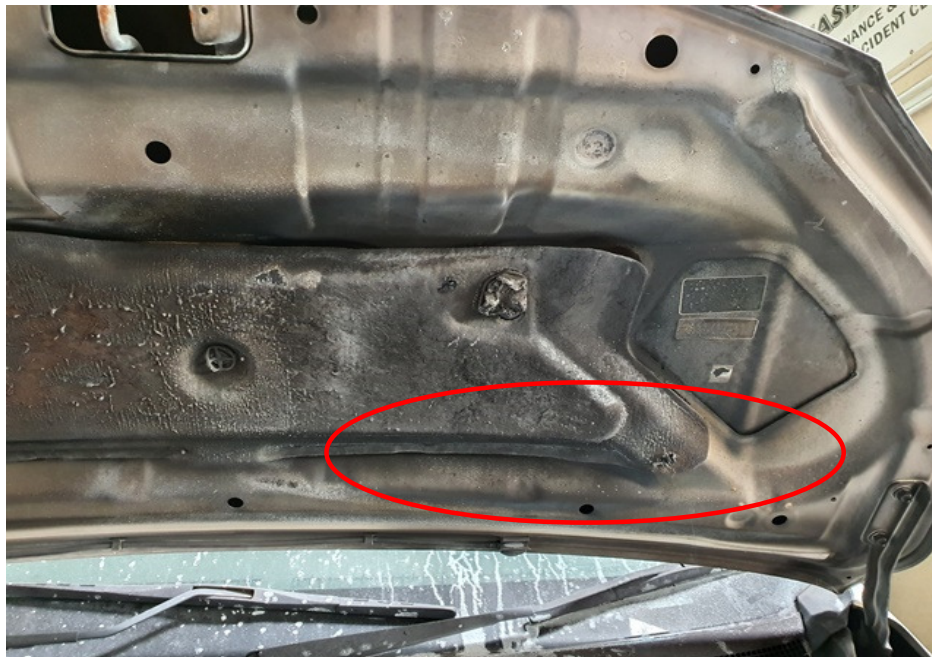
Photo 8 shows the rust that had developed on the underside of the front bonnet, around the left bottom portion (circled). The development of rust is an indication that this area was subjected to prolonged exposure to high heat intensity, which had caused the steel/metal material of the front bonnet to be exposed to natural environmental condition. Hence the fire to the Insured Vehicle can be determined to have originated towards the left centre portion of the engine compartment.

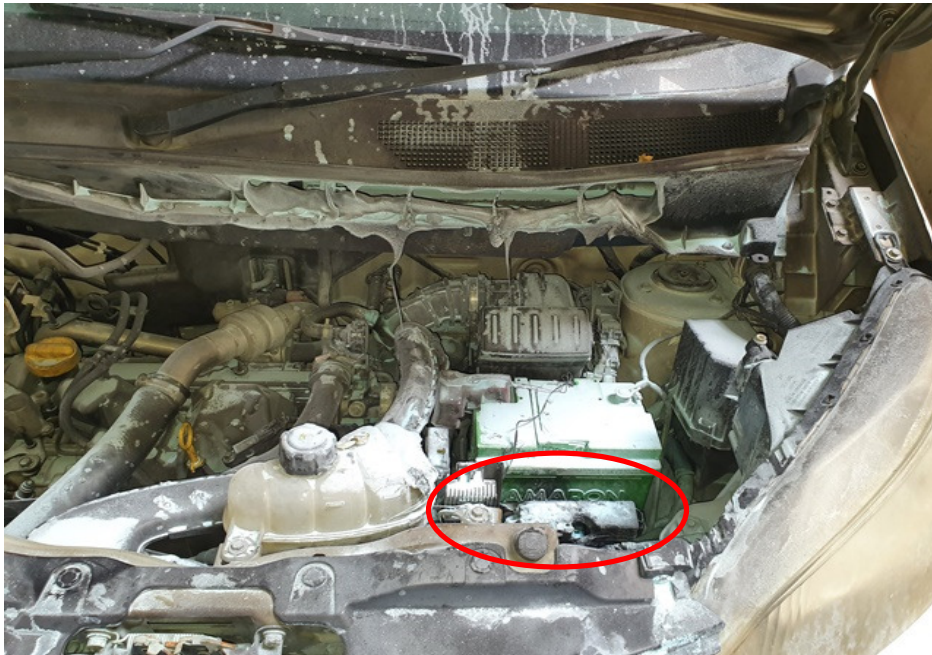
10. Upon closer examination of the engine compartment, in particular to the wire harness closest to the radiator, we had found faint traces of greenish residue on several burnt stretches of original factory fitted wirings around the left centre portion of the engine compartment. The presence of such greenish residue indicates internal heating of copper wires, a sign of an electrical short circuit occurring. The greenish residue is normally left behind from oxidation as a result of chemical reaction involving the copper wires. We also observed that the wirings under the fuse box had partially melted. These physical evidences would then appear to suggest that the cause of fire to the Insured Vehicle could have possibly been due to electrical in nature. See photos 9 - 13 below.

Photo 9 shows the burnt stretches of original factory fitted wirings near the radiator, which is in the immediate vicinity where the fire to the Insured Vehicle had likely started. Faint traces of greenish residue were found on some of the wirings (circled). The presence of such greenish residue suggests occurrence of an electrical short circuit.

22. The possibility of the fire being due to electrical in nature would then seem more likely given that engine overheating and external factors would both seem unlikely. The fire being due to electrical nature is also supported by the faint traces of greenish residue that were found on several burnt stretches of original factory fitted wirings around the left centre portion of the engine compartment of the Insured Vehicle, which was earlier discussed in paragraph 10 above.

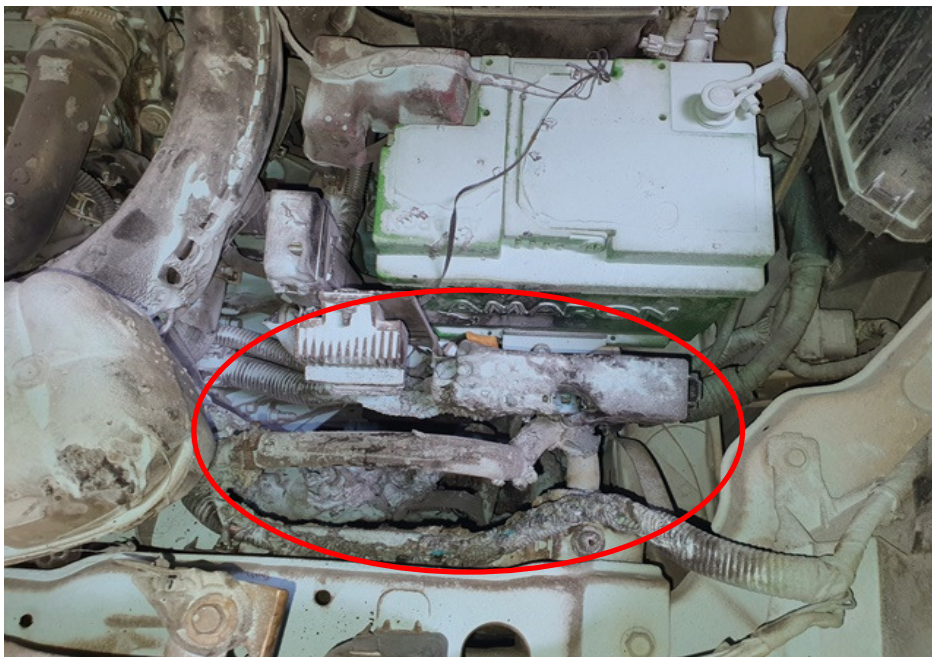
Photo 10 shows a closer view of the burnt stretches of original factory fitted wirings near the radiator, which is in the immediate vicinity where the fire to the Insured Vehicle had likely started (circled).

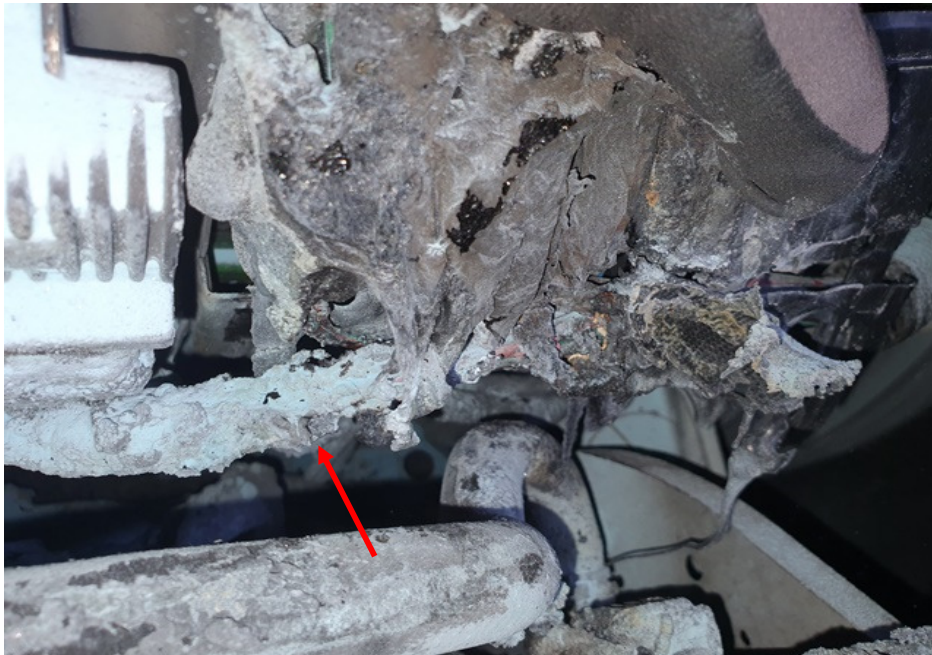
Photo 11 shows a close up view of the wirings under the fuse box of the Insured Vehicle which had partially melted (arrowed).

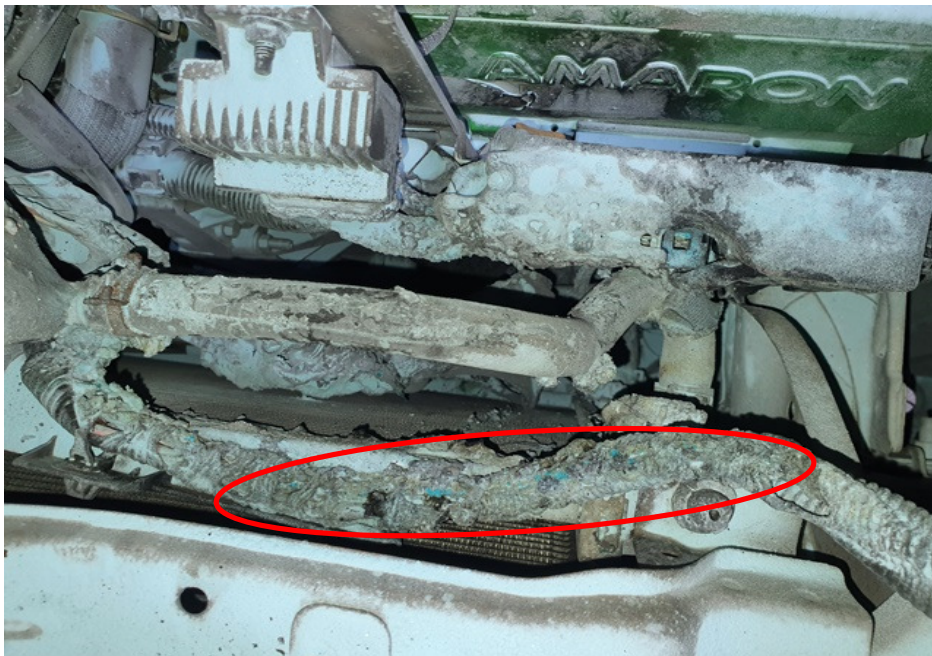
Photo 12 shows a closer view of the burnt stretches of original factory fitted wirings near the radiator, which is in the immediate vicinity where the fire to the Insured Vehicle had likely started. Faint traces of greenish residue were found on some of the wirings (circled).

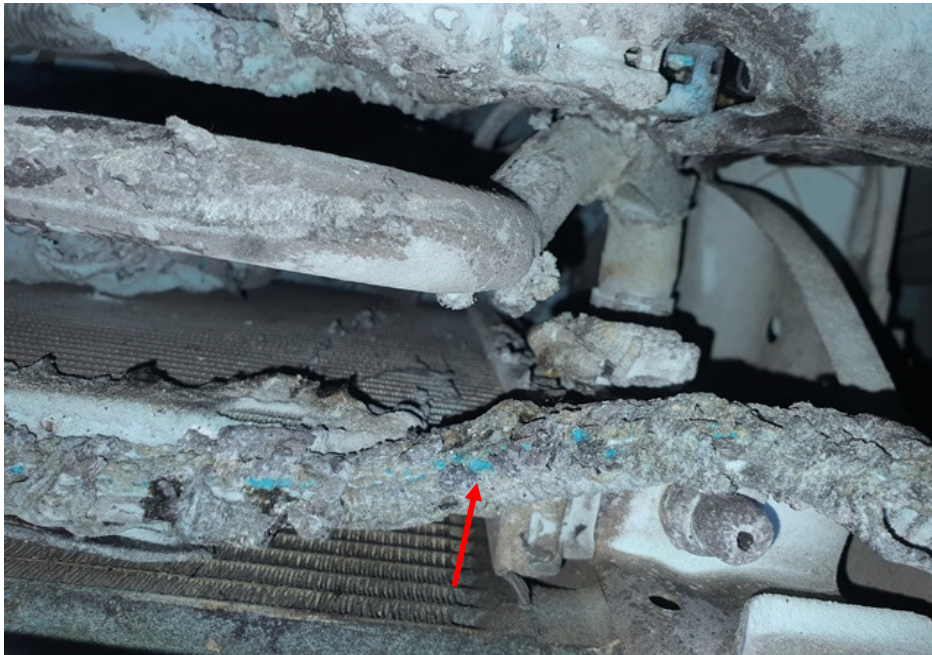
Photo 13 shows a close up view of the wirings around the radiator which is near to the vicinity where the fire to the Insured Vehicle had likely started. We observed greenish residue on the wirings (arrowed).

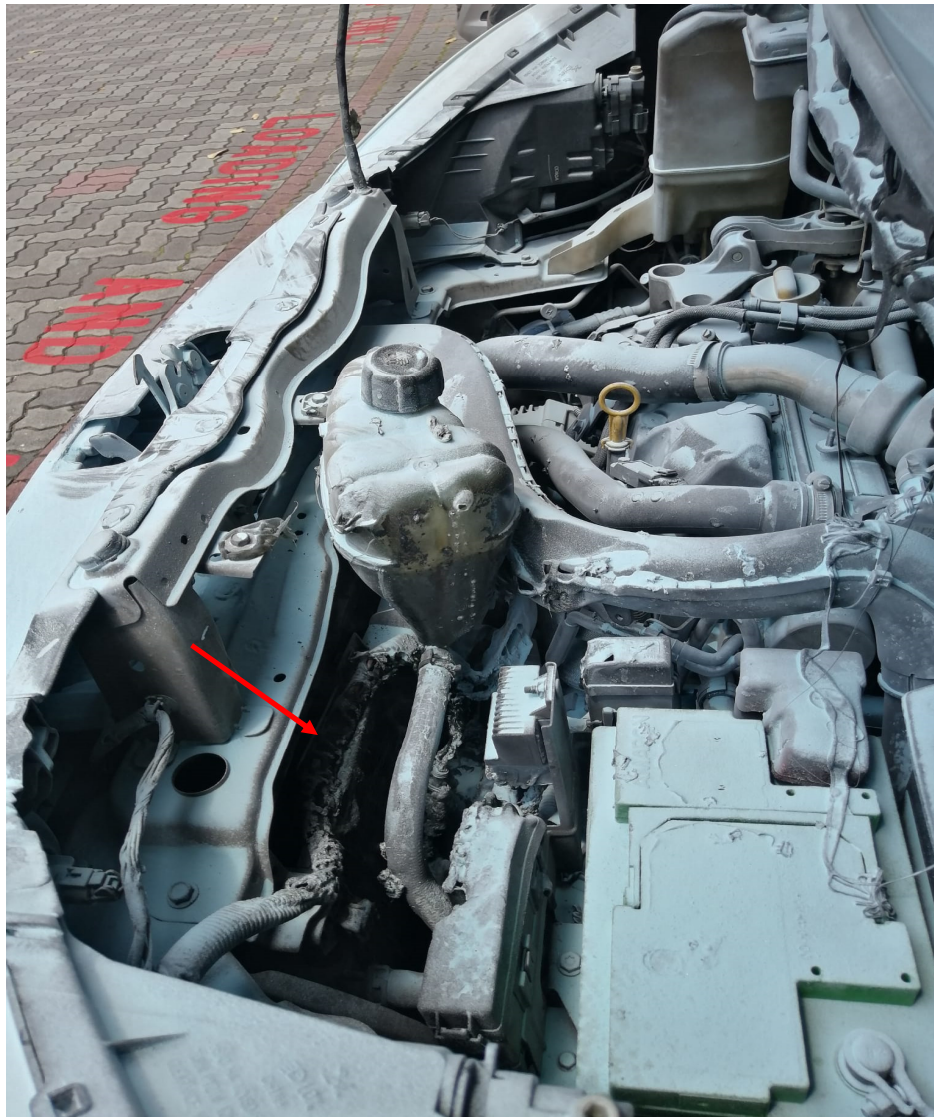
19. We were able to obtain from Mr Nathan a photograph of the Insured Vehicle post- incident. In general, the information that could be gathered from this photograph had corresponded to the events that were related to us by Mr Nathan. See photo 14 below.

Photo 14 shows the engine compartment of the Insured Vehicle at the incident location post- incident. In general, the information that could be gathered from this photograph had corresponded to the events that were related to us by Mr Nathan, which is the fire to the Insured Vehicle had started from the left portion of the engine compartment (arrowed).
