Your Ref: Porsche 911 Carrera GTS  
(chassis number WP0ZZZ99ZNS210932)  
Our Ref: CI/TP23006923/D

**INSPECTION REPORT OF AN UNREGISTERED PORSCHE 911 CARRERA  
GTS MOTOR CAR WITH CHASSIS NUMBER WP0ZZZ99ZNS210932**

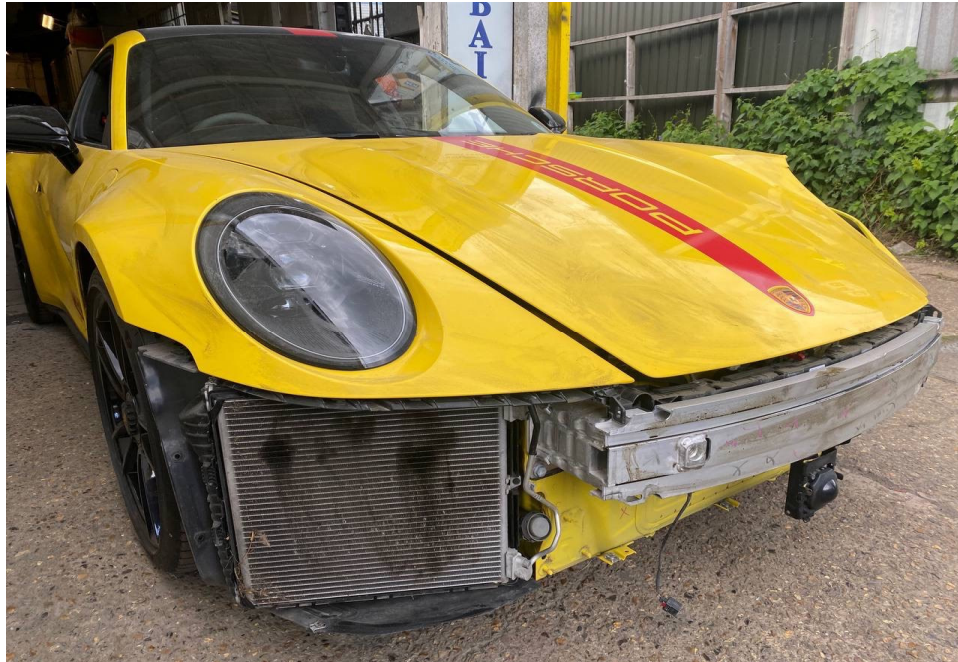
**Photo 1** shows a general view of the front right body of the Motor Car (photograph provided to me). The Motor Car's front bumper and all its related parts and attachments like the front bumper lower lip, front bumper right lower grille, front bumper centre air guide, front bumper sensors, front bumper tow cover, front radar unit, front right day light, and front right signal lamp amongst others, were observed to be missing/dislodged/damaged.

23. The body parts at the frontal portion and rear portion of the Motor Car were visually examined and it was noted that the repair/restoration works carried out to the damaged area of the Motor Car (refer to photograph 1 - 4 above) were reasonably adequate and in order.

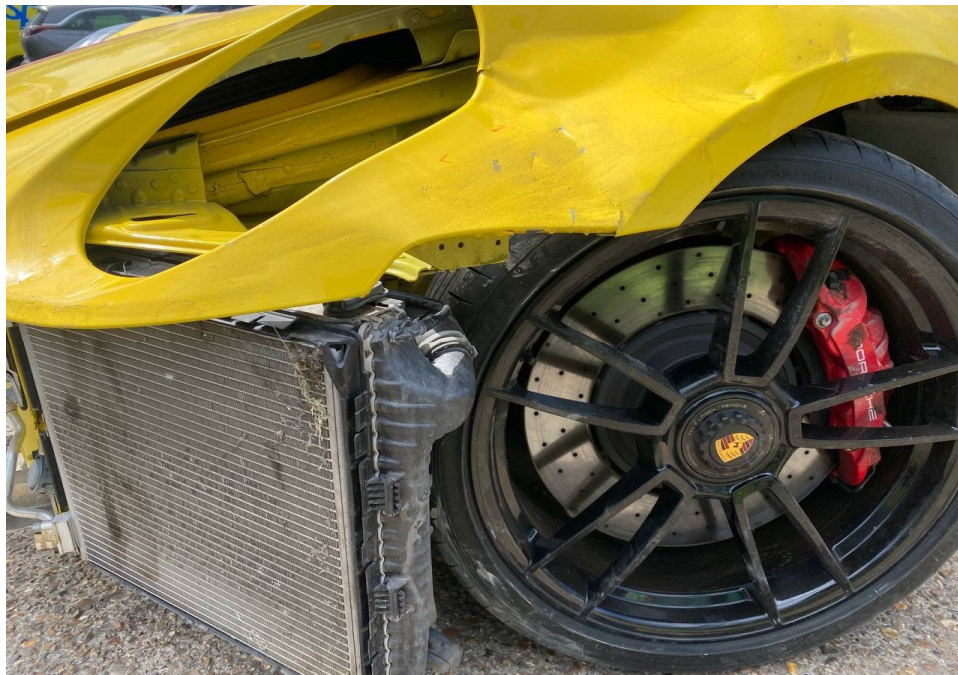
**Photo 2** shows the damaged front left fender of the Motor Car (photograph provided to me). In addition, the Motor Car's front left headlamp, front bumper and all its related parts and attachments like the front bumper lower lip, front bumper left lower grille, front left day light and front left signal lamp amongst others, were also observed to be missing/dislodged/damaged.

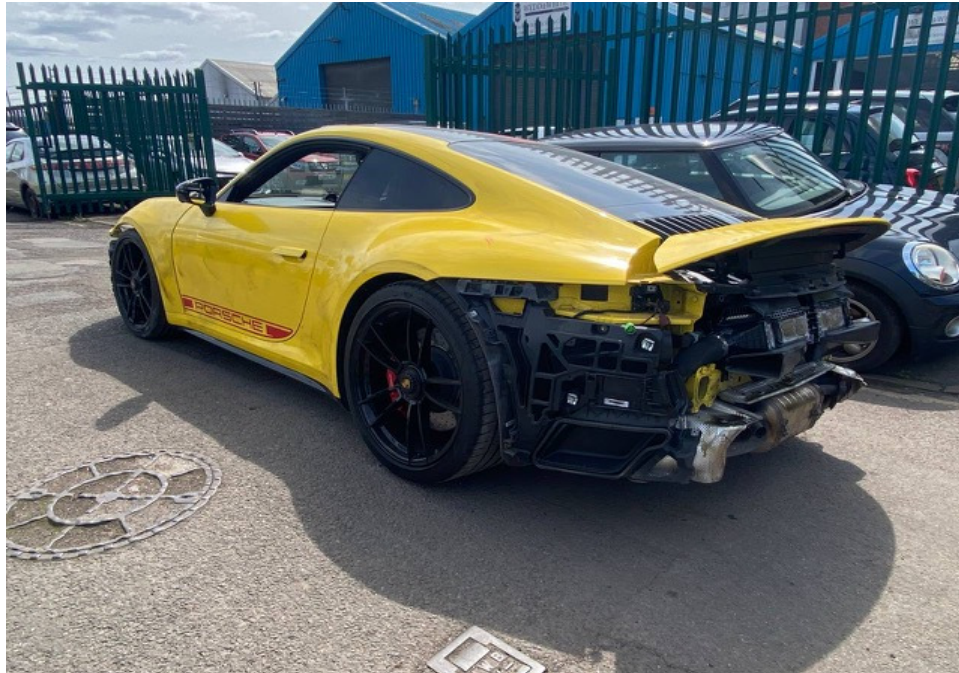
**Photo 3** shows a general view of the rear left body of the Motor Car (photograph provided to me). The Motor Car's rear left taillamp, rear centre lamp, rear bumper and all its related parts and attachments like the rear bumper lower cover, rear bumper left reflector, rear bumper sensors, rear bumper tow cover and rear left exhaust garnish amongst others, were missing/dislodged/damaged.

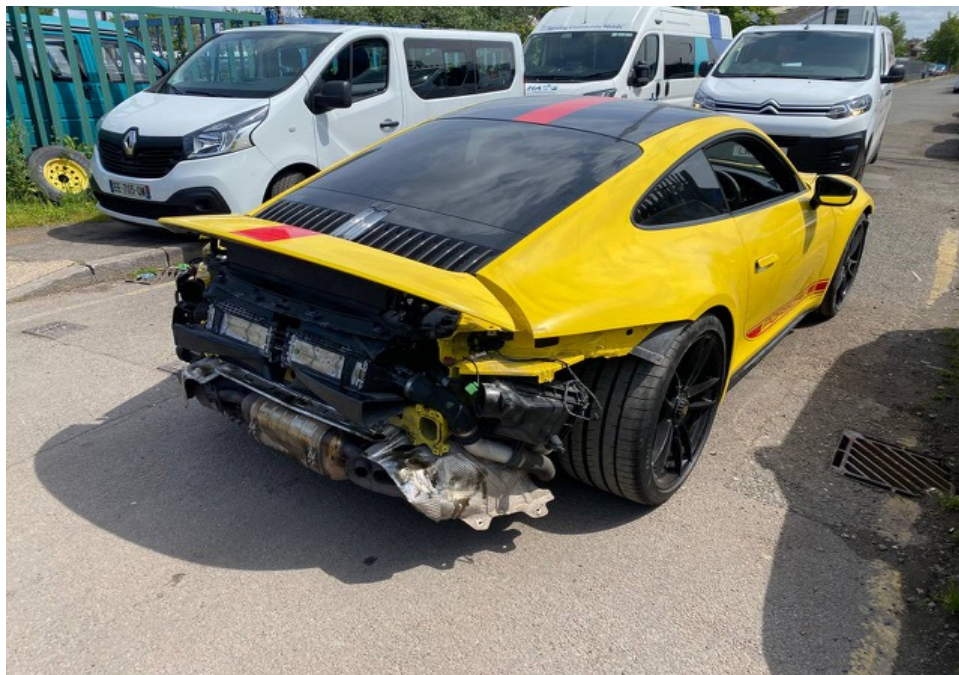
**Photo 4** shows the rear right body of the Motor Car (photograph provided to me). The Motor Car's rear right taillamp, rear centre lamp, rear bumper and all its related parts and attachments like the rear bumper lower cover, rear bumper right bracket, rear bumper right reflector, rear bumper sensors and rear right exhaust garnish amongst others, were missing/dislodged/damaged.

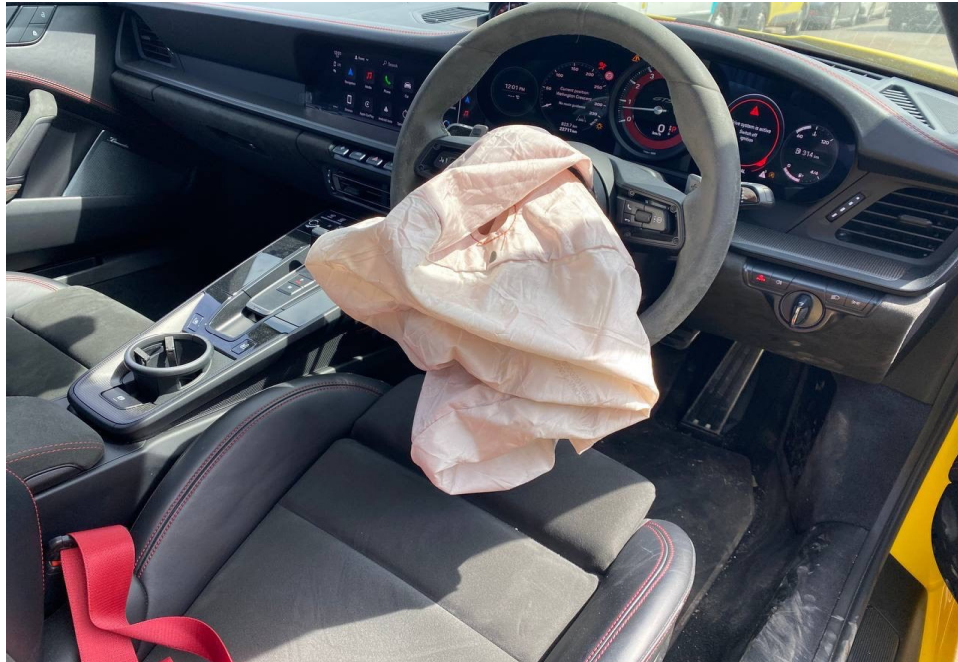
**Photo 5** shows the interior compartment of the Motor Car (photograph provided to me). The various parts and components within the interior compartment were all intact and unaffected. The driver's airbag was deployed.

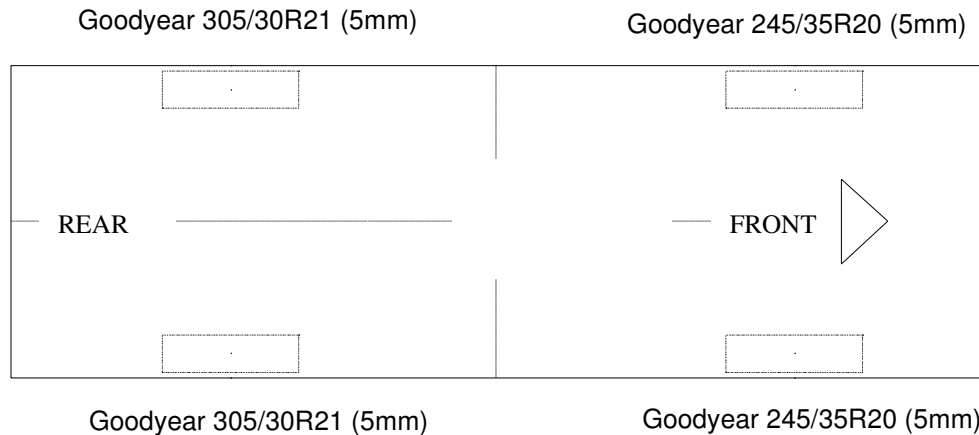
9. It was fitted with 20inch (front) and 21inch (rear) sport wheel rims that were wrapped with tyres that were observed to be of serviceable condition. The tyres were also sufficiently inflated for vehicular operation. The tyre brand, tyre size and approximate remaining tread depth of the 4 tyres of the Motor Car were recorded as follows: -

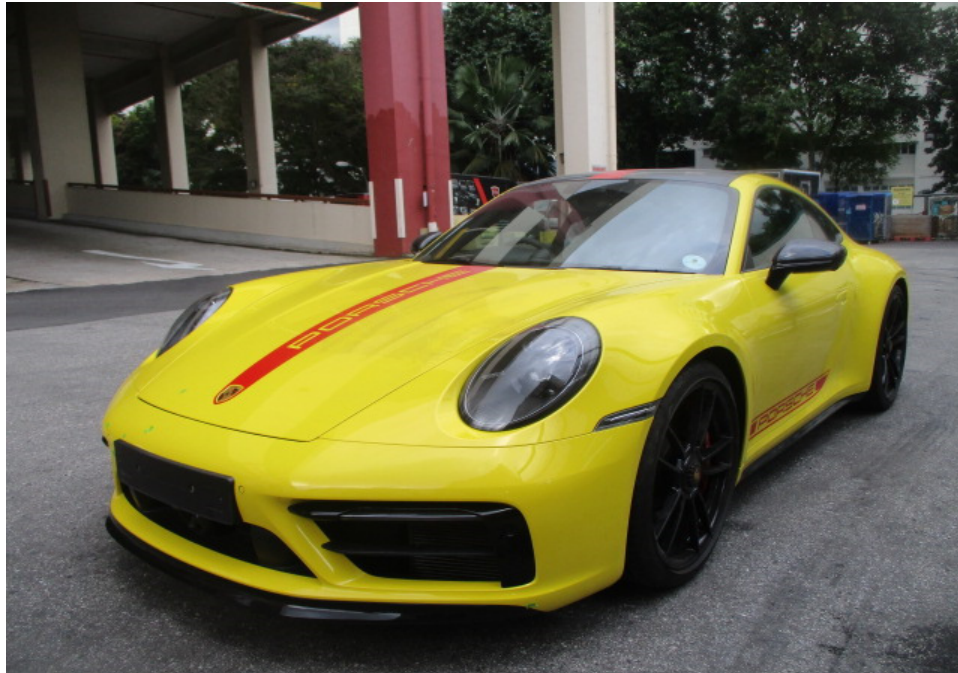
**Photo 6** shows a general view of the front left body of the Motor Car at the time of my inspection. The Motor Car was observed to be in a relatively good general condition with no loose exterior fittings observed. The body parts at the frontal portion of the Motor Car were visually examined and it was observed that the repair/restoration works carried out to the damaged area of the Motor Car (refer to photograph 1 & 2 above) were reasonably adequate and in order.

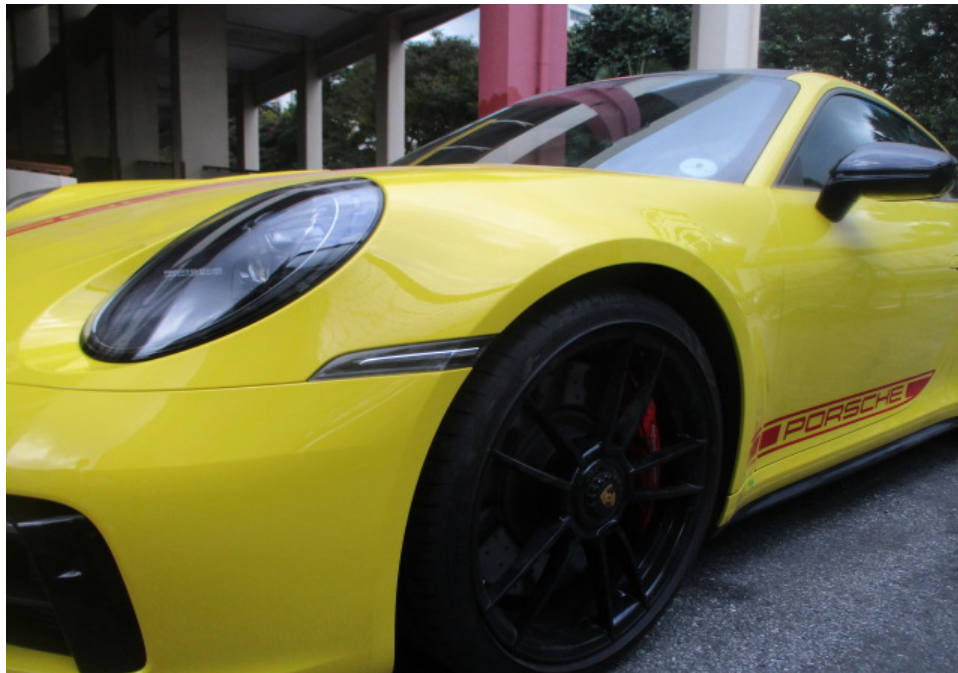
**Photo 7** shows a closer view of the Motor Car's front left headlamp, front left signal lamp, front left fender and front left wheel rim. The body parts at the frontal portion of the Motor Car were visually examined and it was observed that the repair/restoration works carried out to the damaged area of the Motor Car (refer to photograph 1 & 2 above) were reasonably adequate and in order.

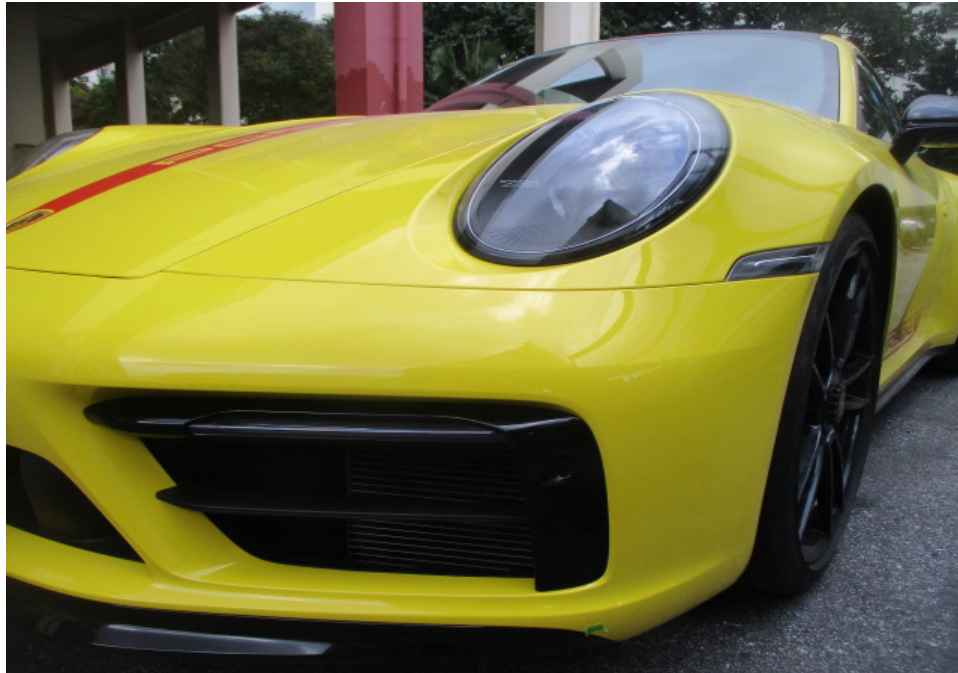
**Photo 8** shows a closer view of the Motor Car's front bumper, front bumper left lower grille, front left day light, front left signal lamp and front left headlamp. The body parts at the frontal portion of the Motor Car were visually examined and it was observed that the repair/restoration works carried out to the damaged area of the Motor Car (refer to photograph 1 & 2 above) were reasonably adequate and in order.

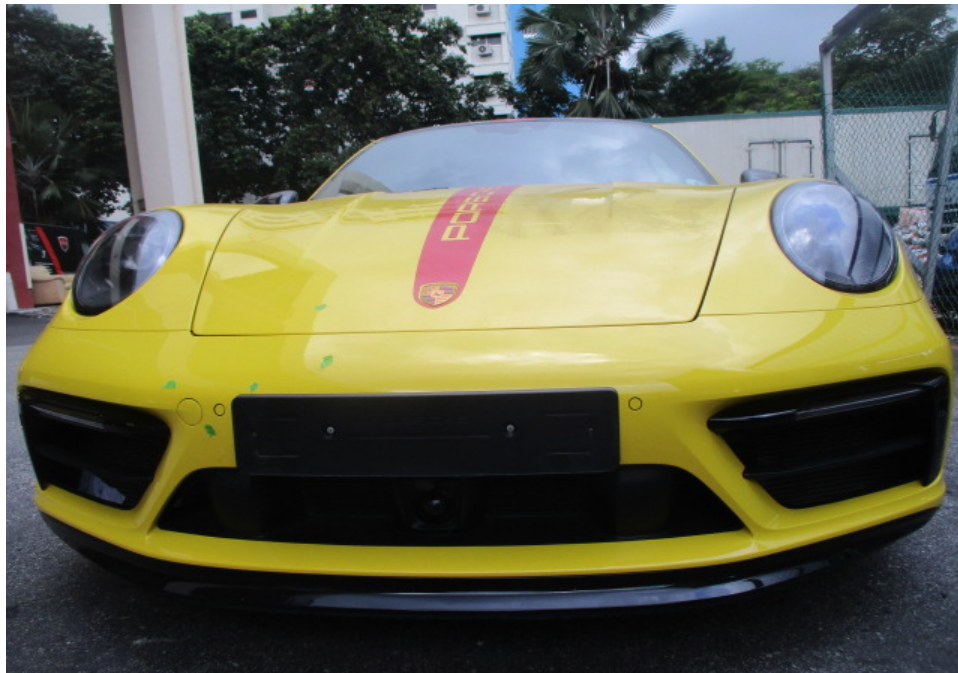
**Photo 9** shows a closer view of the Motor Car's frontal portion at the time of my inspection. The body parts at the frontal portion of the Motor Car were visually examined and it was observed that the repair/restoration works carried out to the damaged area of the Motor Car (refer to photograph 1 & 2 above) were reasonably adequate and in order.

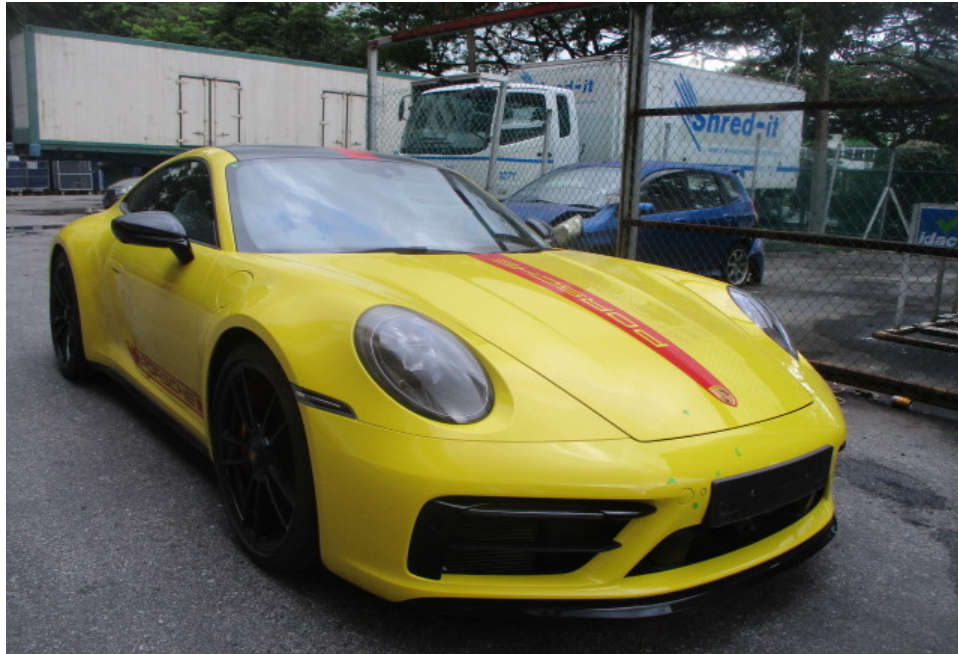
**Photo 10** shows a general view of the front right body of the Motor Car at the time of my inspection. The Motor Car was observed to be in a relatively good general condition with no loose exterior fittings observed. The body parts at the frontal portion of the Motor Car were visually examined and it was observed that the repair/restoration works carried out to the damaged area of the Motor Car (refer to photograph 1 & 2 above) were reasonably adequate and in order.

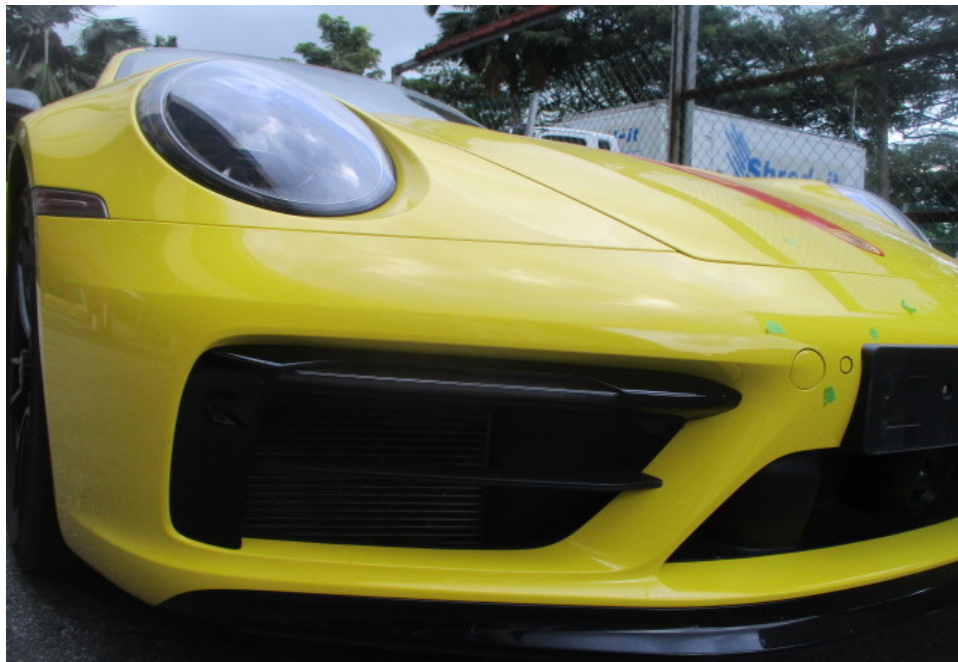
**Photo 11** shows a closer view of the Motor Car's front bumper, front bumper right lower grille, front right day light, front right signal lamp and front right headlamp. The body parts at the frontal portion of the Motor Car were visually examined and it was observed that the repair/restoration works carried out to the damaged area of the Motor Car (refer to photograph 1 & 2 above) were reasonably adequate and in order.

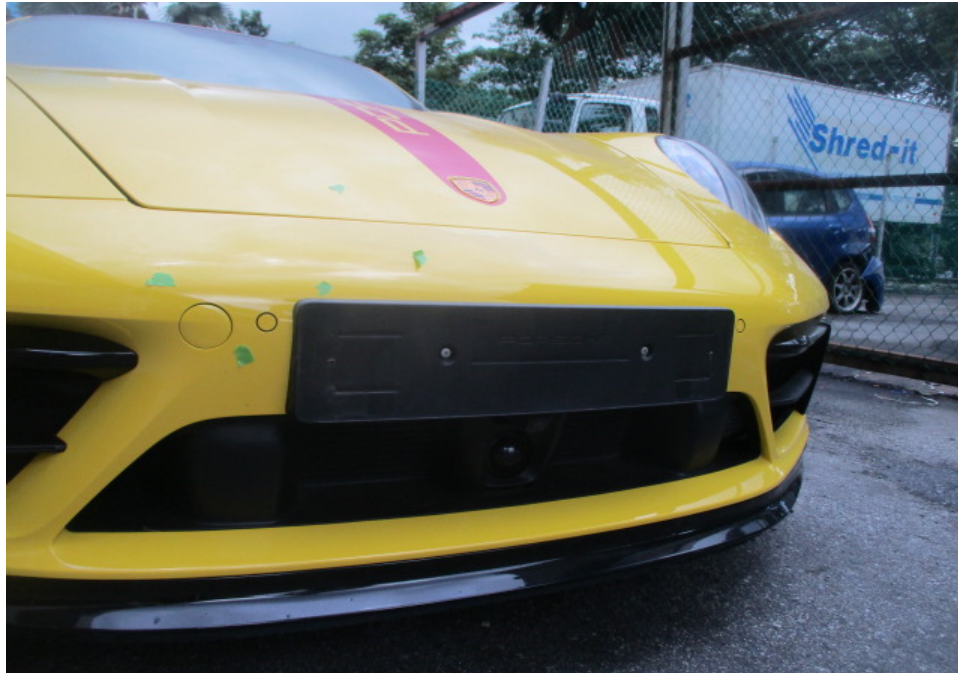
**Photo 12** shows a closer view of the Motor Car's front bumper, front bumper lower lip, front bumper centre air guide and front bumper sensors. The body parts at the frontal portion of the Motor Car were visually examined and it was observed that the repair/restoration works carried out to the damaged area of the Motor Car (refer to photograph 1 & 2 above) were reasonably adequate and in order.

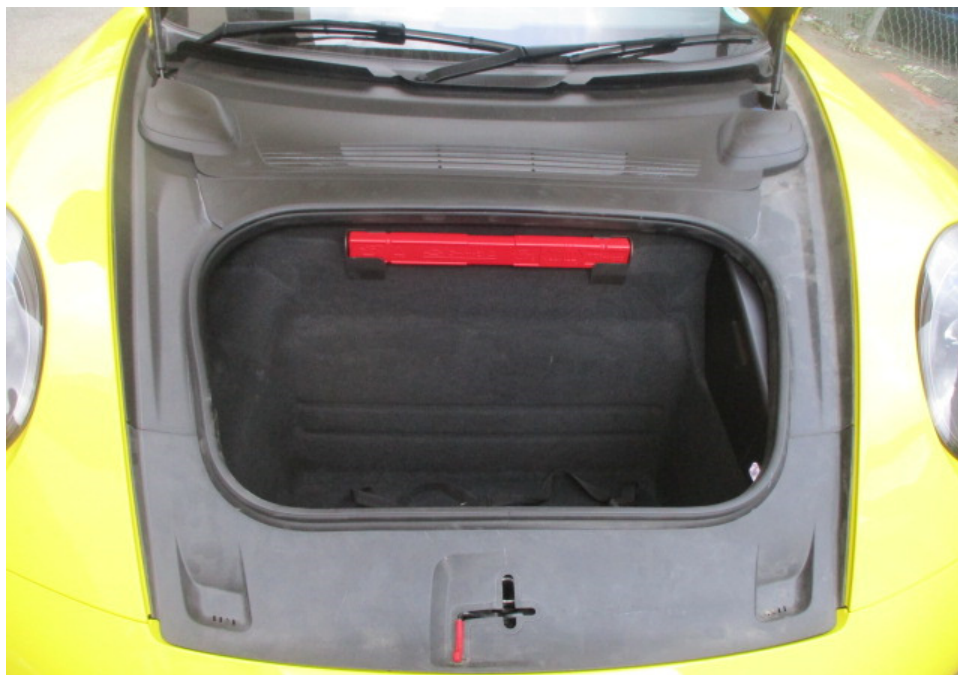
**Photo 13** shows a general view of the Motor Car's front bonnet compartment at the time of my inspection. All inner trims, garnishes and upholstery etc were observed to be properly fitted.

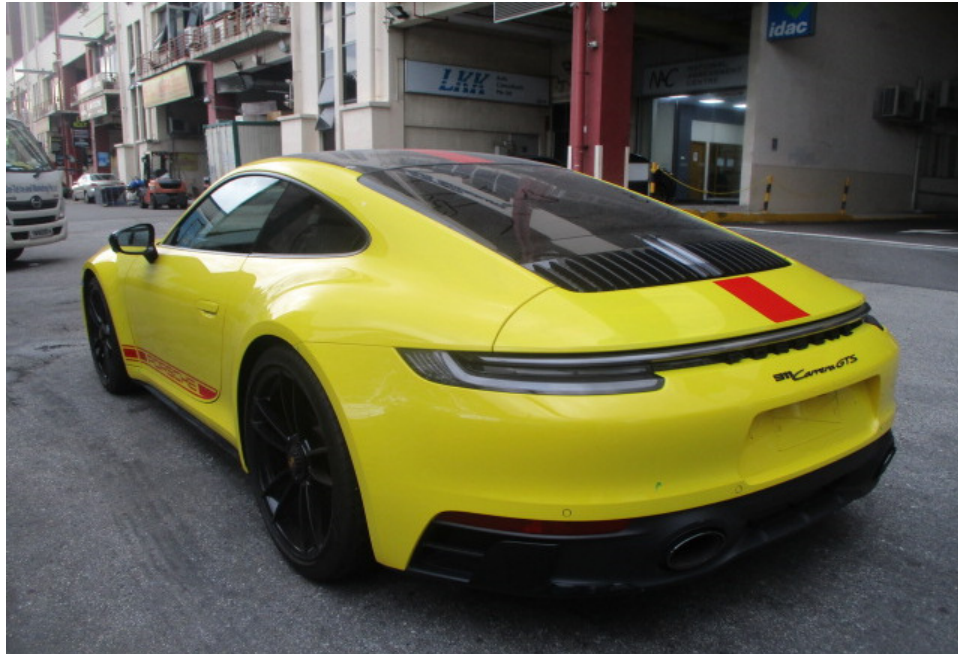
**Photo 14** shows a general view of the rear left body of the Motor Car at the time of my inspection. The Motor Car was observed to be in a relatively good general condition with no loose exterior fittings observed. The body parts at the rear portion of the Motor Car were visually examined and it was observed that the repair/restoration works carried out to the damaged area of the Motor Car (refer to photograph 3 & 4 above) were reasonably adequate and in order.

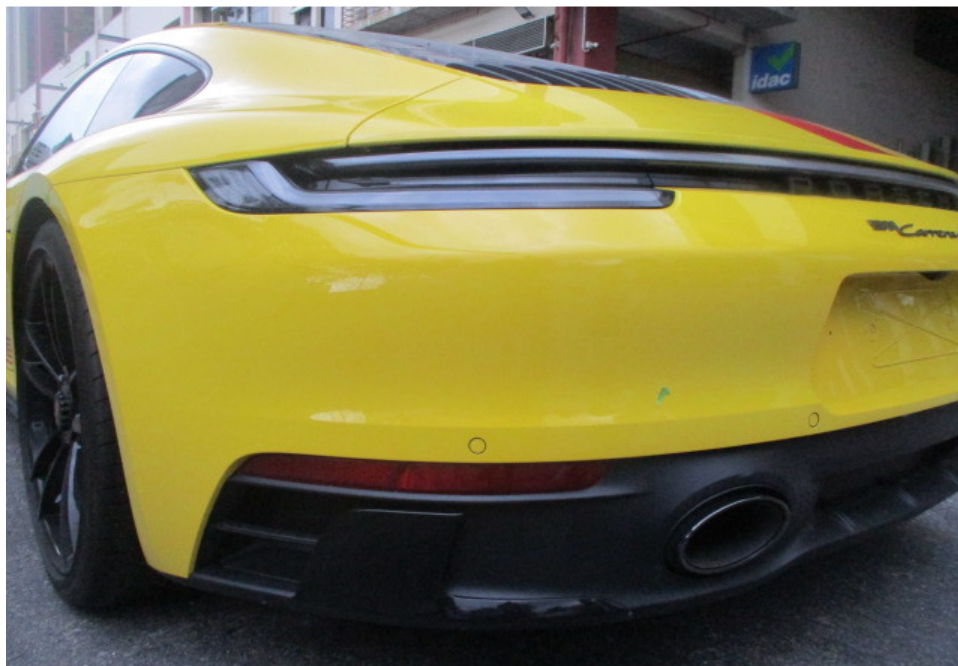
**Photo 15** shows a closer view of the Motor Car's rear bumper, rear bumper lower cover, rear bumper left reflector, rear bumper sensors, rear left exhaust garnish and rear left taillamp. The body parts at the rear portion of the Motor Car were visually examined and it was observed that the repair/restoration works carried out to the damaged area of the Motor Car (refer to photograph 3 & 4 above) were reasonably adequate and in order.

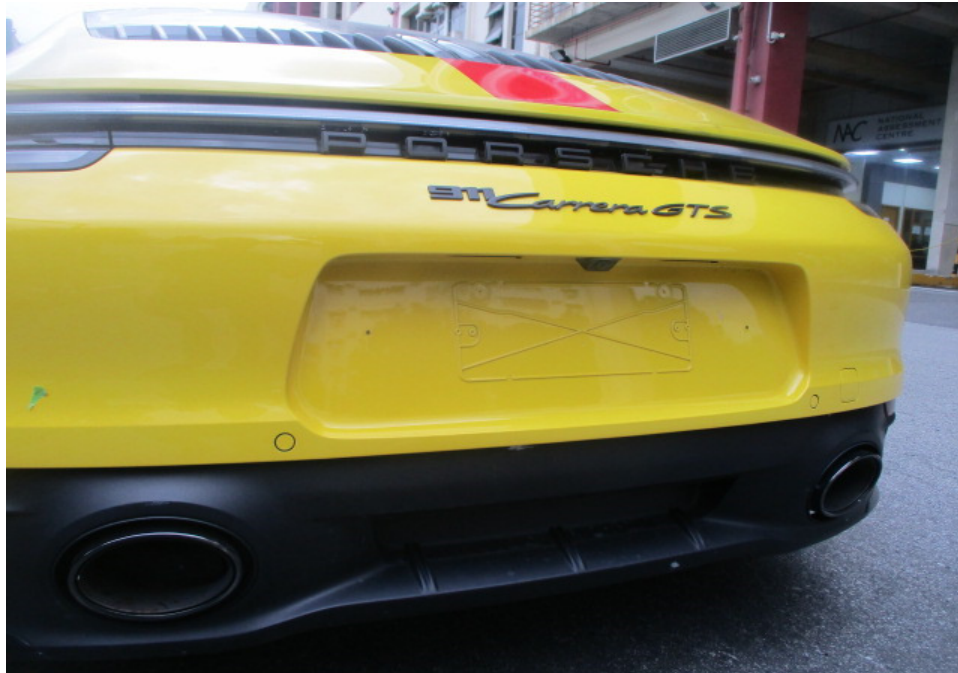
**Photo 16** shows a closer view of the Motor Car's rear bumper, rear bumper lower cover, rear left exhaust garnish and rear centre lamp. The body parts at the rear portion of the Motor Car were visually examined and it was observed that the repair/restoration works carried out to the damaged area of the Motor Car (refer to photograph 3 & 4 above) were reasonably adequate and in order.

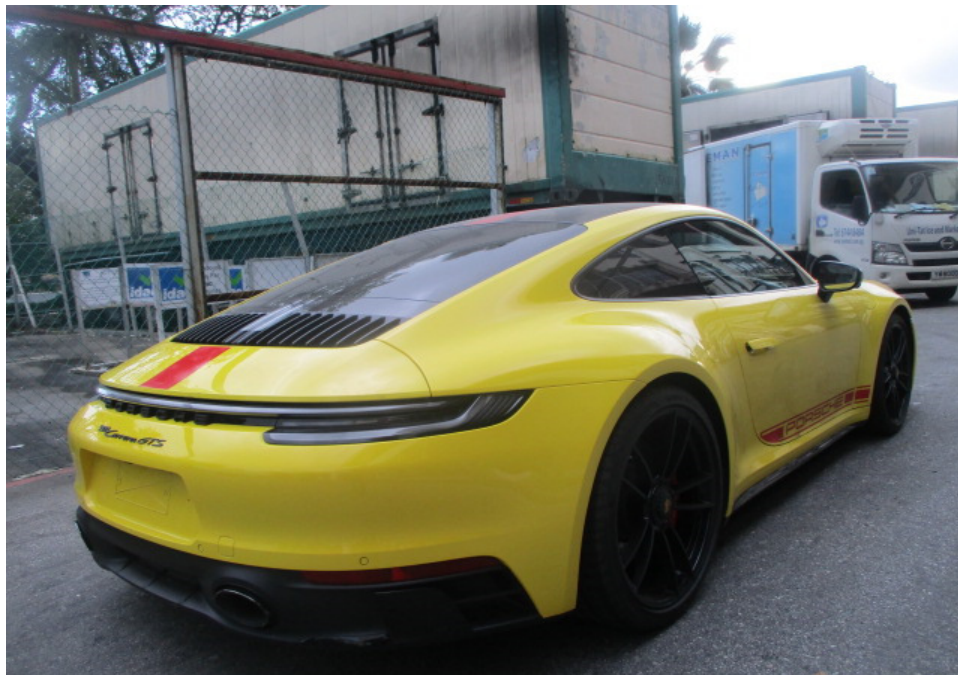
**Photo 17** shows a general view of the rear right body of the Motor Car at the time of my inspection. The Motor Car was observed to be in a relatively good general condition with no loose exterior fittings observed. The body parts at the rear portion of the Motor Car were visually examined and it was observed that the repair/restoration works carried out to the damaged area of the Motor Car (refer to photograph 3 & 4 above) were reasonably adequate and in order.

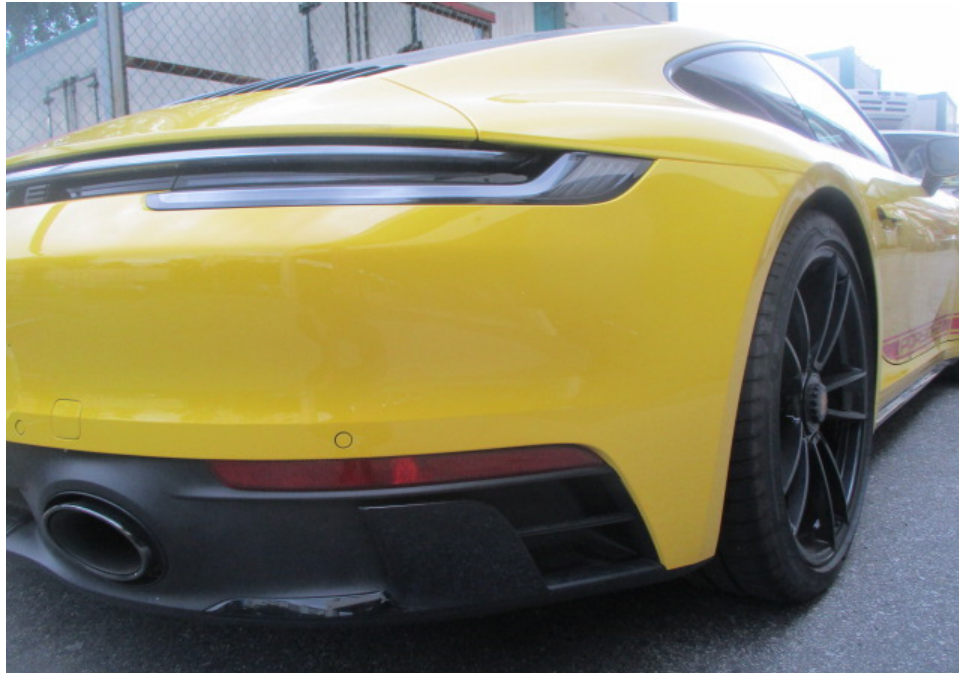
**Photo 18** shows a closer view of the Motor Car's rear bumper, rear bumper lower cover, rear bumper right reflector, rear bumper sensors, rear bumper tow cover, rear right taillamp and rear right exhaust garnish. The body parts at the rear portion of the Motor Car were visually examined and it was observed that the repair/restoration works carried out to the damaged area of the Motor Car (refer to photograph 3 & 4 above) were reasonably adequate and in order.

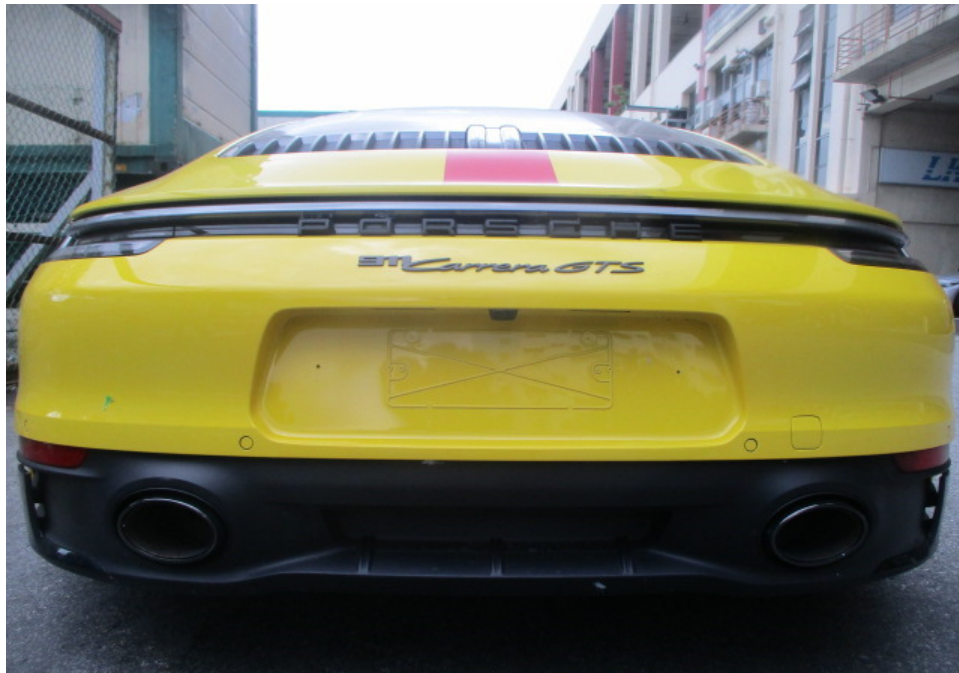
**Photo 19** shows a closer view of the Motor Car's rear portion at the time of my inspection. The body parts at the rear portion of the Motor Car were visually examined and it was observed that the repair/restoration works carried out to the damaged area of the Motor Car (refer to photograph 3 & 4 above) were reasonably adequate and in order.

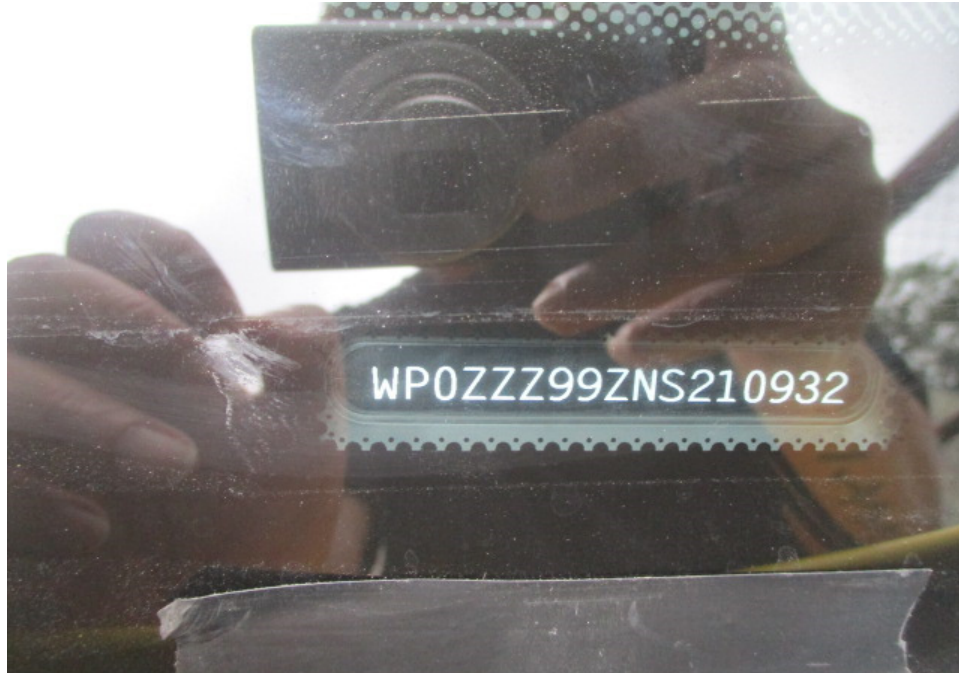
**Photo 20** shows the chassis number of the Motor Car. The chassis number recorded was WP0ZZZ99ZNS210932.

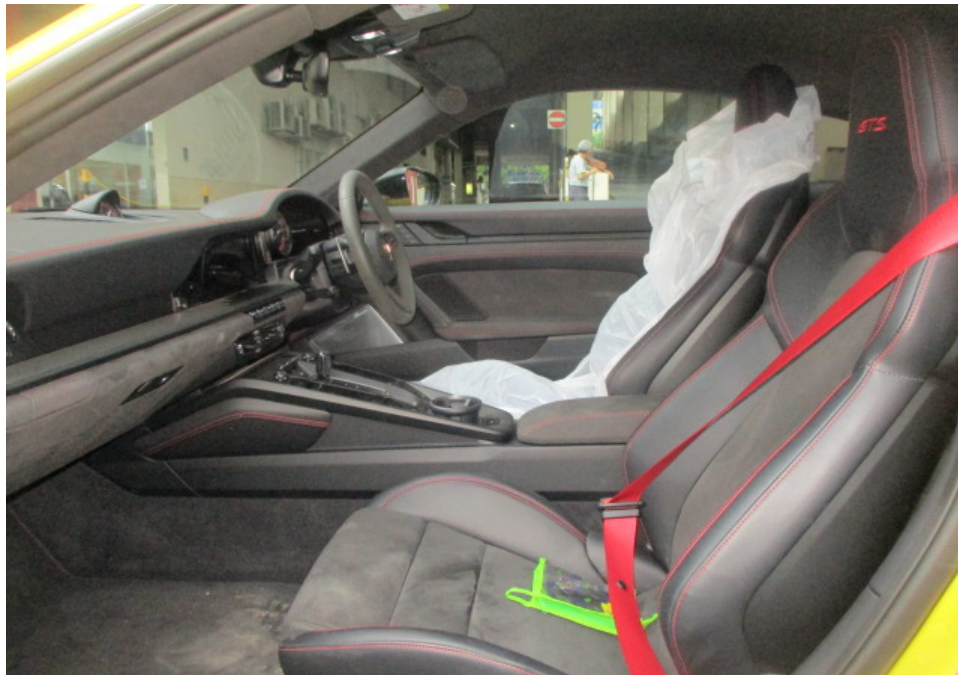
**Photo 21** shows the interior compartment of the Motor Car at the time of my inspection. The various parts and components, trims, carpet, and upholstery inside the interior compartment were all observed to be intact and properly fitted.

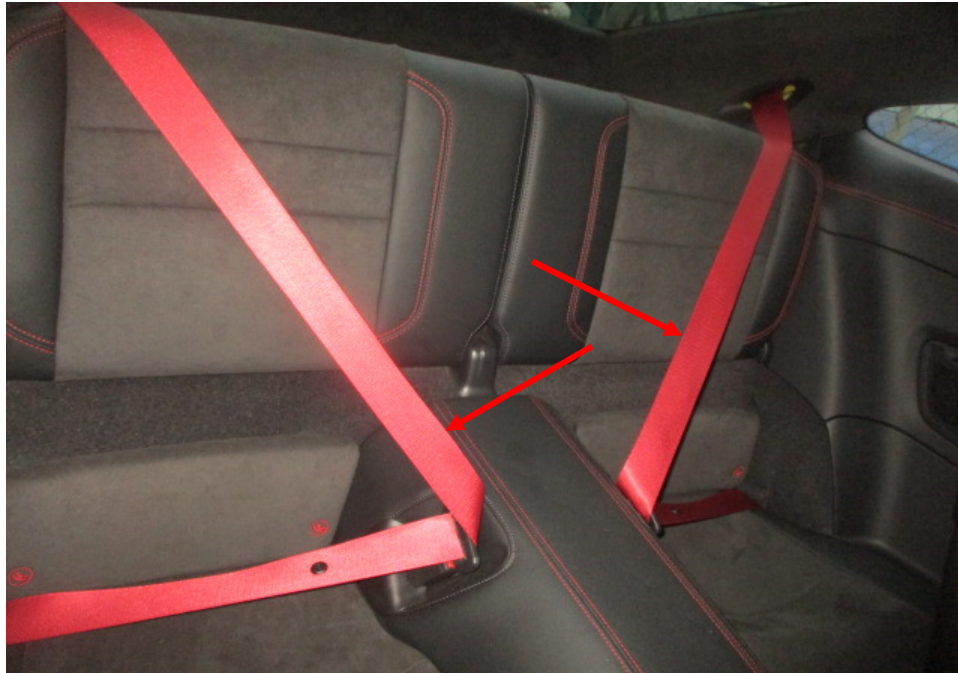
**Photo 22** shows the rear seats of the Motor Car. All the seats of the Motor Car were secured via seat rails to the floorboard. They were also fitted with a retractable seat belt reel and a pre-tensioner. The seat belts (arrowed) were tested and were able to be fastened into the respective pre-tensions that were fitted on the side of each individual seat.

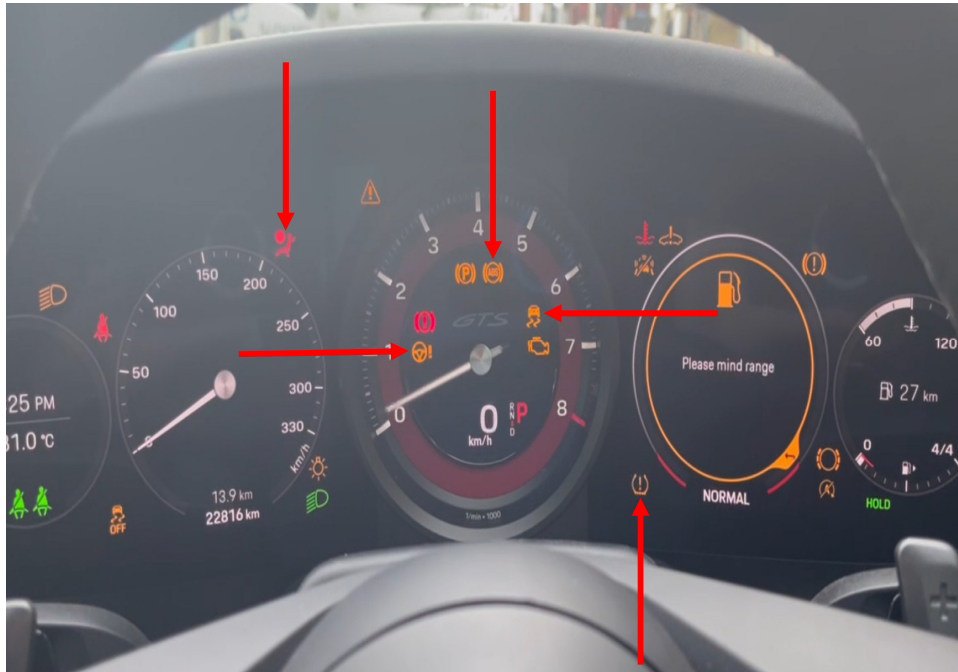
**Photo 23** shows the warning lights for the various electronic safety features appearing on the instrument panel of the Motor Car during its self-test when the engine is cranked, in particular the ABS, SRS, EPS, TPM and TCS lights (arrowed).

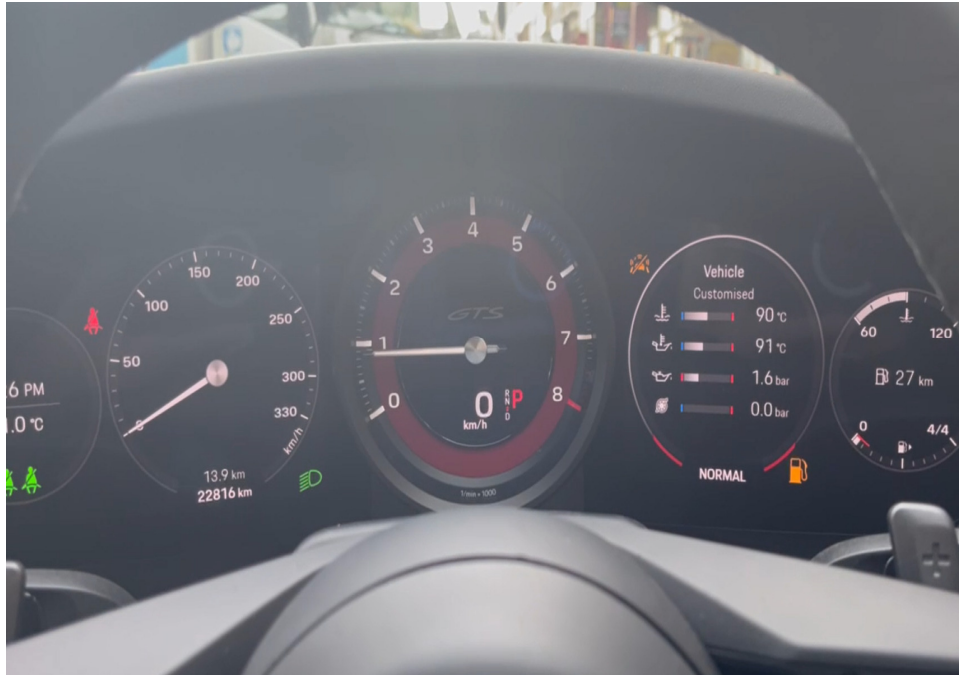
**Photo 24** shows the respective warning lights no longer illuminated, indicating that there is no fault detected to the ABS, SRS, EPS, TPM and TCS systems of the Motor Car during the self-test. These electronic systems were hence in working condition at the time of my inspection.

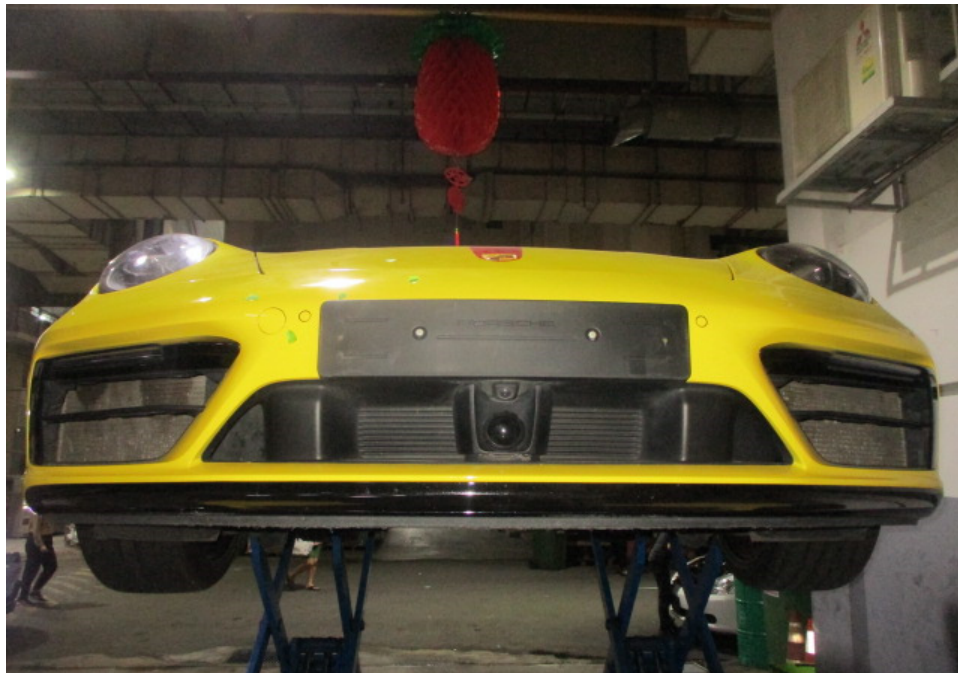
**Photo 25** shows the Motor Car hoisted up for checks on its undercarriage. There was no sign(s) or indication(s) of fluid leakage and/or fluid stain(s) on the underside of the Motor Car. The undercarriage components of the Motor Car were also all observed to be intact and secured in an appropriate manner.

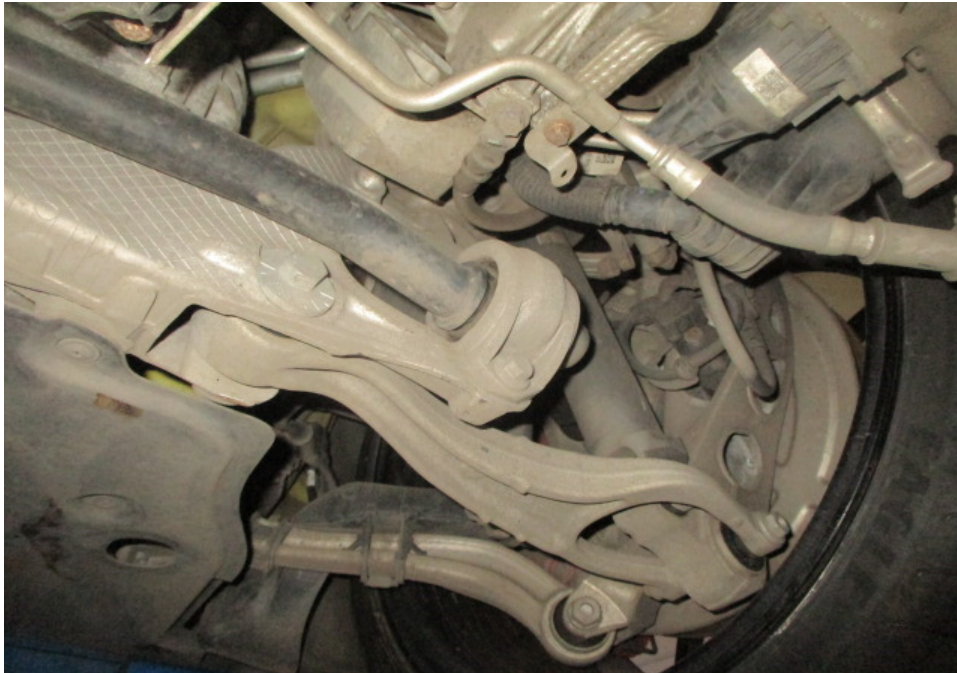
**Photo 26** shows a general view of the control arms and linkages at the rear right wheel of the Motor Car. I did not observe any fluid leak and/or fluid stain on the underside of the Motor Car. All of the Motor Car's undercarriage components were observed to be intact and secured in an appropriate manner.

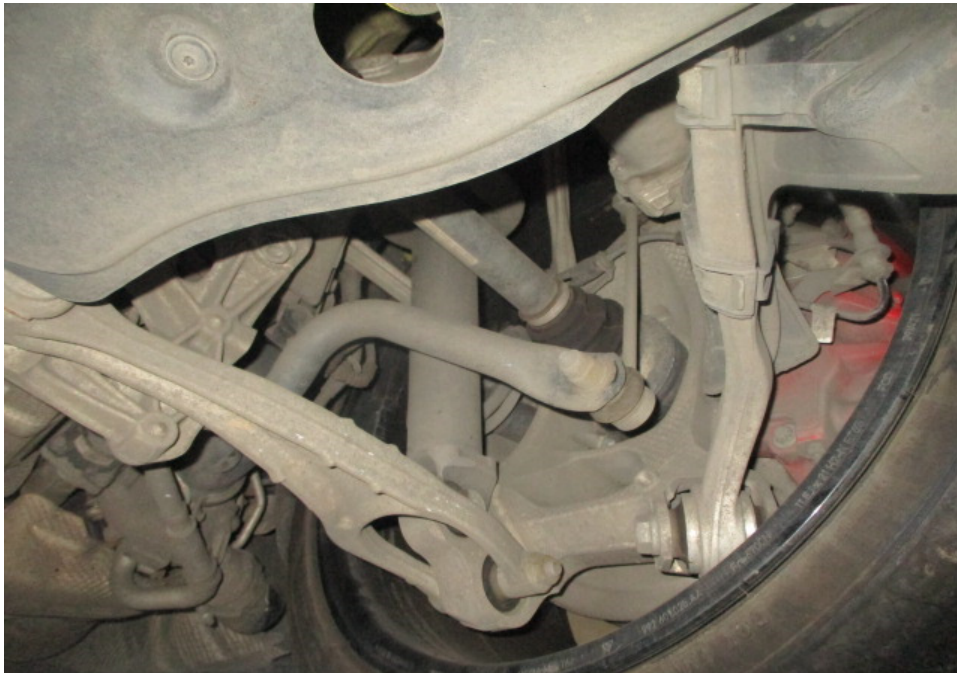
**Photo 27** shows a general view of the control arms and linkages at the rear left wheel of the Motor Car. I did not observe any fluid leak and/or fluid stain on the underside of the Motor Car. All of the Motor Car's undercarriage components were observed to be intact and secured in an appropriate manner.

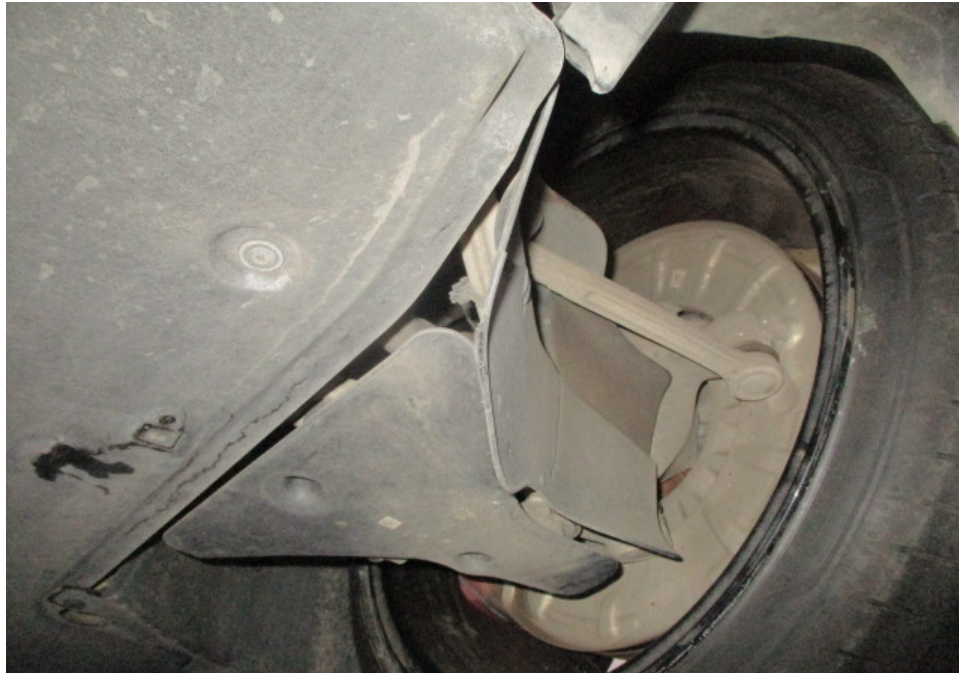
**Photo 28** shows the various undercarriage components at the front left wheel of the Motor Car. The mechanical components, control arms and linkages were all found to be intact and secured in an appropriate manner.

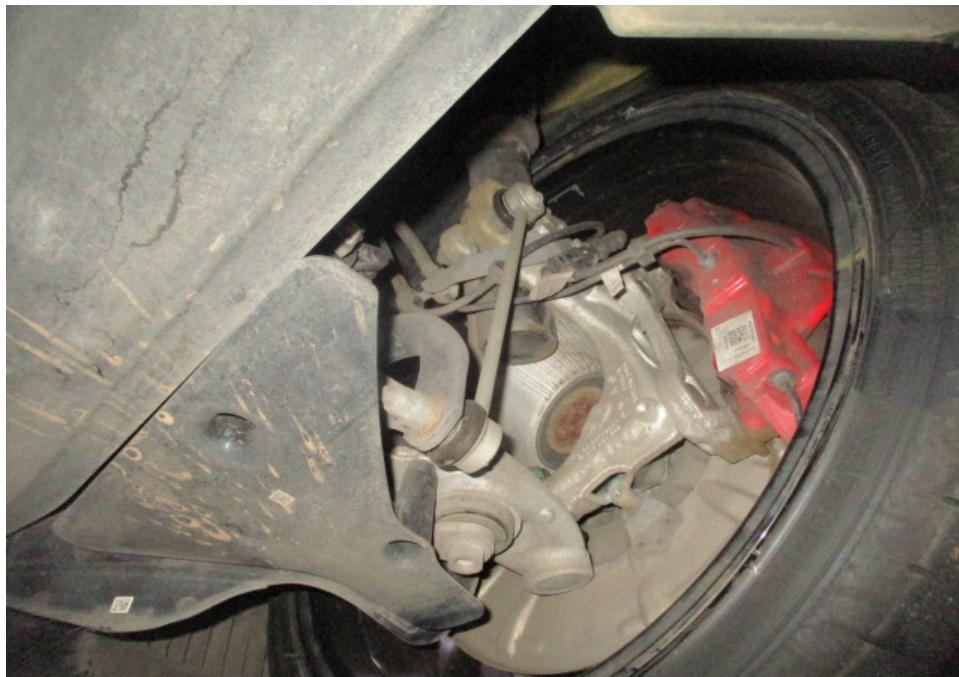
**Photo 29** shows the various undercarriage components at the front right wheel of the Motor Car. The mechanical components, control arms and linkages were all found to be intact and secured in an appropriate manner. I also did not observe any fluid leak and/or fluid stain on the underside of the Motor Car.

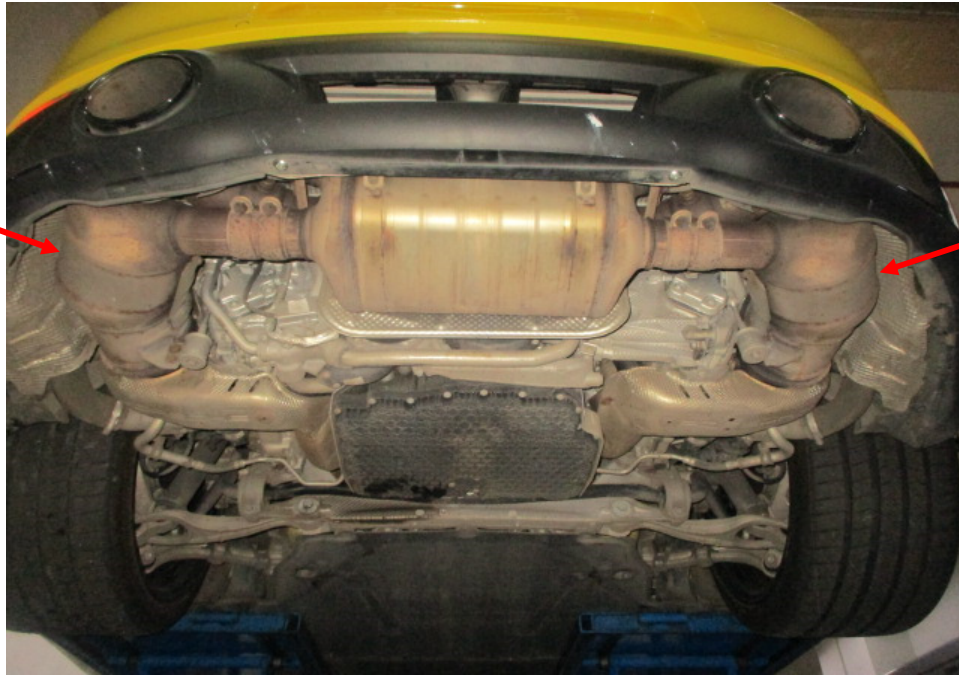
**Photo 30** shows the Motor Car's exhaust system. My examination of the Motor Car's exhaust system revealed no sign(s) or indication(s) of any cut or weld marks along its exhaust pipes, on its catalytic converters (arrowed) and on its rear muffler.
