Your Ref: Porsche 911 Carrera GTS  
(chassis number WP0ZZZ99ZNS210932)  
Our Ref: CI/TP23006923/D

**INSPECTION REPORT OF AN UNREGISTERED PORSCHE 911 CARRERA  
GTS MOTOR CAR WITH CHASSIS NUMBER WP0ZZZ99ZNS210932**

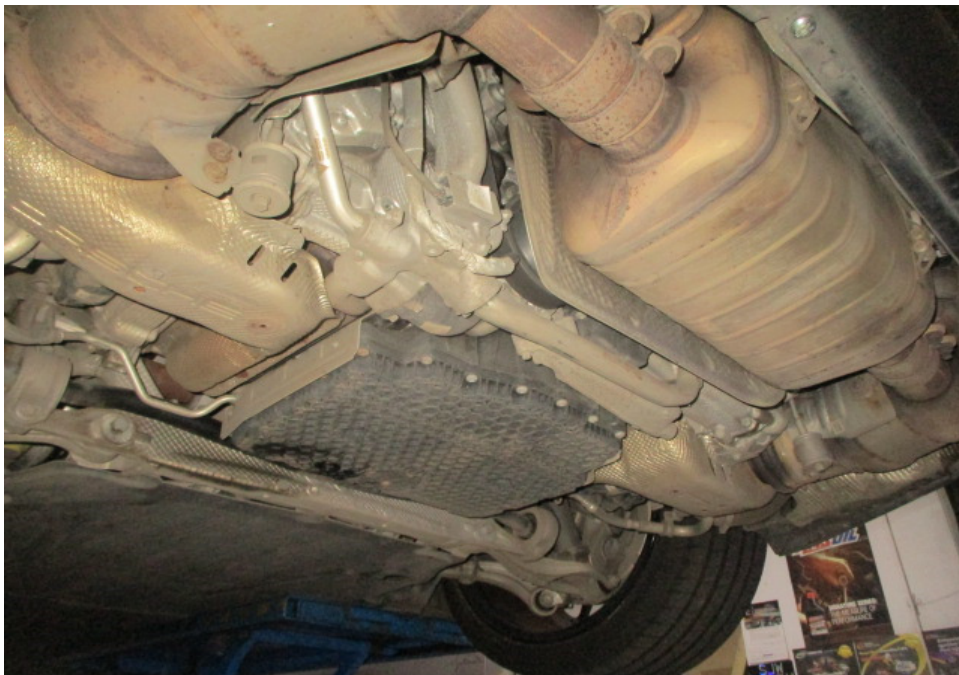
**Photo 31** shows a general view of the Motor Car's engine compartment. The engine compartment was at the rear underside of the Motor Car. The various parts and components within the engine compartment were all observed to be intact and properly fitted. There was also no sign(s) or indication(s) of fluid leak and/or fluid stain found inside the engine compartment.

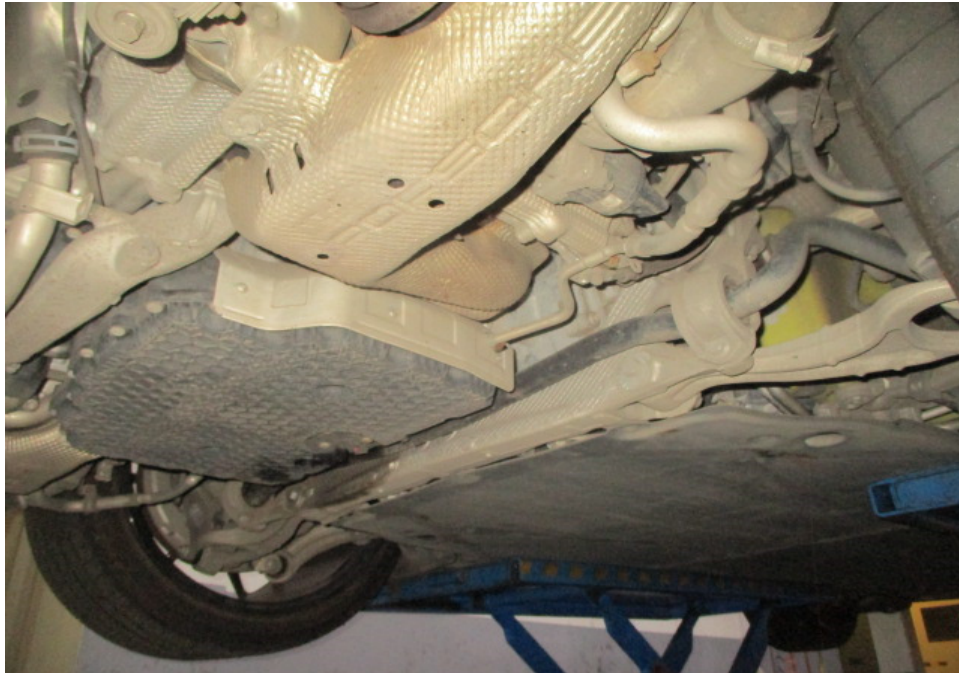
**Photo 32** shows another view of the Motor Car's engine compartment. The engine compartment was at the rear underside of the Motor Car. The various parts and components within the engine compartment were all observed to be intact and properly fitted. There was also no sign(s) or indication(s) of fluid leak and/or fluid stain found inside the engine compartment.

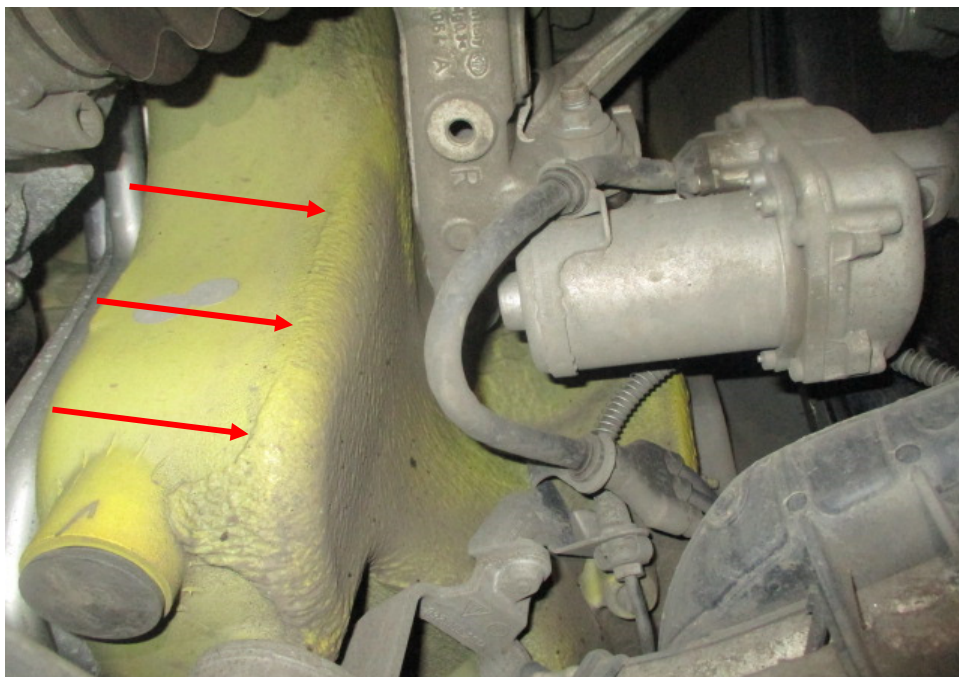
**Photo 33** shows the chassis/structural body at the underside rear right of the Motor Car. I did not find any weld marks other than original spot weld marks on the chassis/structural body of the Motor Car. The original factory sealant (arrowed) at the joints along the chassis/structural body was untouched, indicating no work was done on the chassis/structural body of the Motor Car and that the chassis/structural body was originally fitted.

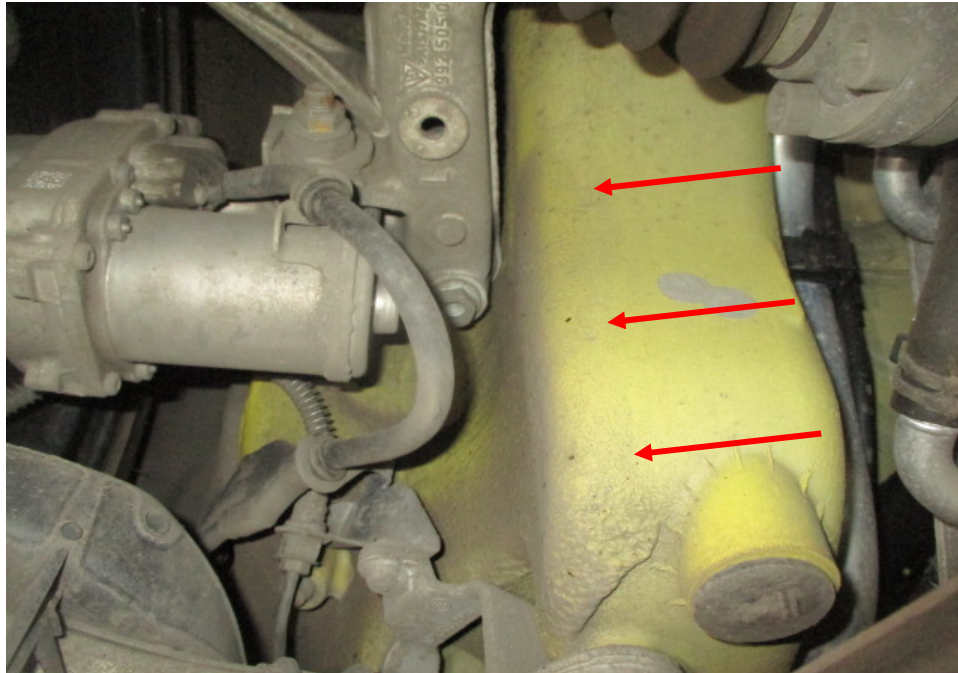
**Photo 34** shows the chassis/structural body at the underside rear left of the Motor Car. The original factory sealant (arrowed) at the joints along the chassis/structural body was observed to be untouched. In general, I had found no work was carried out on the chassis/structural body of the Motor Car. The chassis/structural body of the Motor Car was originally fitted.

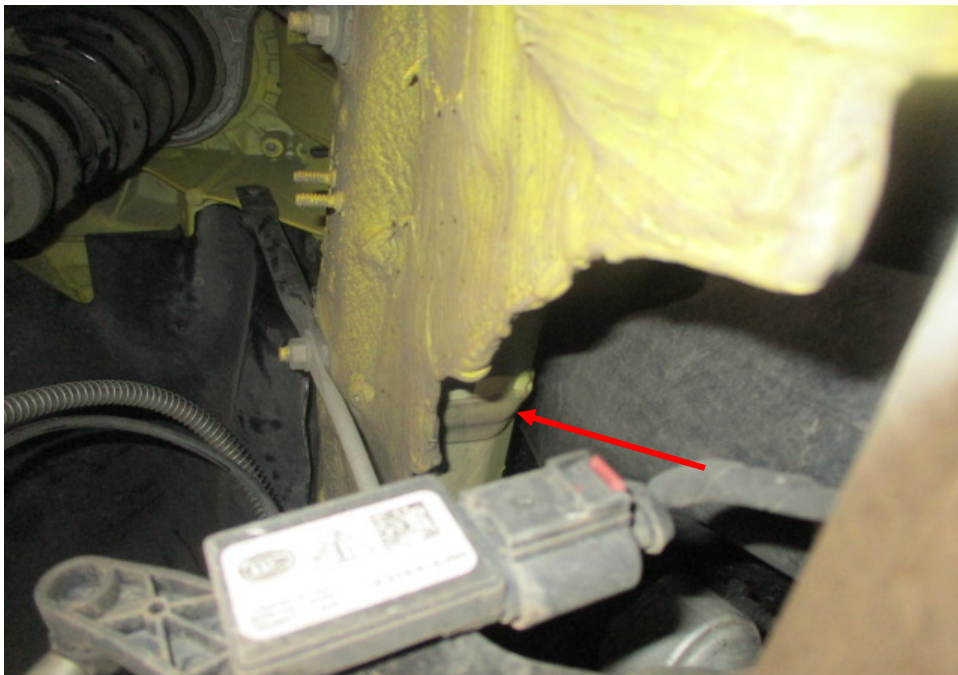
**Photo 35** shows the chassis/structural body at the underside front left of the Motor Car. I did not find any weld marks other than original spot weld marks on the chassis/structural body of the Motor Car. The original factory sealant (arrowed) at the joints along the chassis/structural body was untouched, indicating no work was done on the chassis/structural body of the Motor Car and that the chassis/structural body was originally fitted.

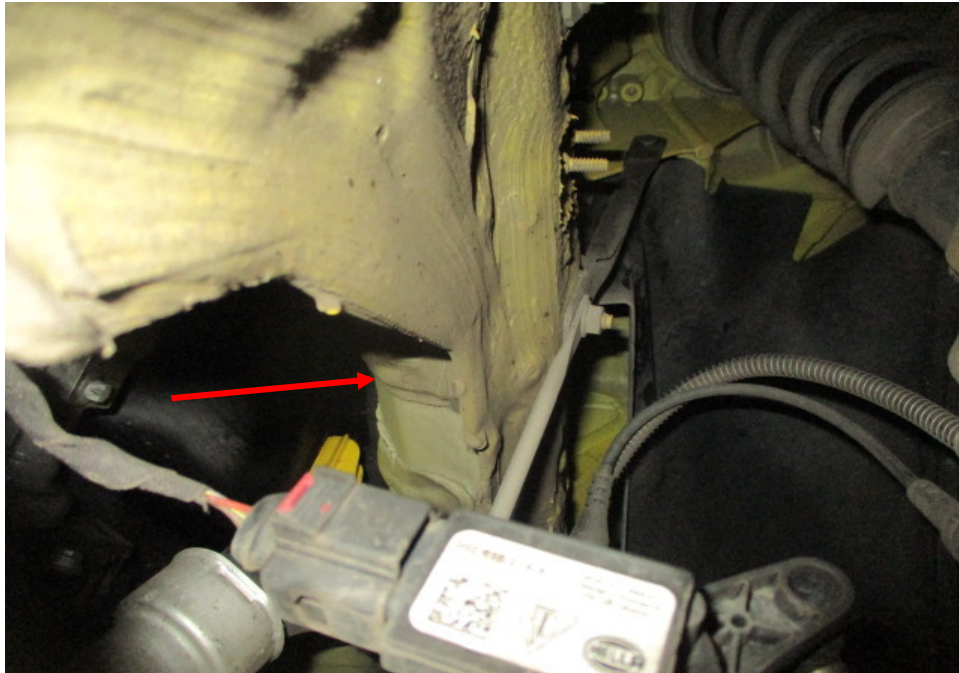
**Photo 36** shows the chassis/structural body at the underside front right of the Motor Car. The original factory sealant (arrowed) at the joints along the chassis/structural body was observed to be untouched. In general, I had found no work was carried out on the chassis/structural body of the Motor Car. The chassis/structural body of the Motor Car was originally fitted.
