Your Ref: Audi RS 6
(chassis number WUAZZZF28NN901124)
Our Ref : CI/TP23006925/D

**INSPECTION REPORT OF AN UNREGISTERED AUDI RS 6 MOTOR CAR
WITH CHASSIS NUMBER WUAZZZF28NN901124**

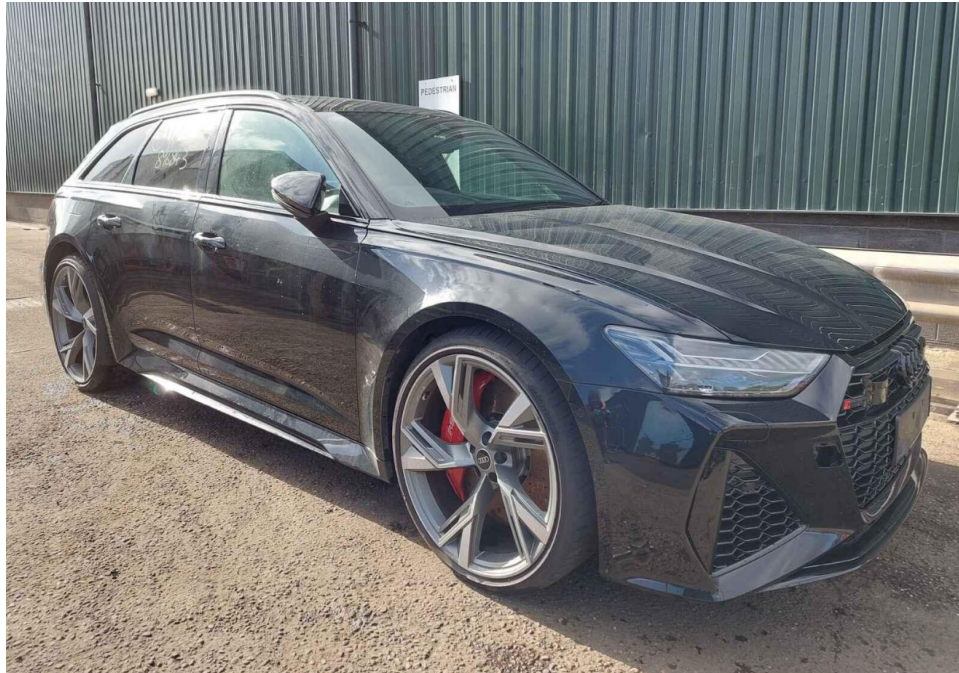
Photo 1 shows the front right body of the Motor Car (photograph provided to me). The photographs provided to me had showed damage of fire/heat/smoke nature to several parts and components within the interior compartment of the Motor Car. The exterior body of the Motor Car was observed to be relatively undamaged.

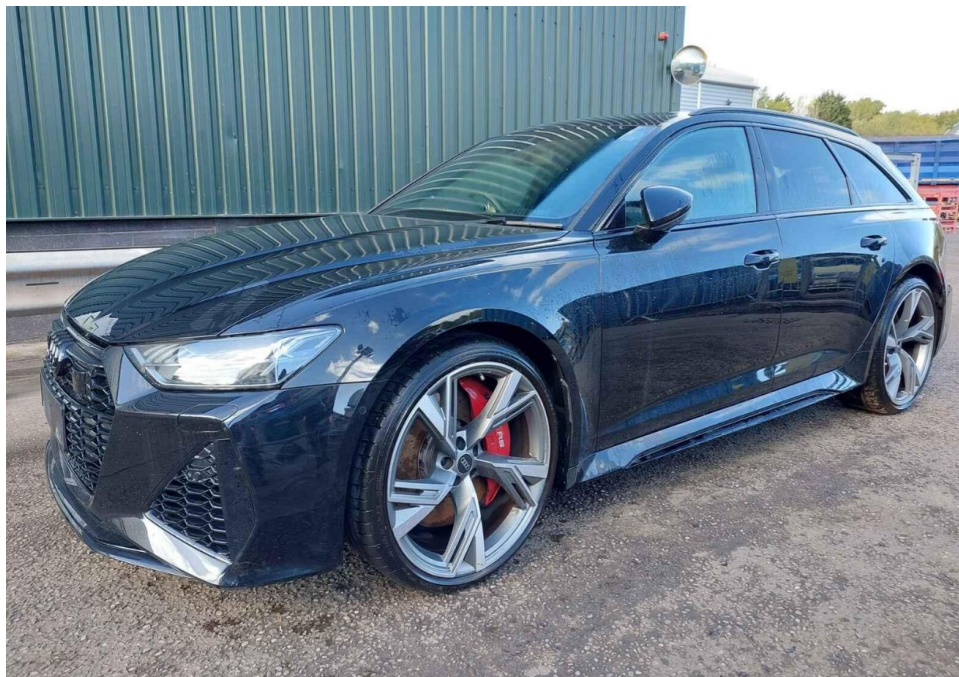
Photo 2 shows the front left body of the Motor Car (photograph provided to me). The photographs provided to me had showed damage of fire/heat/smoke nature to several parts and components within the interior compartment of the Motor Car. The exterior body of the Motor Car was observed to be relatively undamaged.

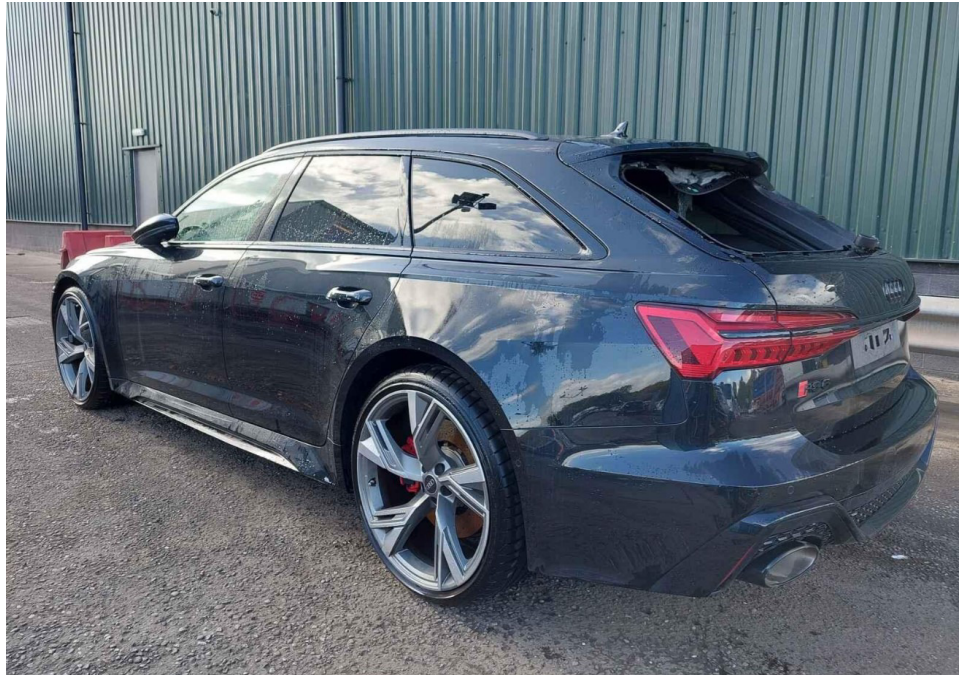
Photo 3 shows the rear left body of the Motor Car (photograph provided to me). The photographs provided to me had showed damage of fire/heat/smoke nature to several parts and components within the interior compartment of the Motor Car. The exterior body of the Motor Car was observed to be relatively undamaged. I did however observe that the rear windscreen was shattered.

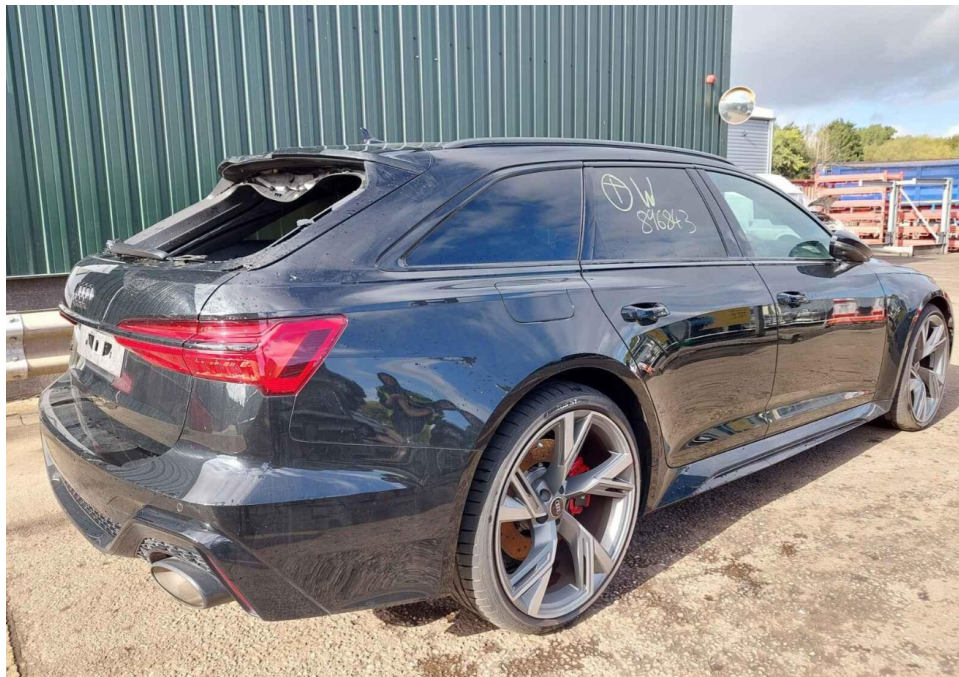
Photo 4 shows the rear right body of the Motor Car (photograph provided to me). The photographs provided to me had showed damage of fire/heat/smoke nature to several parts and components within the interior compartment of the Motor Car. The exterior body of the Motor Car was observed to be relatively undamaged. I did however observe that the rear windscreen was shattered.

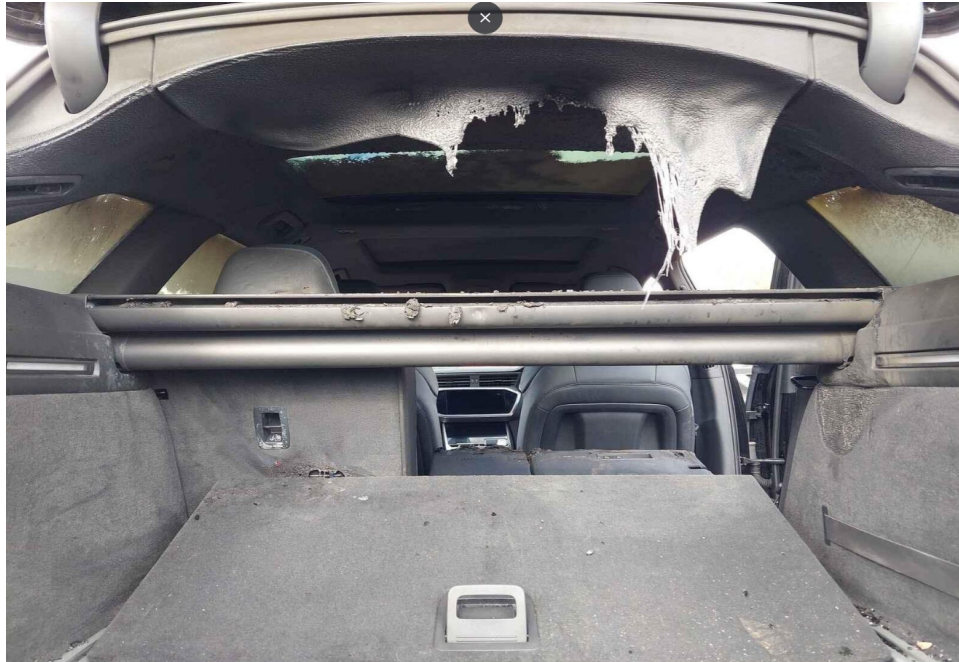
Photo 5 shows the rear interior compartment of the Motor Car (photograph provided to me). The photographs provided to me had showed damage of fire/heat/smoke nature to several parts and components within the interior compartment of the Motor Car. Parts and components affected had included the rear seats, roof upholstery, various inner trims, door windows, front windscreen and moon roof glass amongst others.

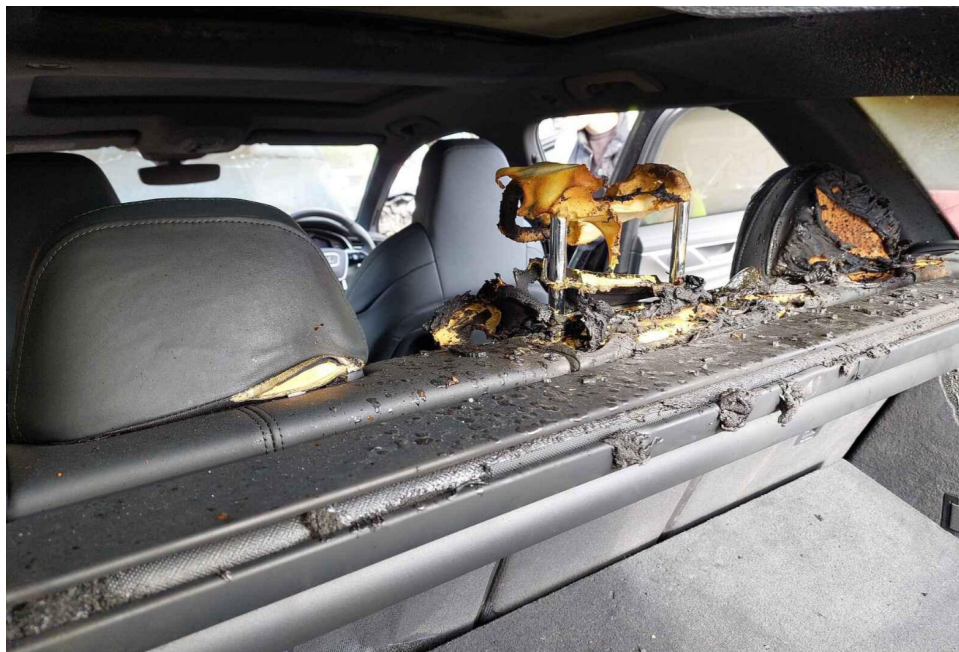
Photo 6 shows another view of the rear interior compartment of the Motor Car (photograph provided to me). Damage of fire/heat/smoke nature was seen to several parts and components within the interior compartment of the Motor Car. Parts and components affected had included the rear seats, roof upholstery, various inner trims, door windows, front windscreen and moon roof glass amongst others.

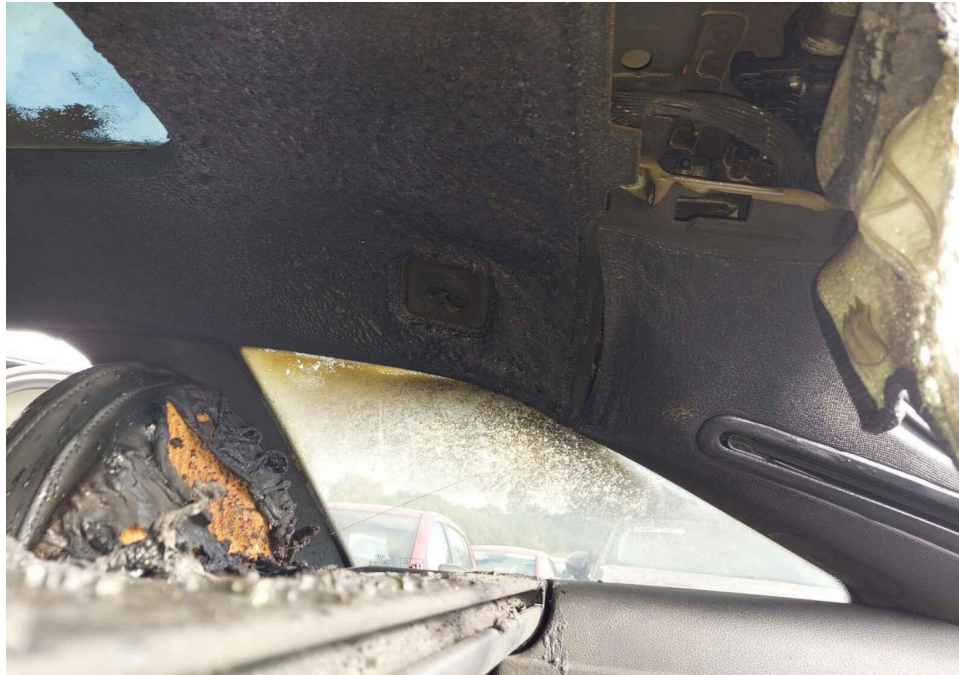
Photo 7 shows another view of the rear interior compartment of the Motor Car (photograph provided to me). Damage of fire/heat/smoke nature was seen to several parts and components within the interior compartment of the Motor Car. Parts and components affected had included the rear seats, roof upholstery, various inner trims, door windows, front windscreen and moon roof glass amongst others.

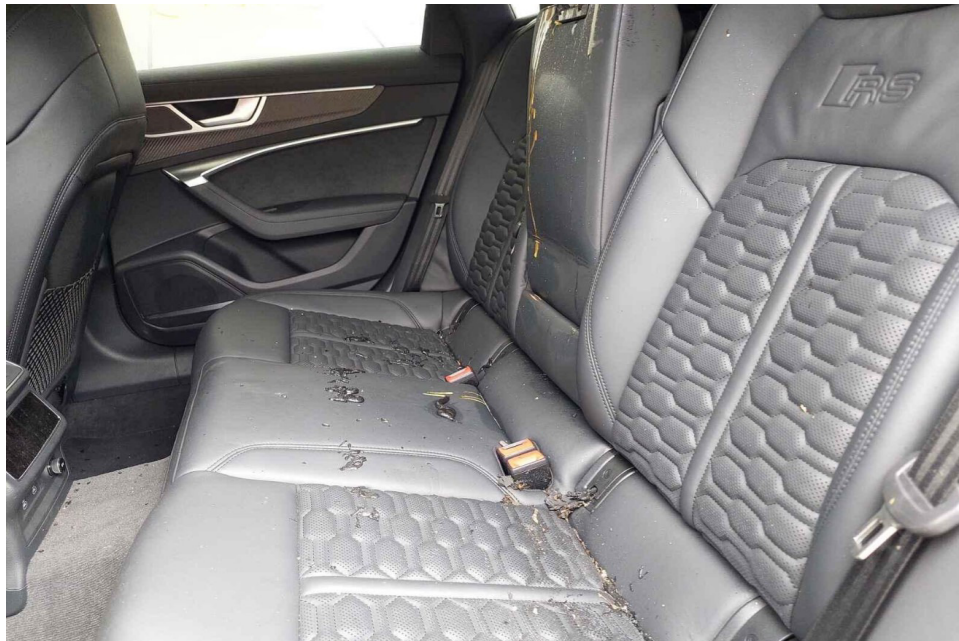
Photo 8 shows another view of the rear interior compartment of the Motor Car (photograph provided to me). Damage of fire/heat/smoke nature was seen to several parts and components within the interior compartment of the Motor Car. Parts and components affected had included the rear seats, roof upholstery, various inner trims, door windows, front windscreen and moon roof glass amongst others.

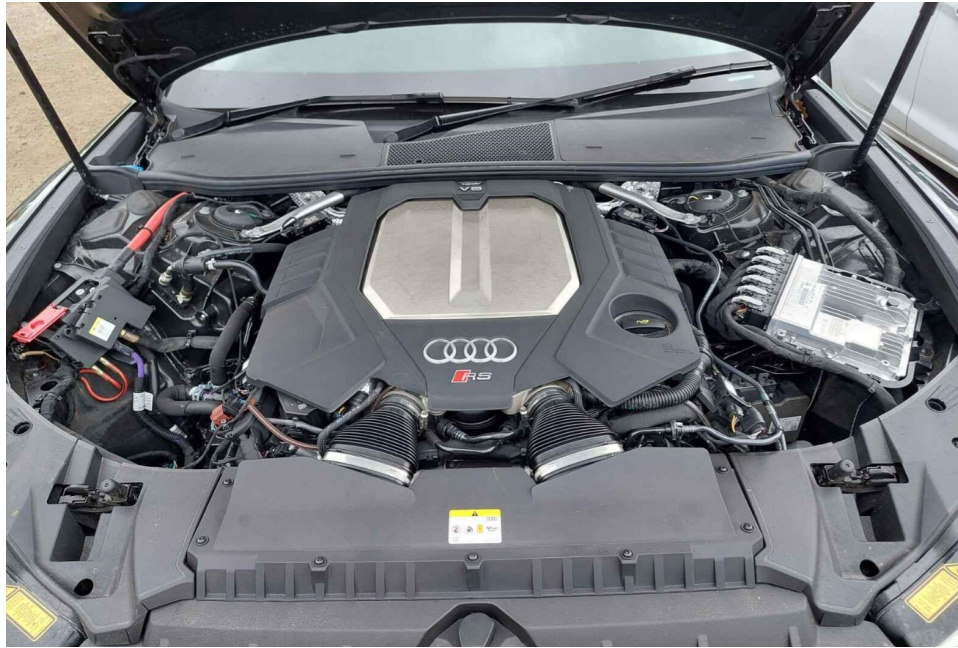
Photo 9 shows the engine compartment of the Motor Car (photograph provided to me). The various parts and components within the engine compartment were observed to be intact and unaffected.

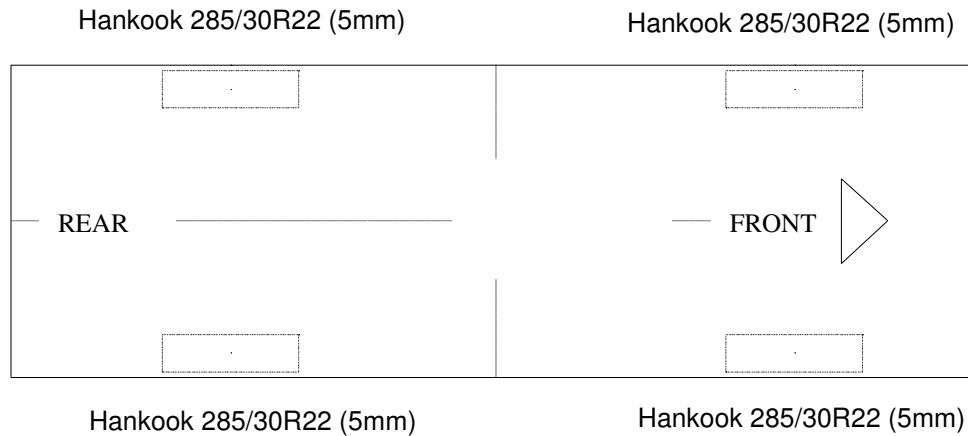
8. The Motor Car was fitted with 22inch sport wheel rims that were wrapped with tyres that were observed to be of serviceable condition. The tyres were also sufficiently inflated for vehicular operation. The tyre brand, tyre size and approximate remaining tread depth of the 4 tyres of the Motor Car were recorded as follows: -

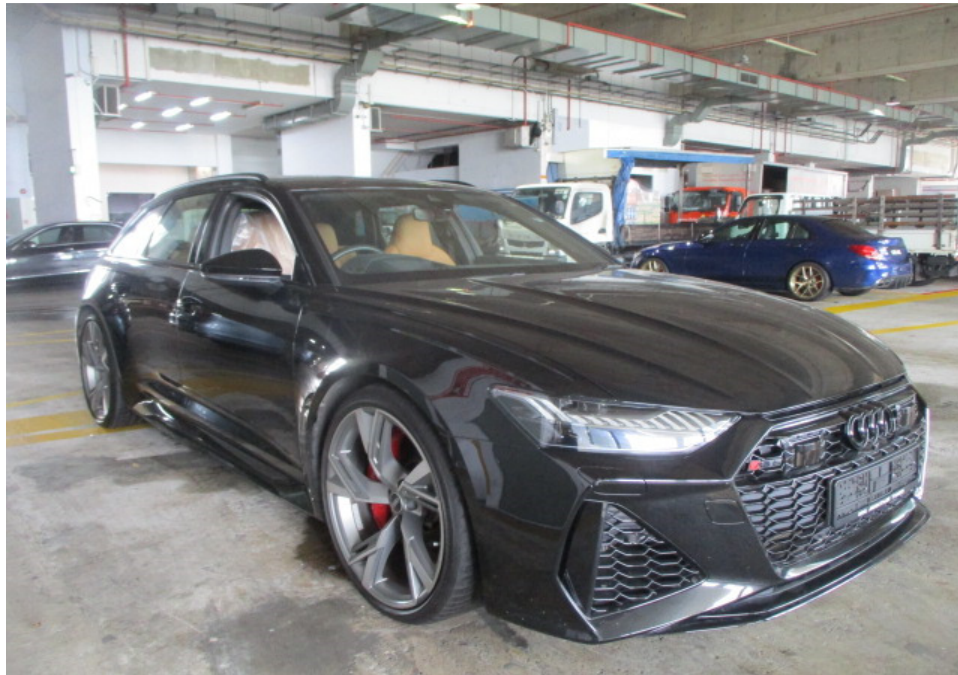
Photo 10 shows a general view of the front right body of the Motor Car at the time of my inspection. The Motor Car was observed to be in a relatively good general condition with no loose exterior fittings observed. The mileage of the Motor Car recorded at the time of my inspection was 8km.

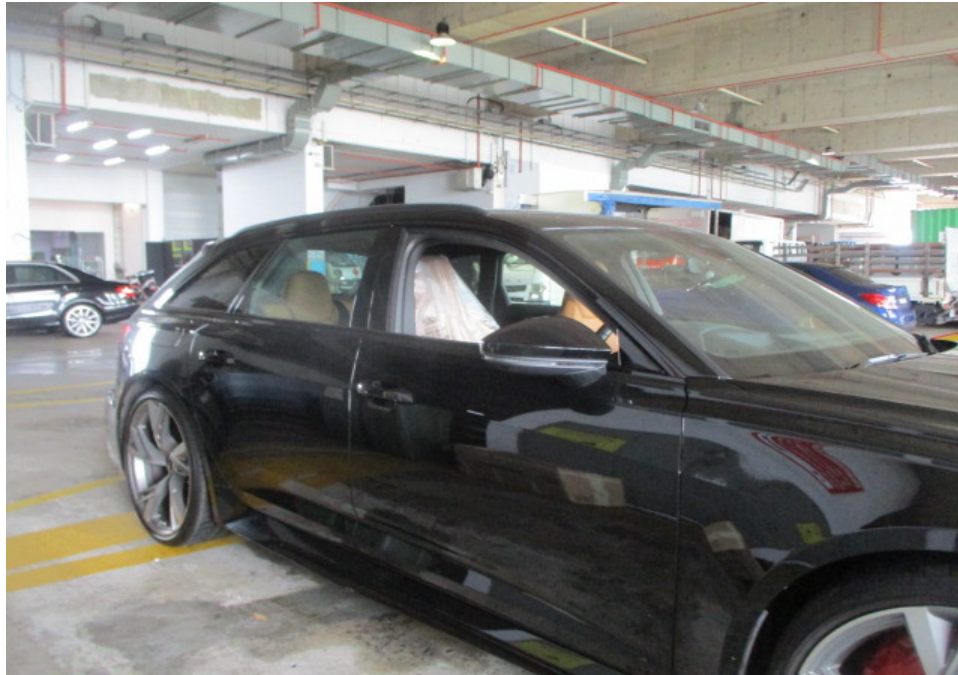
Photo 11 shows a general view of the right centre body of the Motor Car at the time of my inspection. The Motor Car was observed to be in a relatively good general condition with no loose exterior fittings observed. The mileage of the Motor Car recorded at the time of my inspection was 8km.

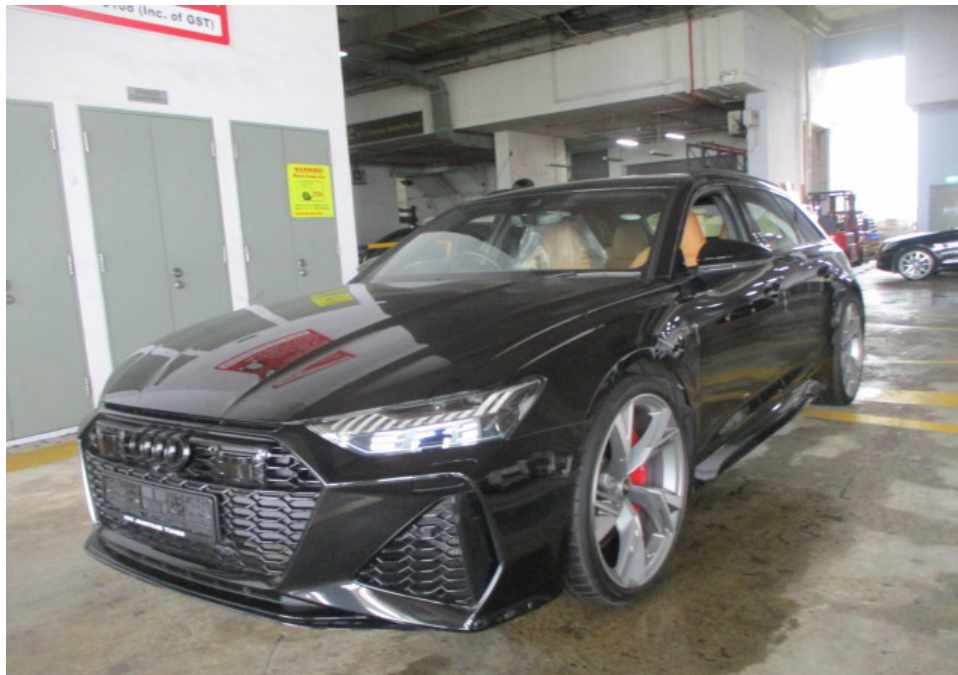
Photo 12 shows a general view of the front left body of the Motor Car at the time of my inspection. The Motor Car was observed to be in a relatively good general condition with no loose exterior fittings observed. The mileage of the Motor Car recorded at the time of my inspection was 8km.

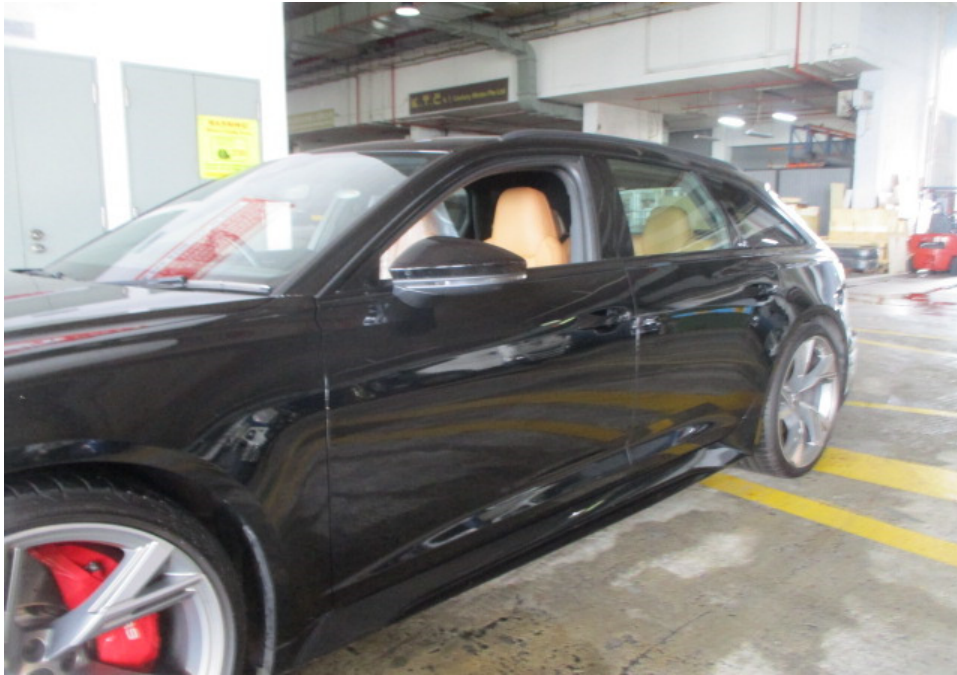
Photo 13 shows a general view of the left centre body of the Motor Car at the time of my inspection. The Motor Car was observed to be in a relatively good general condition with no loose exterior fittings observed. The mileage of the Motor Car recorded at the time of my inspection was 8km.

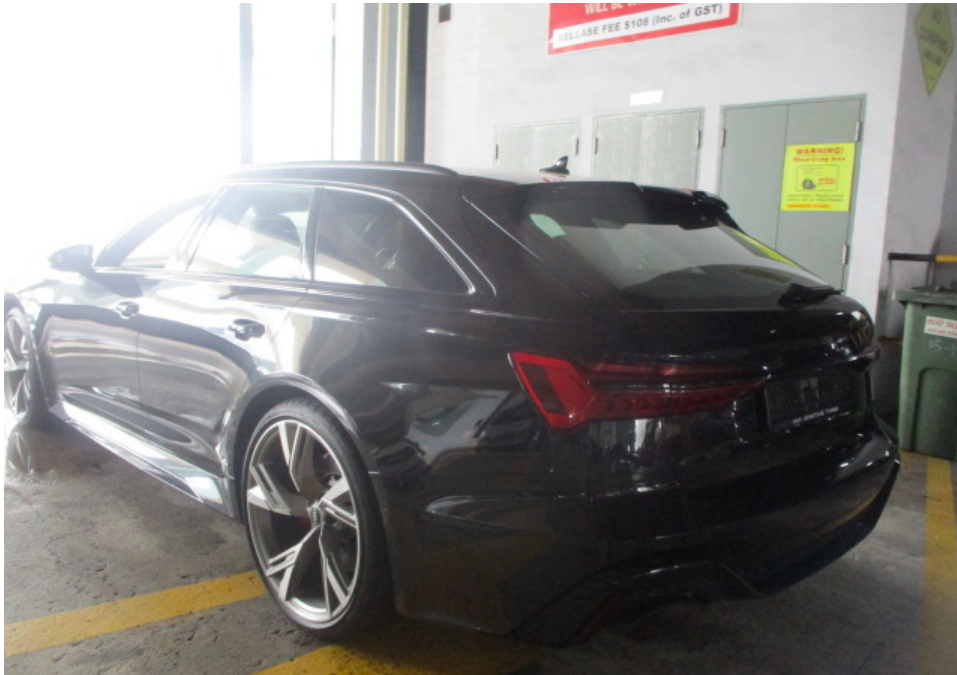
Photo 14 shows a general view of the rear left body of the Motor Car at the time of my inspection. The Motor Car was observed to be in a relatively good general condition with no loose exterior fittings observed. The mileage of the Motor Car recorded at the time of my inspection was 8km.

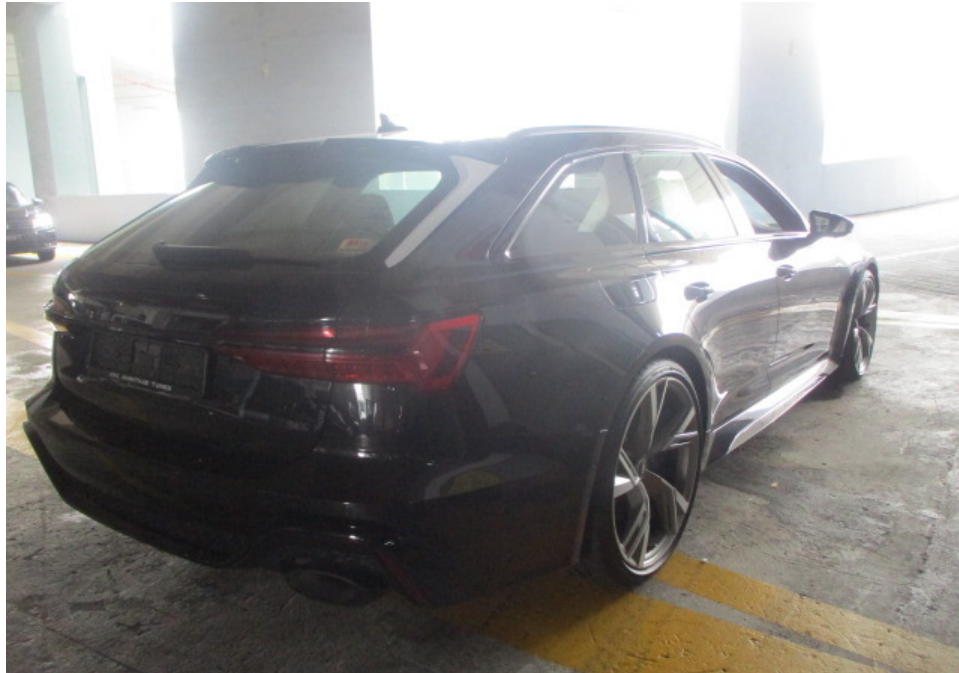
Photo 15 shows a general view of the rear right body of the Motor Car at the time of my inspection. The Motor Car was observed to be in a relatively good general condition with no loose exterior fittings observed. The mileage of the Motor Car recorded at the time of my inspection was 8km.

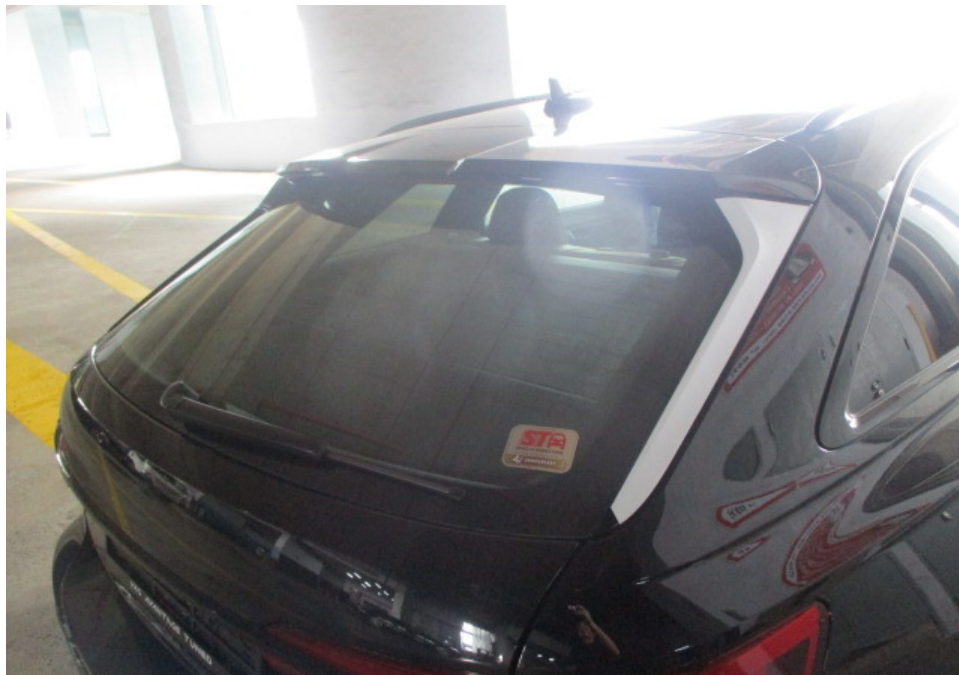
Photo 16 shows a closer view of the Motor Car's rear tailgate and rear windscreen. The body parts at the rear portion of the Motor Car were visually examined and it was observed that the repair/restoration works carried out to the damaged area of the Motor Car (refer to photograph 3 & 4 above) were reasonably adequate and in order.

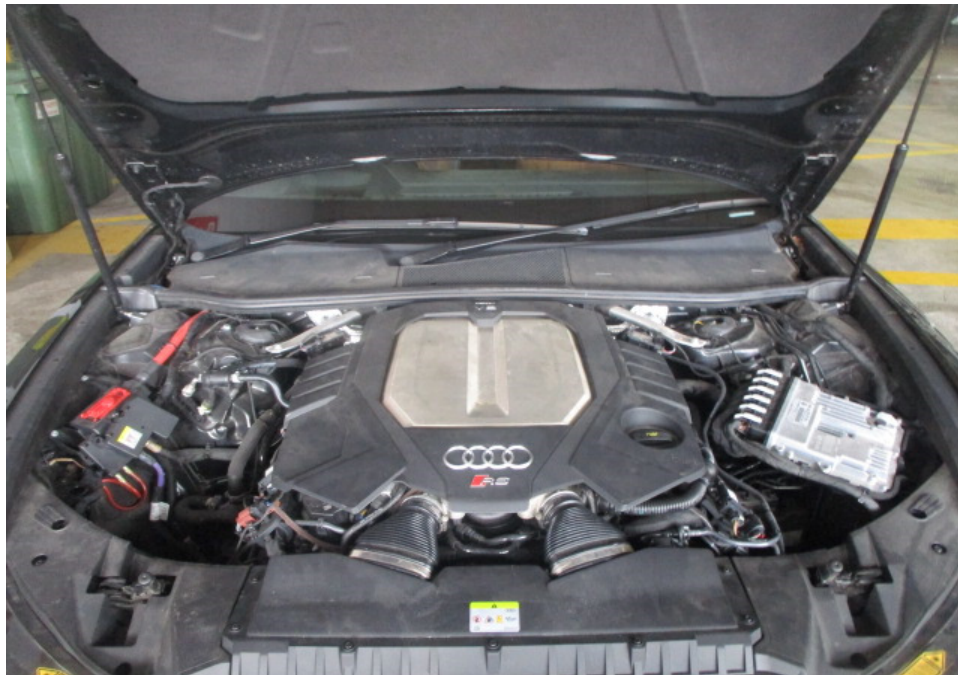
Photo 18 shows a general view of the engine compartment of the Motor Car at the time of my inspection. The various parts and components within the engine compartment were all observed to be intact and properly fitted. There was also no sign(s) or indication(s) of fluid leak and/or fluid stain found inside the engine compartment.

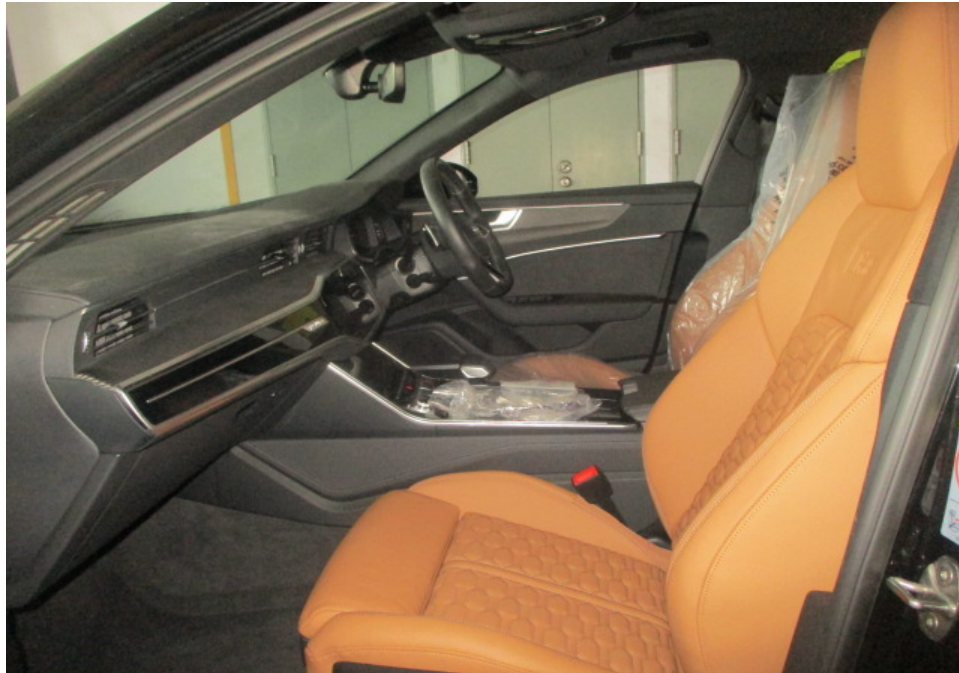
Photo 19 shows the interior compartment of the Motor Car at the time of my inspection. The various parts and components, inner trims, carpet and upholstery within the interior compartment were all observed to be intact and properly fitted. The repair/restoration works carried out to the damaged area of the Motor Car (refer to photograph 5 - 8 above) were reasonably adequate and in order.

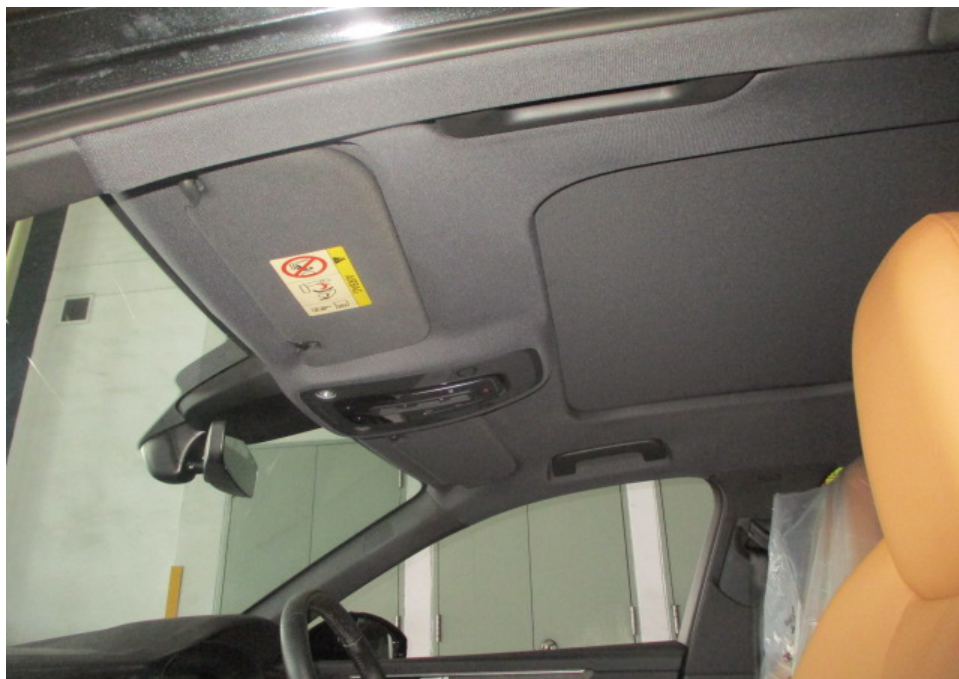
Photo 20 shows the roof upholstery, inner trims and front windscreen of the Motor Car at the time of my inspection. The various parts and components, inner trims, carpet and upholstery within the interior compartment were all observed to be intact and properly fitted. The repair/restoration works carried out to the damaged area of the Motor Car (refer to photograph 5 - 8 above) were reasonably adequate and in order.

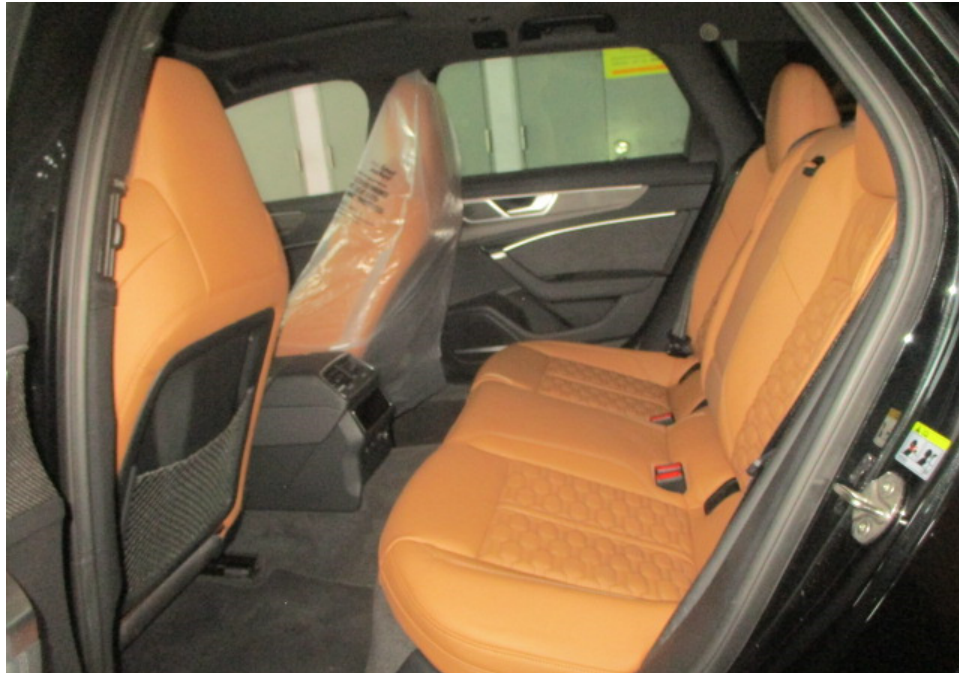
Photo 21 shows the front seats, rear seats, carpet and inner trims of the Motor Car. The various parts and components, inner trims, carpet and upholstery within the interior compartment were all observed to be intact and properly fitted. The repair/restoration works carried out to the damaged area of the Motor Car (refer to photograph 5 - 8 above) were reasonably adequate and in order.

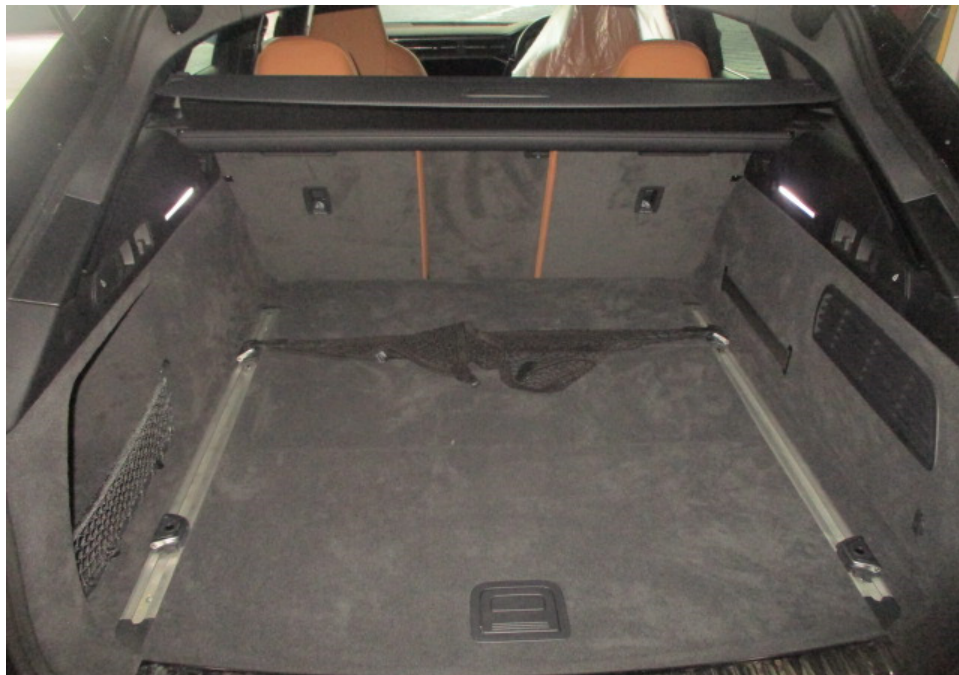
Photo 22 shows the rear interior compartment of the Motor Car at the time of my inspection. The various parts and components, inner trims, carpet and upholstery within the interior compartment were all observed to be intact and properly fitted. The repair/restoration works carried out to the damaged area of the Motor Car (refer to photograph 5 - 8 above) were reasonably adequate and in order.

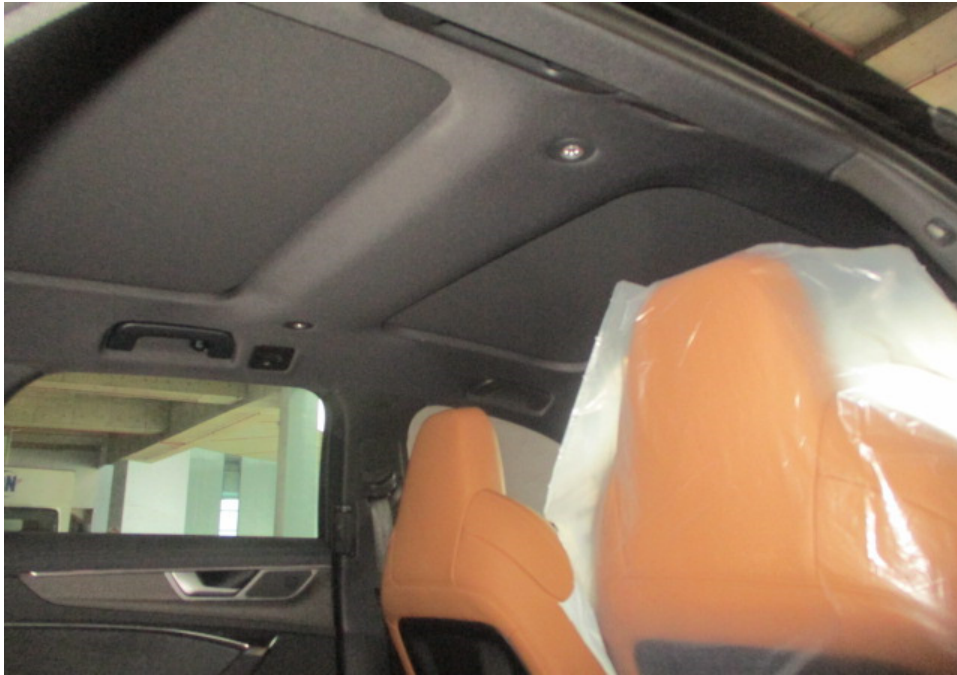
Photo 23 shows the front seats, roof upholstery and inner trims of the Motor Car. The various parts and components, inner trims, carpet and upholstery within the interior compartment were all observed to be intact and properly fitted. The repair/restoration works carried out to the damaged area of the Motor Car (refer to photograph 5 - 8 above) were reasonably adequate and in order.

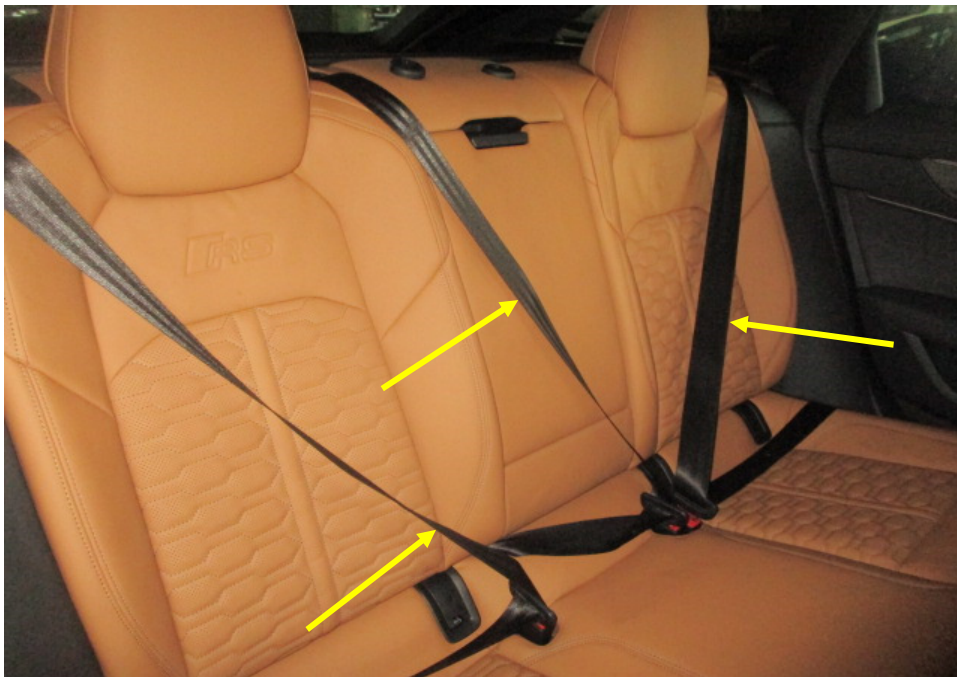
Photo 24 shows the rear seats of the Motor Car. All the seats of the Motor Car were secured via seat rails to the floorboard. They were also fitted with a retractable seat belt reel and a pre-tensioner. The seat belts (arrowed) were tested and were able to be fastened into the respective pre-tensions that were fitted on the side of each individual seat.

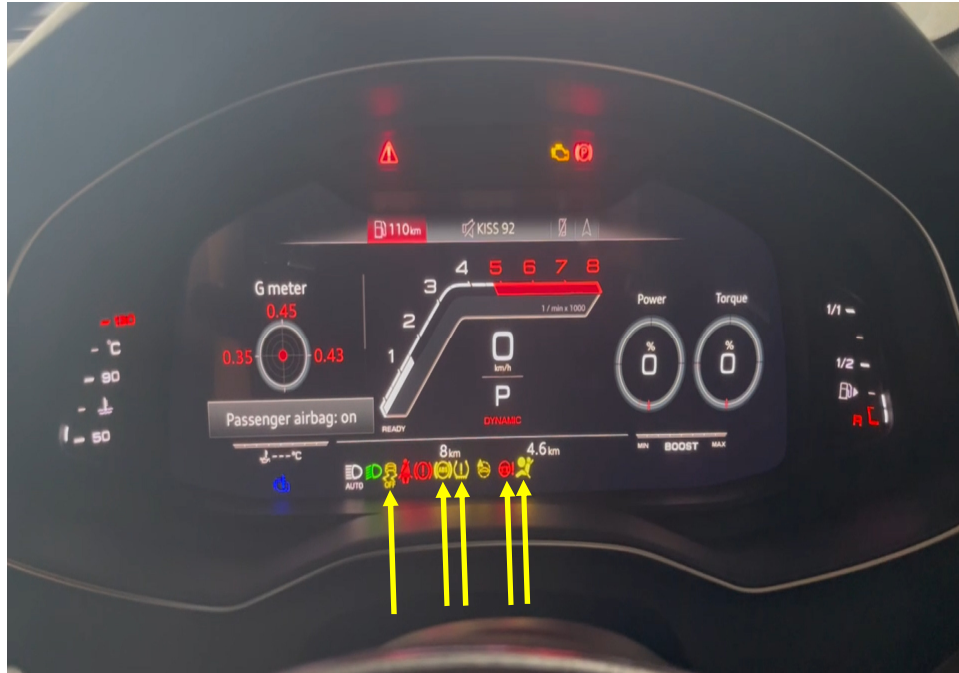
Photo 25 shows the warning lights for the various electronic safety features appearing on the instrument panel of the Motor Car during its self-test when the engine is cranked, in particular the ABS, SRS, EPS, TPM and ESC lights (arrowed).

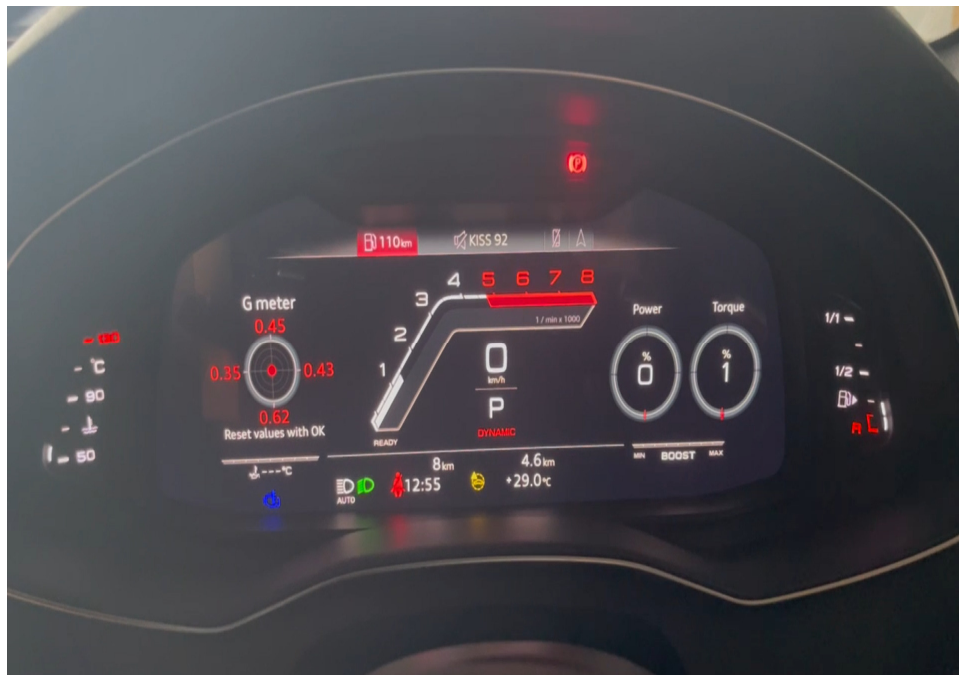
Photo 26 shows the respective warning lights no longer illuminated, indicating that there is no fault detected to the ABS, SRS, EPS, TPM and ESC systems of the Motor Car during the self-test. These electronic systems were hence in working condition at the time of my inspection.

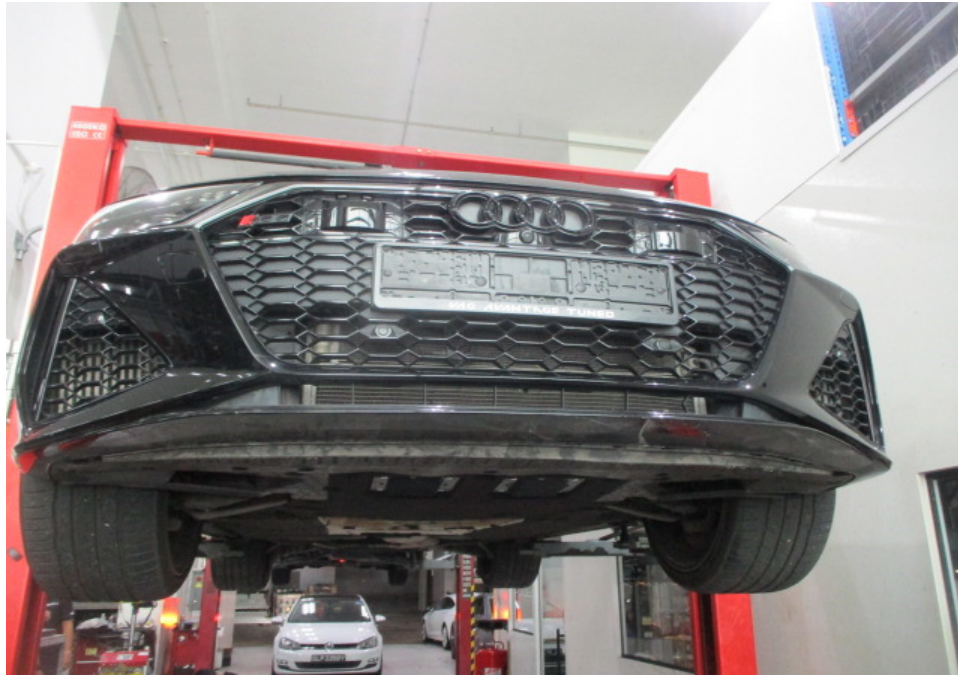
Photo 27 shows the Motor Car hoisted up for checks on its undercarriage. There was no sign(s) or indication(s) of fluid leakage and/or fluid stain(s) on the underside of the Motor Car. The undercarriage components of the Motor Car were also all observed to be intact and secured in an appropriate manner.

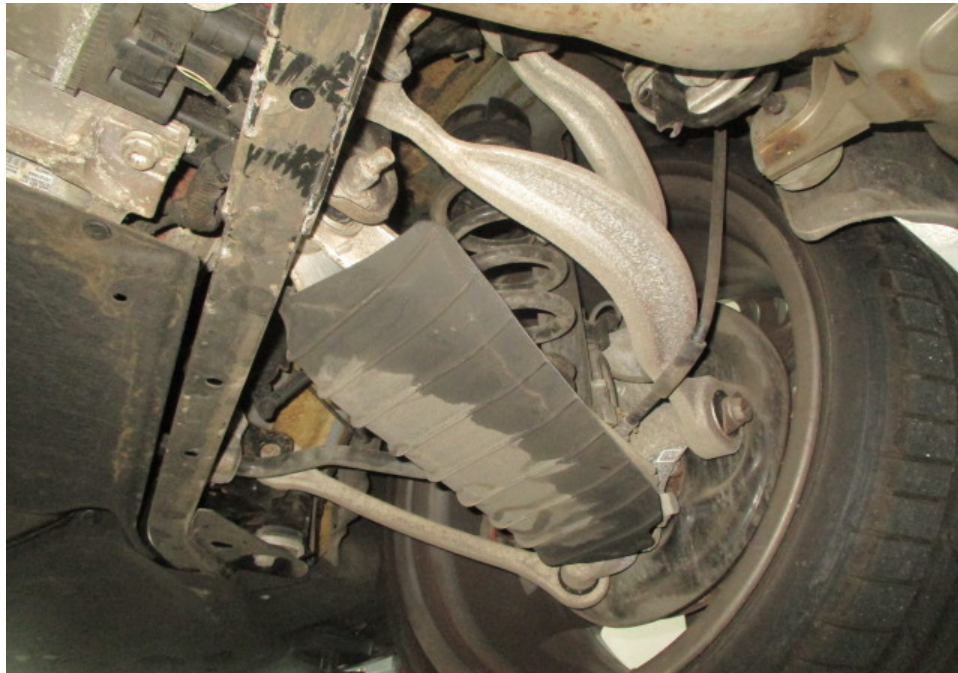
Photo 28 shows a general view of the control arms and linkages at the rear right wheel of the Motor Car. I did not observe any fluid leak and/or fluid stain on the underside of the Motor Car. All of the Motor Car's undercarriage components were observed to be intact and secured in an appropriate manner.

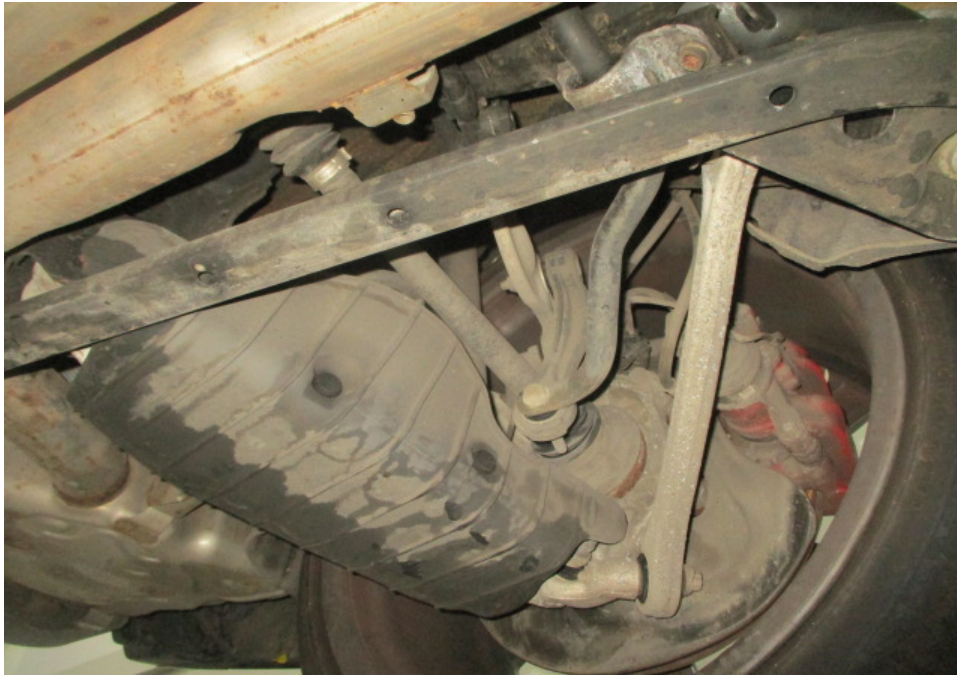
Photo 29 shows a general view of the control arms and linkages at the rear left wheel of the Motor Car. I did not observe any fluid leak and/or fluid stain on the underside of the Motor Car. All of the Motor Car's undercarriage components were observed to be intact and secured in an appropriate manner.

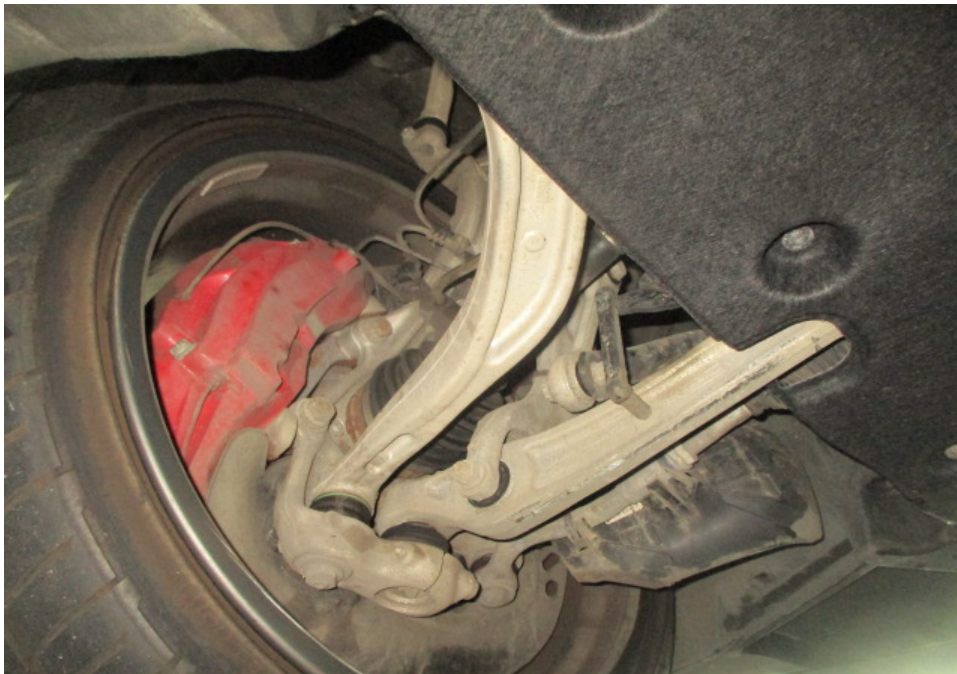
Photo 30 shows the various undercarriage components at the front left wheel of the Motor Car. The mechanical components, control arms and linkages were all found to be intact and secured in an appropriate manner.

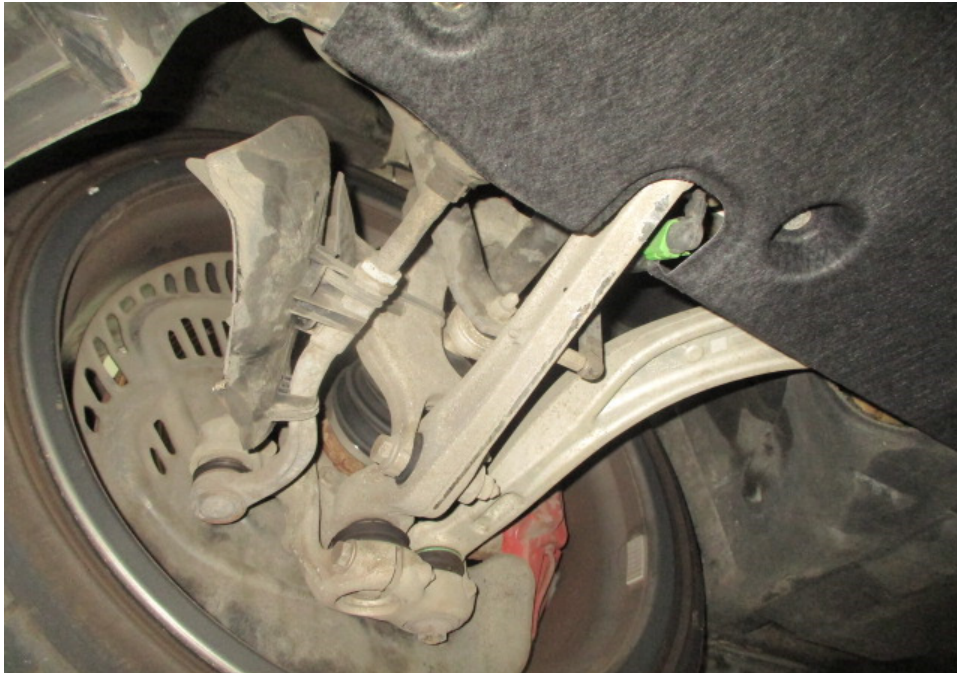
Photo 31 shows the various undercarriage components at the front right wheel of the Motor Car. The mechanical components, control arms and linkages were all found to be intact and secured in an appropriate manner. I also did not observe any fluid leak and/or fluid stain on the underside of the Motor Car.
