Your Ref: Audi RS 6
(chassis number WUAZZZF28NN901124)
Our Ref : CI/TP23006925/D

**INSPECTION REPORT OF AN UNREGISTERED AUDI RS 6 MOTOR CAR
WITH CHASSIS NUMBER WUAZZZF28NN901124**

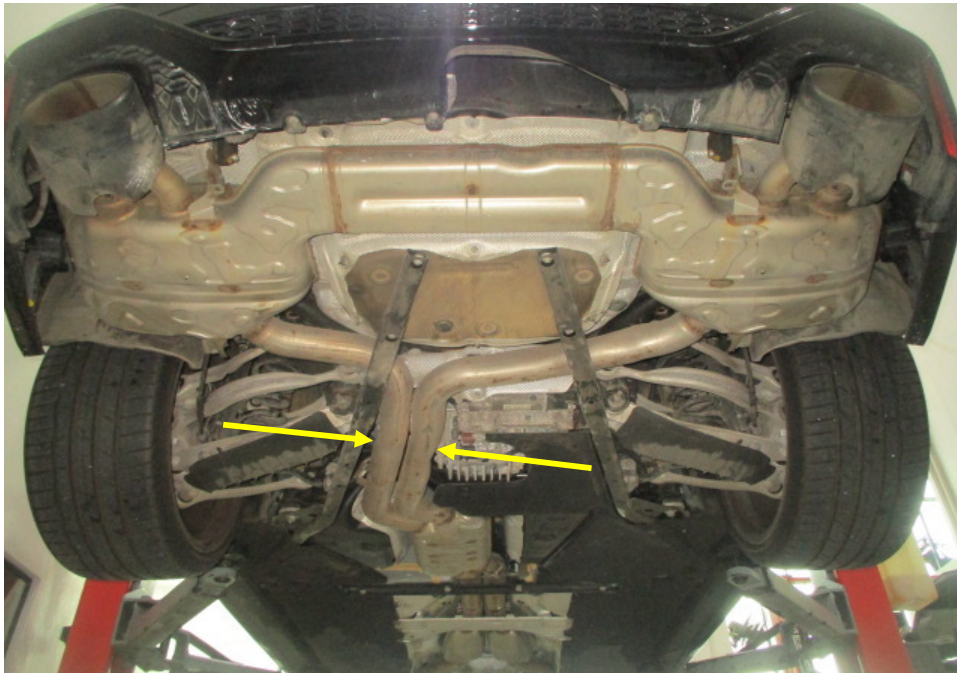
Photo 32 shows the rear section of the Motor Car's exhaust system. My examination of the Motor Car's exhaust system revealed no sign(s) or indication(s) of any cut or weld marks along its exhaust pipes (arrowed), on its centre resonator boxes, on its rear muffler and on its catalytic converters.

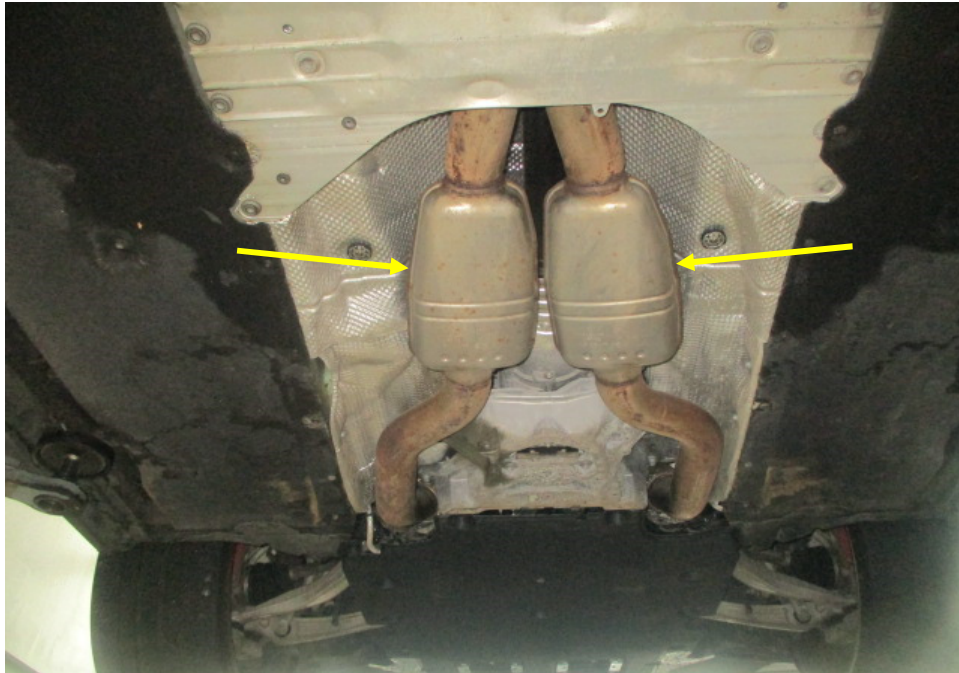
Photo 33 shows the front section of the Motor Car's exhaust system. My examination of the Motor Car's exhaust system revealed no sign(s) or indication(s) of any cut or weld marks along its exhaust pipes, on its centre resonator boxes (arrowed), on its rear muffler and on its catalytic converters.

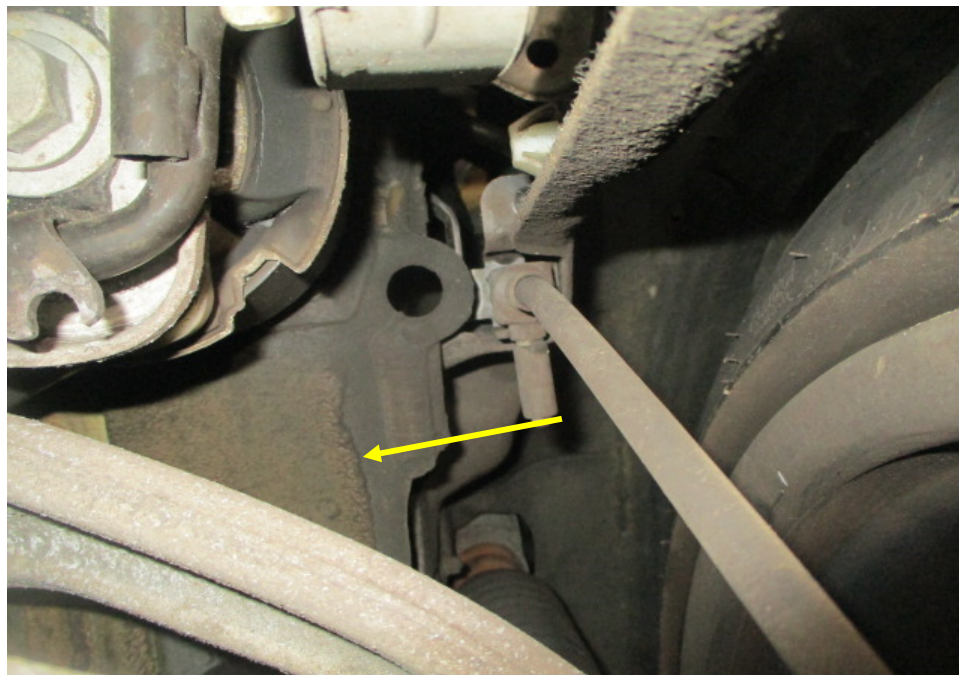
Photo 34 shows the chassis/structural body at the underside rear right of the Motor Car. I did not find any weld marks other than original spot weld marks on the chassis/structural body of the Motor Car. The original factory sealant (arrowed) at the joints along the chassis/structural body was also untouched, indicating no work was done on the chassis/structural body of the Motor Car and that the chassis/structural body was originally fitted.

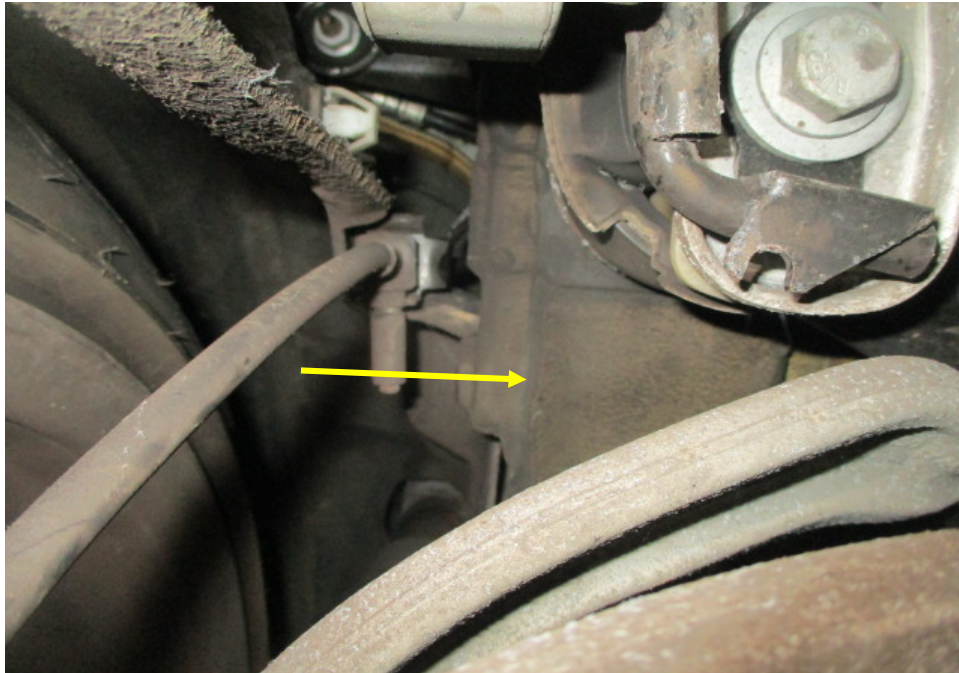
Photo 35 shows the chassis/structural body at the underside rear left of the Motor Car. I did not find any weld marks other than original spot weld marks on the chassis/structural body of the Motor Car. The original factory sealant (arrowed) at the joints along the chassis/structural body was also untouched, indicating no work was done on the chassis/structural body of the Motor Car and that the chassis/structural body was originally fitted.

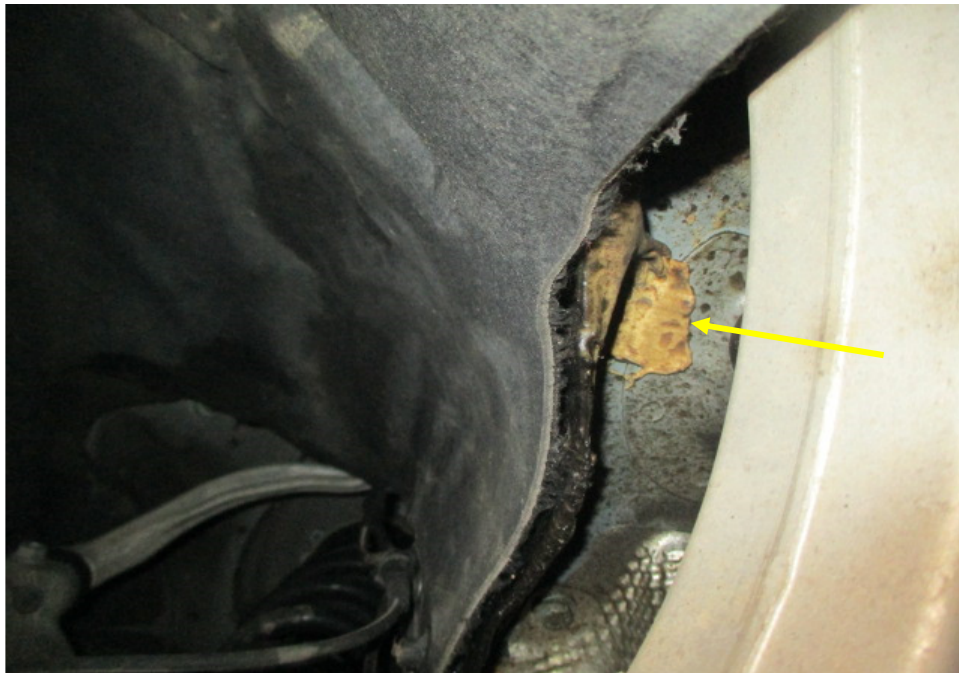
Photo 36 shows the chassis/structural body at the underside front left of the Motor Car. The original factory sealant (arrowed) at the joints along the chassis/structural body was observed to be untouched. In general, I had found no work was carried out on the chassis/structural body of the Motor Car. The chassis/structural body of the Motor Car was originally fitted.

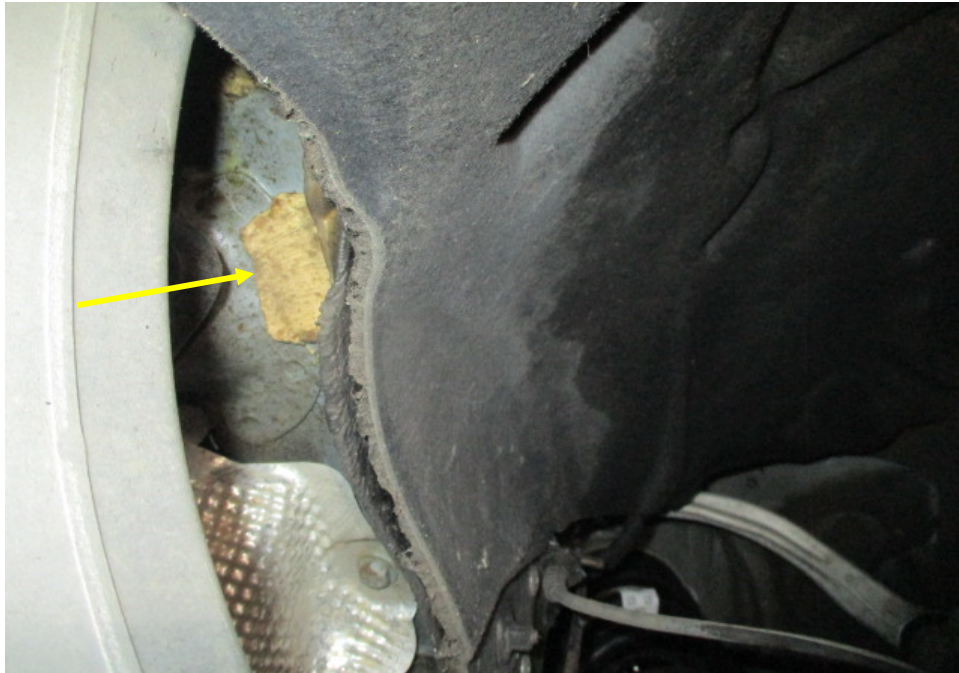
Photo 37 shows the chassis/structural body at the underside front right of the Motor Car. I did not find any weld marks other than original spot weld marks on the chassis/structural body of the Motor Car. The original factory sealant (arrowed) at the joints along the chassis/structural body was also untouched, indicating no work was done on the chassis/structural body of the Motor Car and that the chassis/structural body was originally fitted.

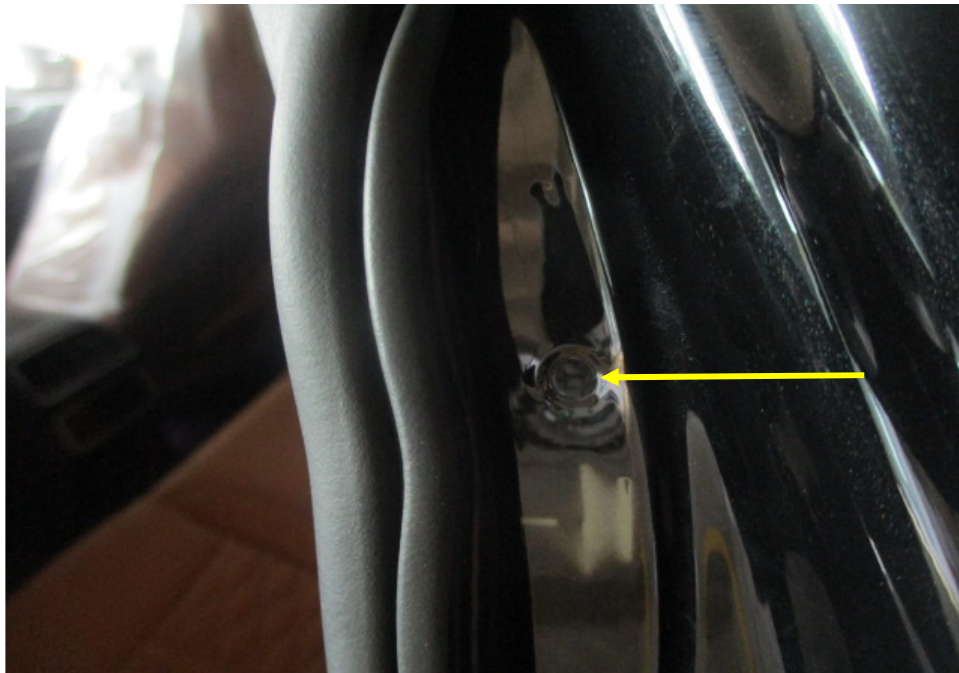
Photo 38 shows the left side "C" pillar of the Motor Car. I did not find any weld marks other than original spot weld marks (arrowed) on the left side "C" pillar of the Motor Car which, indicates that there was no re-welding works carried out. In general, I had found all the non-detachable body panels of the Motor Car to be originally fitted at the time of my inspection.

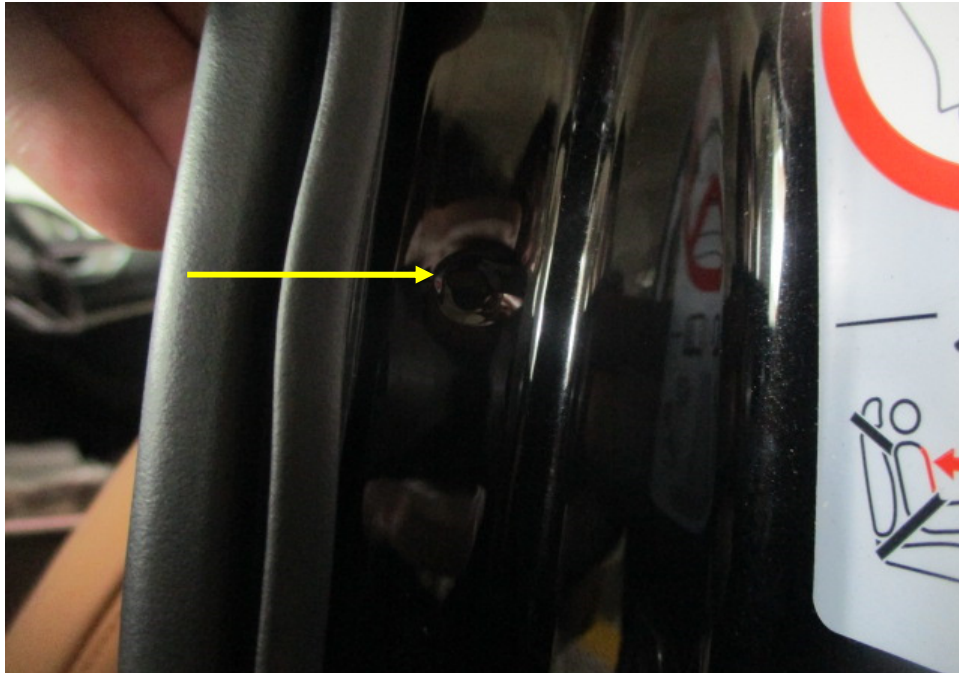
Photo 39 shows the left side "B" pillar of the Motor Car. I did not find any weld marks other than original spot weld marks (arrowed) on the left side "B" pillar of the Motor Car which, indicates that there was no re-welding works carried out. In general, I had found all the non-detachable body panels of the Motor Car to be originally fitted at the time of my inspection.

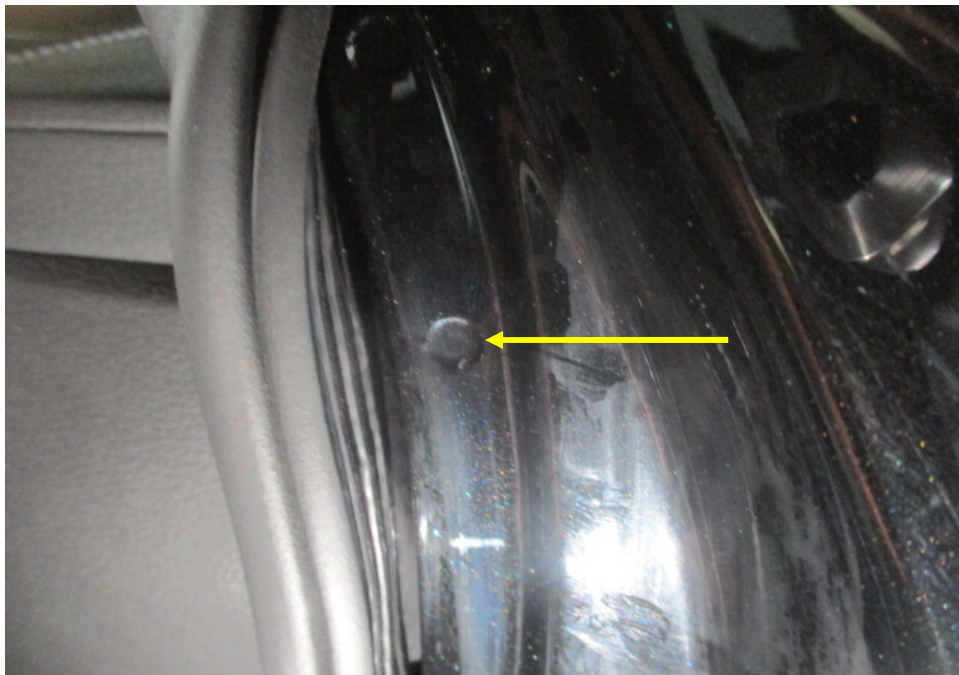
Photo 40 shows the right side "A" pillar of the Motor Car. I did not find any weld marks other than original spot weld marks (arrowed) on the right side "A" pillar of the Motor Car which, indicates that there was no re-welding works carried out. In general, I had found all the non-detachable body panels of the Motor Car to be originally fitted at the time of my inspection.

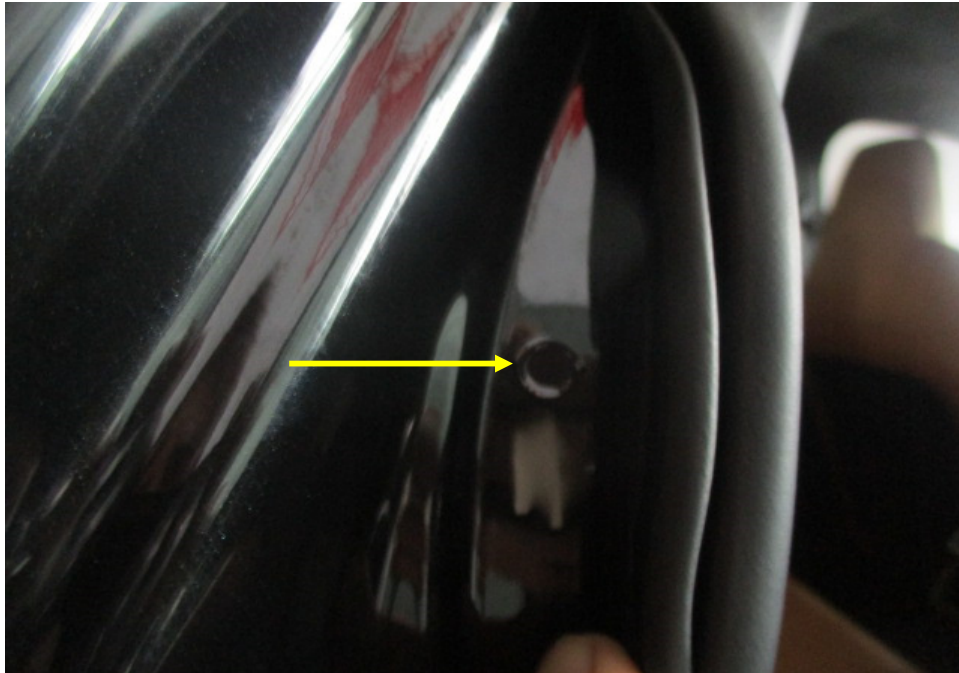
Photo 41 shows the right side "C" pillar of the Motor Car. I did not find any weld marks other than original spot weld marks (arrowed) on the right side "C" pillar of the Motor Car which, indicates that there was no re-welding works carried out. In general, I had found all the non-detachable body panels of the Motor Car to be originally fitted at the time of my inspection.

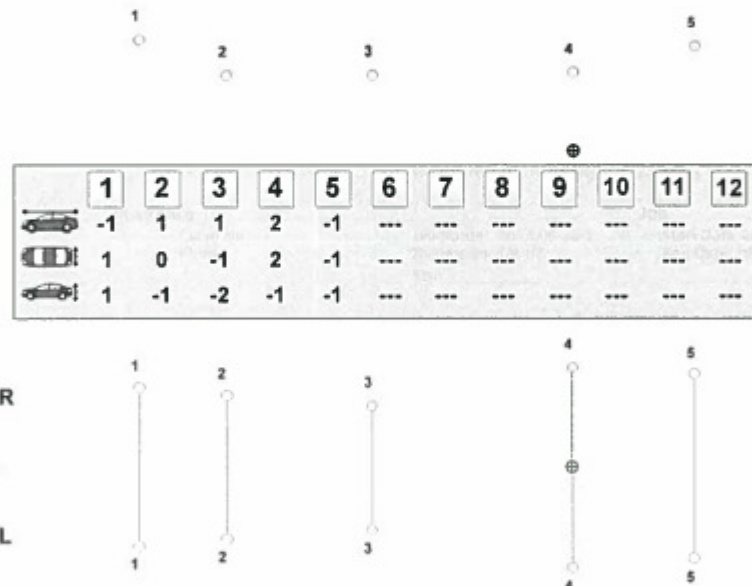
BodyShop	Notes
Company STA Inspection Centre Address 13 KAKI BUKIT ROAD 4, #01-02 City SINGAPORE Zip 417807 State Phone 63840606 E-mail information@stal.com.sg	NO MAJOR DEVIATION

Appendix 1 shows the chassis/structural measurements of the Motor Car that was carried out by STA Inspection Pte Ltd on 26 June 2023. I note that the chassis/structural measurements of the Motor Car were recorded to be with no major deviation (arrowed).
