Your Ref: SNM23D204795/C01/LEEPG
Our Ref : CS4/CTI23007097/N

17 July 2023

**TECHNICAL INVESTIGATION REPORT OF FIRE INCIDENT INVOLVING THE
INSURED VEHICLE SDK 8922G ON 9 JULY 2023**

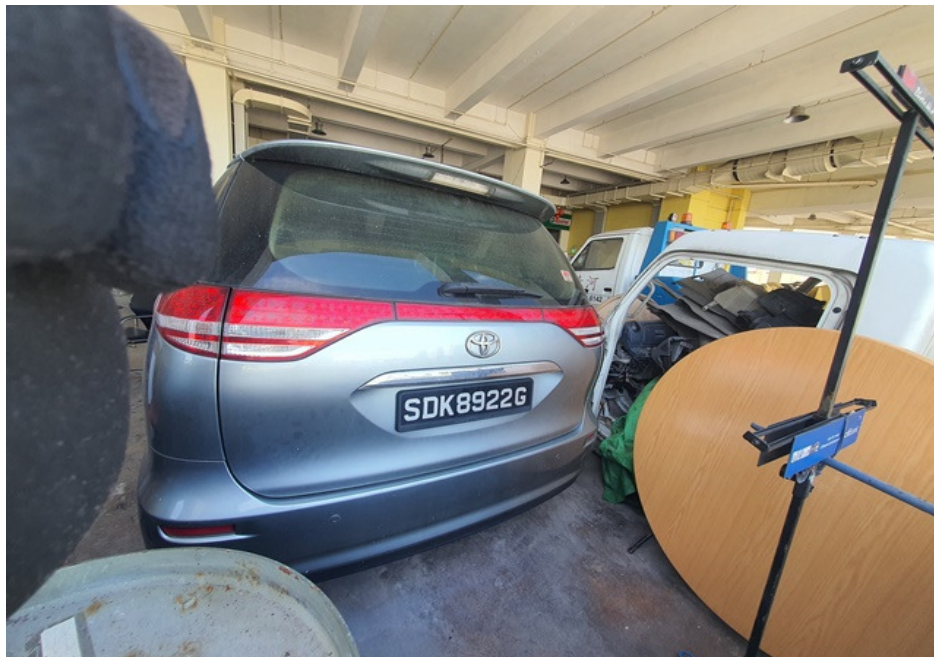
Photo 1 shows the rear view of the Insured Vehicle. The rear portion of the Insured Vehicle was observed to be relatively unaffected by the fire.

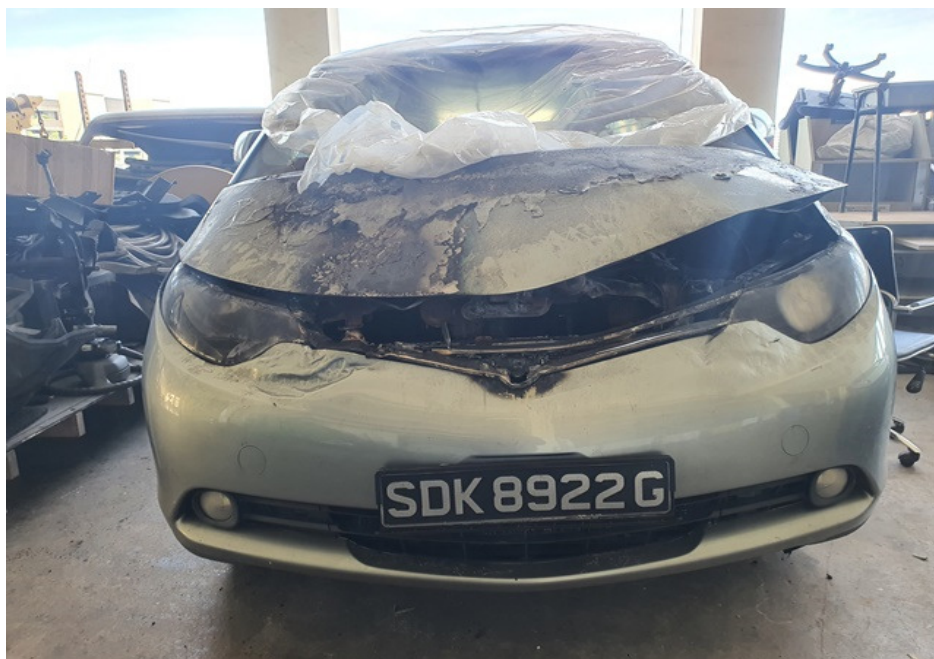
5. The exterior front body of the Insured Vehicle sustained visible fire damage. This included its front windscreen, front bonnet, headlights, front bumper and side panels.
6. The fire had resulted in extensive damage to the engine compartment of the Insured Vehicle. Most of the components inside the engine compartment were found to be severely burnt and/or melted as a result of the fire. The interior compartment was observed to have been severely affected by the fire. See photos 1 – 6 below.

Photo 2 shows the general view of the frontal portion of the Insured Vehicle at the time of our inspection. The exterior body of the Insured Vehicle had sustained visible fire damage. This included its front windscreen, front bonnet, front bumper, headlights and side panels.

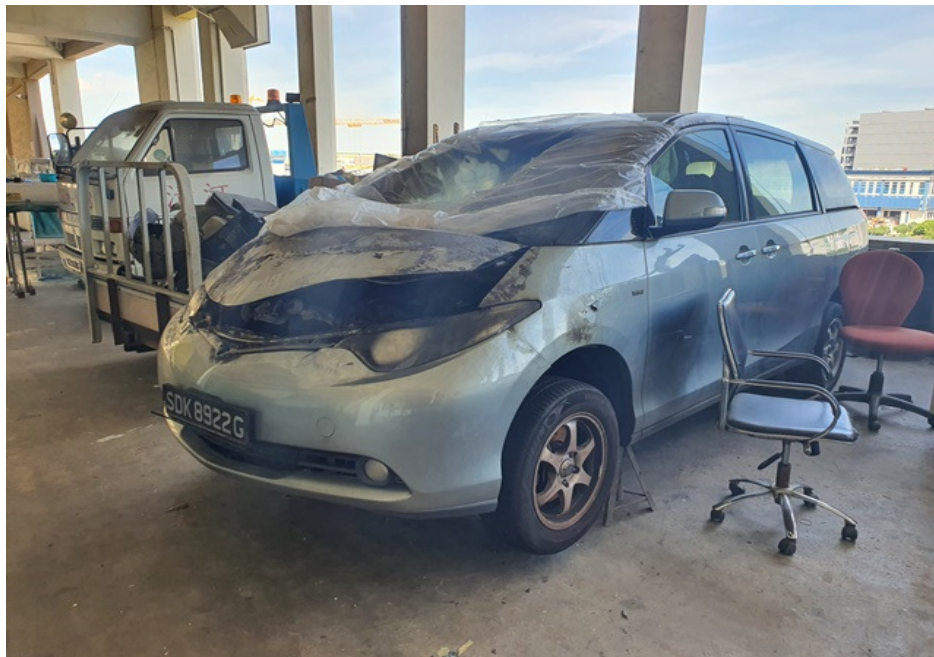
Photo 3 shows the general view of the left portion of the Insured Vehicle at the time of our inspection. The exterior body of the Insured Vehicle had sustained visible fire damage. This included its front windscreen, front bonnet, left headlight, front bumper and left front panel.

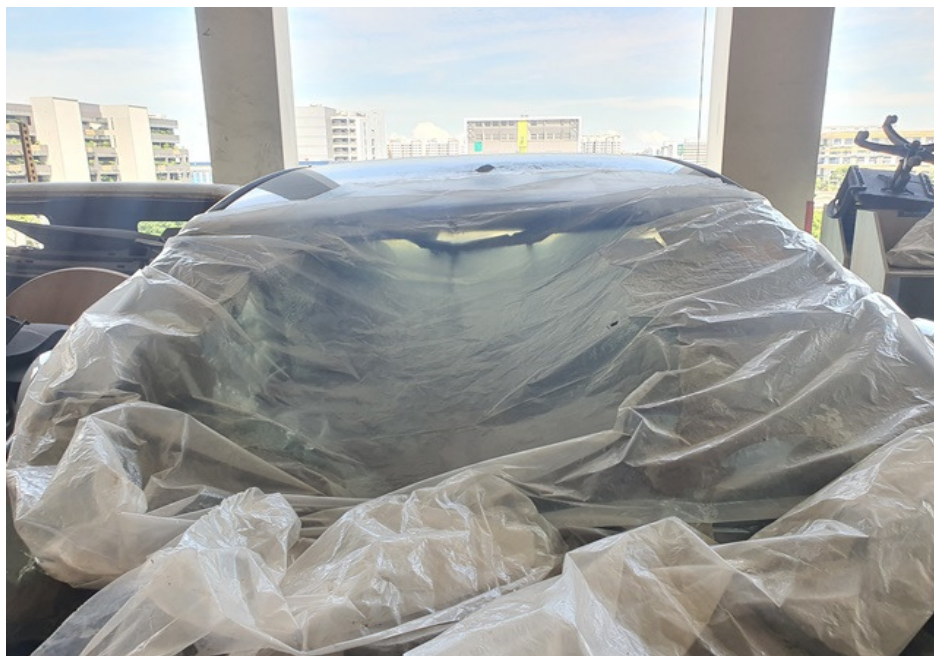
Photo 4 shows a closer view of the front windscreen of the Insured Vehicle at the time of our inspection. The front windscreen had sustained extensive fire damage.

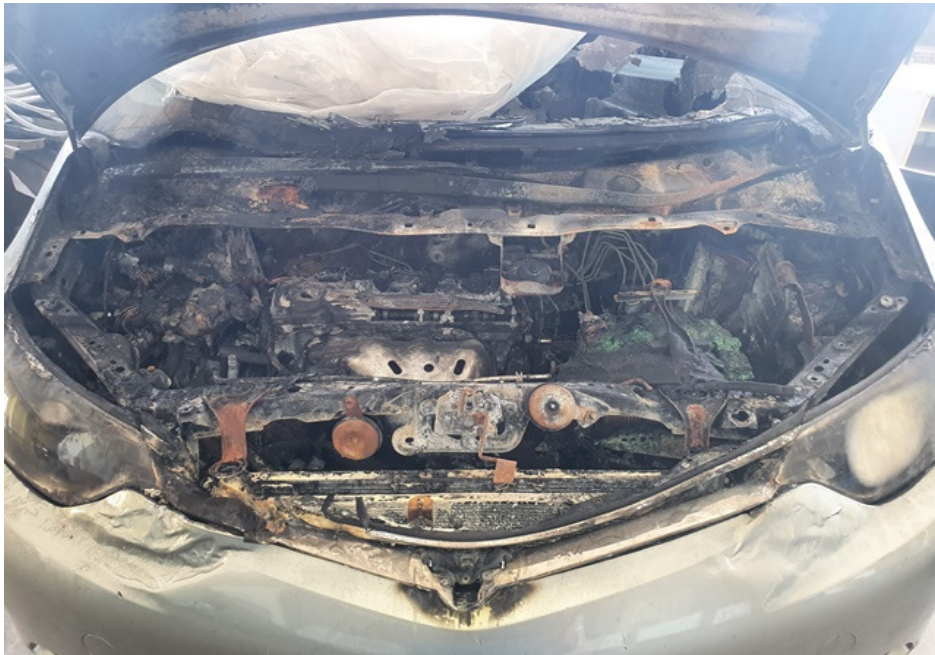
Photo 5 shows a general view of the engine compartment of the Insured Vehicle at the time of our inspection. Most of the components inside the engine compartment were found to be severely burnt and/or melted as a result of the fire.

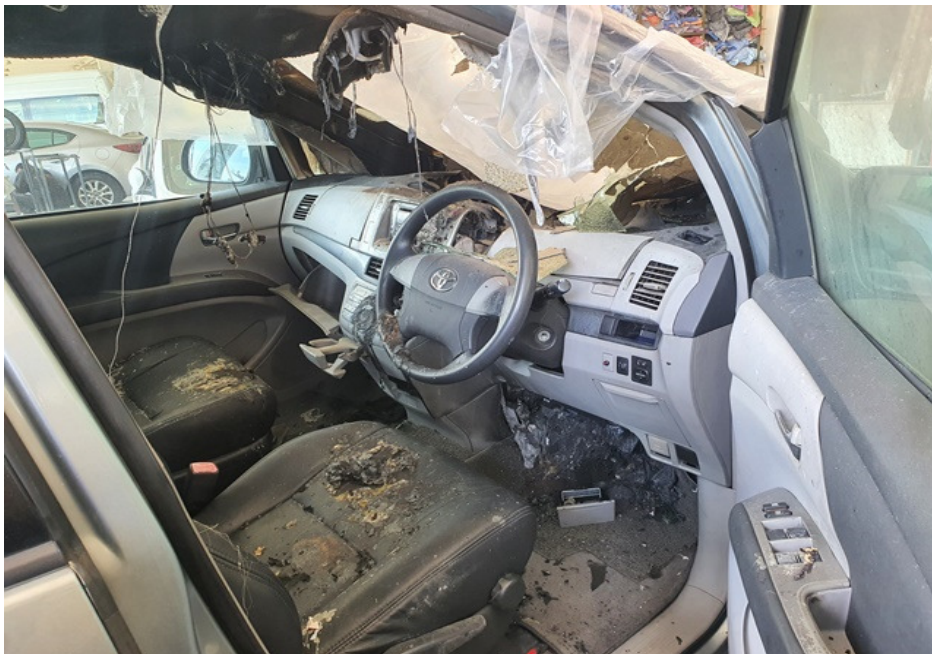
Photo 6 shows the interior compartment of the Insured Vehicle, which was observed to be severely affected by the fire.

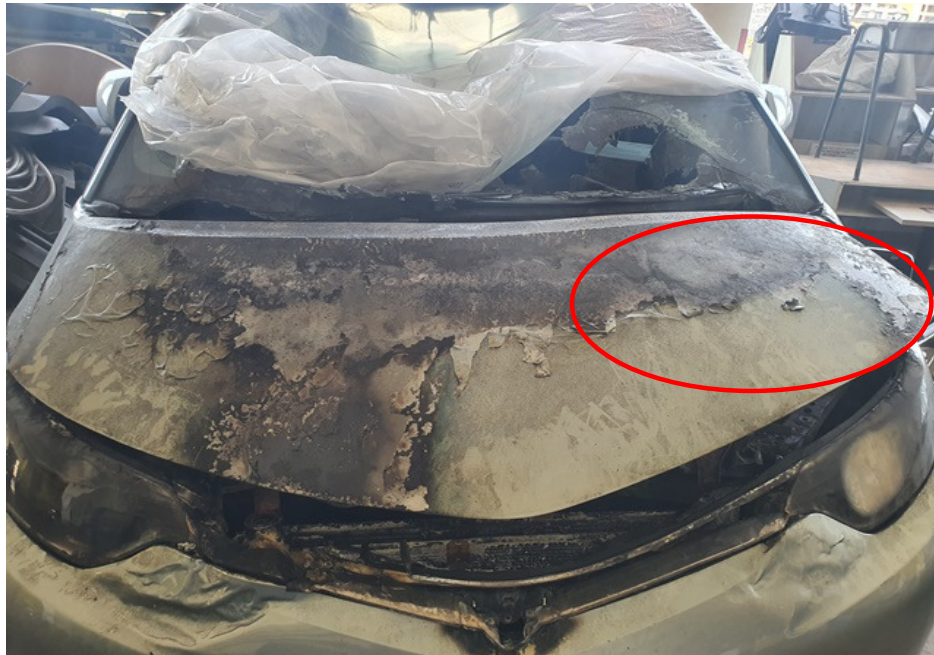
8. For this particular case, the fire appears to have originated within the engine compartment of the Insured Vehicle, somewhere around the left portion of the engine compartment. This can be determined from the whitish burn marks on the left portion of the front bonnet of the Insured Vehicle and also the rust that had developed on the underside of the front bonnet, at the left bottom portion.

9. The whitish burn marks are a result of exposure to prolonged heat intensity. Rust would normally start to develop around these areas soon after a fire as prolonged exposure to high heat intensity usually causes steel/metal material body parts to be exposed to natural environmental condition. The rust that had developed on the underside of the front bonnet, around the left bottom portion, is an indication that the left portion of the engine compartment had sustained exposure to prolonged high heat intensity. See photos 7 & 8 below.

Photo 7 shows the burn pattern and whitish burn marks that were found on the left portion of the front bonnet of the Insured Vehicle (circled). Such whitish burn marks are a result of exposure to prolonged heat intensity, which may indicate where the fire had started. Rust would also begin to develop on these areas soon after the fire.

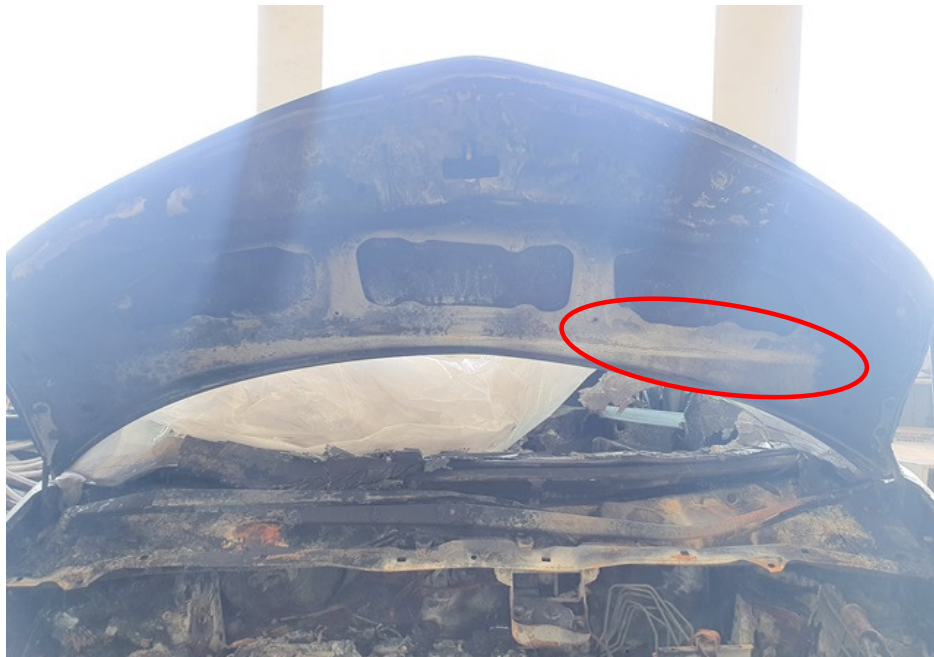
Photo 8 shows the rust that had developed on the underside of the front bonnet, around the left bottom portion (circled). The development of rust is an indication that this area was subjected to prolonged exposure to high heat intensity, which had caused the steel/metal material of the front bonnet to be exposed to natural environmental condition. Hence the fire to the Insured Vehicle can be determined to have originated towards the left portion of the engine compartment.

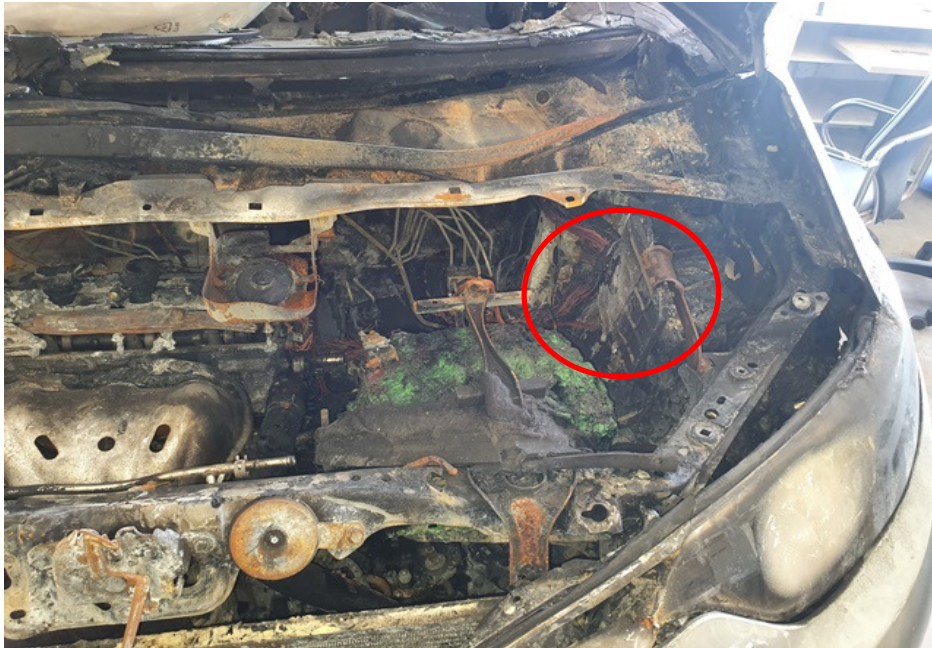
10. Upon closer examination of the left portion of the engine compartment, which was where the fire to the Insured Vehicle had likely started, we had found traces of greenish residue on several stretches of burnt wirings leading from the Engine Control Module (ECM). The presence of greenish residue indicates internal heating of copper wires, a sign of an electrical short circuit occurring. The greenish residue is normally left behind from oxidation as a result of chemical reaction involving the copper wires. This physical evidence would then appear to suggest that the cause of fire to the Insured Vehicle could have possibly been due to electrical in nature. See photos 9 - 12 below.

Photo 9 shows the burnt wirings around the left portion of the engine compartment which is in the immediate vicinity where the fire to the Insured Vehicle had likely started. We noticed greenish residue on several stretches of burnt wirings leading from the Engine Control Module (ECM) (circled). The presence of greenish residue indicates internal heating of copper wires, a sign of an electrical short circuit occurring.

27. Having investigated and technically analysed the damages to the Insured Vehicle, we are of the view that the cause of fire to the Insured Vehicle was of electrical in nature. For this particular case, the fire had originated along the wirings inside the engine compartment, somewhere around the left portion. The wirings were original factory wirings leading from the Engine Control Module (ECM) of the Insured Vehicle.

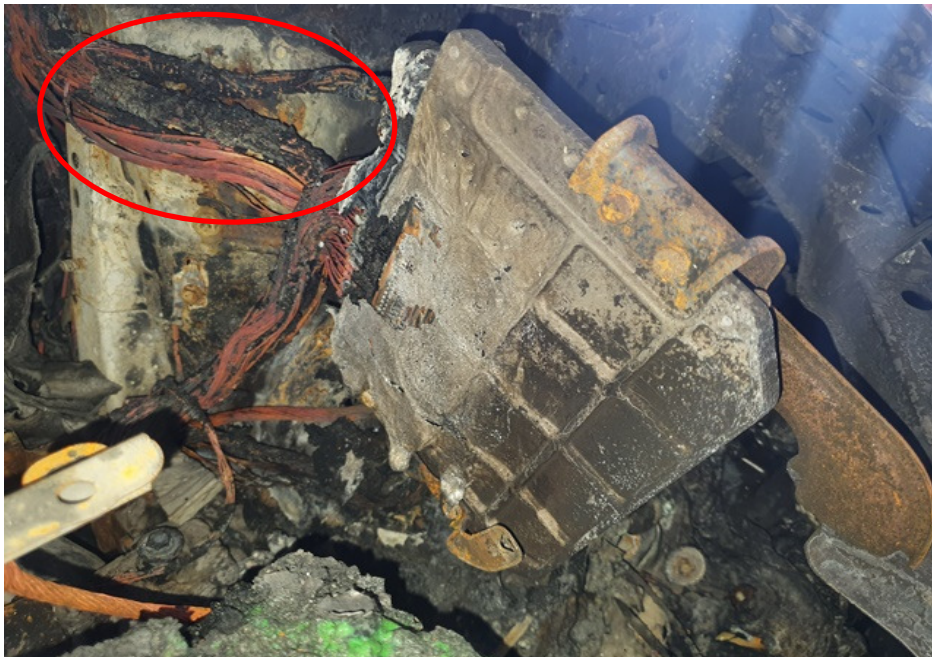
Photo 10 shows a closer view of the burnt wirings leading from the Engine Control Module (ECM). We noticed greenish residue on several stretches of the burnt wirings (circled). The greenish residue is normally left behind from oxidation as a result of chemical reaction involving the copper wires.

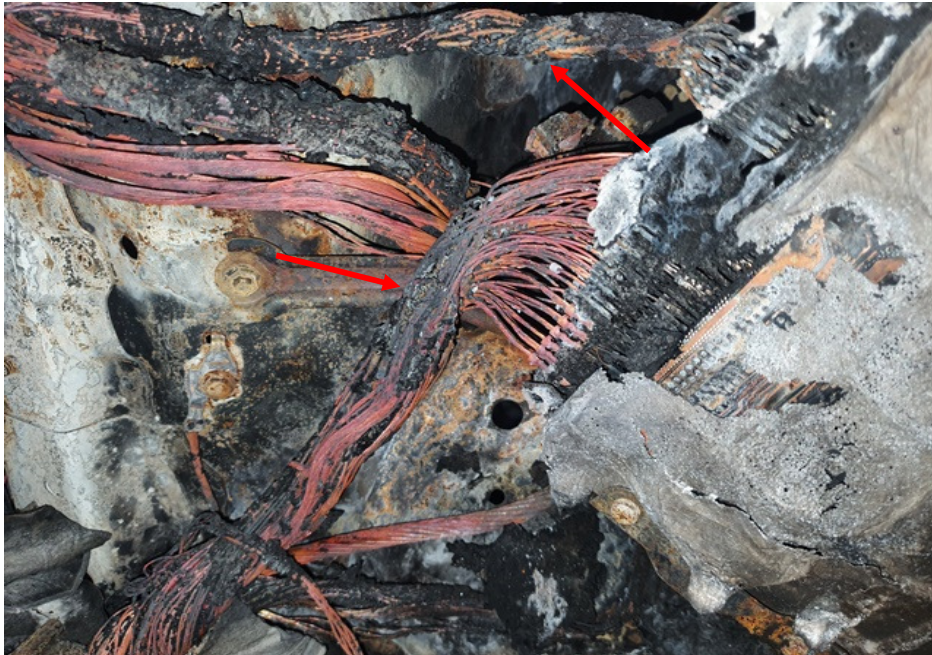
Photo 11 shows a close up view of the greenish residue found on several stretches of burnt wirings leading from the Engine Control Module (ECM) (red arrows). The presence of such greenish residue suggests occurrence of an electrical short circuit.

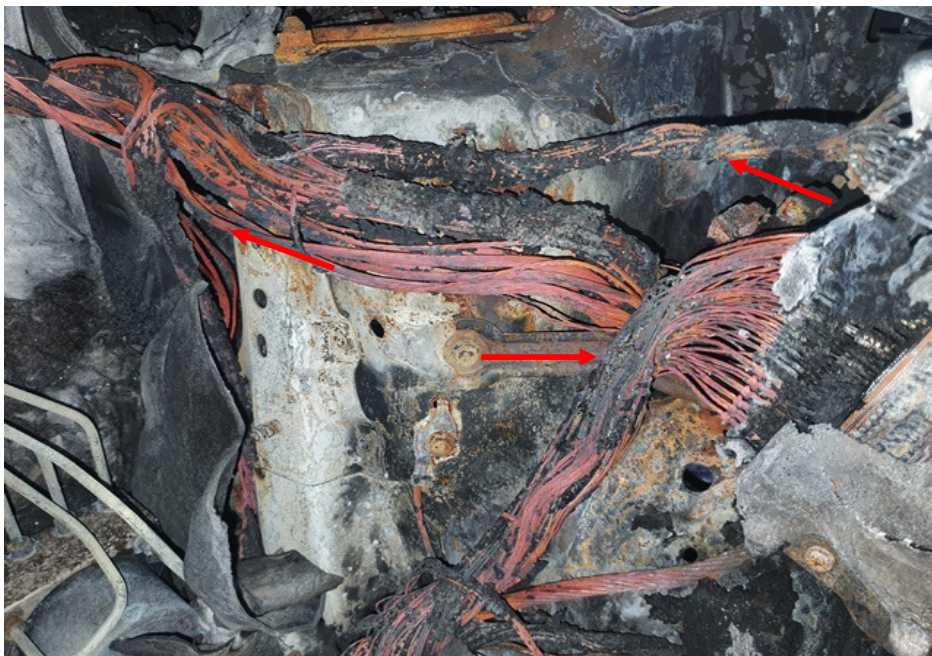
Photo 12 shows a close up view of the greenish residue found on several stretches of burnt wirings leading from the Engine Control Module (ECM) (red arrows). The presence of such greenish residue suggests occurrence of an electrical short circuit.

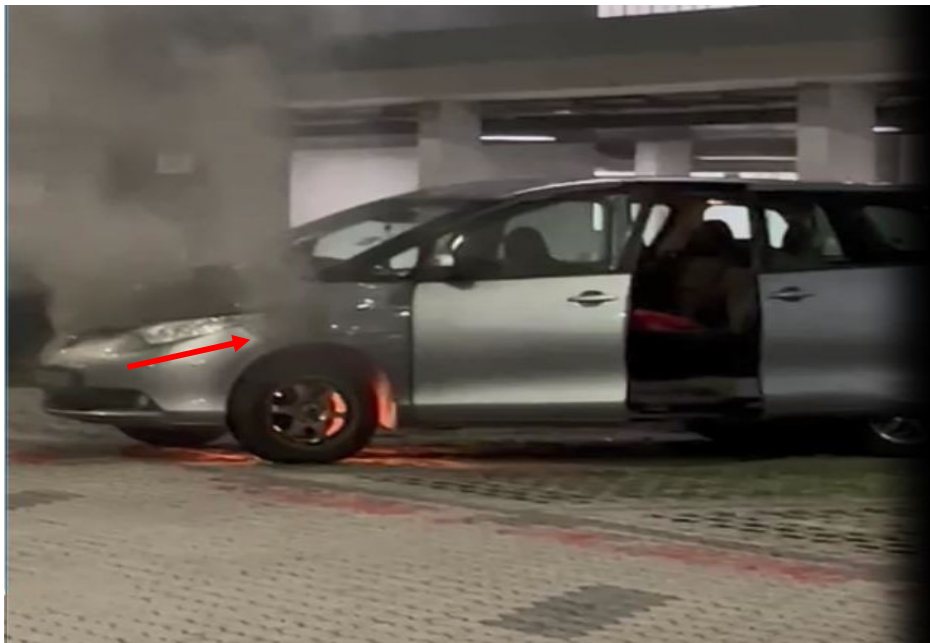
Photo 13 shows the Insured Vehicle on fire before the arrival of the SCDF. In general, the information that could be gathered from this photograph had corresponded to the events that were related to us by Ms Chua, which is the fire had started from the left rear portion of the engine compartment (arrowed).

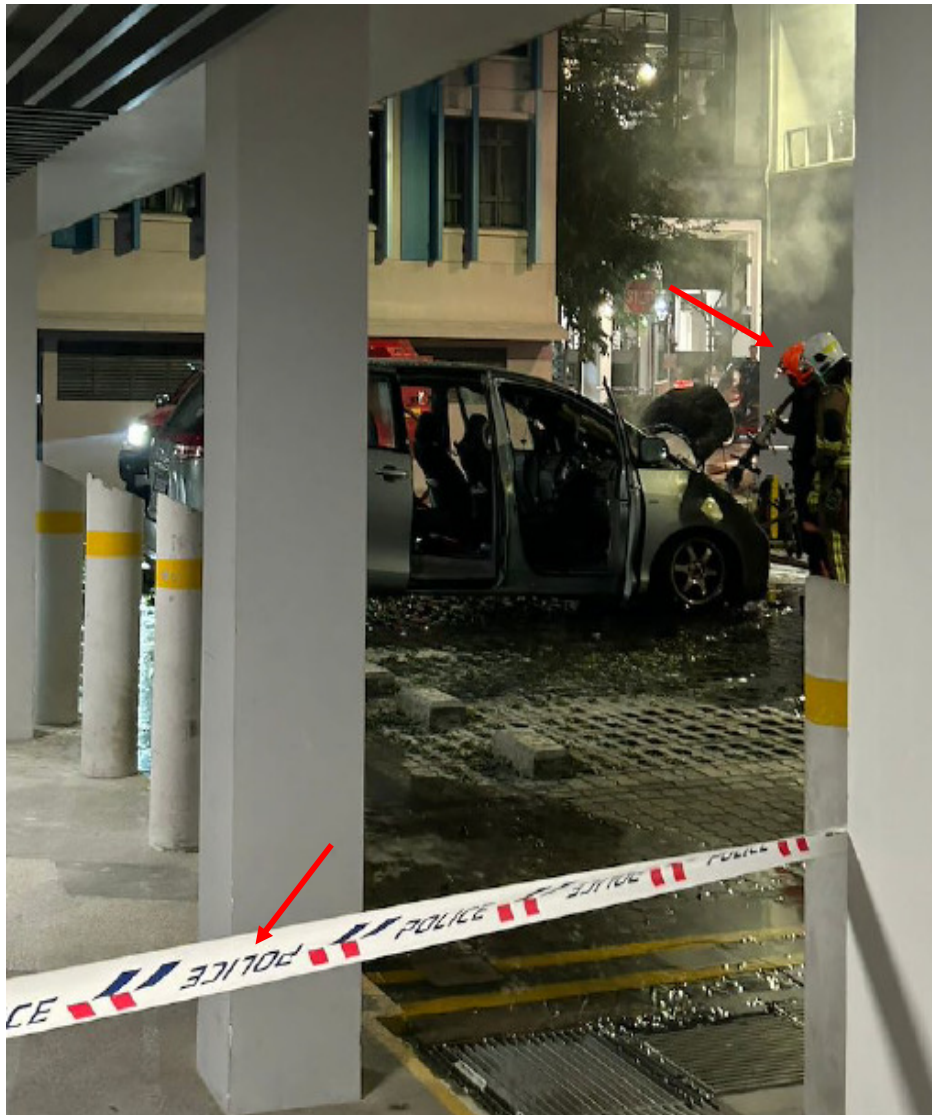
Photo 14 shows the Insured Vehicle at the incident scene after the fire was extinguished. In general, the information that could be gathered from this photograph had corresponded to the events that were related to us by Ms Chua, which is the police and SCDF were present at the incident location (arrowed).

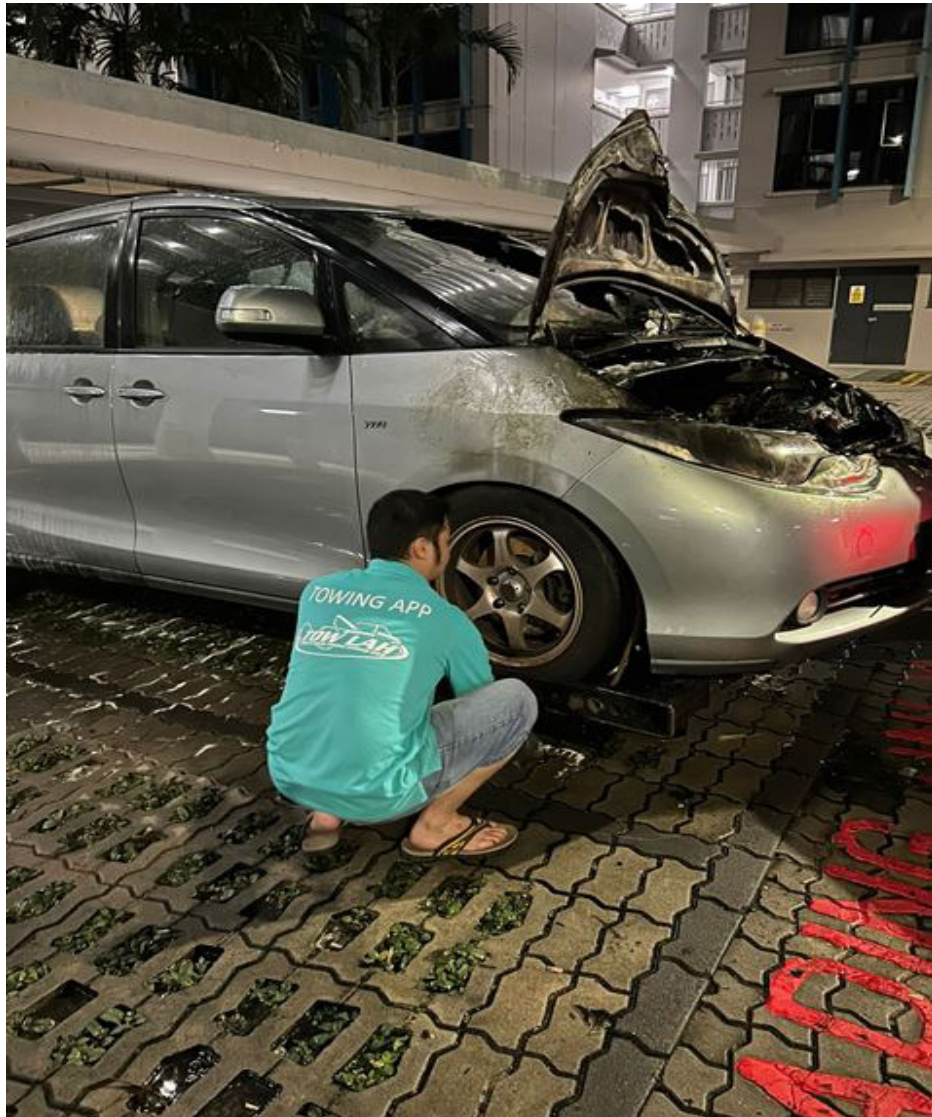
Photo 15 shows the Insured Vehicle at the incident scene being prepped to be towed to AKH.
