Our Reference : KAAS/TA/6432/2740/TP/07.22  
Date : 19 August 2022

## VEHICLE APPRAISAL REPORT

| Registration No. | : SMP 2740X | Chassis Frame No. | : GP7-2007360 |
| Make / Model | : Honda Shuttle Hybrid 1.5A | Engine No. ( Logcard ) | : LEB7109253 |

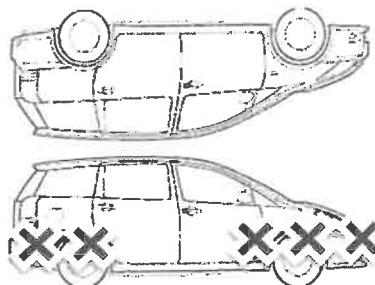
Damages sustained were consistent with the subject vehicle being involved in a collision with another vehicle and the impact was delivered **to the RH Side portion** of the vehicle.

The general area of damages is at the **RH Side portion**  
( Please refer to the parts list and photographs as attached for more information )
