### INSPECTION REPORT

<b>Assign Date:</b>	14/03/2023	<b>Inspection Date:</b>	14/03/2023	<b>TP Report Date:</b>	08/03/2023
<b>Accident Date:</b>	07/03/2023	<b>TP Policy No:</b>	NA	<b>Our Ref:</b>	AVS2023-35583/ID
<b>Place of Inspection:</b>	Prompt Auto Pte Ltd 8 Kaki Bukit Avenue 4 #02-37 Premier @ Kaki Bukit Singapore 208642			<b>Your Ref:</b>	SHB5025R
				<b>Claimant:</b>	Certact Engineering Pte Ltd

<b>Veh. No:</b>	SLH93Y	<b>Make/Model:</b>	Porsche Boxster GTS (981) PDK E6	<b>Sum Insured (\$\$):</b>	Market Value
<b>Colour:</b>	White	<b>Engine No:</b>	DF06420	<b>Mkt Value (\$\$):</b>	\$288,000.00
<b>Engine Capacity:</b>	3,436 cc	<b>Chassis No:</b>	WPOZZZ98ZFK130785	<b>Excess (\$\$):</b>	NA
<b>Odometer:</b>	73 564	<b>Reg. Date:</b>	28/01/2015

### Adjustment of Repair Cost for Vehicle:

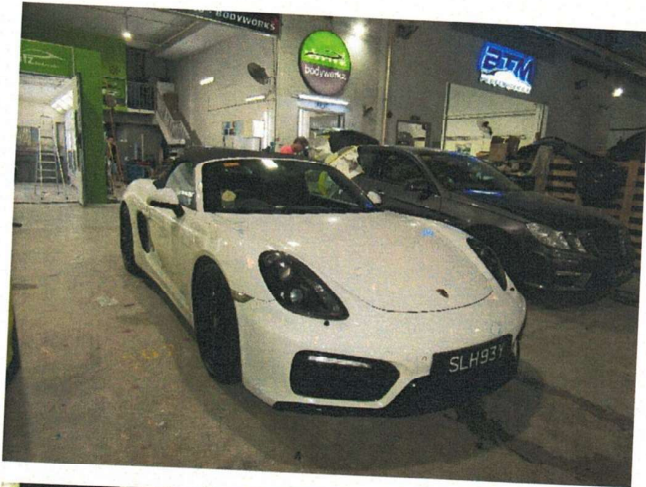
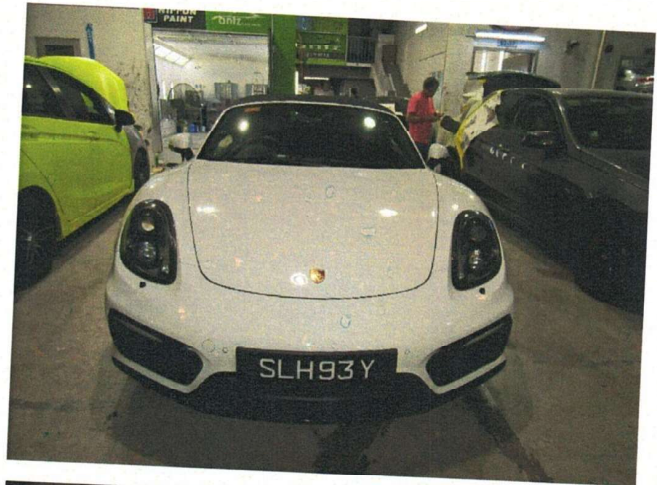
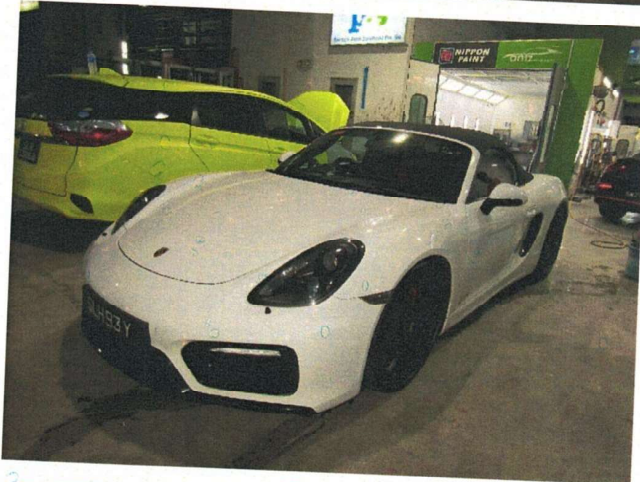
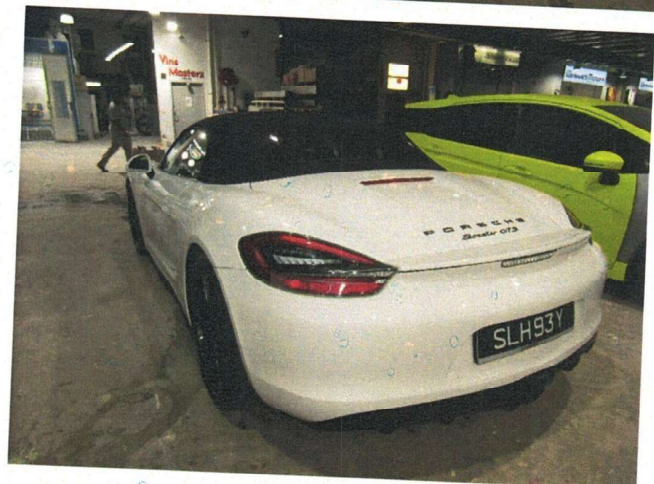
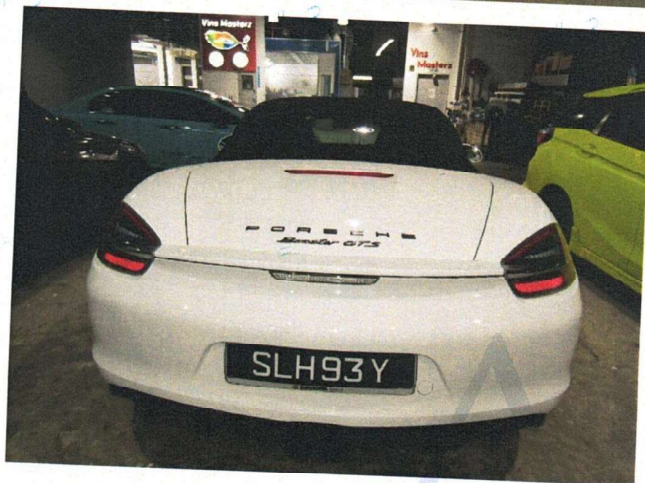
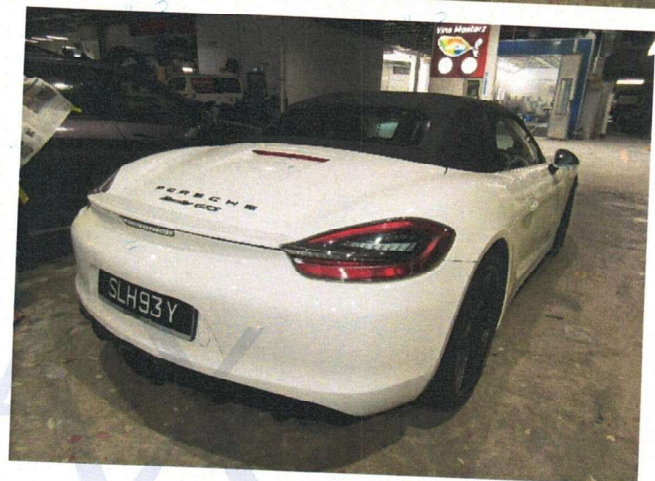
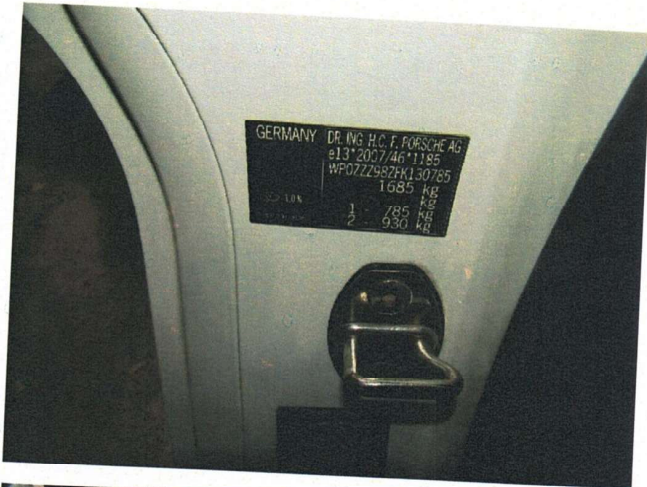
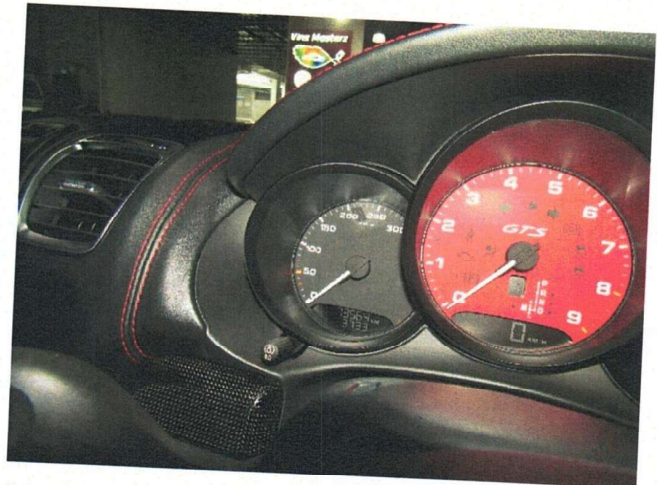
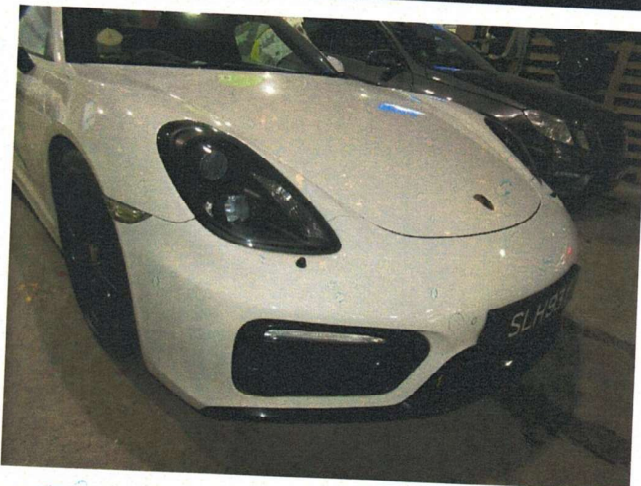
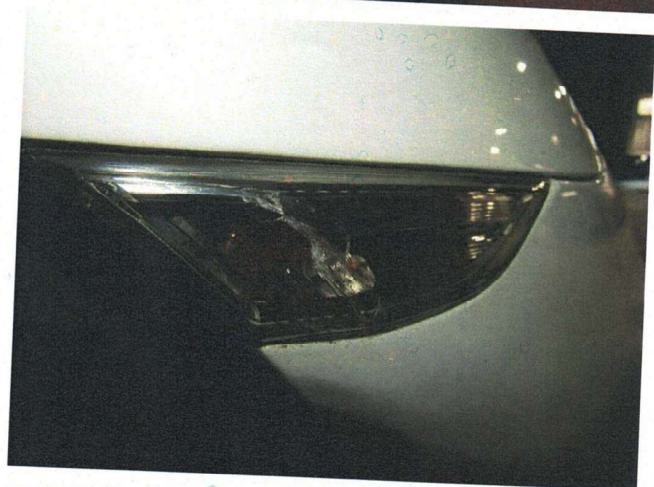
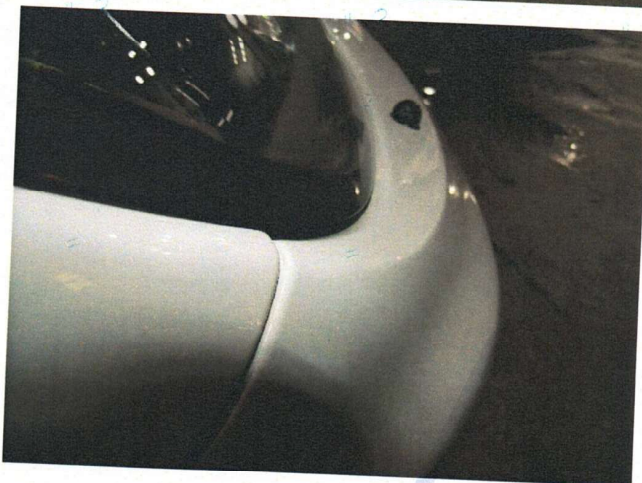
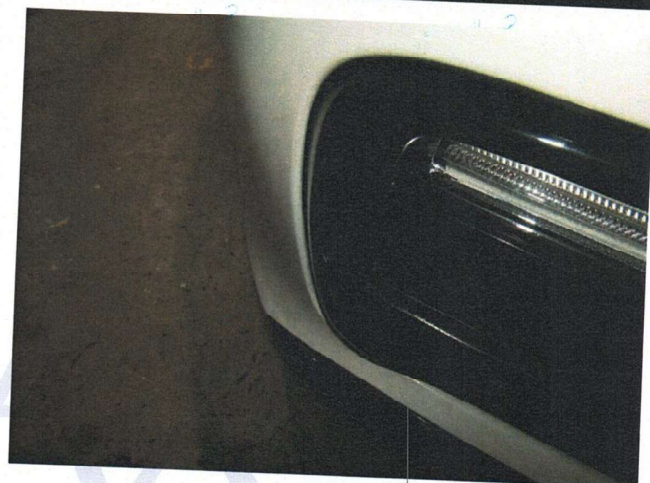
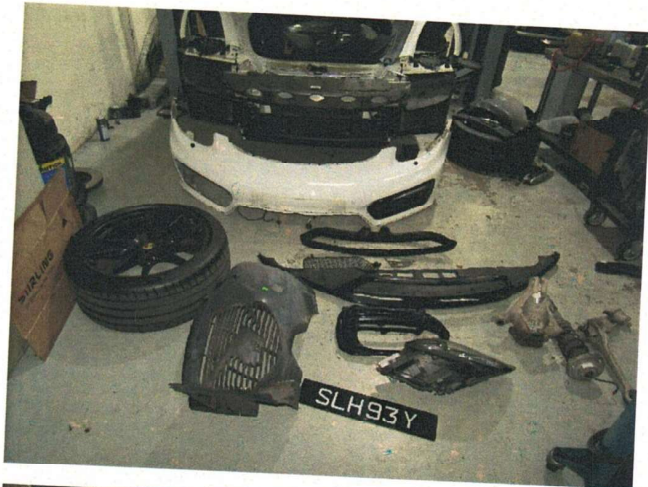
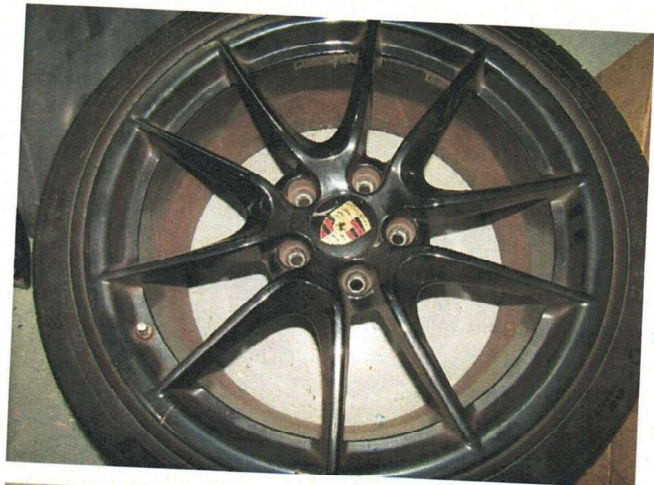
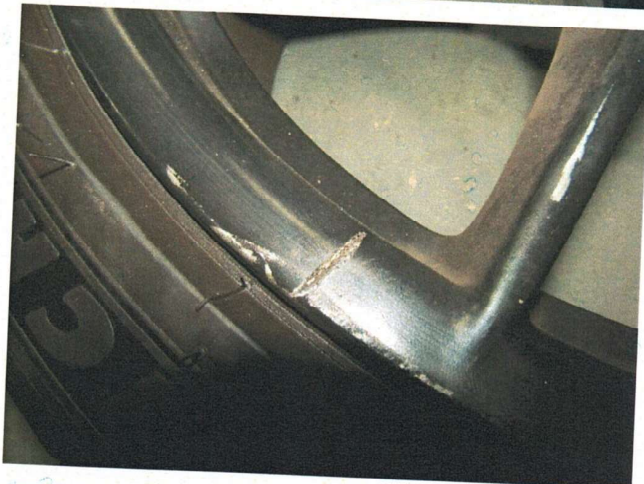
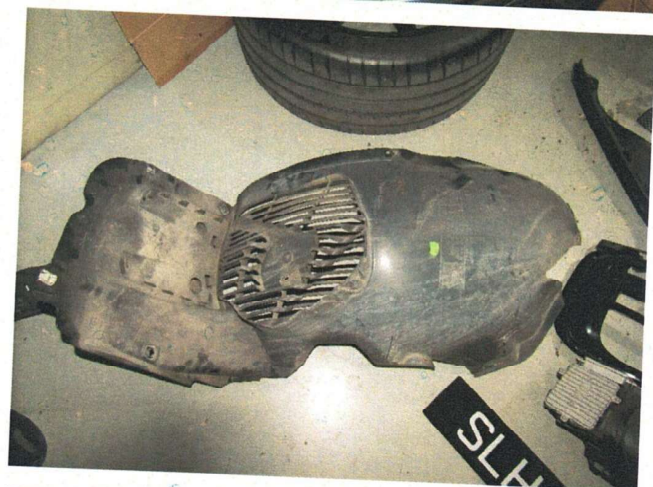
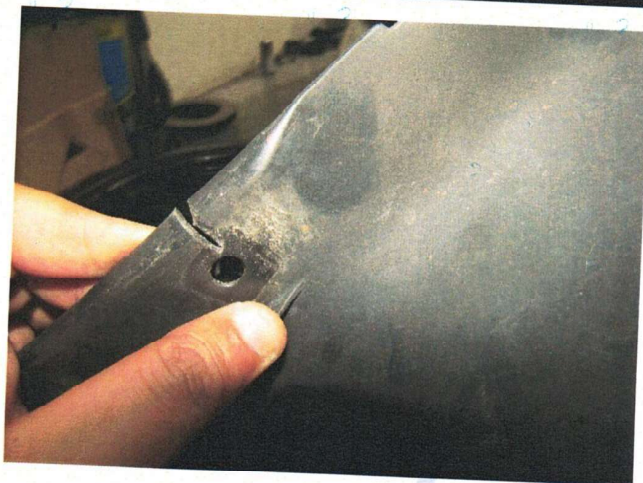
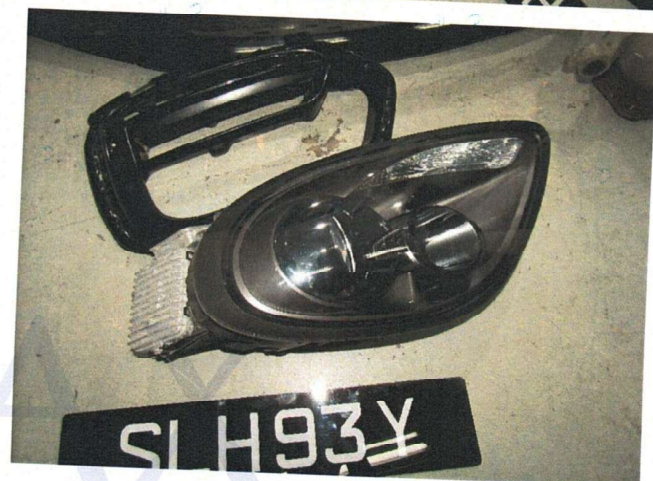
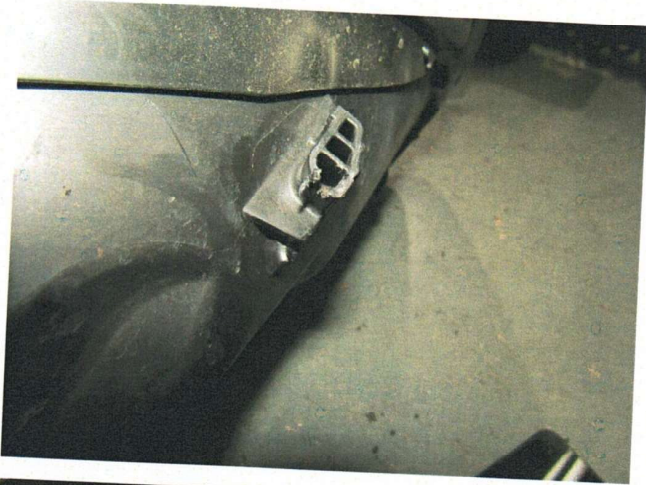
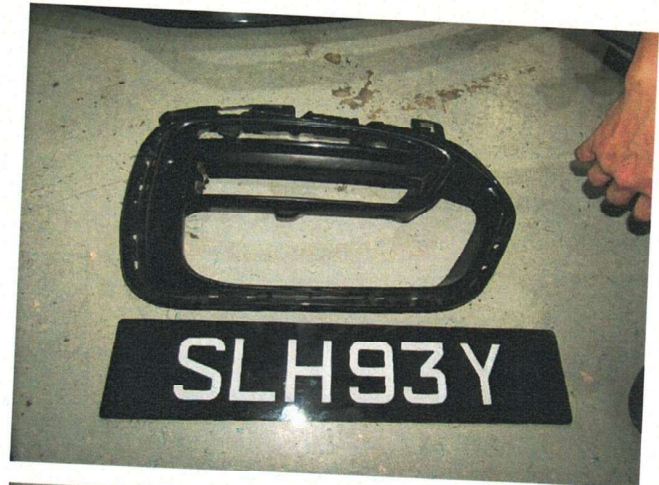
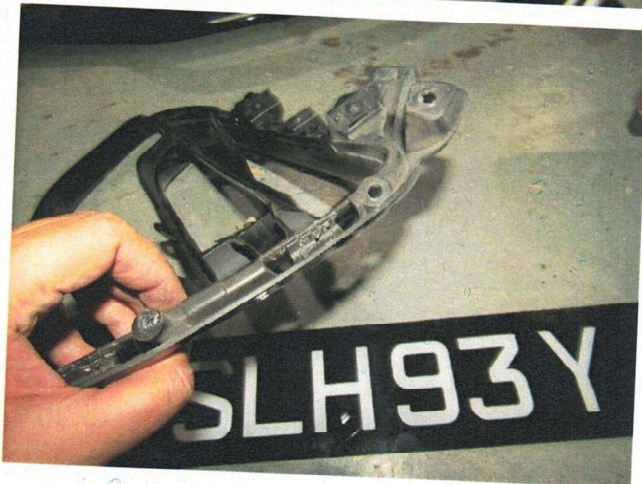
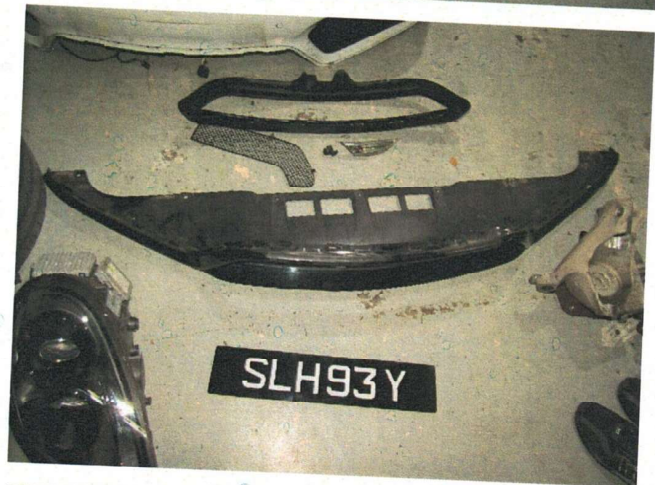
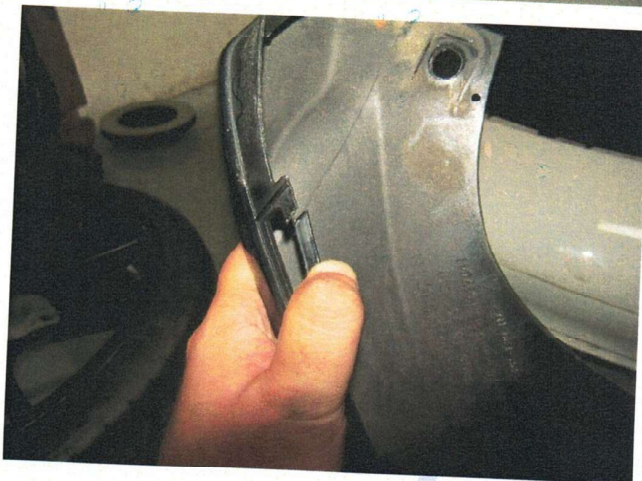
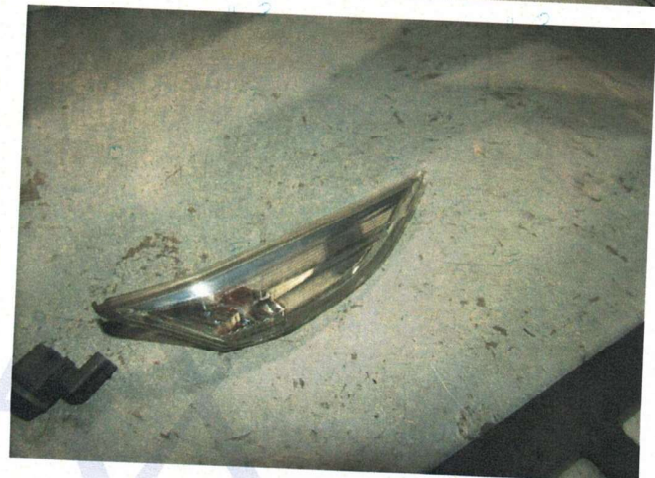
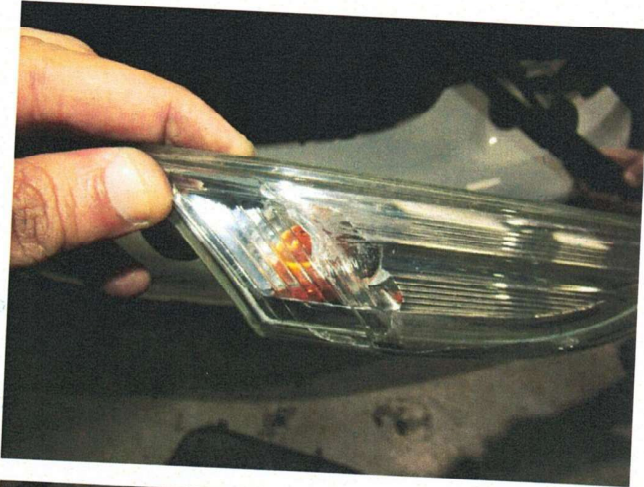
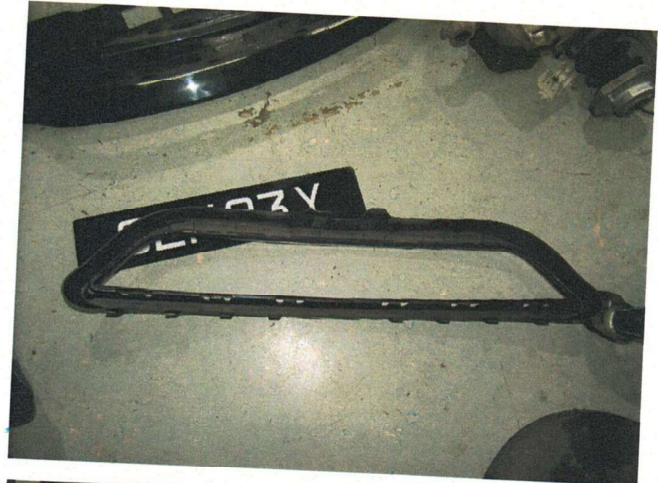
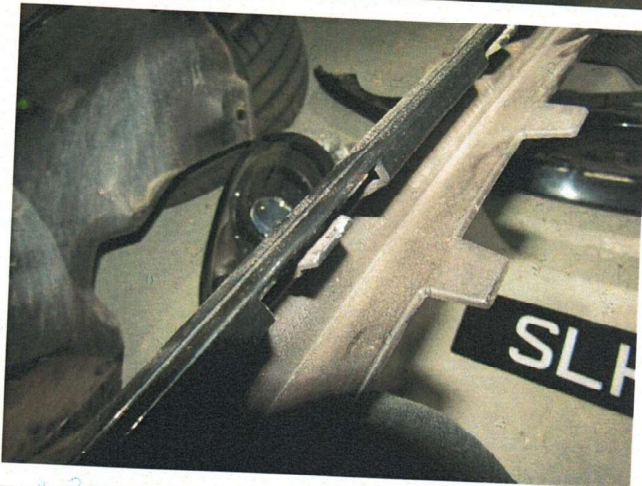
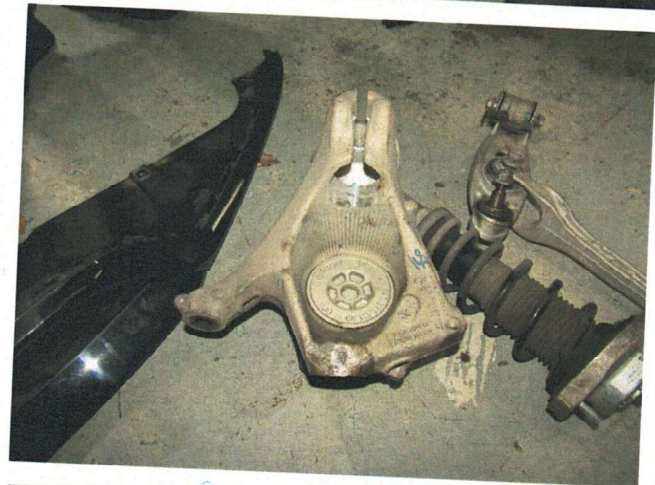
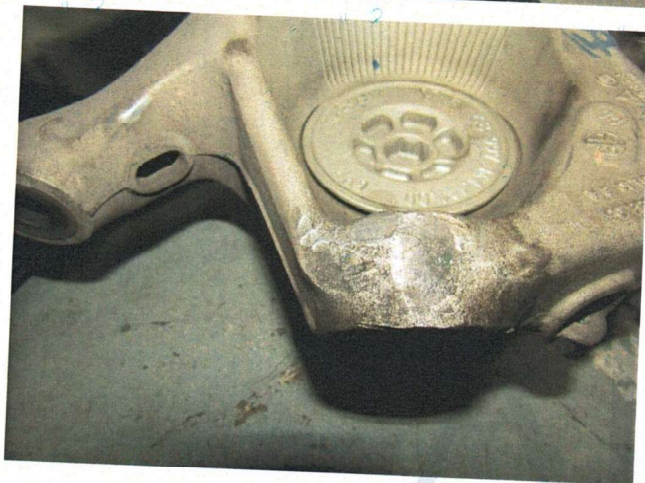
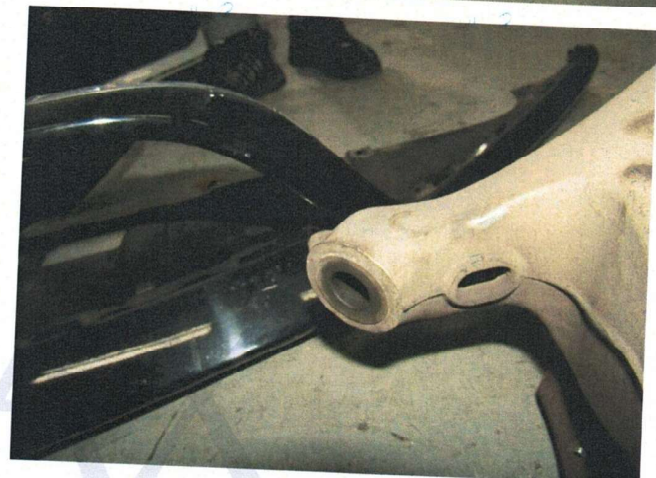
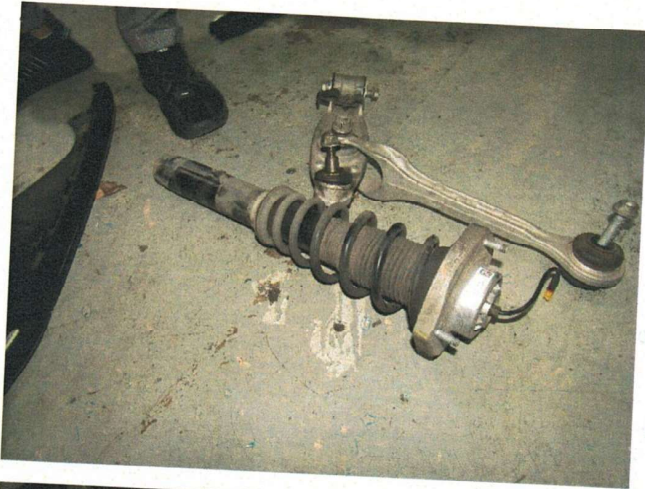
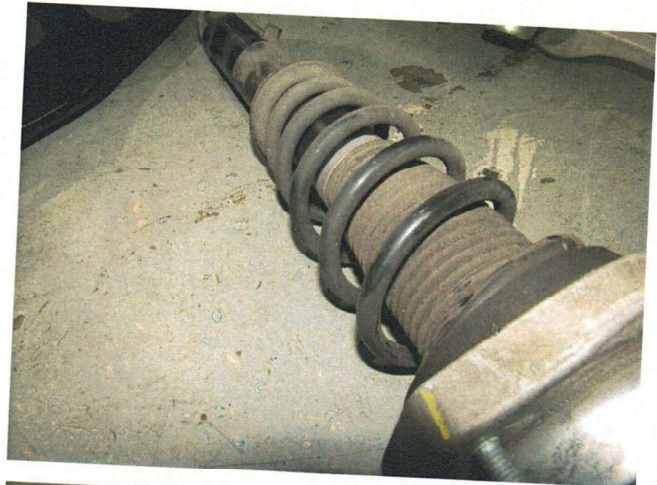
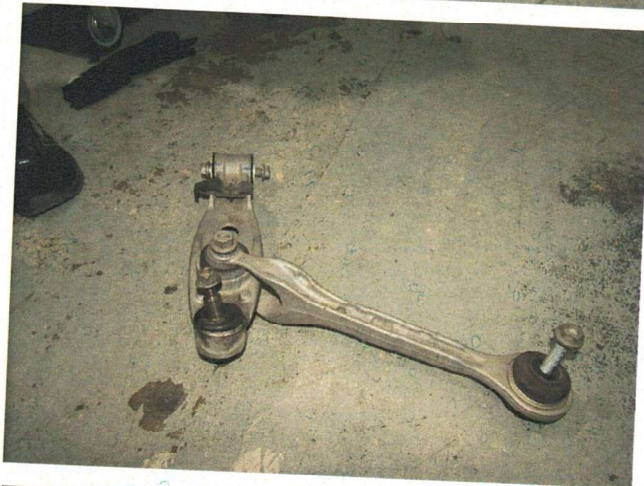
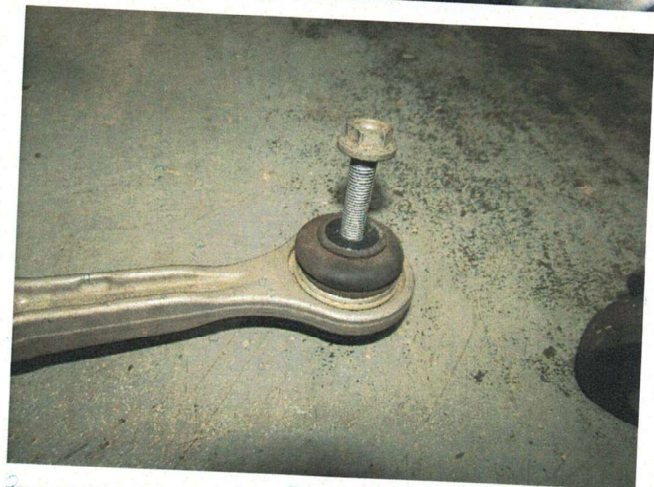
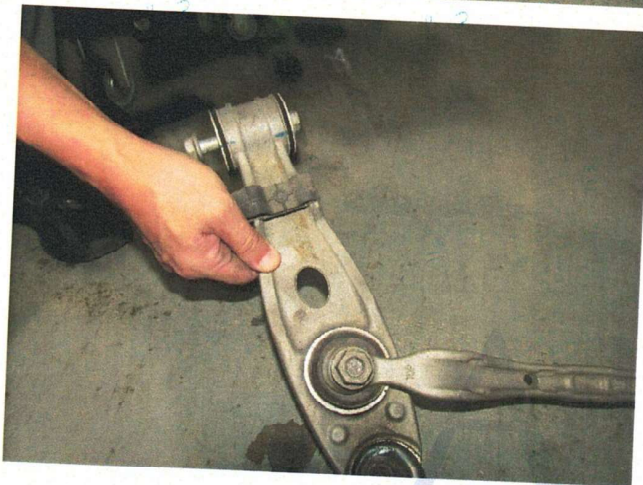
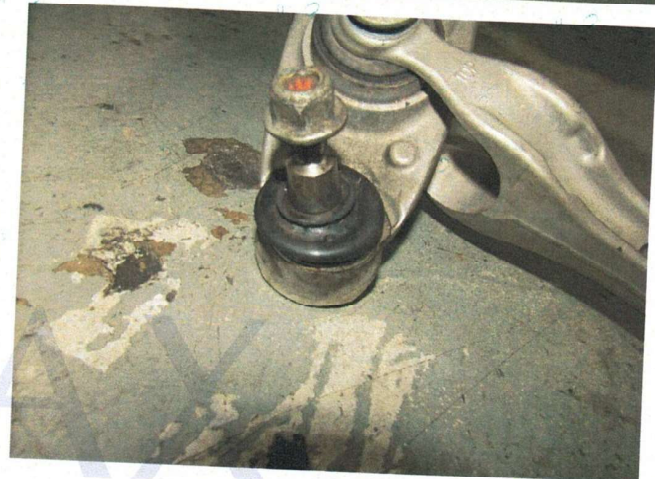
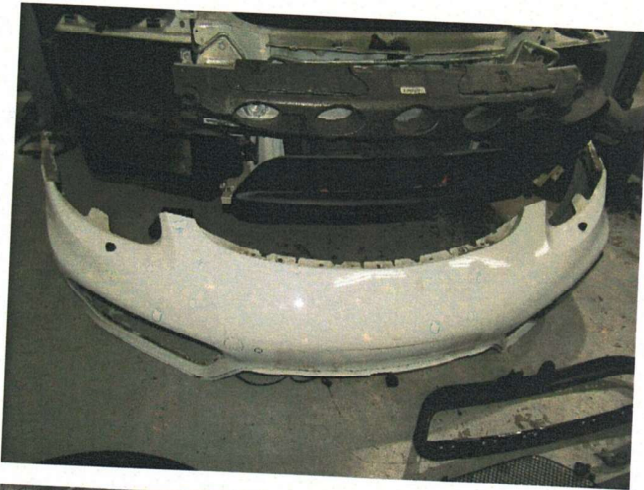
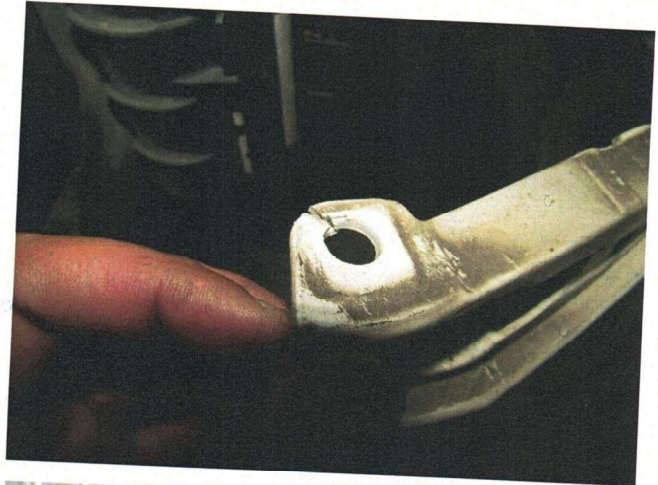
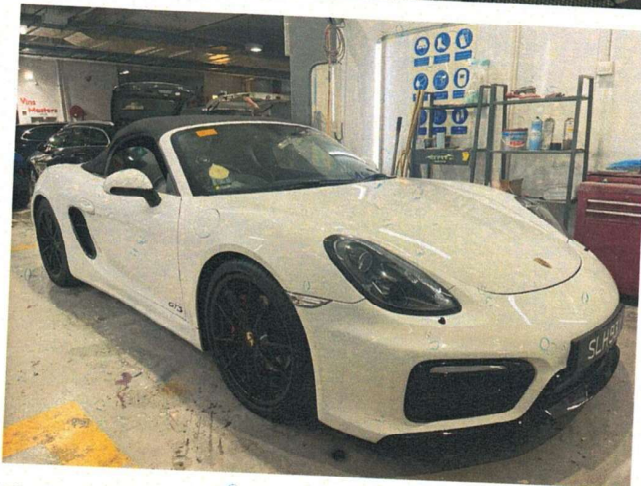
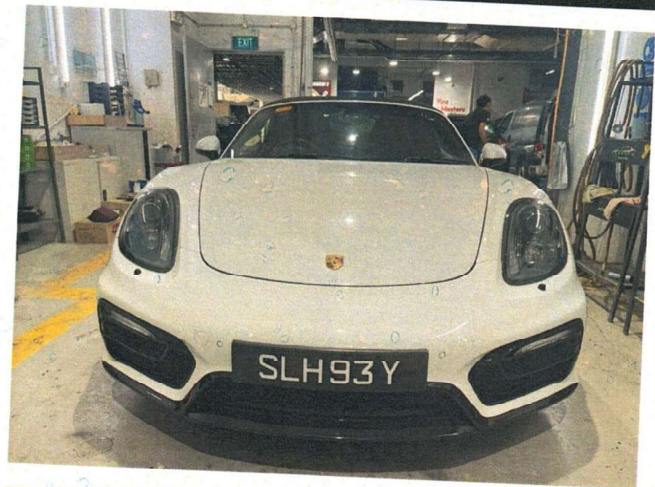
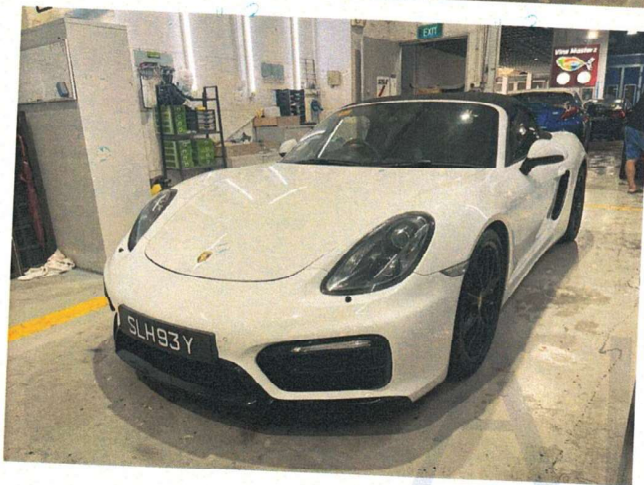
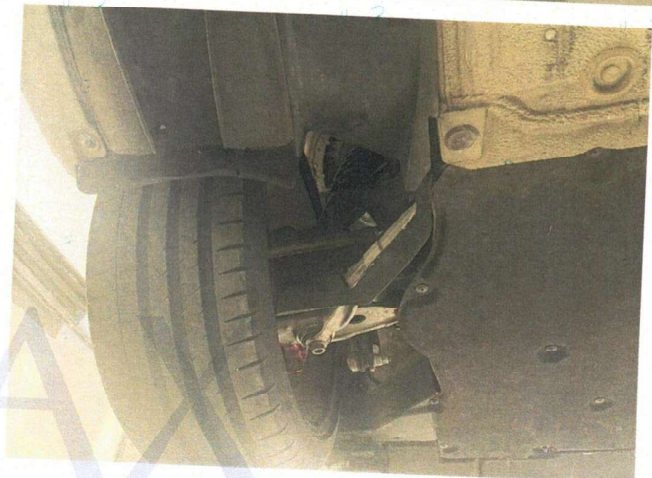
The damage was found on the right portion.

No.	Qty	Description of Parts	Condition	Repairer's Estimate S\$	Our Recommendation S\$
<b>List Items</b>					
1	1	Front headlamp RH	Broken	3,365.40	3,365.40
2	1	Front headlamp mounting RH	Broken	520.00	520.00
3	1	Front signal lamp RH	Cracked	90.00	90.00
4	1	Front bumper	Broken	3,811.50	3,811.50
5	10	Front bumper clips @ \$6.00	Necessary	60.00	60.00
6	1	Front bumper bracket RH	Necessary	80.00	80.00
7	1	Front fender RH	Repair	2,110.65	--
8	1	Front fender lining RH	Necessary	35.00	35.00
9	1	Front fender innershield RH	Torn	775.30	775.30
10	8	Front fender innershield clips	Necessary	48.00	48.00
11	1	Front shock absorber RH	Bent	2,840.00	2,840.00
12	1	Front wheel hub RH	Distorted	950.00	950.00
13	1	Front wheel hub bearing RH	Distorted	350.00	350.00
14	1	Front hub cover RH	Necessary	90.00	90.00
15	1	Power steering	Serviceable	7,540.00	--
16	1	Front tie rod RH	Bent	380.00	380.00
17	1	Front joint RH	Bent	400.00	400.00

18	1	Front upper link RH	Bent	1,050.00	1,050.00
19	1	Front track control arm RH	Bent	1,790.00	1,790.00
20	1	Front stabilizer bar RH	Bent	875.00	875.00
21	1	Front rim RH	Cracked	4,565.00	2,282.50
<b>Sub Total:</b>				31,725.85	19,792.70
<b>Discount (less 10% ):</b>				<b>3,172.59</b>	<b>1,979.27</b>
				28,553.27	17,813.43

We have inspected the actual damages found on the vehicle and recommended the replacement of parts and repairs accordingly. The estimate repair cost is S\$ 32,493.27. The repairer has agreed to undertake the repairs at our adjusted sum amount of S\$ 16,200.00
