## **DAMAGED VEHICLE (SLJ 1362 D) INSPECTION REPORT (WITHOUT PREJUDICE)**

| Registration No | : SLJ 1362 D | Mileage | : 160062 Km |
| Make & Model | : HONDA SHUTTLE 1.5 CVT | Chassis No. | : GP71043538 |

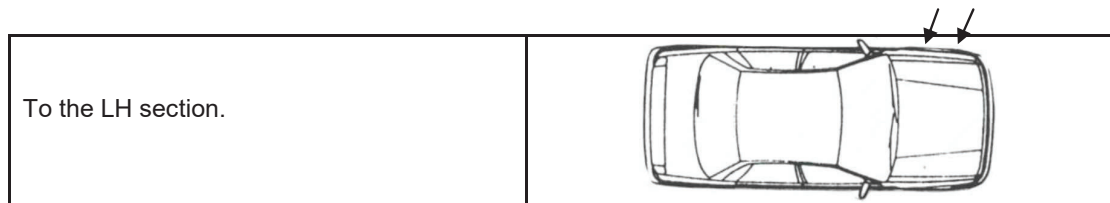
(E) Point of Impact

The impact of the collision has damaged/affected the front fender, front bumper, headlamp, front suspension and etc.
