Date : 12th June 2023

Our Ref : TP / SVAW SLJ1362D/ 05.17/23

DAMAGED VEHICLE (SLJ 1362 D) INSPECTION REPORT (WITHOUT PREJUDICE)

Registration No	: SLJ 1362 D	Mileage	: 160062 Km
Make & Model	: HONDA SHUTTLE 1.5 CVT	Chassis No.	: GP71043538
Date of Registration	: 29 th November 2016	Engine No.	: LEB4263435
Colour	: Black	Engine Capacity.	: 1,496 cc

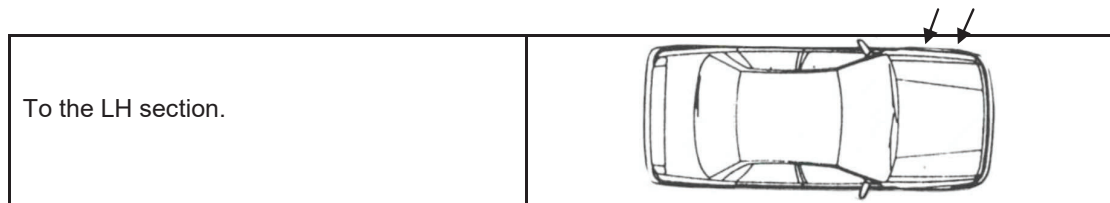
(E) Point of Impact

The impact of the collision has damaged/affected the front fender, front bumper, headlamp, front suspension and etc.
