## VEHICLE DAMAGE ASSESSMENT REPORT

| Model / Make | : MERCEDES BENZ GLC250D | Pre-accident damage | : NIL |

Our Reference : 2023/02033

Vehicle Number : SNE1888G

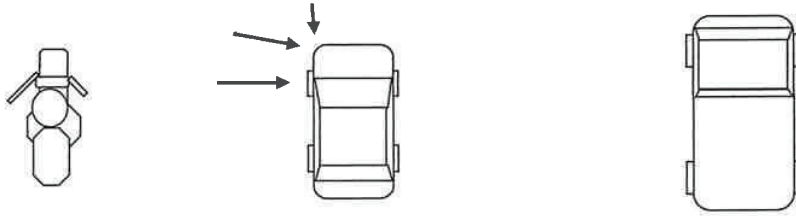
At the time of inspection, this vehicle sustained damages to the **Front N/S** Portion.

Front bumper assy, front n/s headlamp, front n/s fender, front n/s rim, front n/s undercarriage etc.
