Your Ref: TP/IP/02937/2022  
Our Ref : CI/TPD22005243/N

**Fatal Accident Investigation Team**

**MECHANICAL INSPECTION REPORT OF MOTORCYCLE FBM 1552A**

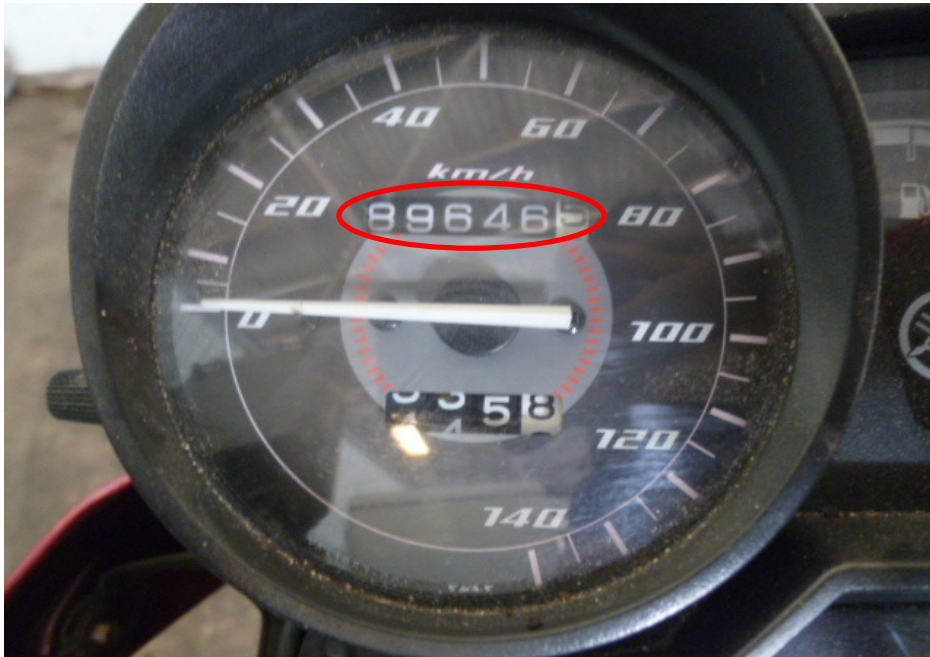
**Photo 1** shows the speedometer gauge of the Motorcycle. The mileage of the Motorcycle at the time of our inspection was 89, 646km (circled).

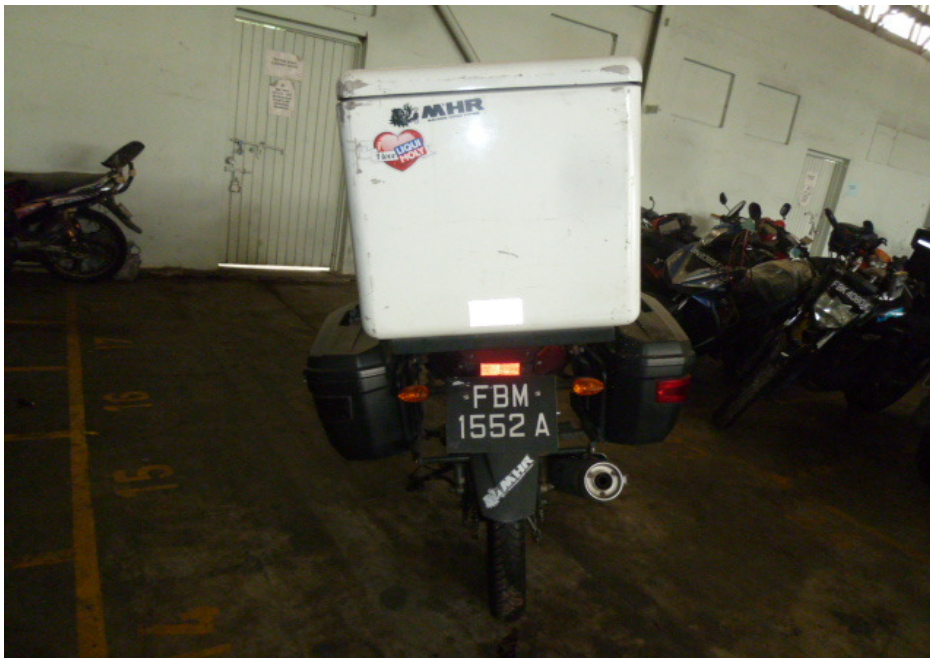
**Photo 2** shows a general view of the rear portion of the Motorcycle at the time of our inspection. The Motorcycle had sustained damages all around.

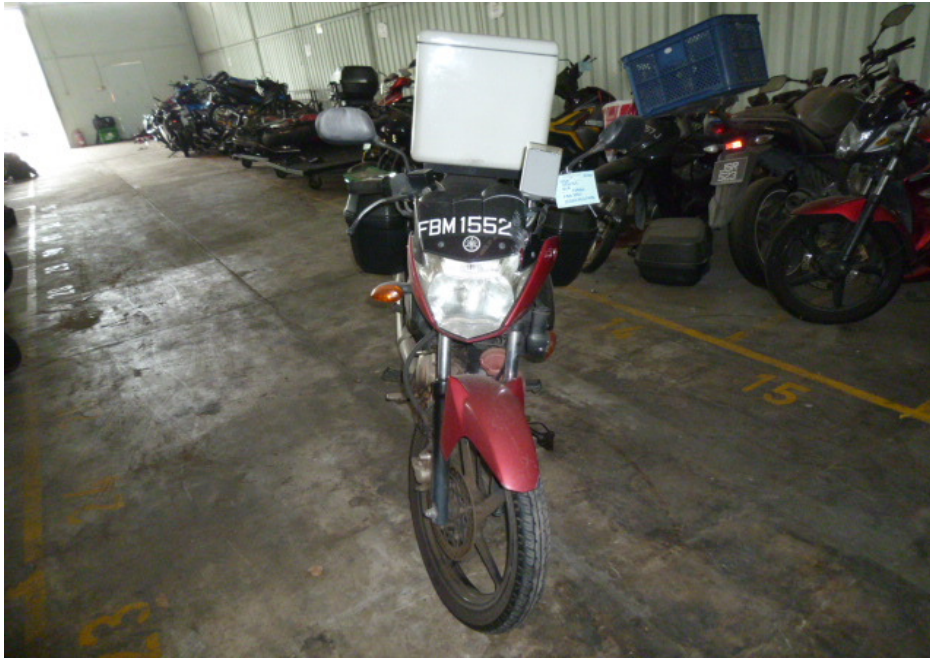
**Photo 3** shows a general view of the frontal portion of the Motorcycle at the time of our inspection. The Motorcycle had sustained damages all around.

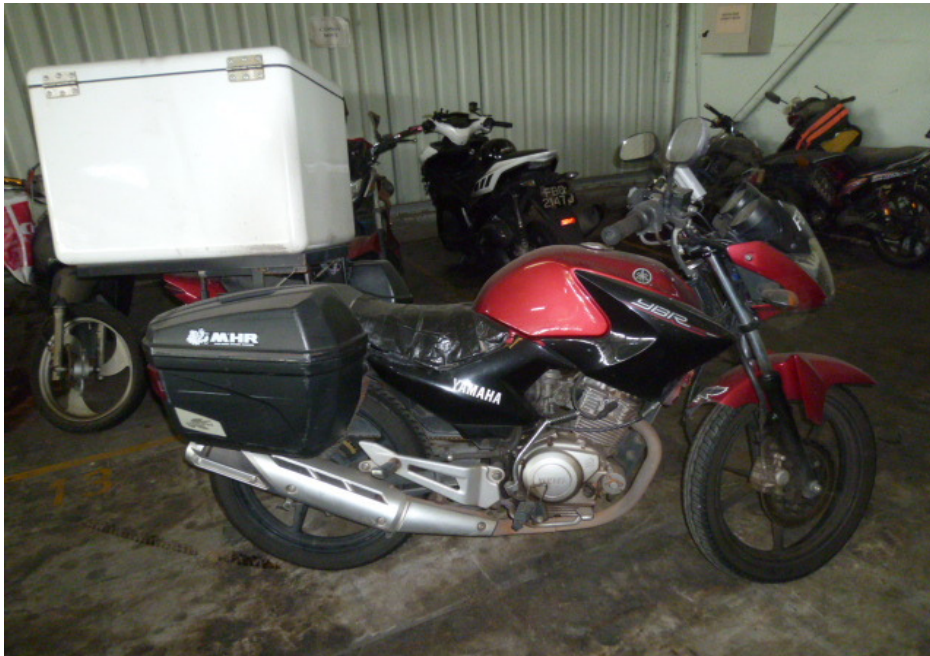
**Photo 4** shows a general view of the right body of the Motorcycle at the time of our inspection. The Motorcycle had sustained damages all around.

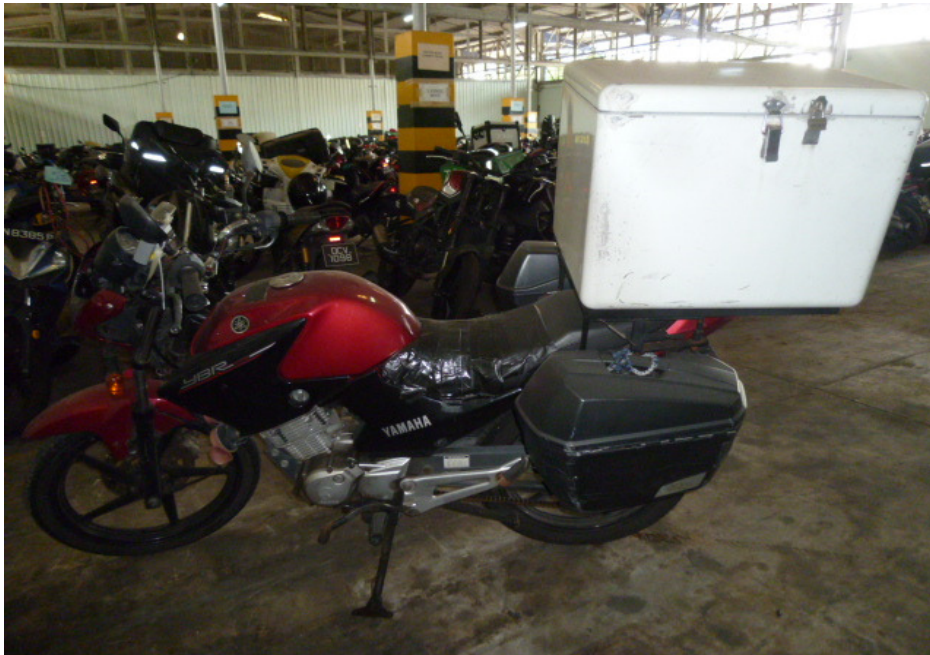
**Photo 5** shows a general view of the left body of the Motorcycle at the time of our inspection. The Motorcycle had sustained damages all around. Body parts that were found to have been damaged include its headlight assembly, speedometer gauge, front fork assembly, front mudguard, left handlebar end, left side mirror, clutch lever, left cowling, left pillion foot peg, top box and side panniers, amongst others.

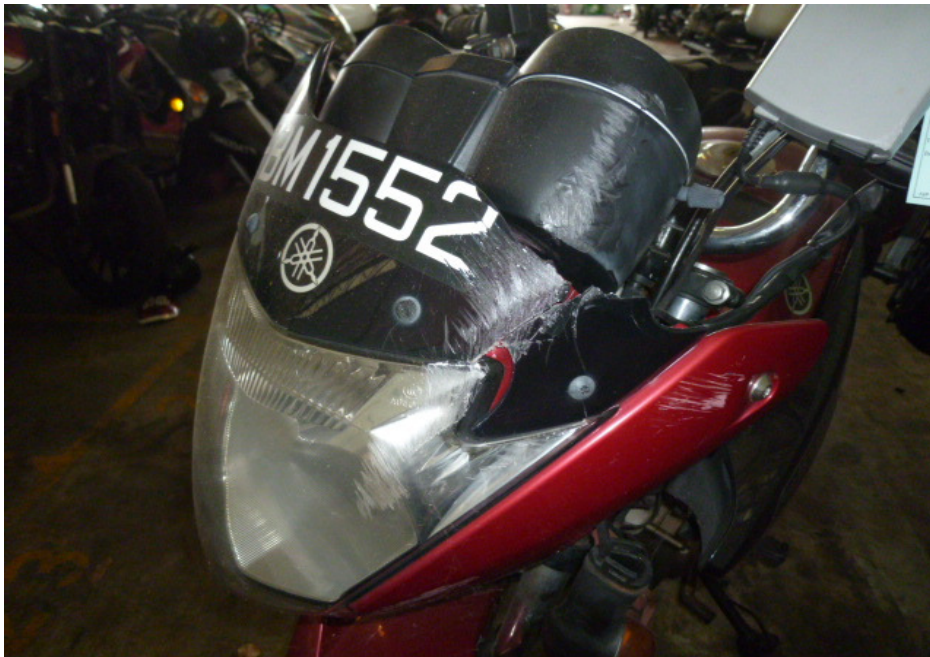
**Photo 6** shows a closer view of the headlight assembly which was amongst the body parts at the front body of the Motorcycle that had sustained damage as a result of the accident.

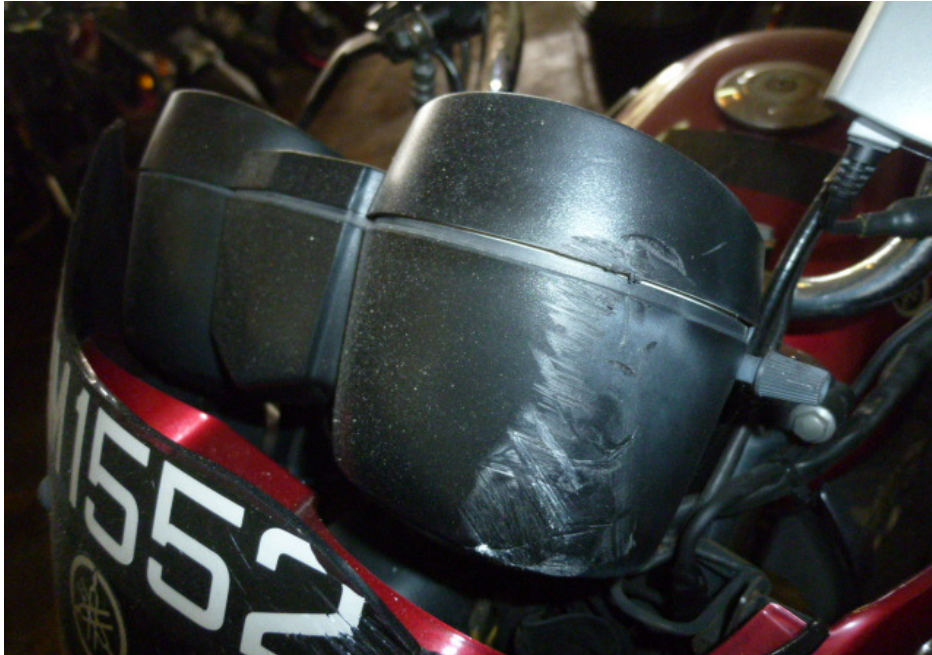
**Photo 7** shows a closer view of the speedometer gauge which was amongst the body parts at the front body of the Motorcycle that had sustained damage as a result of the accident.

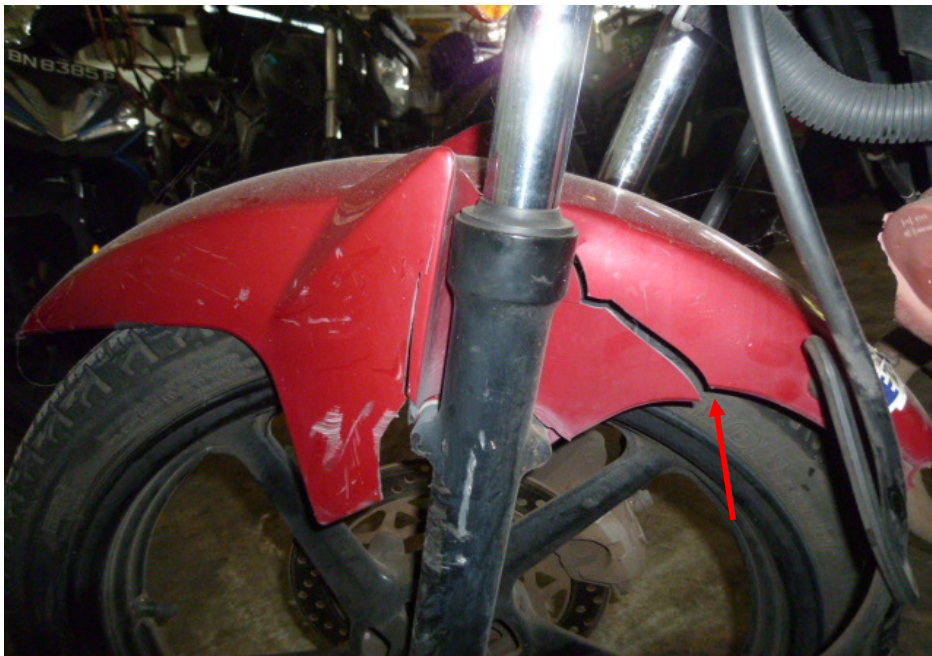
**Photo 8** shows a closer view of the front mudguard which was amongst the body parts at the front body of the Motorcycle that had sustained damage as a result of the accident (arrowed).

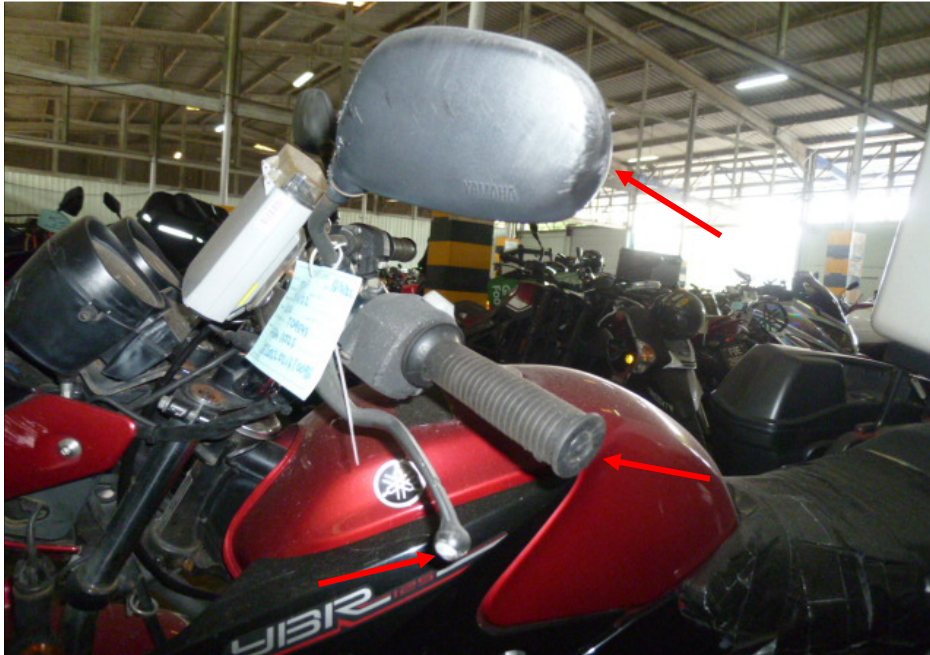
**Photo 9** shows a closer view of the left side mirror, clutch lever and left handlebar end of the Motorcycle (arrowed). These parts were amongst the body parts of the Motorcycle which were damaged as a result of the accident.

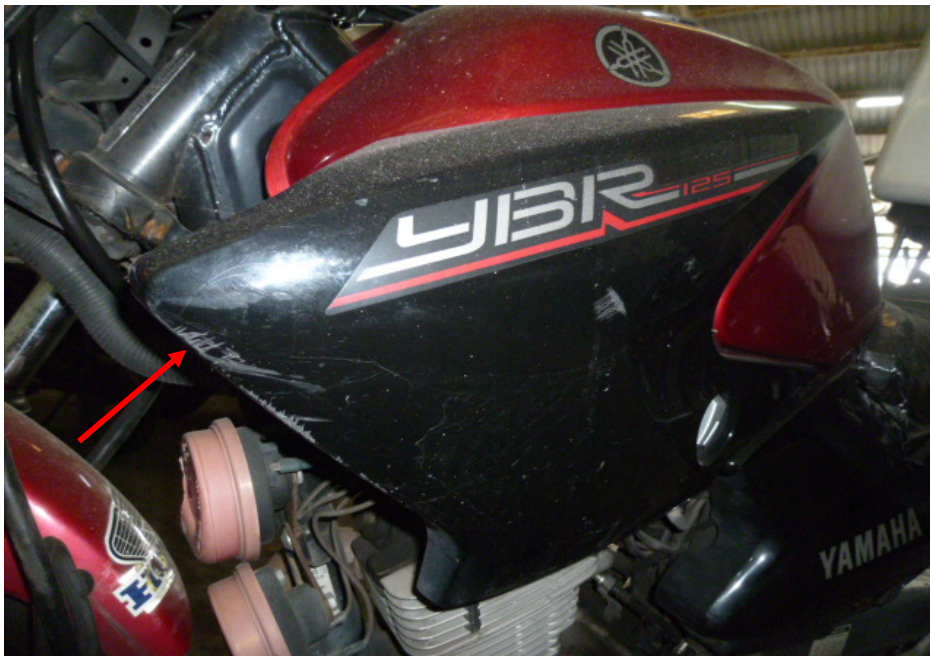
**Photo 10** shows a closer view of the grazed left cowling of the Motorcycle as a result of the accident (arrowed).

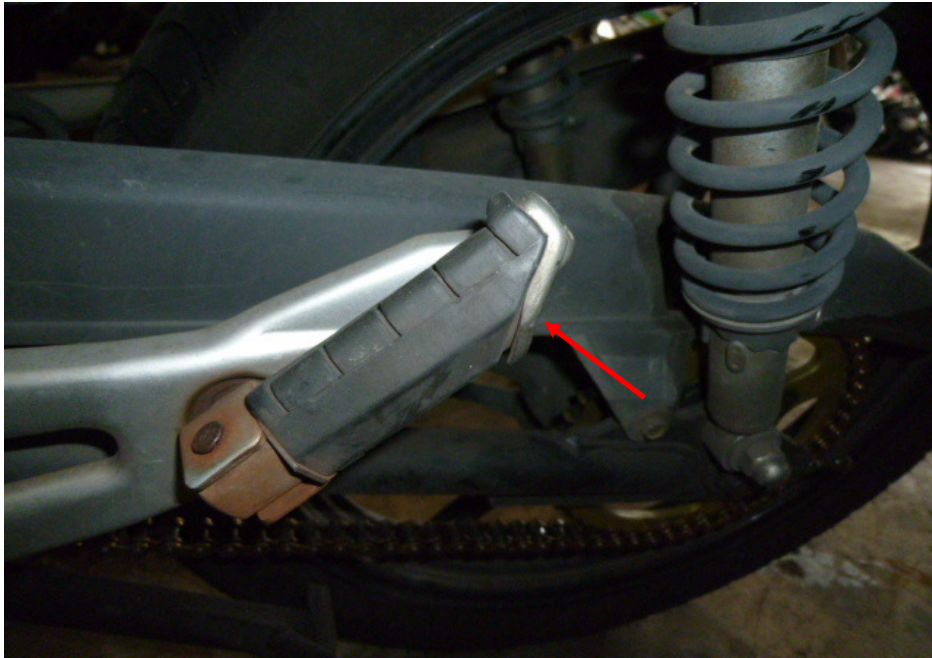
**Photo 11** shows a closer view of the left pillion foot peg which was amongst the body parts of the Motorcycle that had sustained damage as a result of the accident (arrowed).

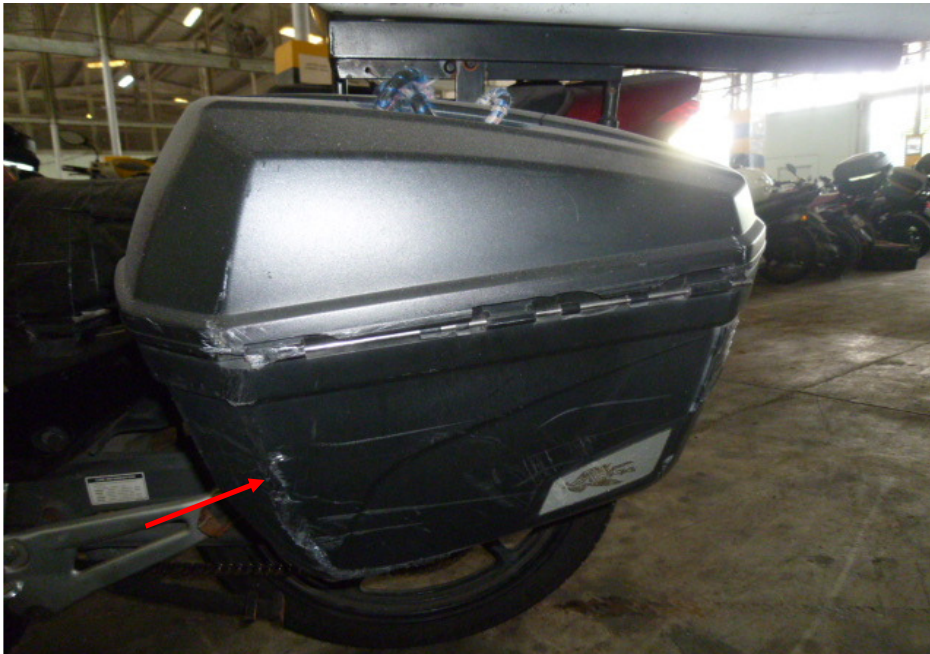
**Photo 12** shows the left side pannier of the Motorcycle which had sustained damage as a result of the accident (arrowed).

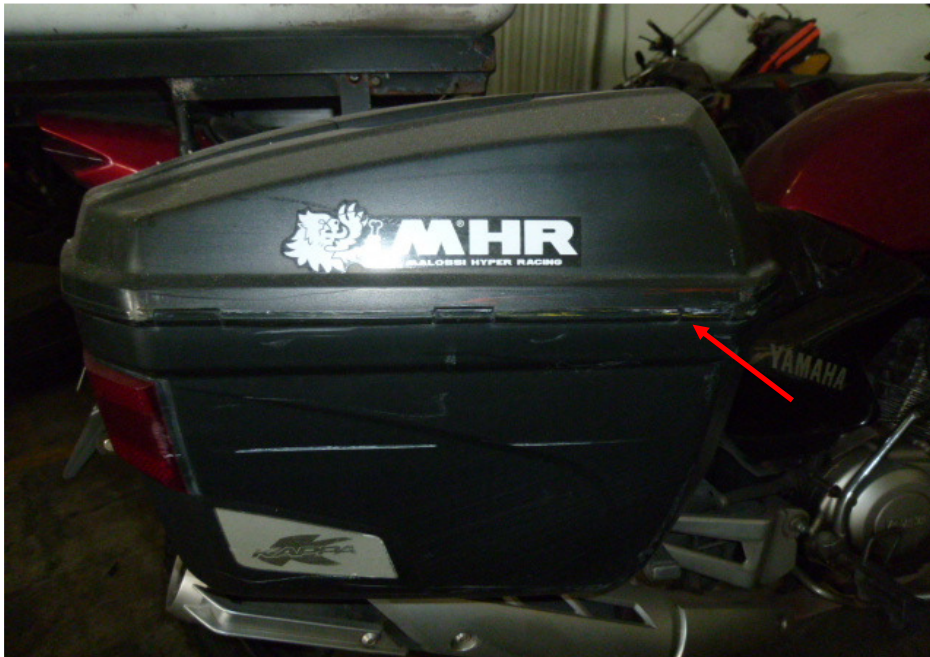
**Photo 13** shows the right side pannier of the Motorcycle which had sustained damage as a result of the accident (arrowed).

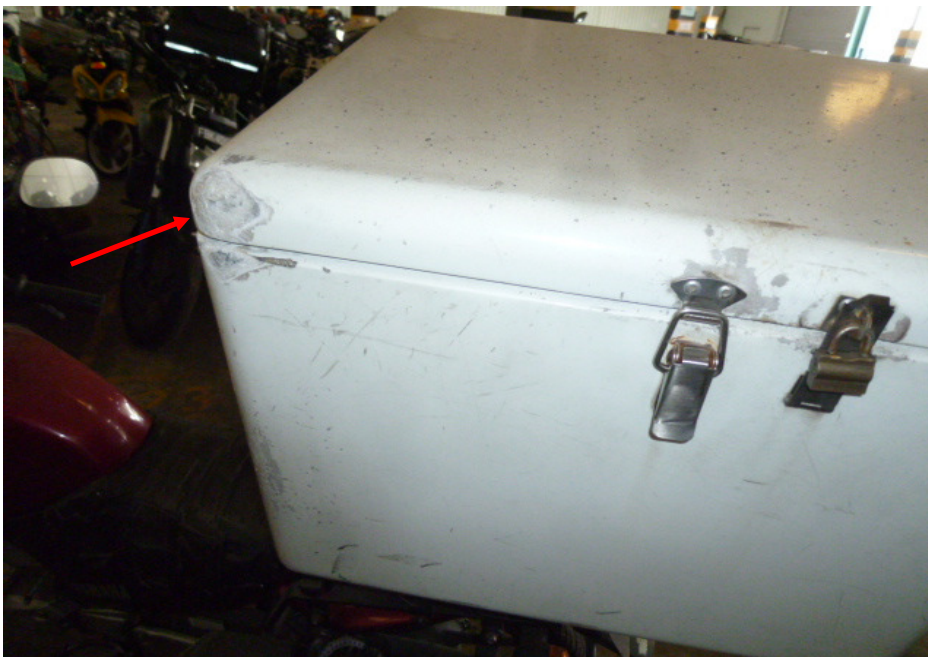
**Photo 14** shows the top box of the Motorcycle which had sustained damage as a result of the accident (arrowed).

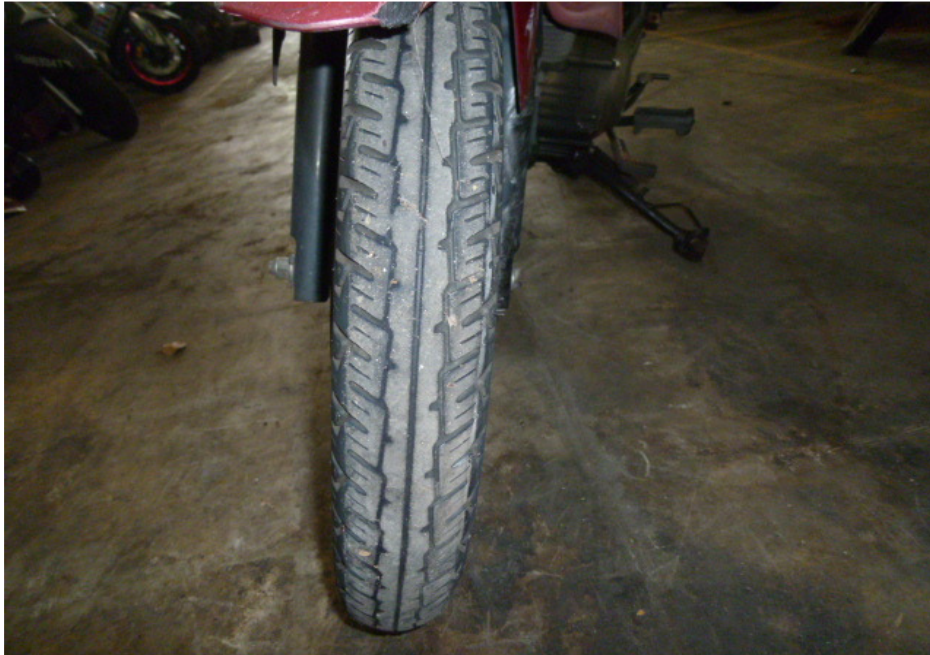
**Photo 15** shows the condition of the Motorcycle's front tyre. The front tyre was observed to be in serviceable condition with remaining tread depth of approximately 2mm. There was no tear, burst mark(s) and/or punctured hole(s) on the sidewalls as well as across the tread of the front tyre.

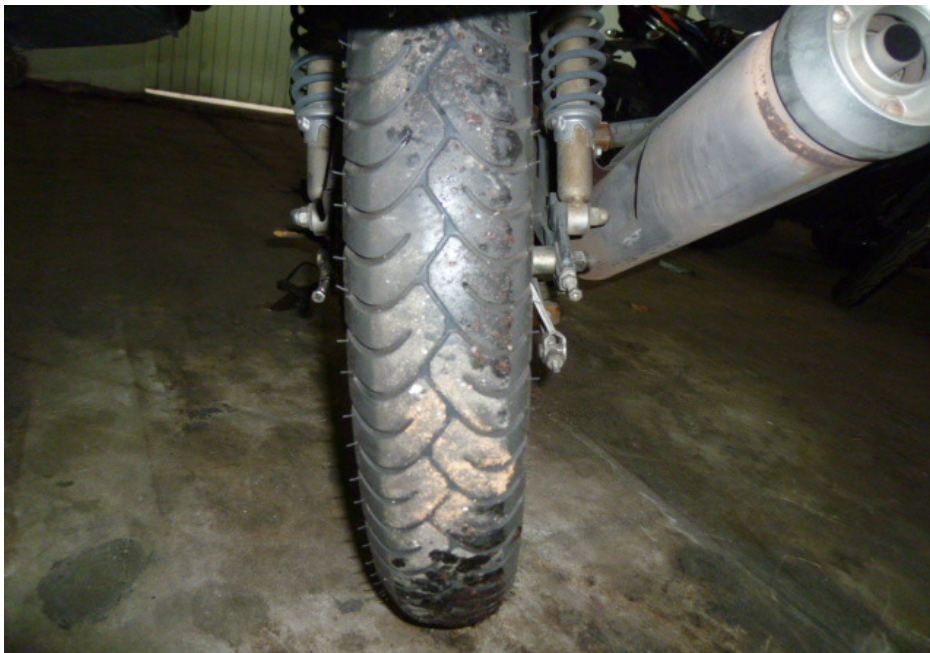
**Photo 16** shows the condition of the Motorcycle's rear tyre. The pattern of the tread was clearly visible with remaining tread depth of approximately 2mm. We did not observe any tear, burst mark(s) and/or punctured hole(s) on the sidewalls as well as across the tread of the rear tyre.

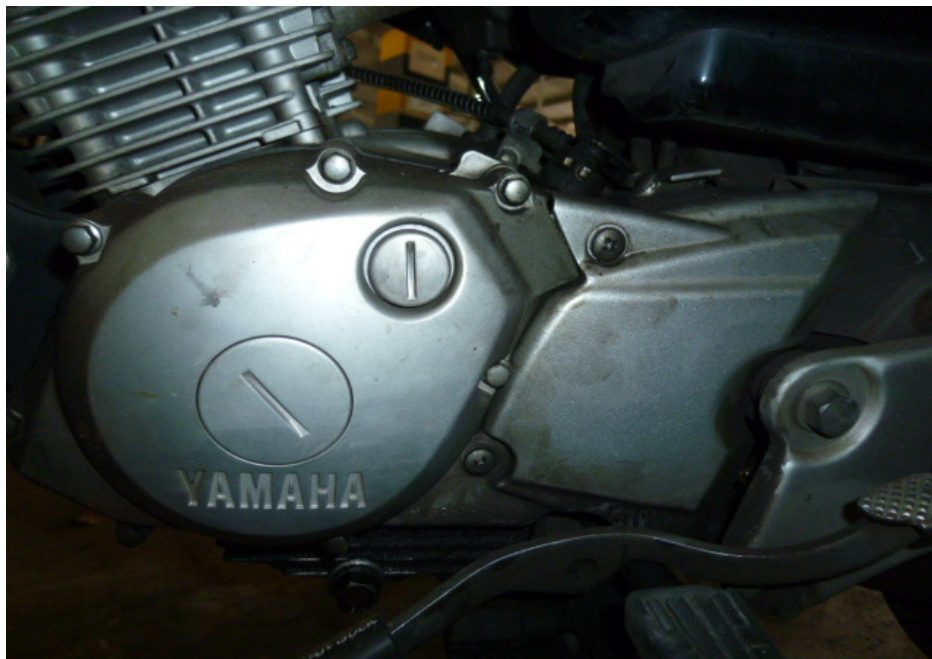
**Photo 17** shows the left side of the engine of the Motorcycle at the time of our inspection. The various engine related parts and components were found to be intact with no visible damage. There was also no sign(s) or indication(s) of fluid leak observed around the left engine area of the Motorcycle.

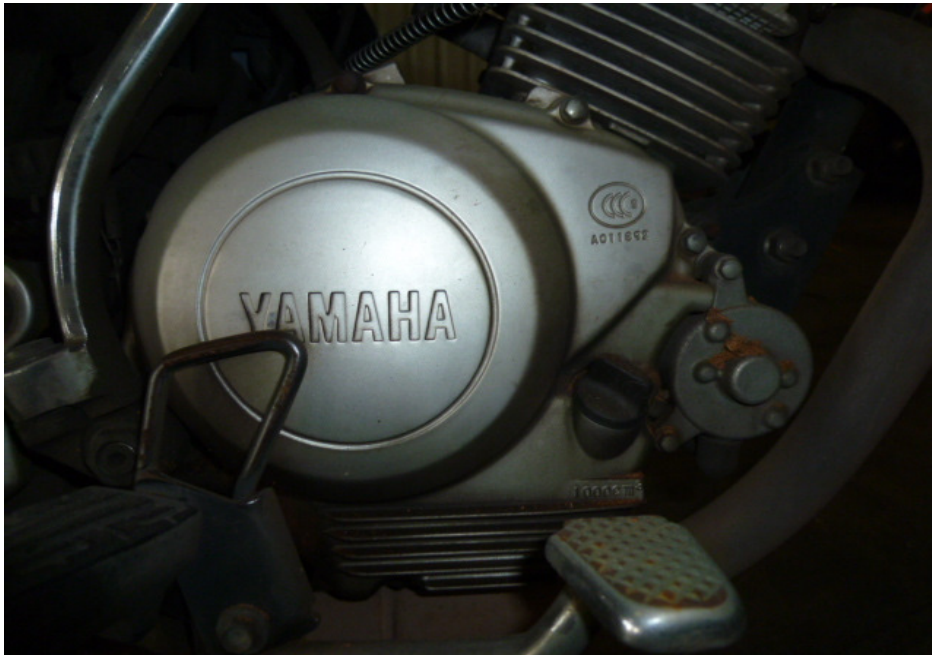
**Photo 18** shows the right side of the engine of the Motorcycle at the time of our inspection. The various engine related parts and components were found to be intact with no visible damage. There was also no sign(s) or indication(s) of fluid leak observed around the right engine area of the Motorcycle.

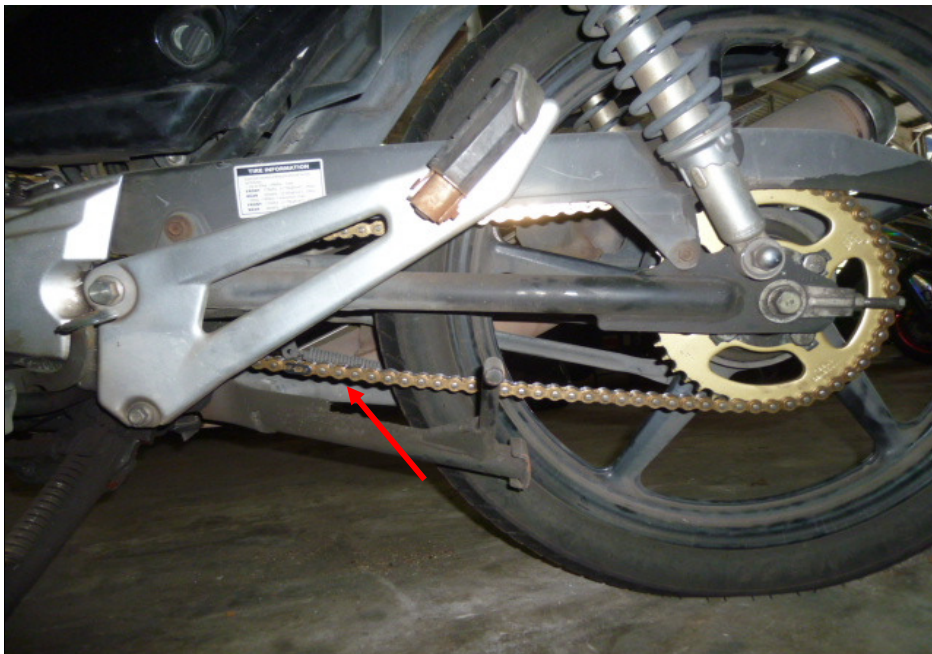
**Photo 19** shows the gear train (arrowed) of the Motorcycle, which was observed to be intact with no misalignment. It was also adequately lubricated for operating purposes. The gear train rotates the rear wheel of the Motorcycle.

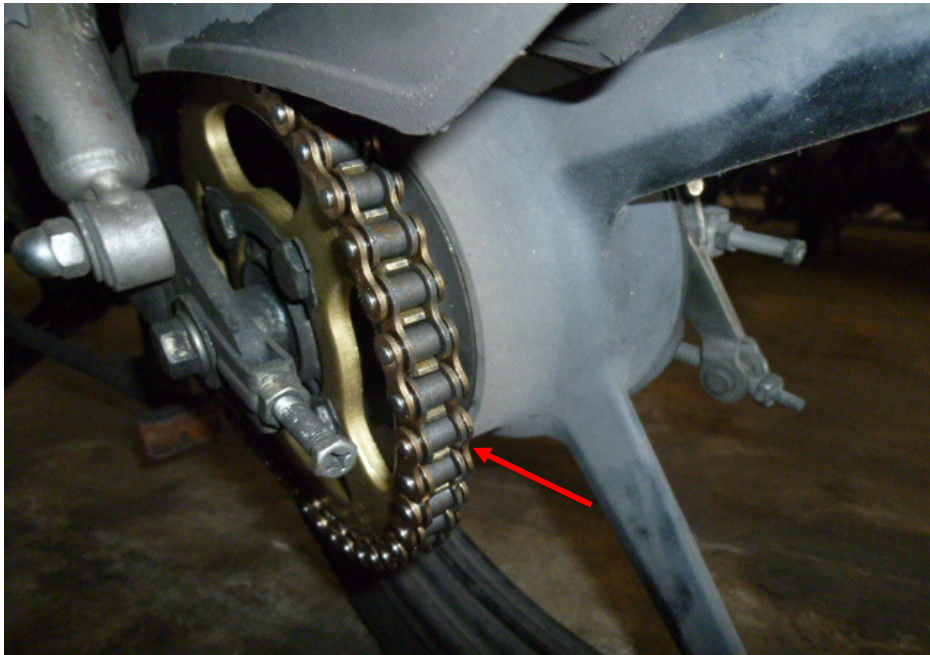
**Photo 20** shows the closer view of the gear train (arrowed) of the Motorcycle, which was observed to be intact with no misalignment. It was also adequately lubricated for operating purposes.

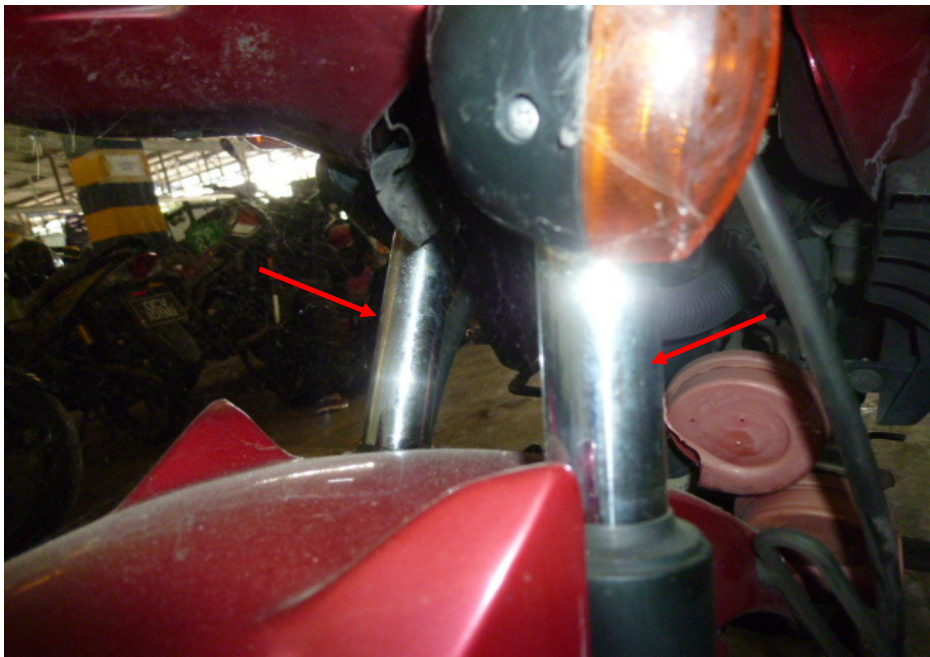
11. For this case, we were not able to conduct any test(s) on the steering system of the Motorcycle due to the damage of its fork assembly. The front forks were found to be bent inwards as a result of the accident.

**Photo 21** shows the front forks of the Motorcycle. The front forks were observed to be bent inwards as a result of the accident (arrowed). We were hence not able to conduct any tests on the steering system of the Motorcycle.

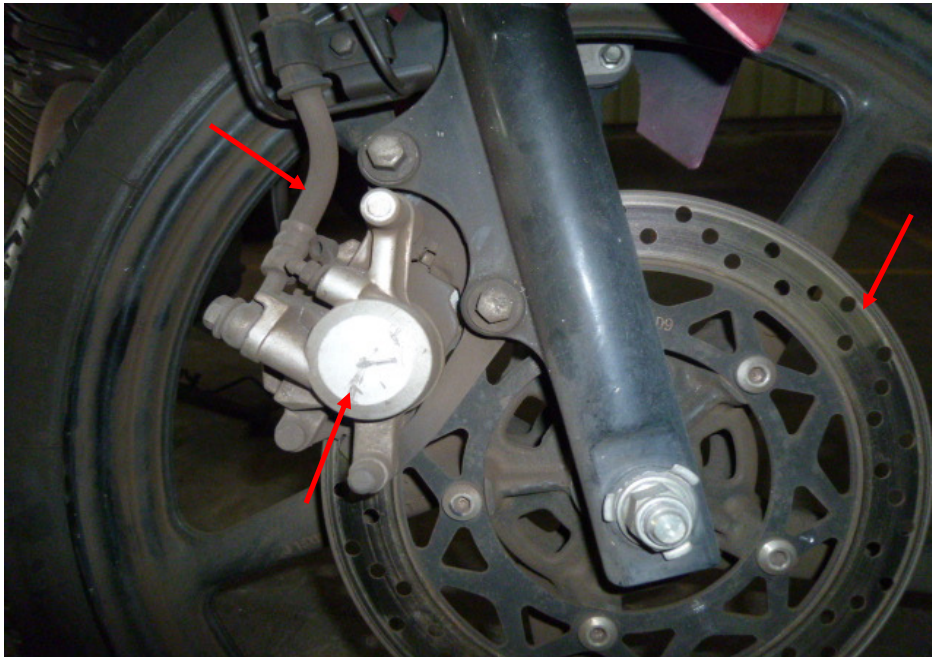
**Photo 22** shows a close up view of the front brake caliper, front brake disc and front brake hose (arrowed) of the Motorcycle, which are all part of the components in the hydraulic front brake system of the Motorcycle. Our visual checks of these various components had revealed all to be intact with no visible damage. No leakage of brake fluid was also observed.

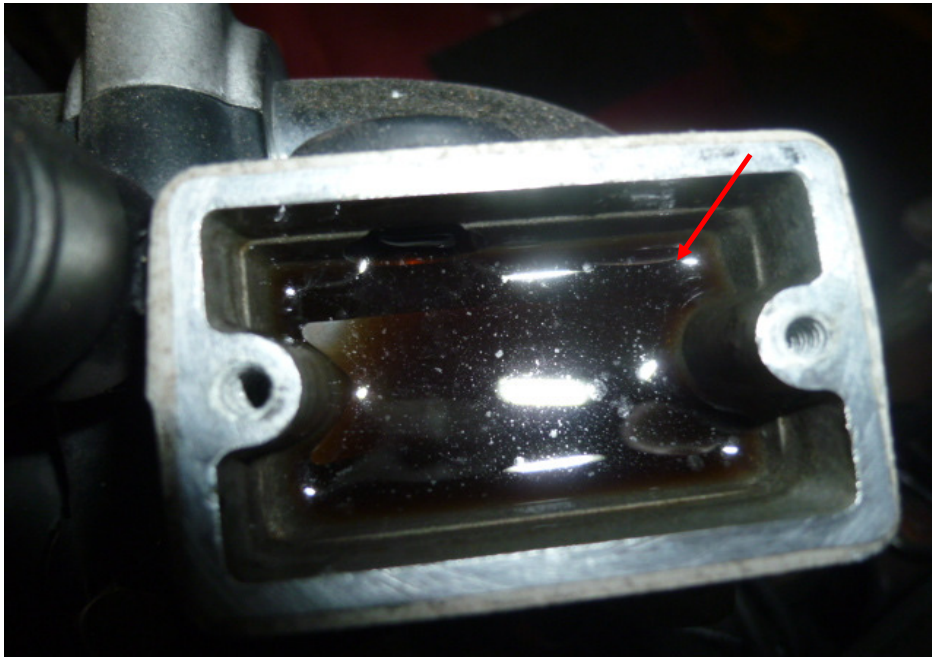
**Photo 23** shows the brake fluid reservoir for the front brake of the Motorcycle. The brake fluid was found to be of sufficient level for operating purposes. However the brake fluid was found to be slightly contaminated (arrowed).

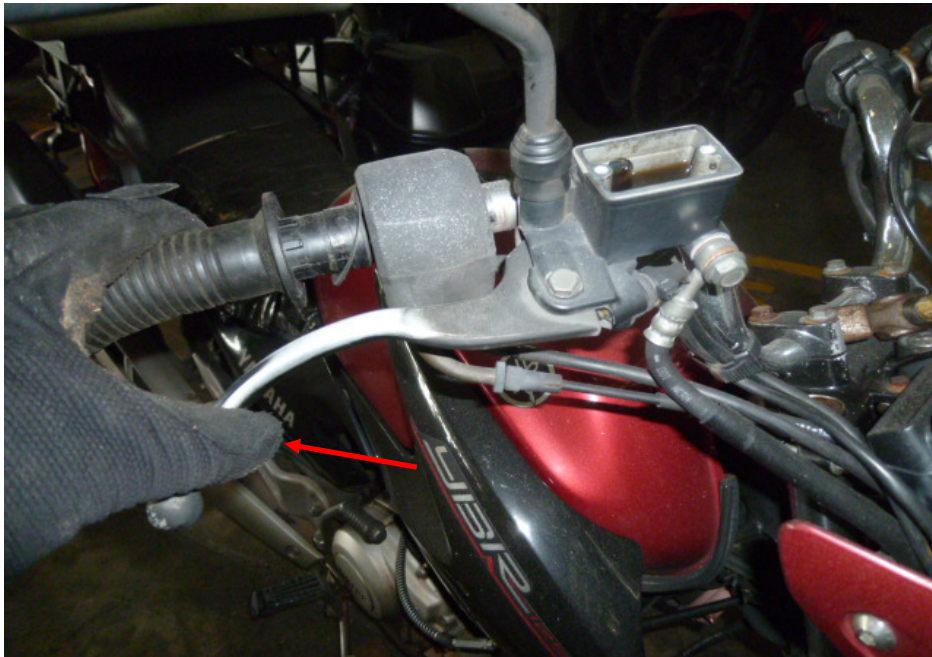
13. Static brake tests conducted on the Motorcycle had appeared to indicate that the front brake system of the Motorcycle was in serviceable condition. There was some resistance felt (spongy like feel) upon pressing the front brake lever. This would indicate that there's no leakage of pressure/vacuum in the front brake system.
14. For this case, we were not able to carry out any operational tests to the steering system and braking system of the Motorcycle due to the damage of its front forks, which had rendered the Motorcycle immobile for the operational tests. We were not able to push the Motorcycle manually forward and backward, simulating movement of the Motorcycle, for the operational tests. See photos 21 – 25 below.

**Photo 24** shows the front brake lever being depressed. There was some resistance felt (spongy like feel) upon pressing the front brake lever (arrowed). This would indicate that there is no leakage of pressure/vacuum in the brake system.

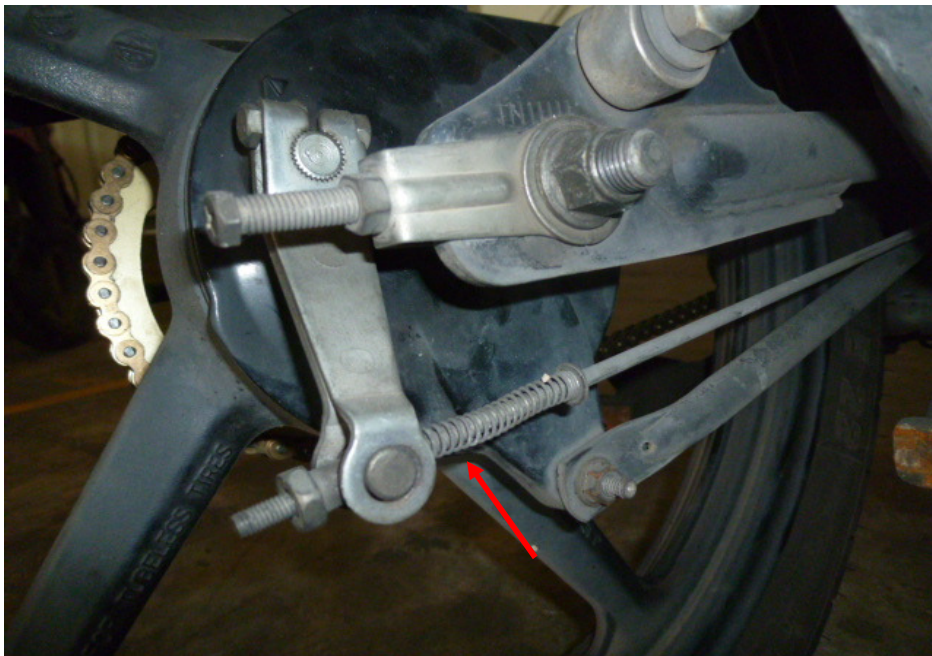
**Photo 25** shows the rear wheel of the Motorcycle. The type of brake system for the rear wheel was of a mechanical type, controlled by the brake foot pedal of the Motorcycle. Our checks of the cable (arrowed), spring and drum which are all part of the components in the rear brake system of the Motorcycle reveal all to be intact and without damage.
