**From:** Veron Chen (LKKAuto)  
**Sent:** Monday, 16 September 2019 11:12 AM  
**To:** 'Alan Chng'  
**Cc:** Taufikh (LKKAuto); SUR  
**Subject:** FW: 1st reminder resend the finalization for veh no:WD158K  
**Attachments:** 06082019163145-0001.pdf; 06082019163128-0001.pdf

| CLAIM SUBFOLDER DETAILS | | [Created by insurer] |
|---|---|---|
| Vehicle Reg. No.: | WD158K | Date of Loss: 07/07/2018 05:00 - :59<br>[26 Months and 15 Days From LTA Reg Date (Man Yr)] |

## VEHICLE DAMAGE INSPECTION REPORT

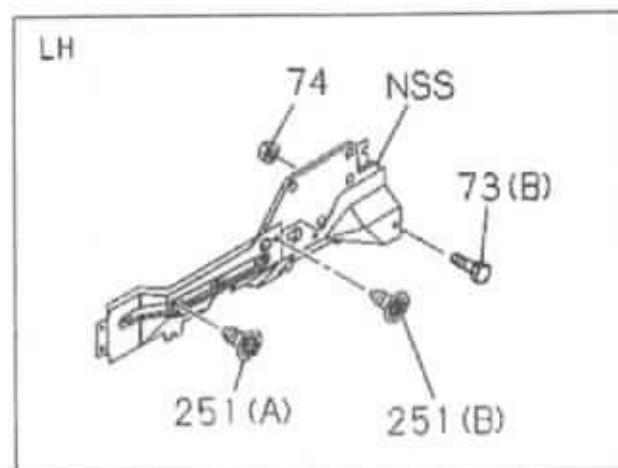
item - 224

130 (A)
