**REPORT OF A TRAFFIC ACCIDENT**

**CASE OF TRAFFIC ACCIDENT ALONG TEBAN GARDENS CRESCENT ON 27 SEP 2017 @ 4.05 PM**

Report No: 0326-18-TCA

## ACCIDENT VEHICLE SURVEY REPORT

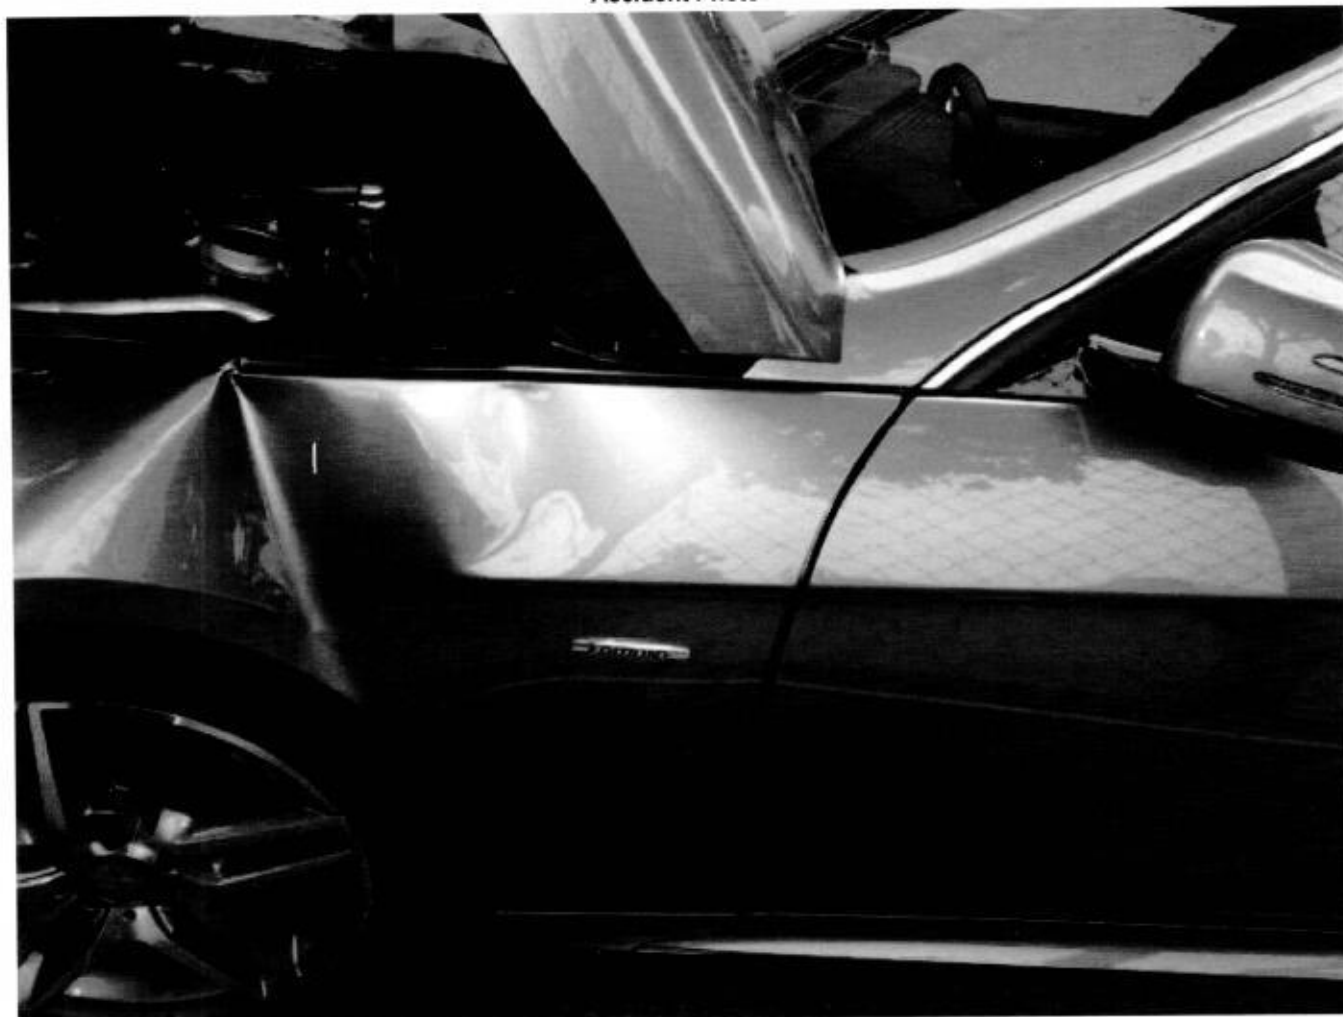
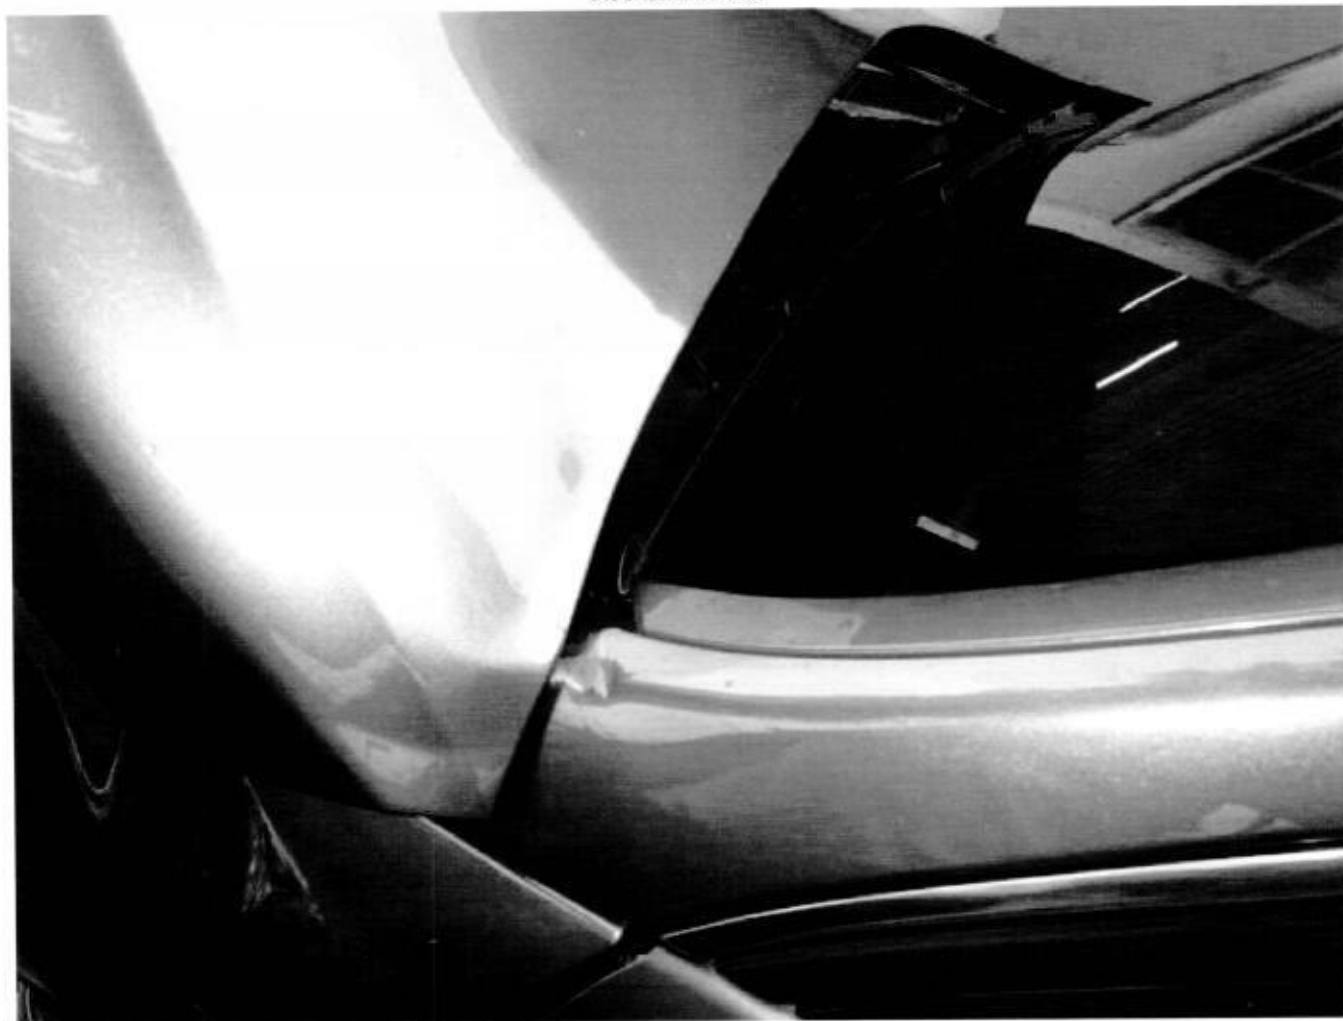
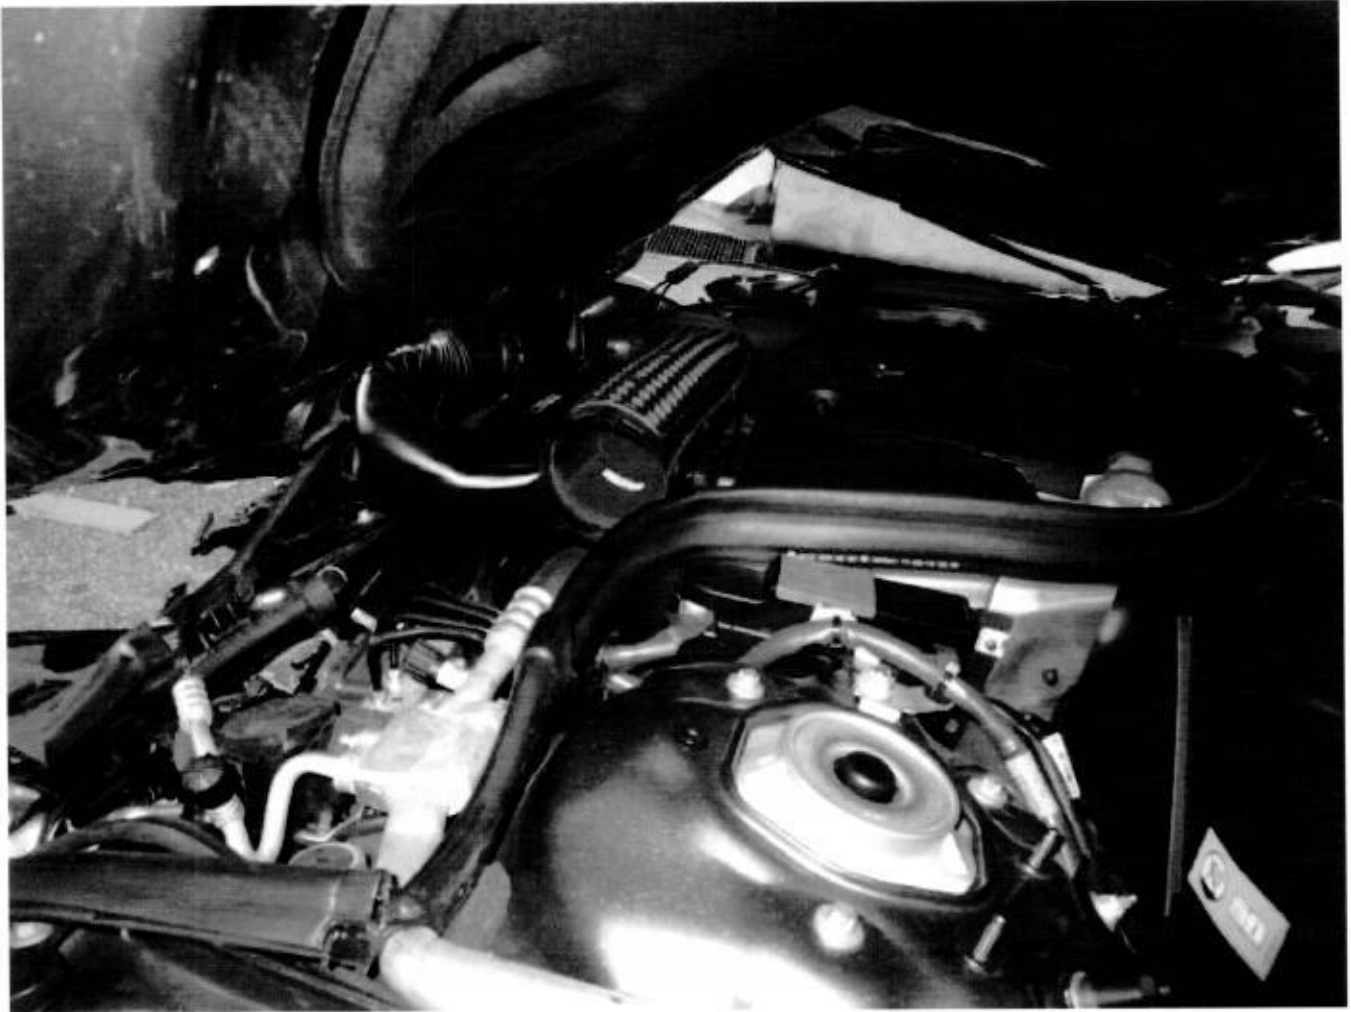
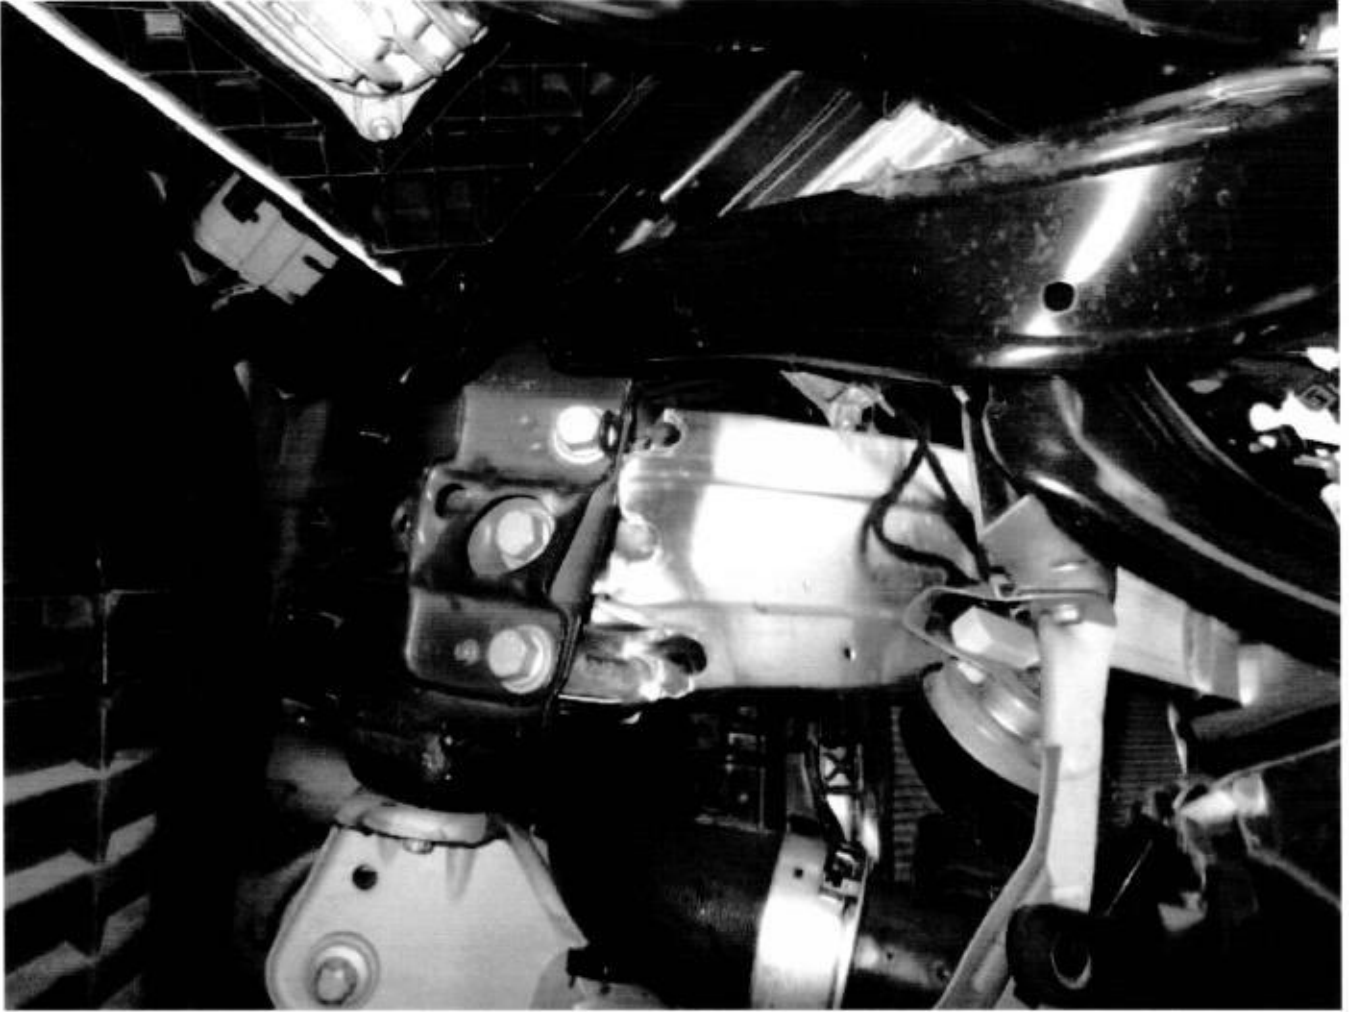
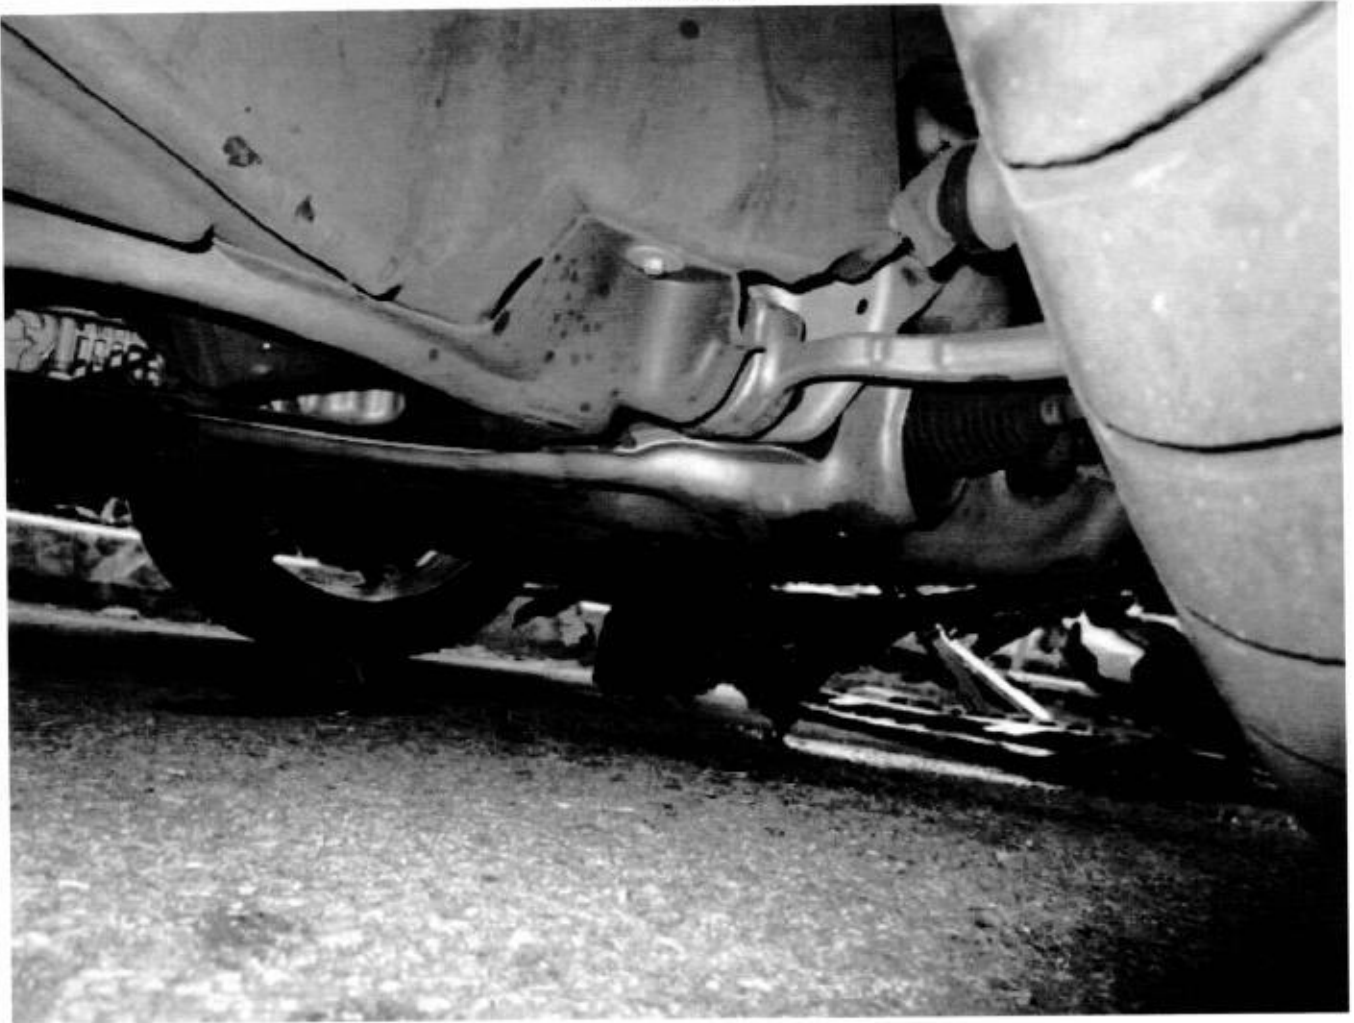
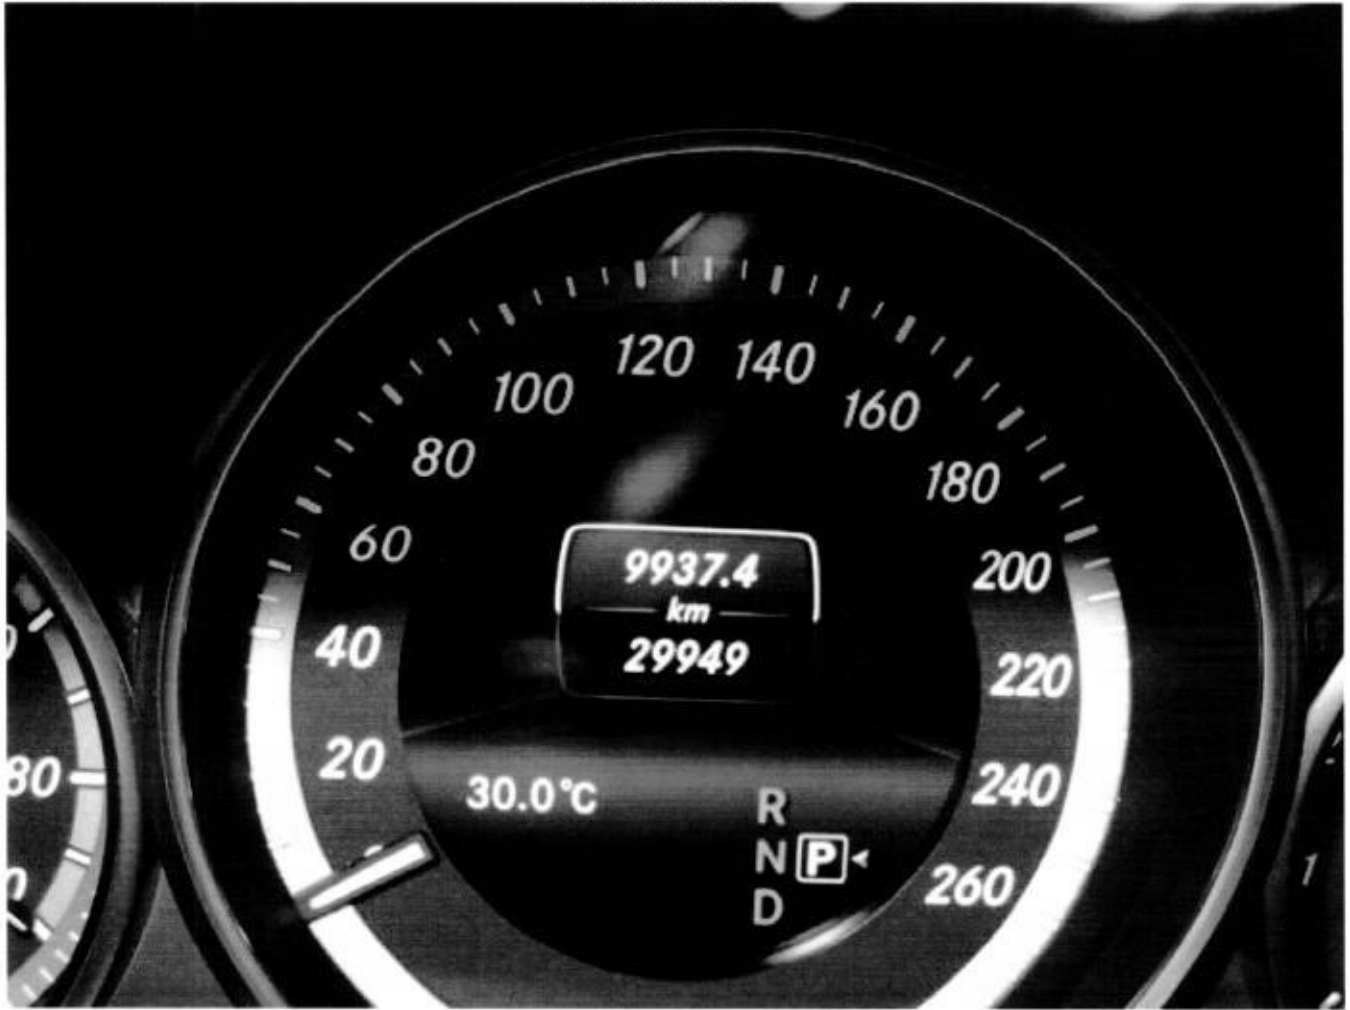
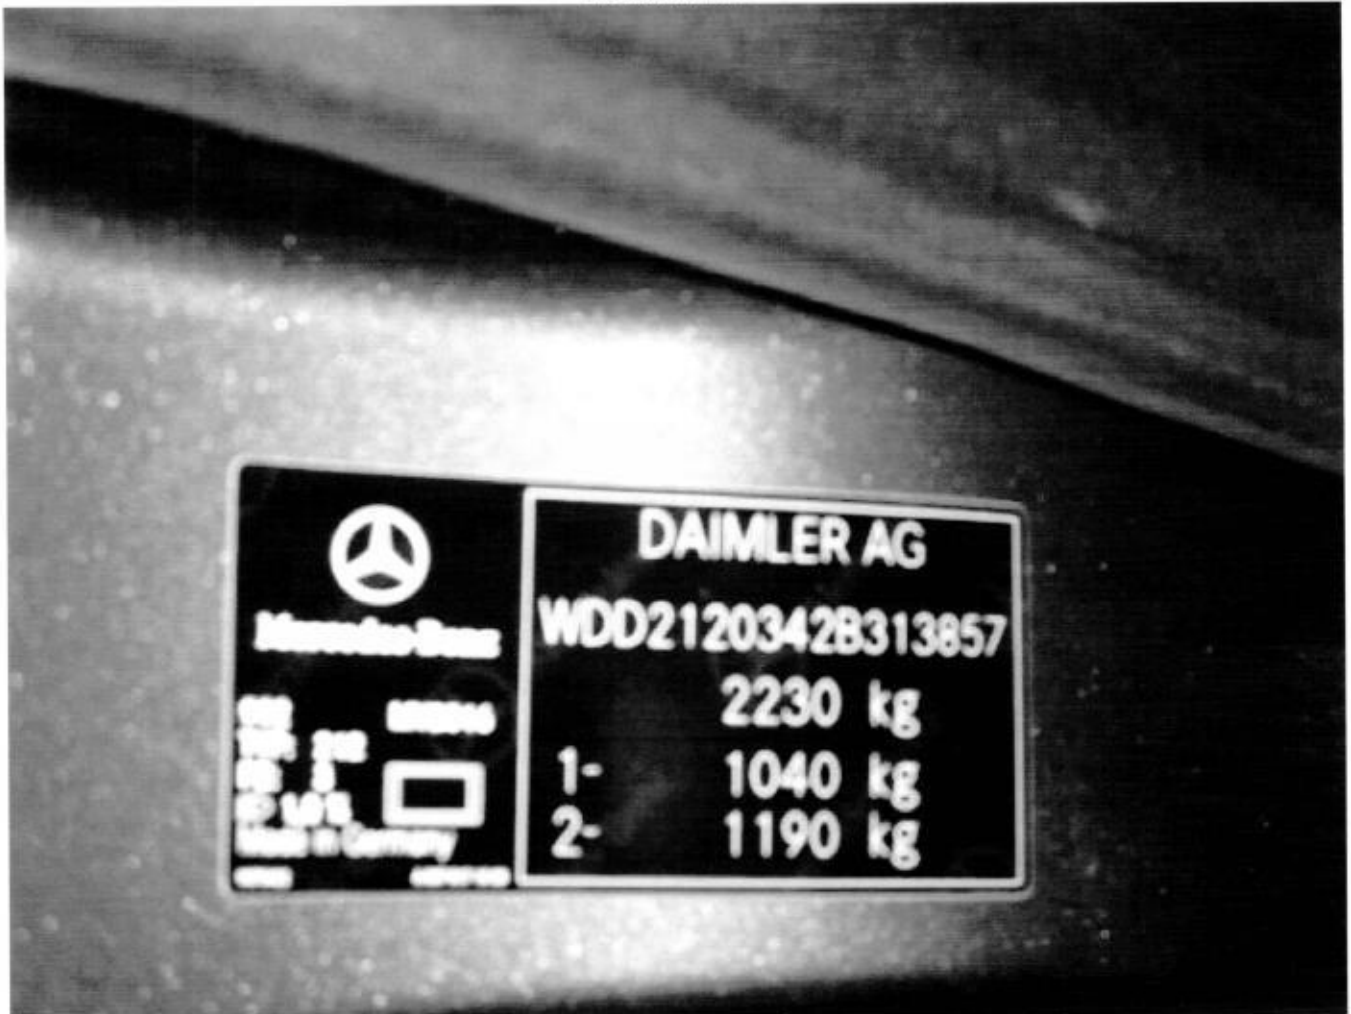
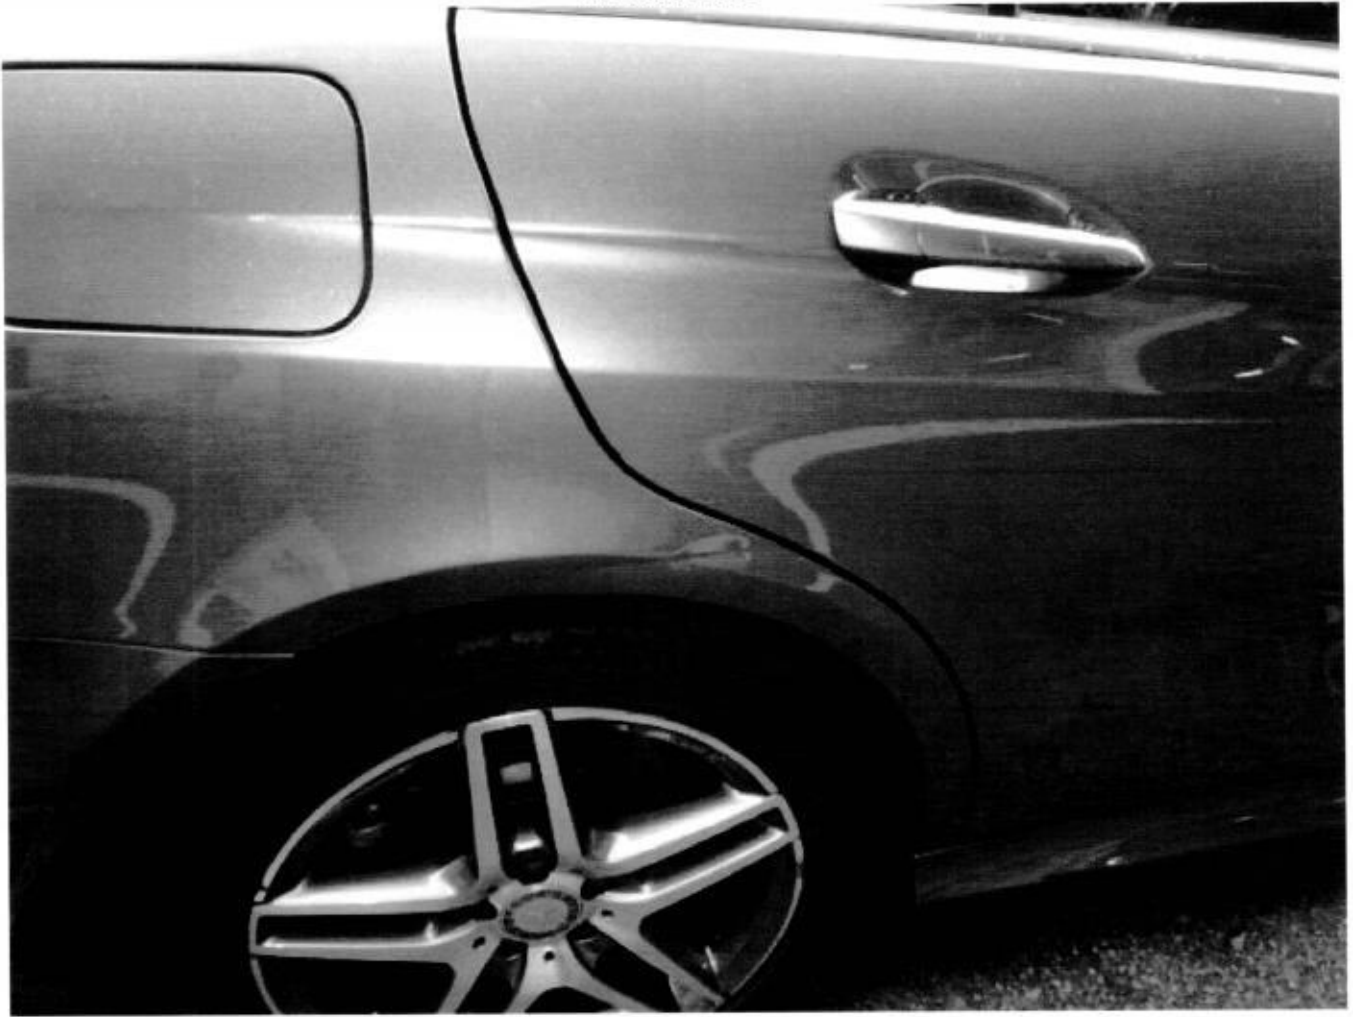
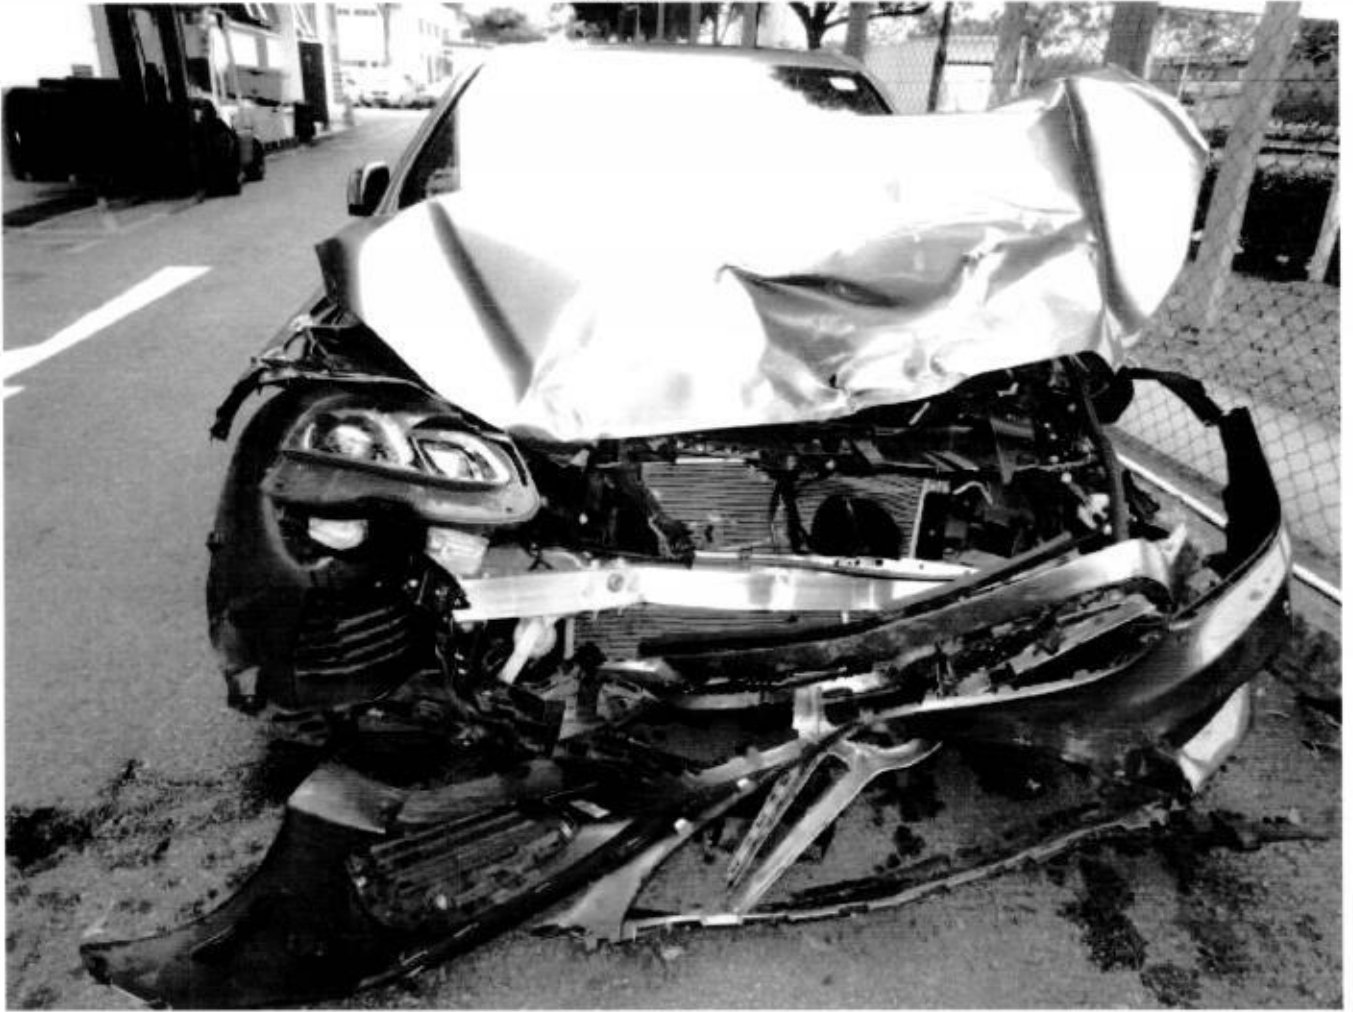
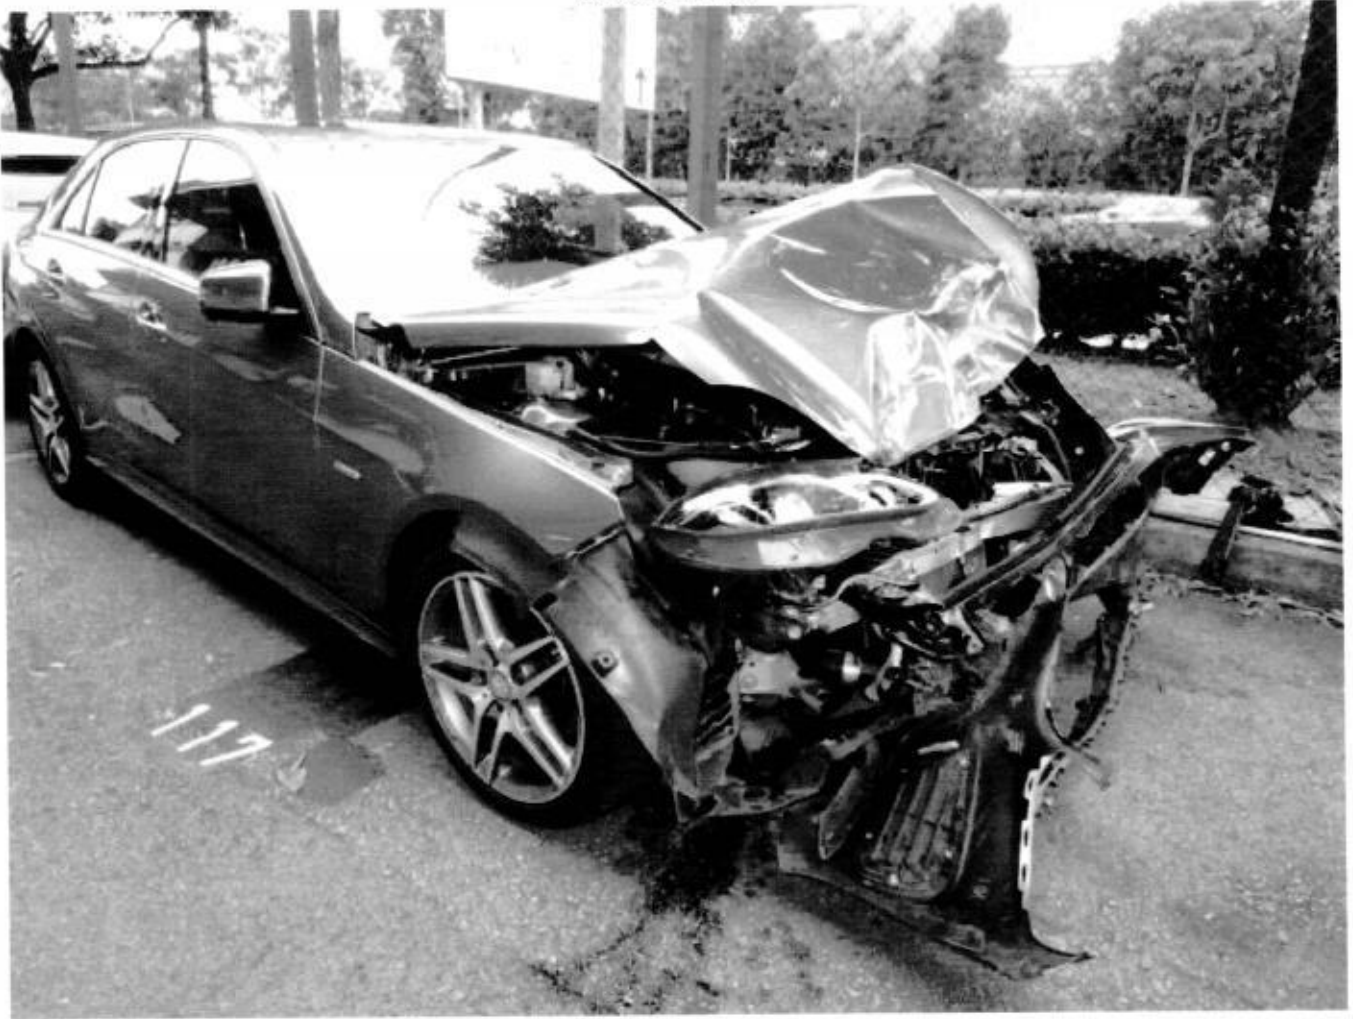
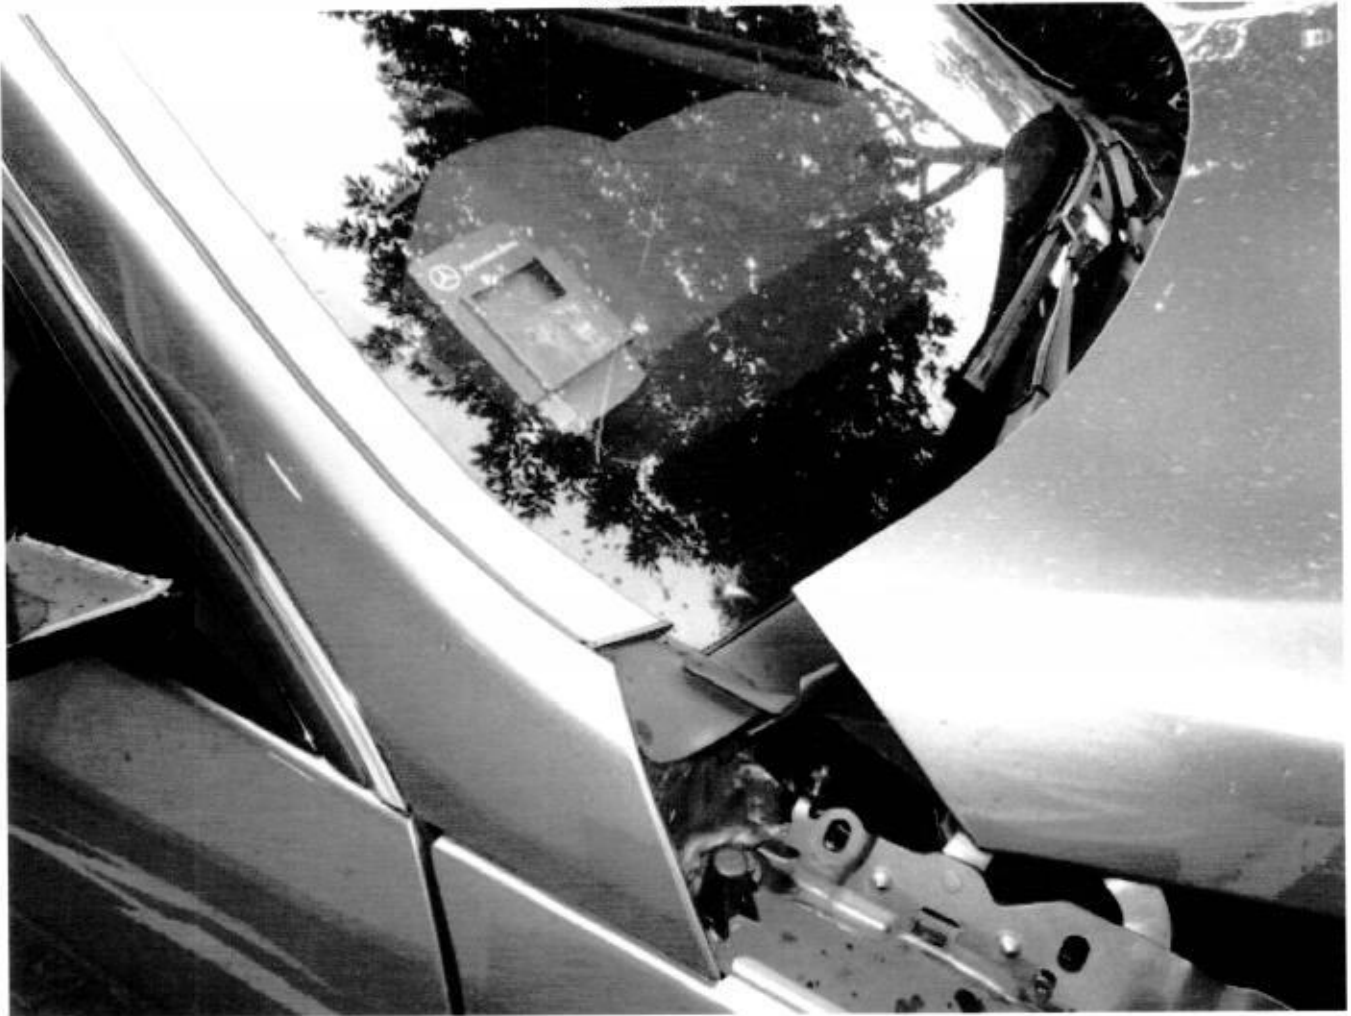
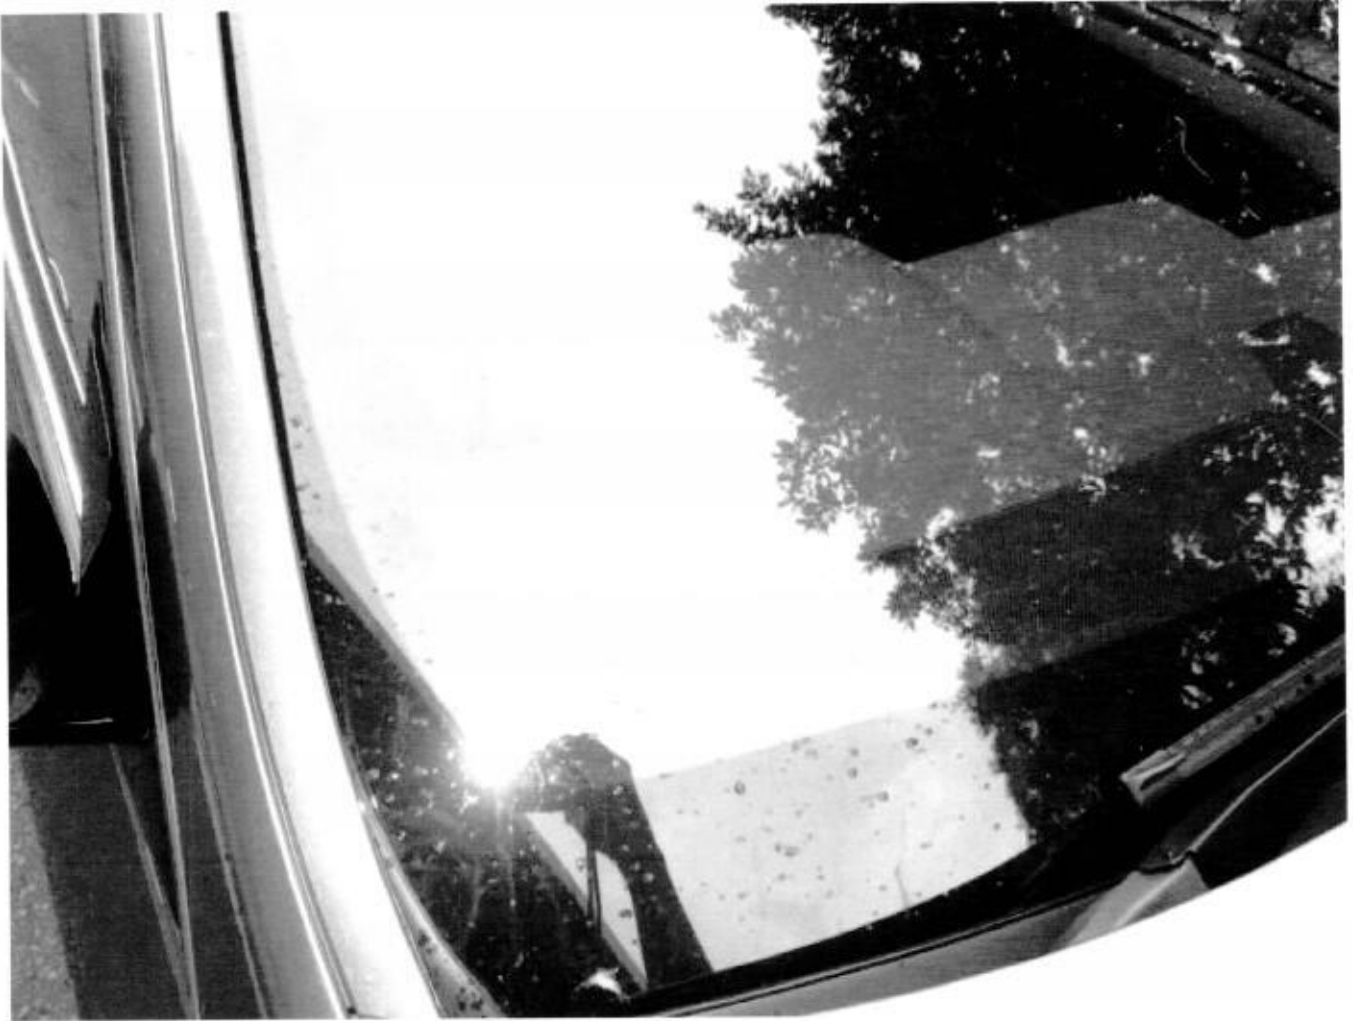
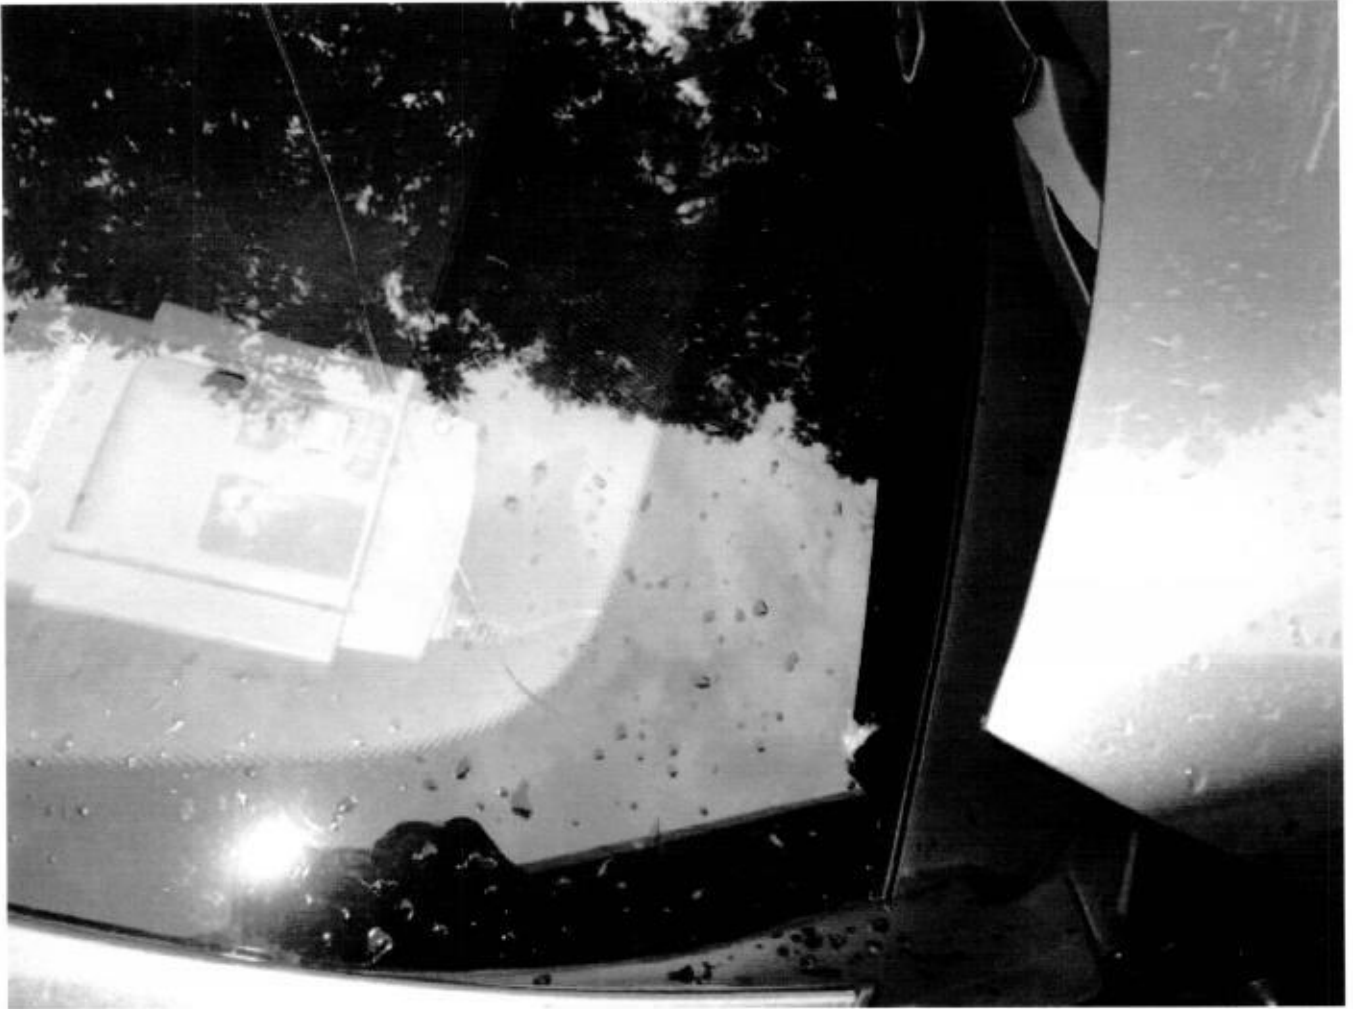
Accident Photo

Impact on the front LH portion  
Please see details as described in the Annex for parts and labour.
