Vehicle No : SLW 9196X
Make/ Model : BMW 520i 2.0L AT D/AB 2WD
Year of Manufacture : 2013
Chassis No. : WBAXG12000DX53675
Colour : White
Name : Thong Lee Automobile Pte Ltd
Address : 3 Ang Mo Kio Street 62
#01-15 / 16 Link @ AMK
Singapore 569139

Re : Third Party Claim For Vehicle Registration No. SLW9196X

VEHICLE INSPECTION REPORT

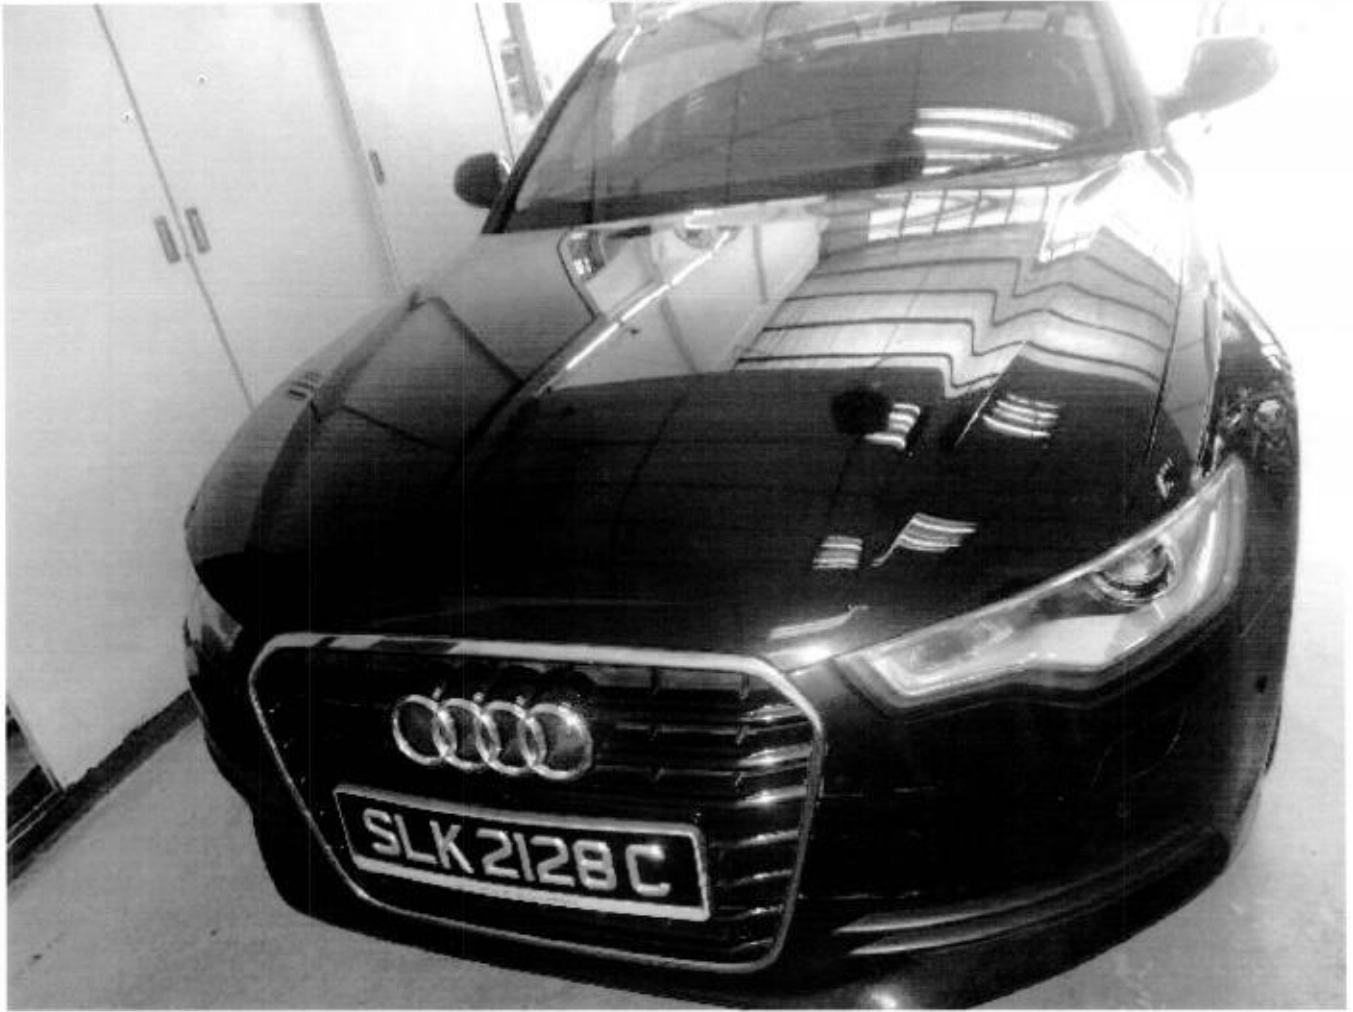
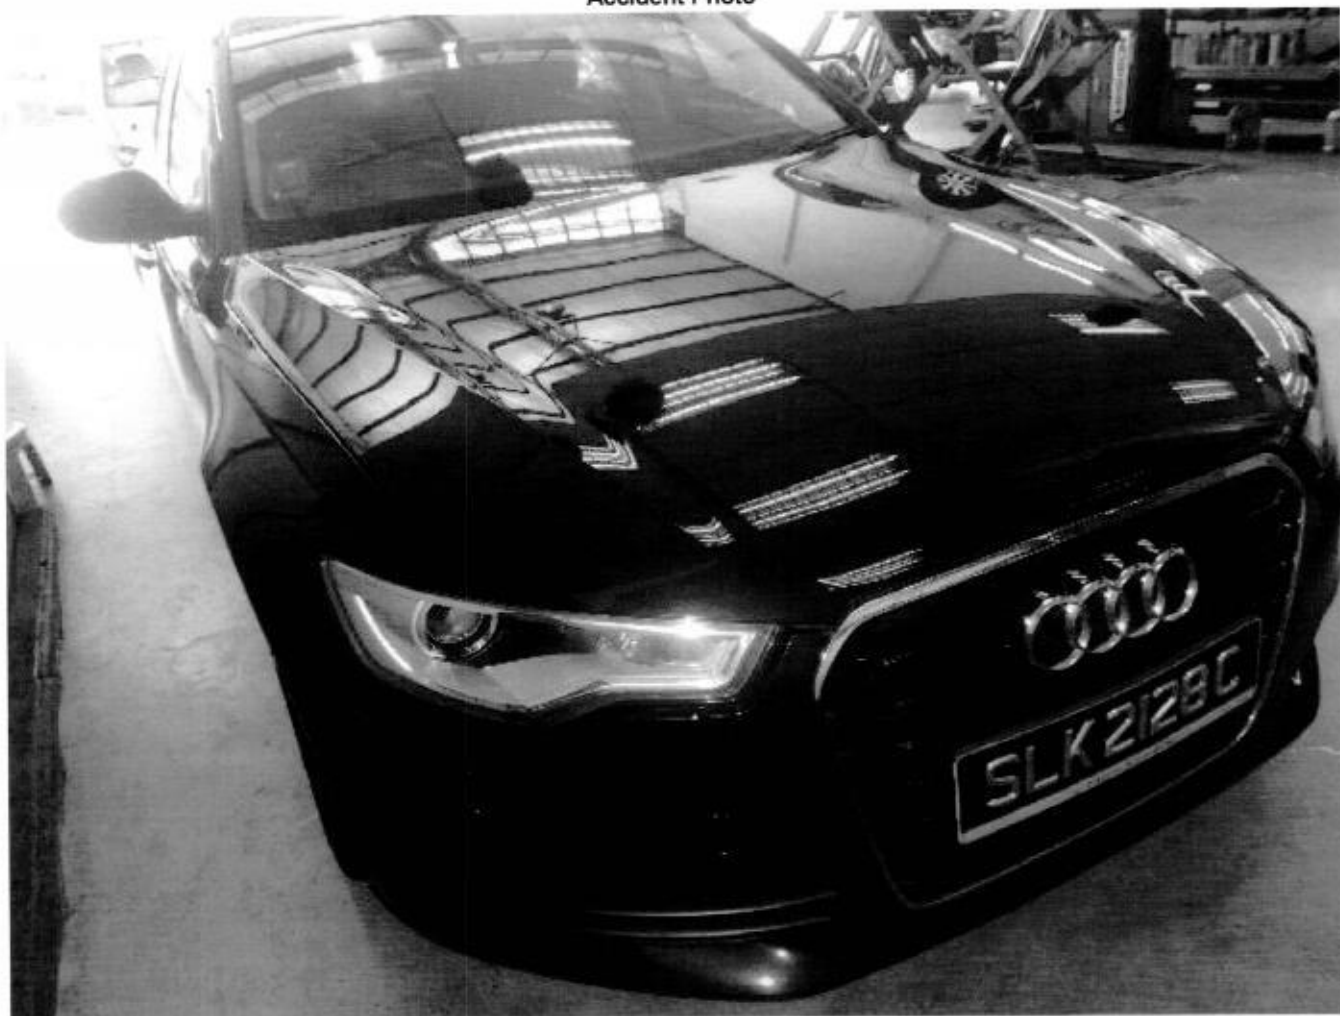
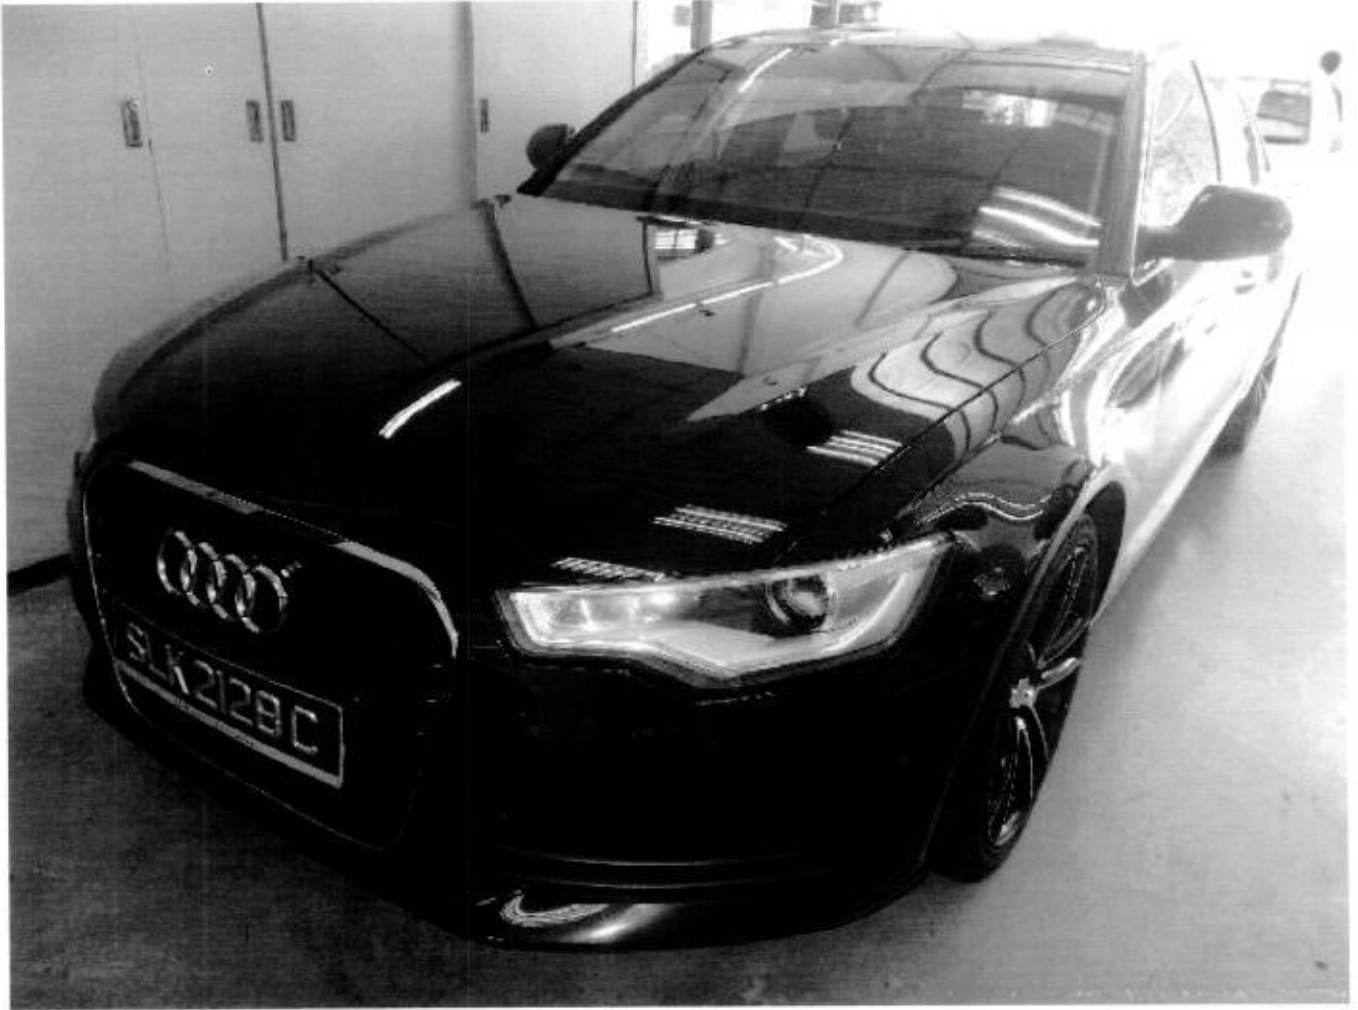
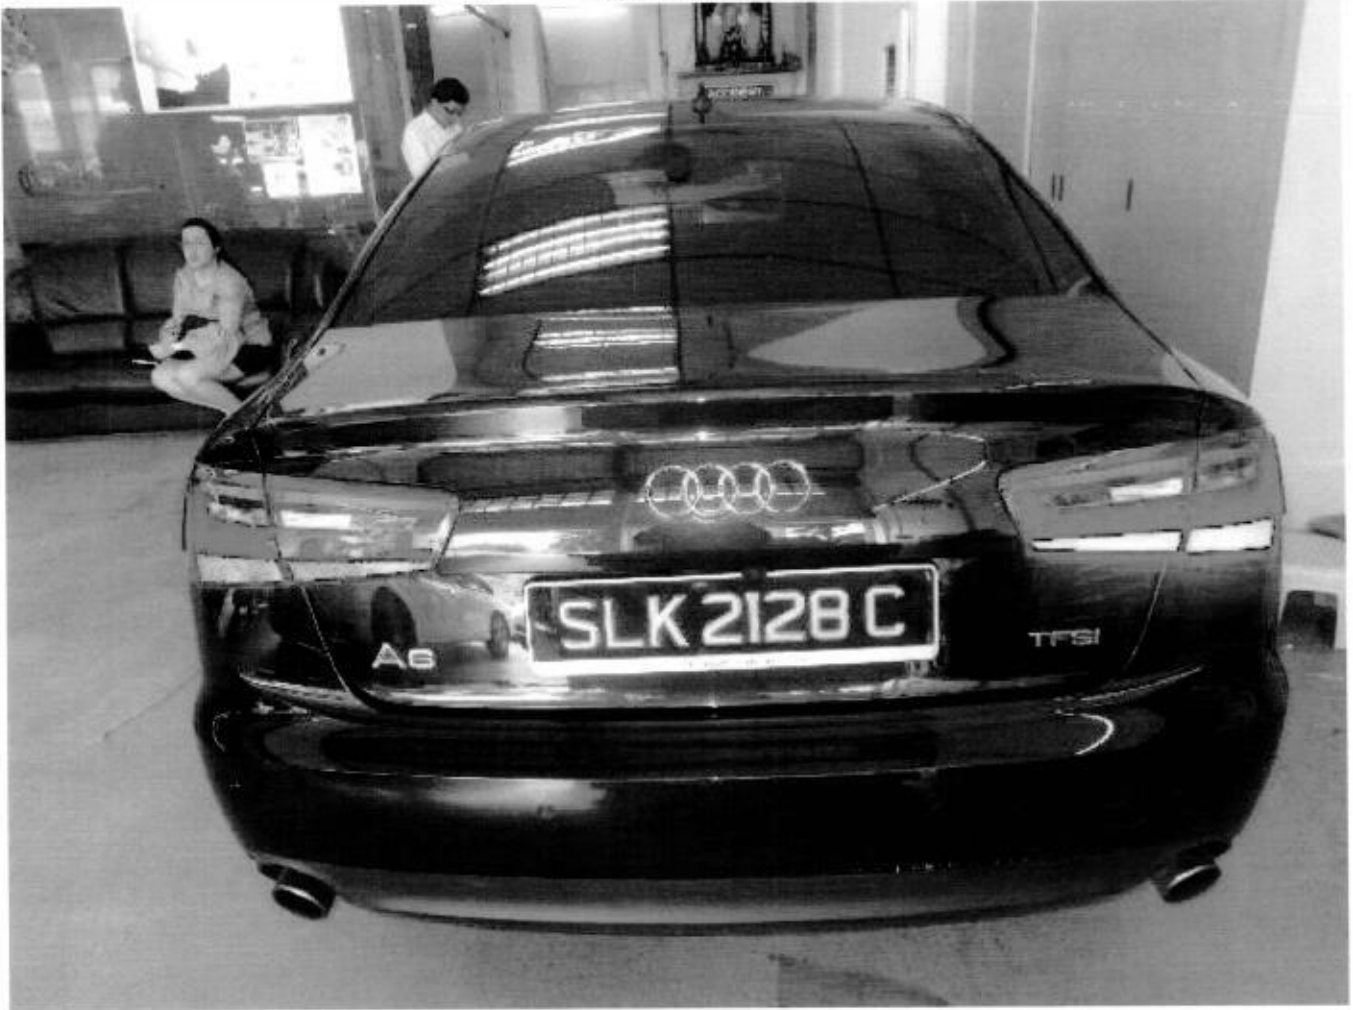
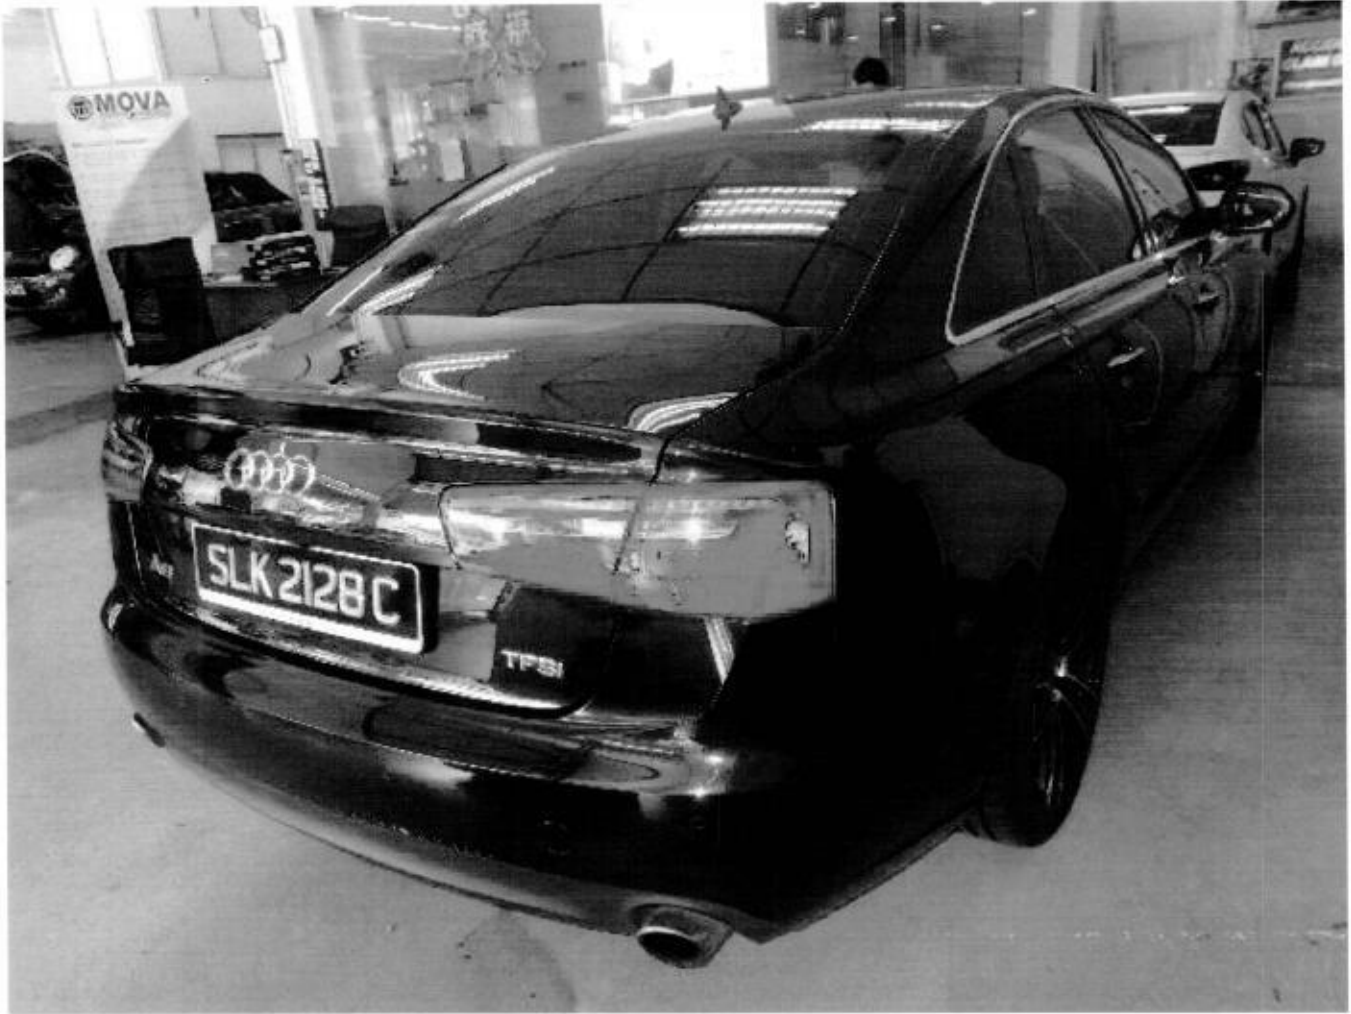
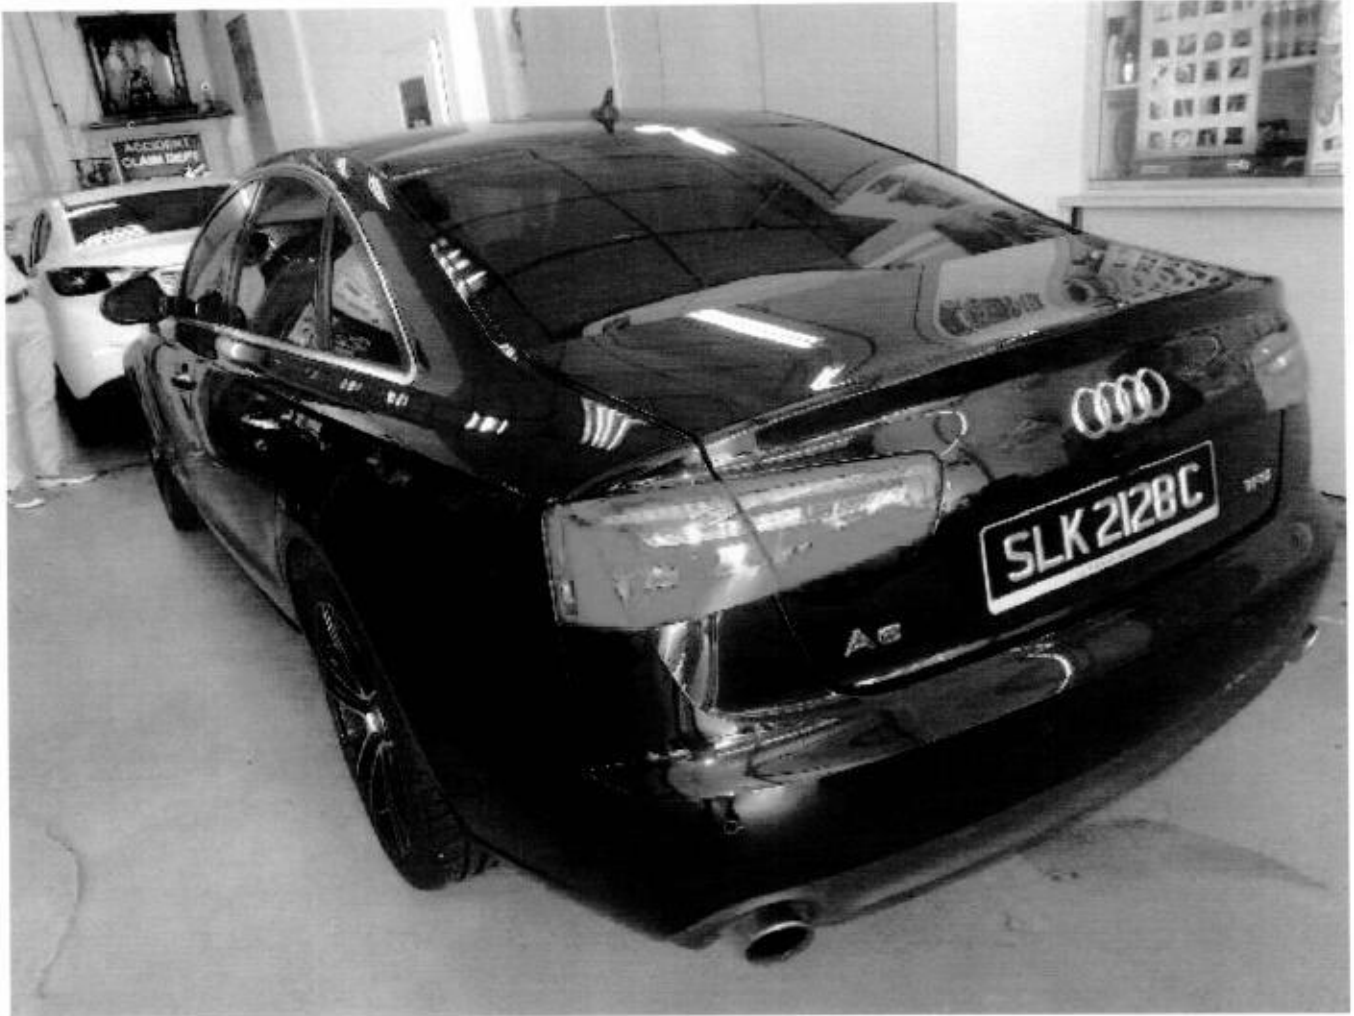
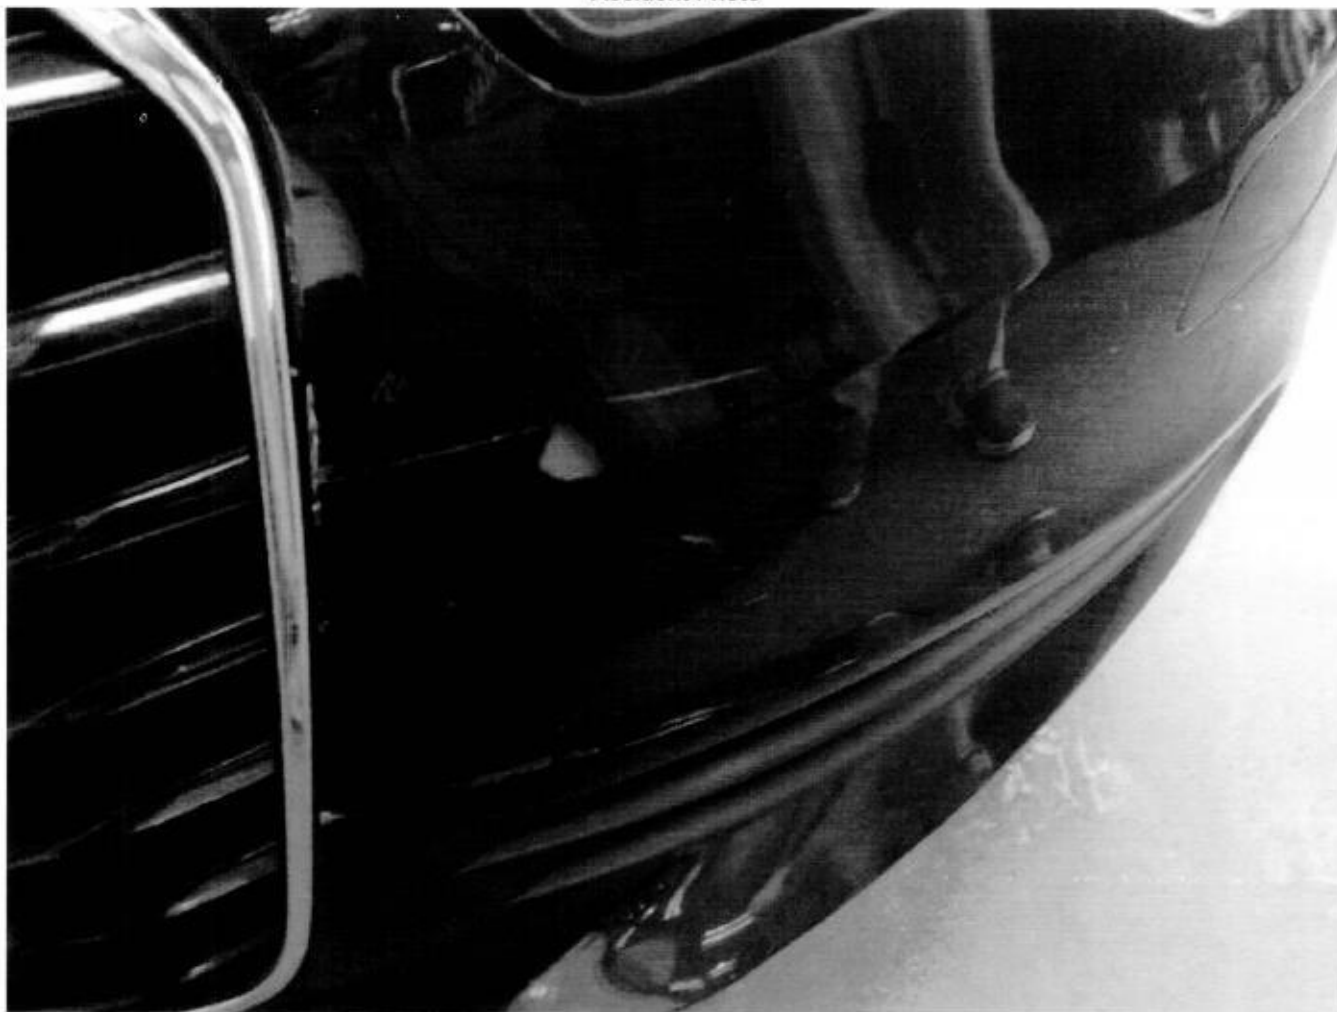
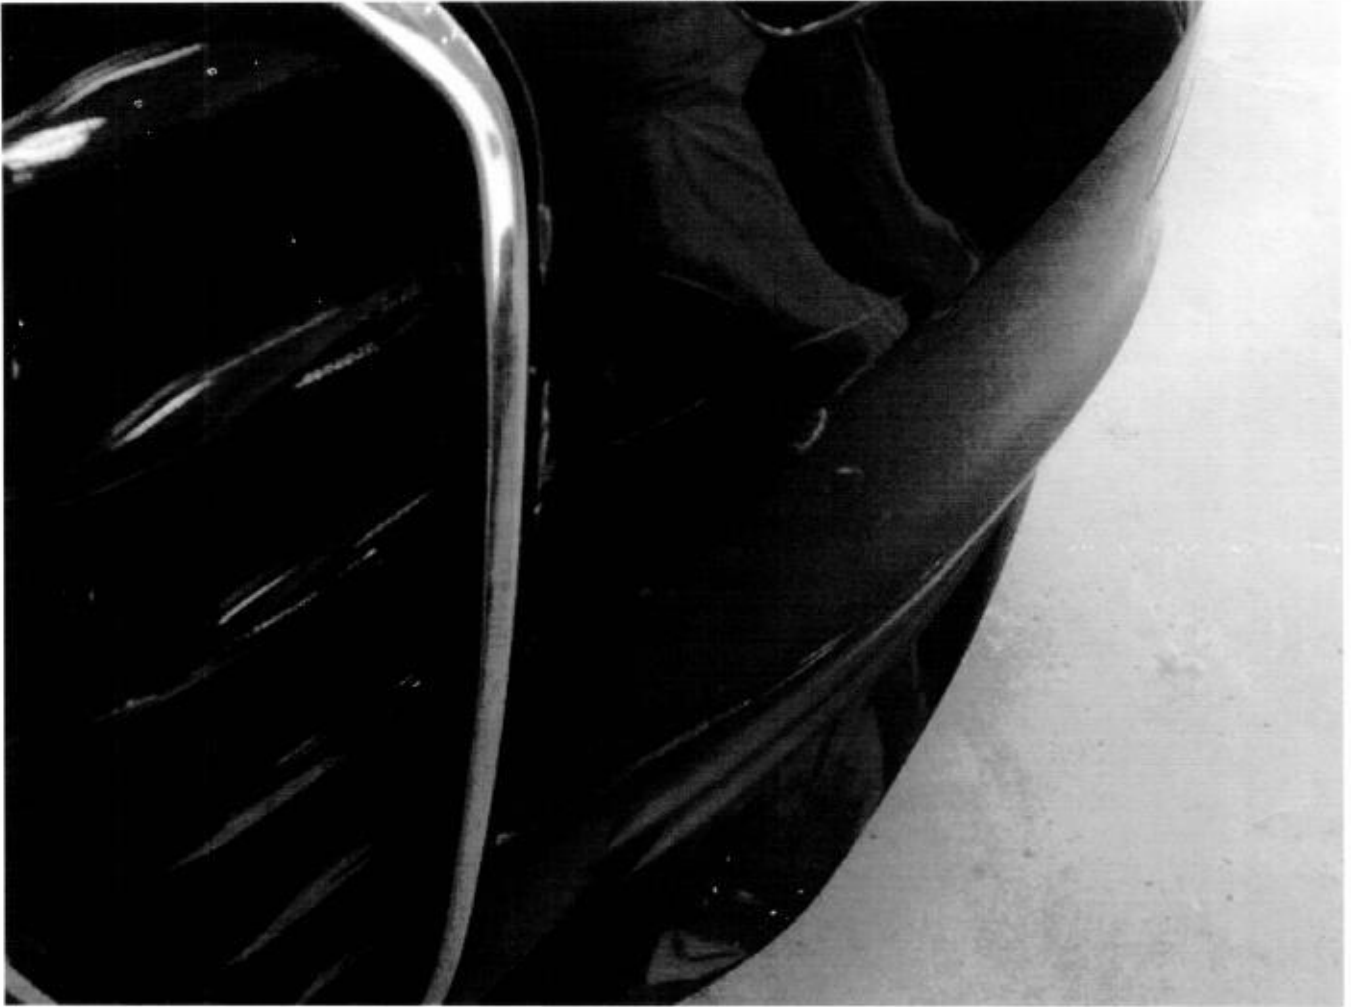
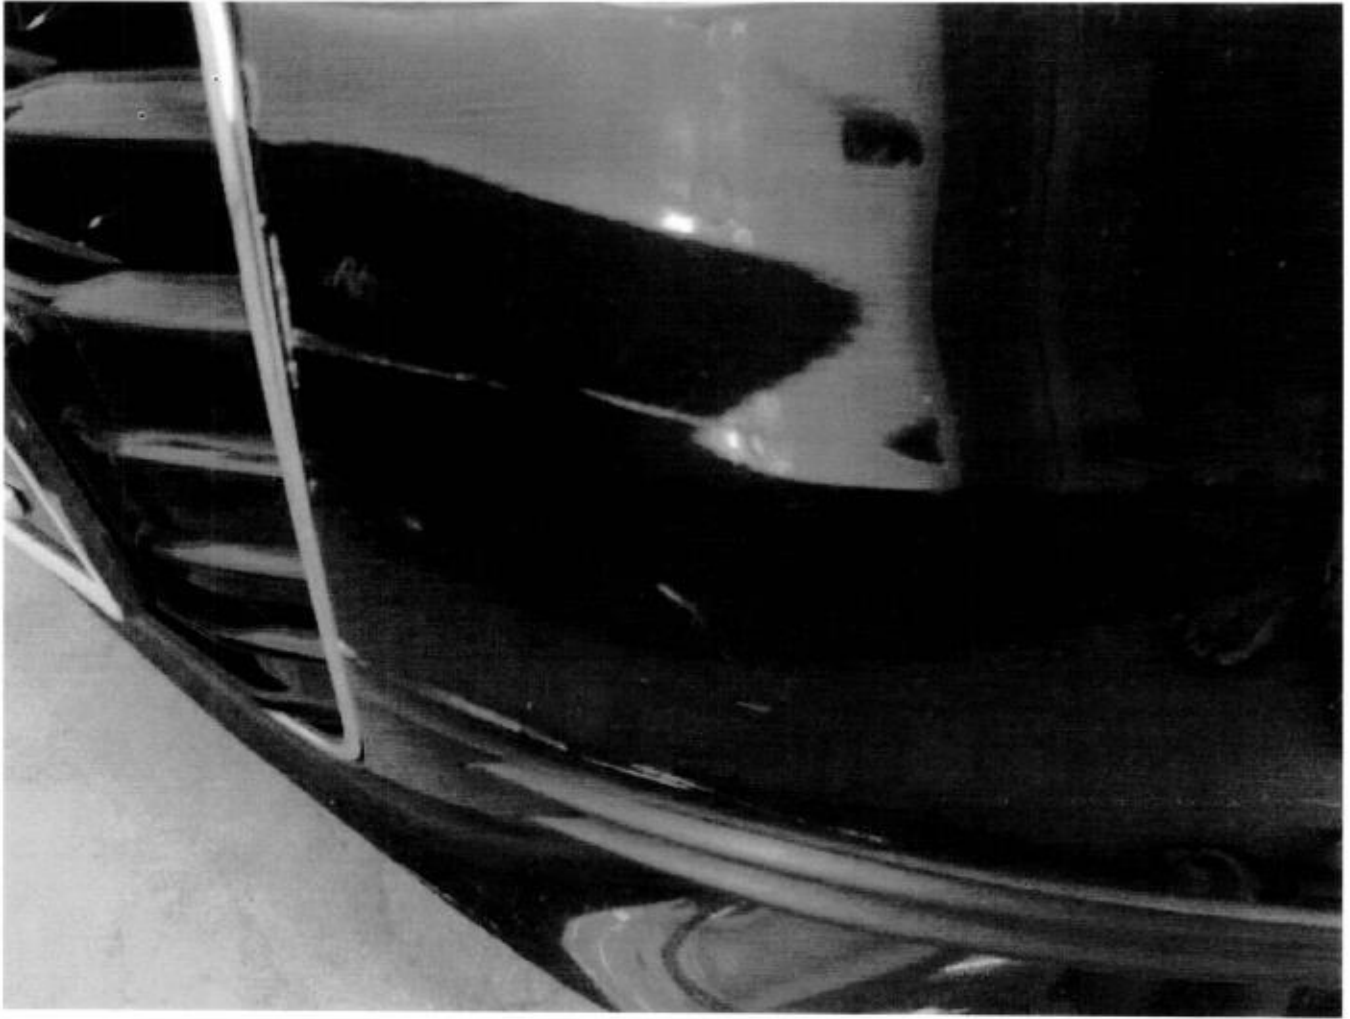
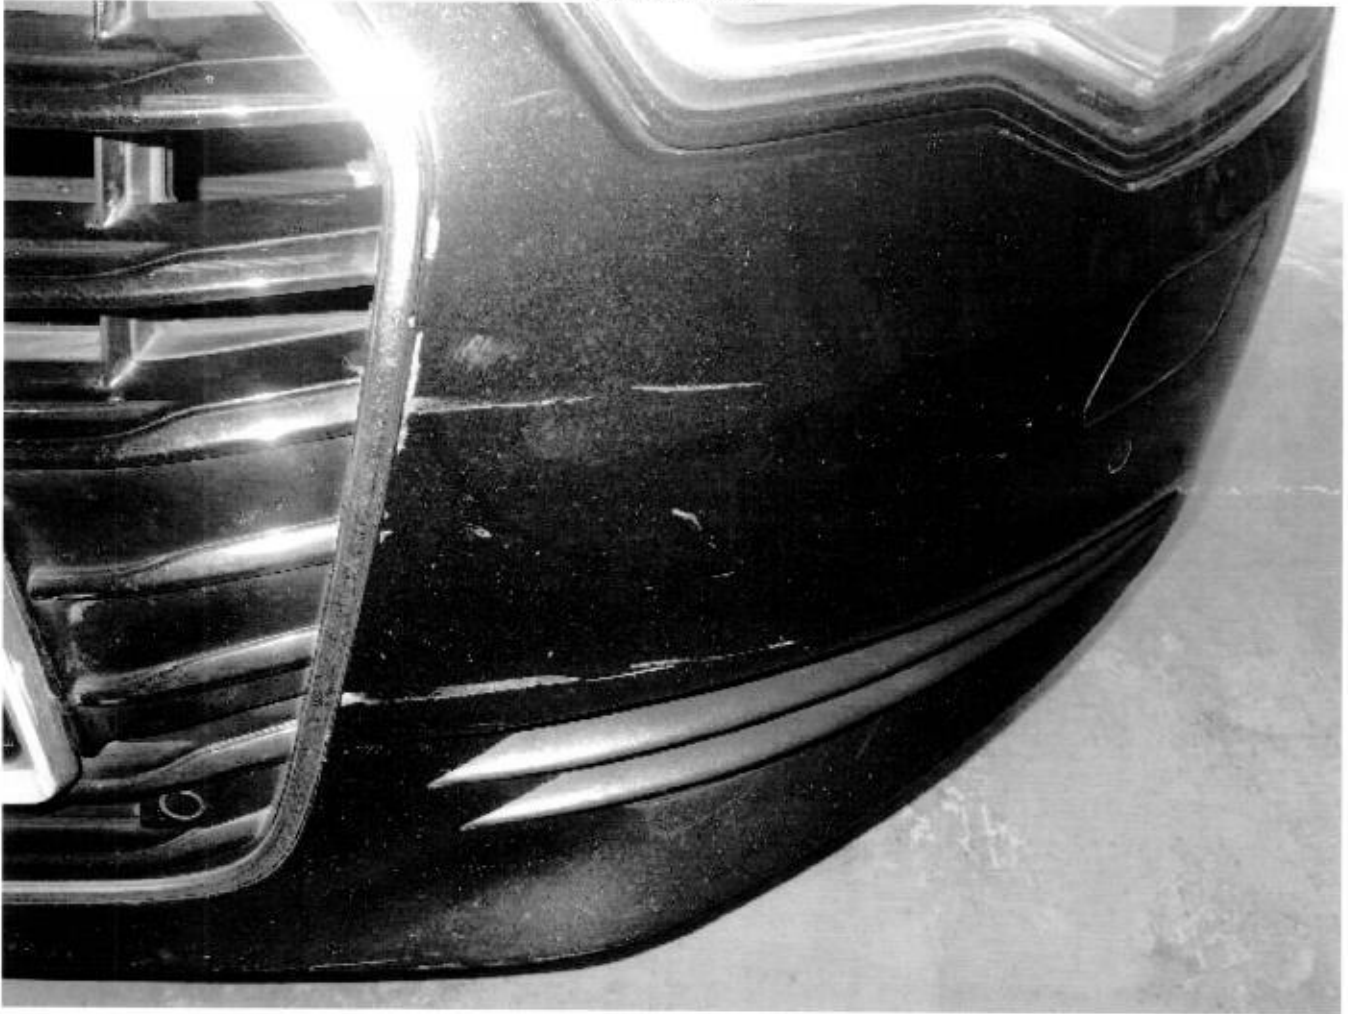
Accident Photo

On the front in the direction from front to rear.

The impact of the collision has damaged / affected the front bumper, headlamp, intercooler, front fender and etc...

The estimate cost of repair submitted by Messrs Hiap Lek Automobile Trading as per schedule attached has been revised and scrutinised, and in our opinion, we consider it to be fair and reasonable. The repairers have agreed to undertake the repairs to the owner's satisfaction at our revision. We have not authorised the repairs.

Our adjusted cost of repair is SGD 8,550.00 to carry out the repairs. Please refer to Annex A (Appraisal Schedule) for a detailed account of the cost estimates.
