**PRELIMINARY ADVICE OF VEHICLE NO.**

**SHC8487R**

| Affiliated to Federation Internationale Des Experts En Automobile | | | | |
|---|---|---|---|--|
| <b>1. Policy Particulars :- THIRD PARTY CLAIM</b> | | | | |

**ADJUSTMENT ON REPAIR COST FOR VEHICLE NO. SHC 8487R**

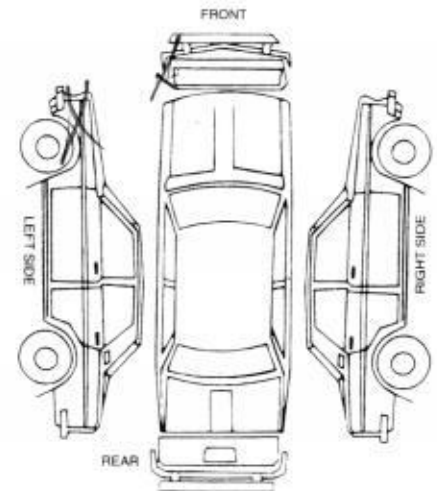
*Left Front*

The vehicle sustained damages at the  
N/S Front Portion
