### VEHICLE DAMAGE INSPECTION REPORT

Our Ref: 817/TP/2018

Date of loss: 2/11/2018

| Reg No: | SBZ9022S | Make & | Honda |

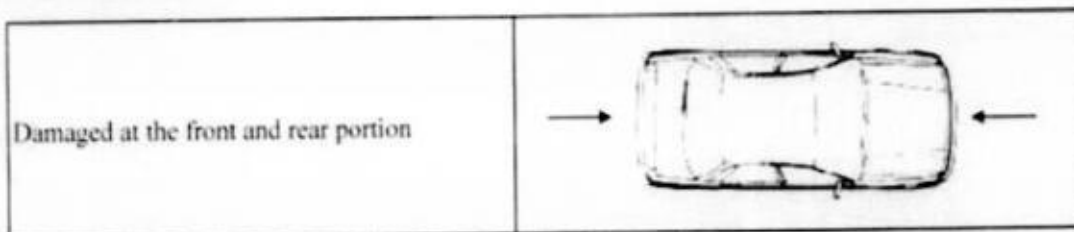
### **POINT OF IMPACT**

The Insured's vehicle collided onto the Third Party's vehicle along TPE Expressway towards PIE Expressway before Tampines Avenue 7 exit.

Our visual inspection of the vehicle revealed that the damages noted are at the front and rear portion.

We have inspected the actual damages found on the vehicle and recommend the replacement of parts and repairs accordingly. The estimated repair cost is \$37,048.80. The repairer has agreed to undertake the repairs at our adjusted lump sum amount of \$26,700.00.
