# **Accident Photo**

## **AUTOMOBILE** INSPECTION REPORT 9/5/TP006/R NO.

## ADJUSTMENT ON REPAIR COST FOR VEHICLE NO. EA 4367B

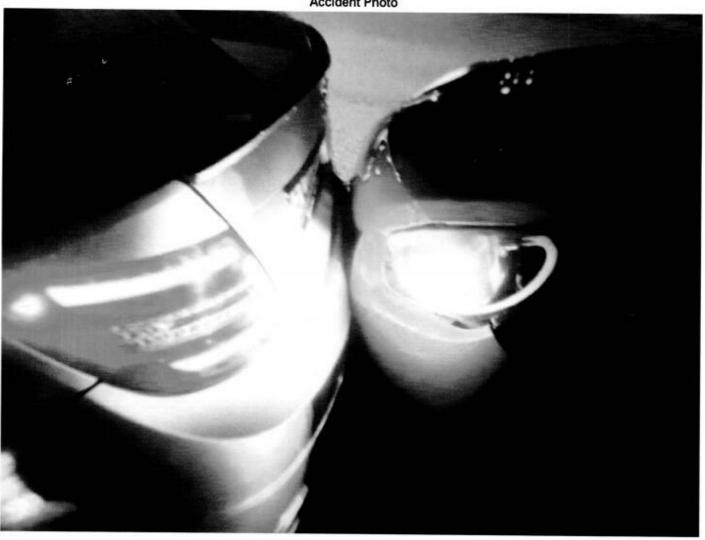
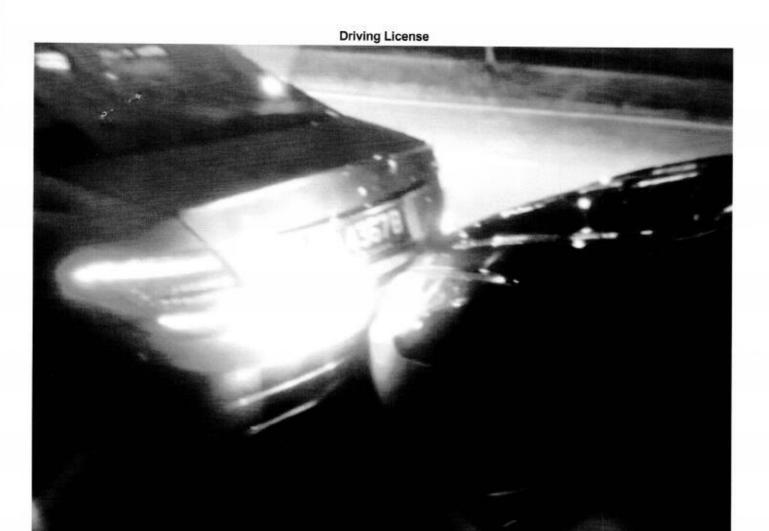
Boot lid assy, dented and bent, lock assy, bent, rear panel assy, bent, rear lamps assy. shifted, bumper assy, dented, bent and deformed, lower centre garnish bent and dislodged, fasteners snapped, reverse sensors distorted, fenders bent and distorted, boot floor panel assy, bent.

The above were due to impact to the rear portion of the vehicle.

Alternatively, we recommend that repairs be carried out on a Lump Sum basis instead, @\$7,550/- Nett.
