Supreme Container & Warehousing Pte Ltd  
c/o 38 Woodlands Industrial Park E1  
#05-13  
Singapore 757700

## THIRD PARTY SURVEY ACCIDENT HAPPENED ON 11 Apr 2018

## VEHICLE DAMAGE INSPECTION REPORT

Our File No: CS3/MSG18007239/GQF3S2-1  
Date: 23/07/2019

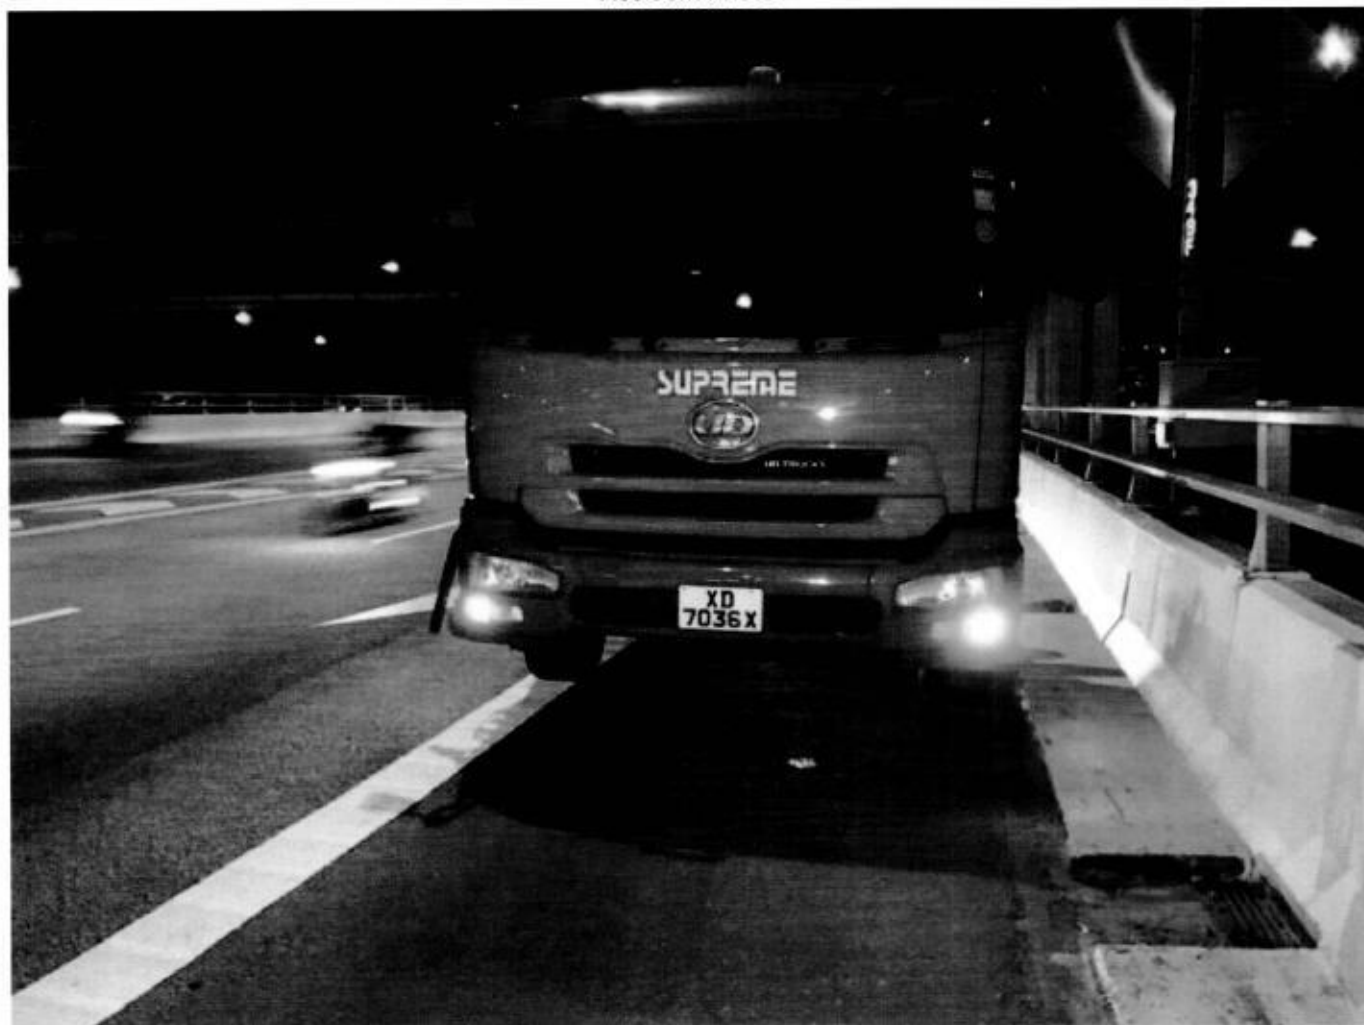
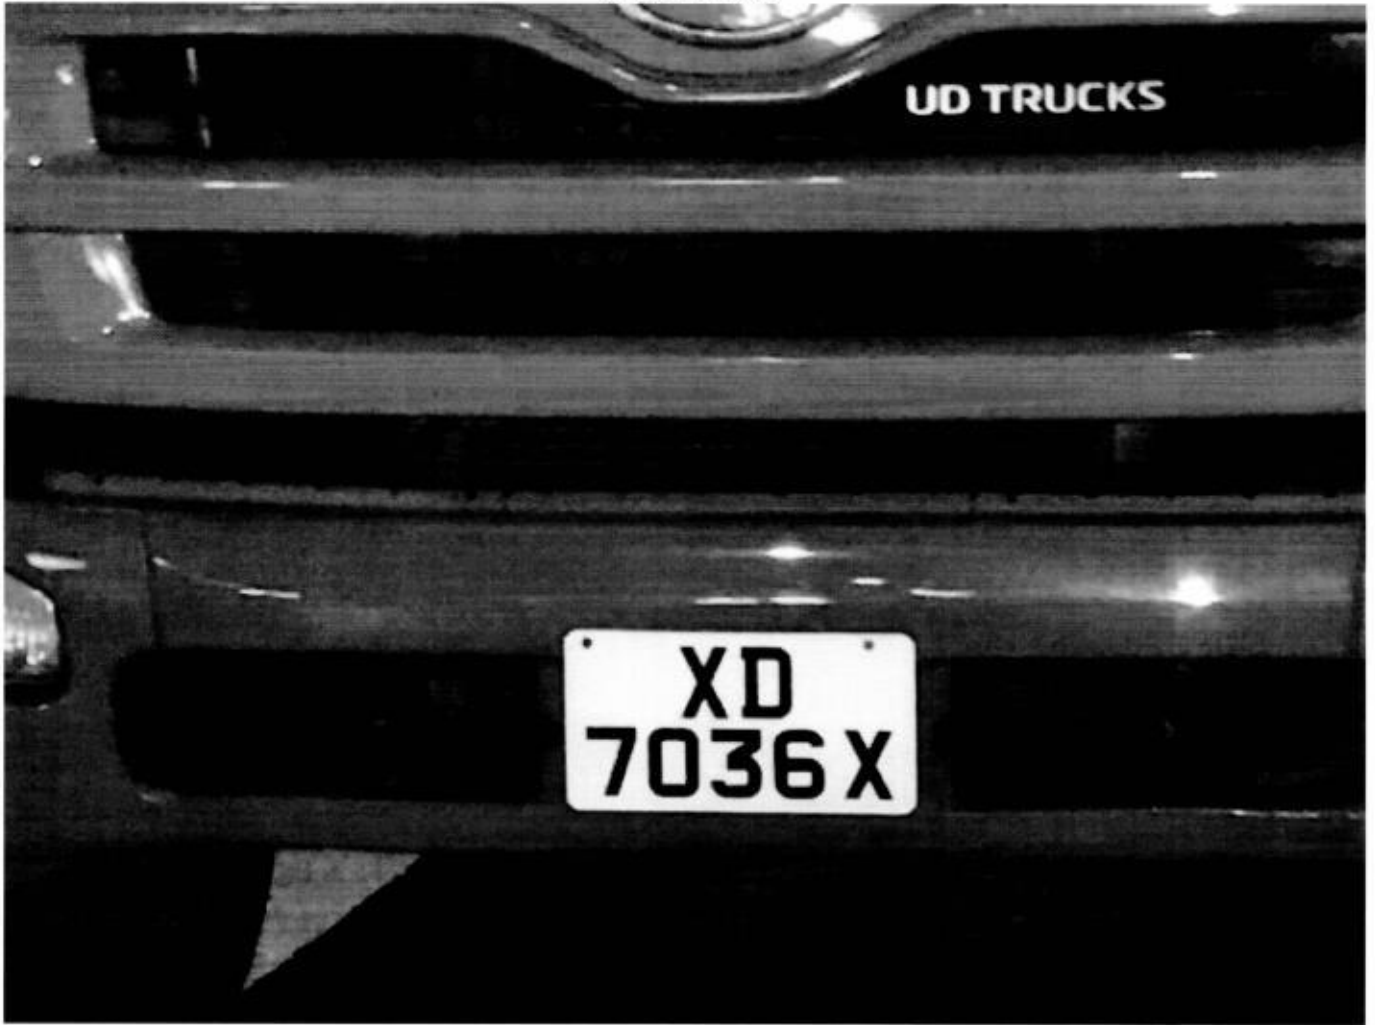
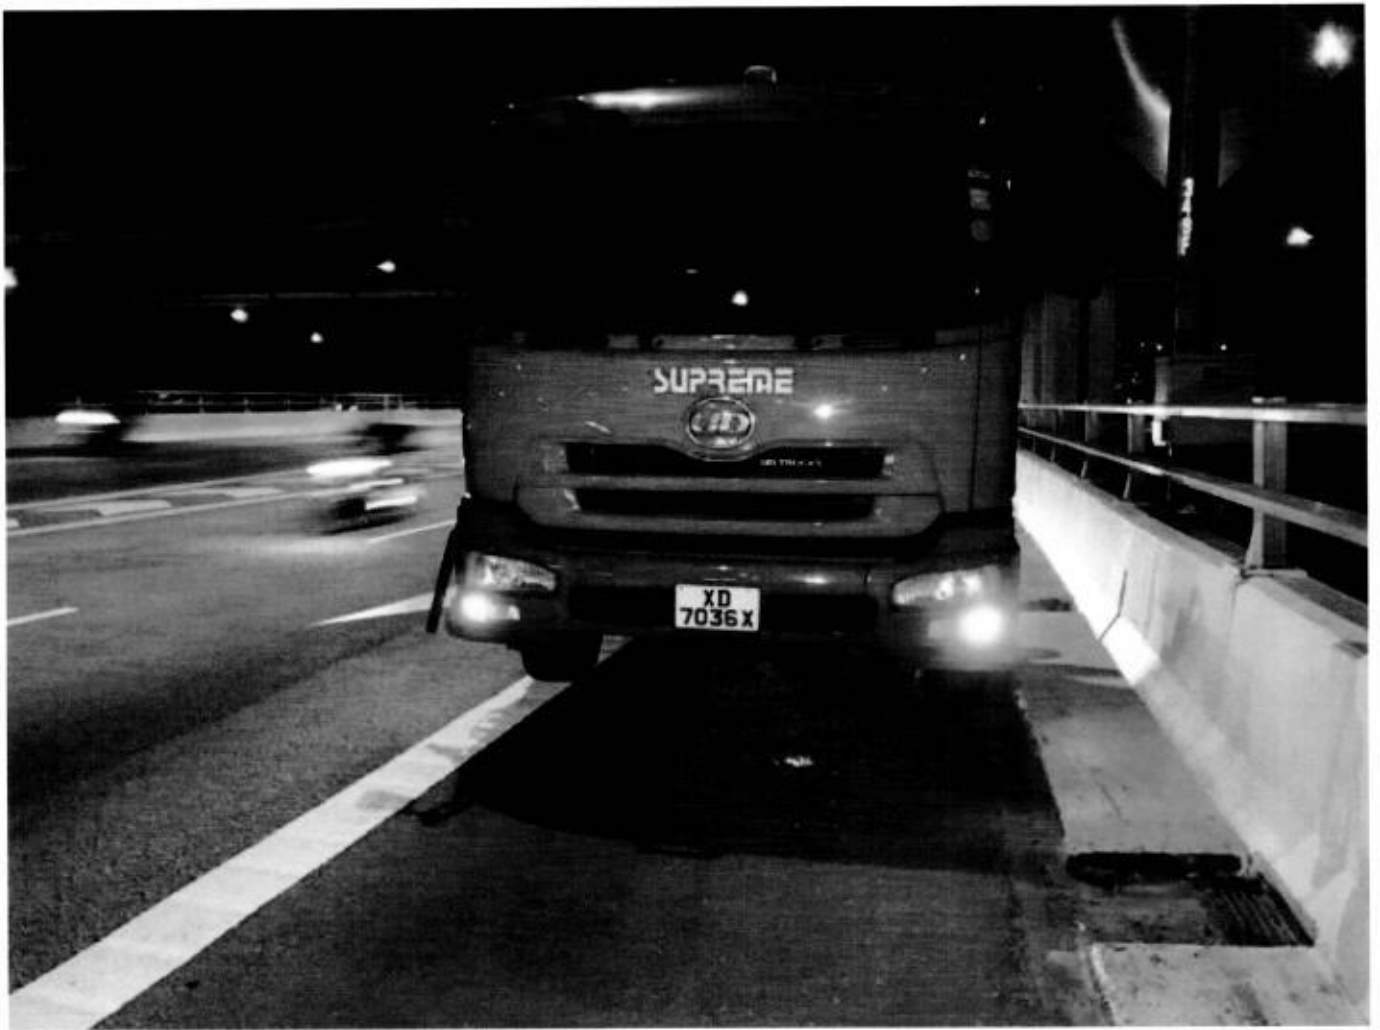
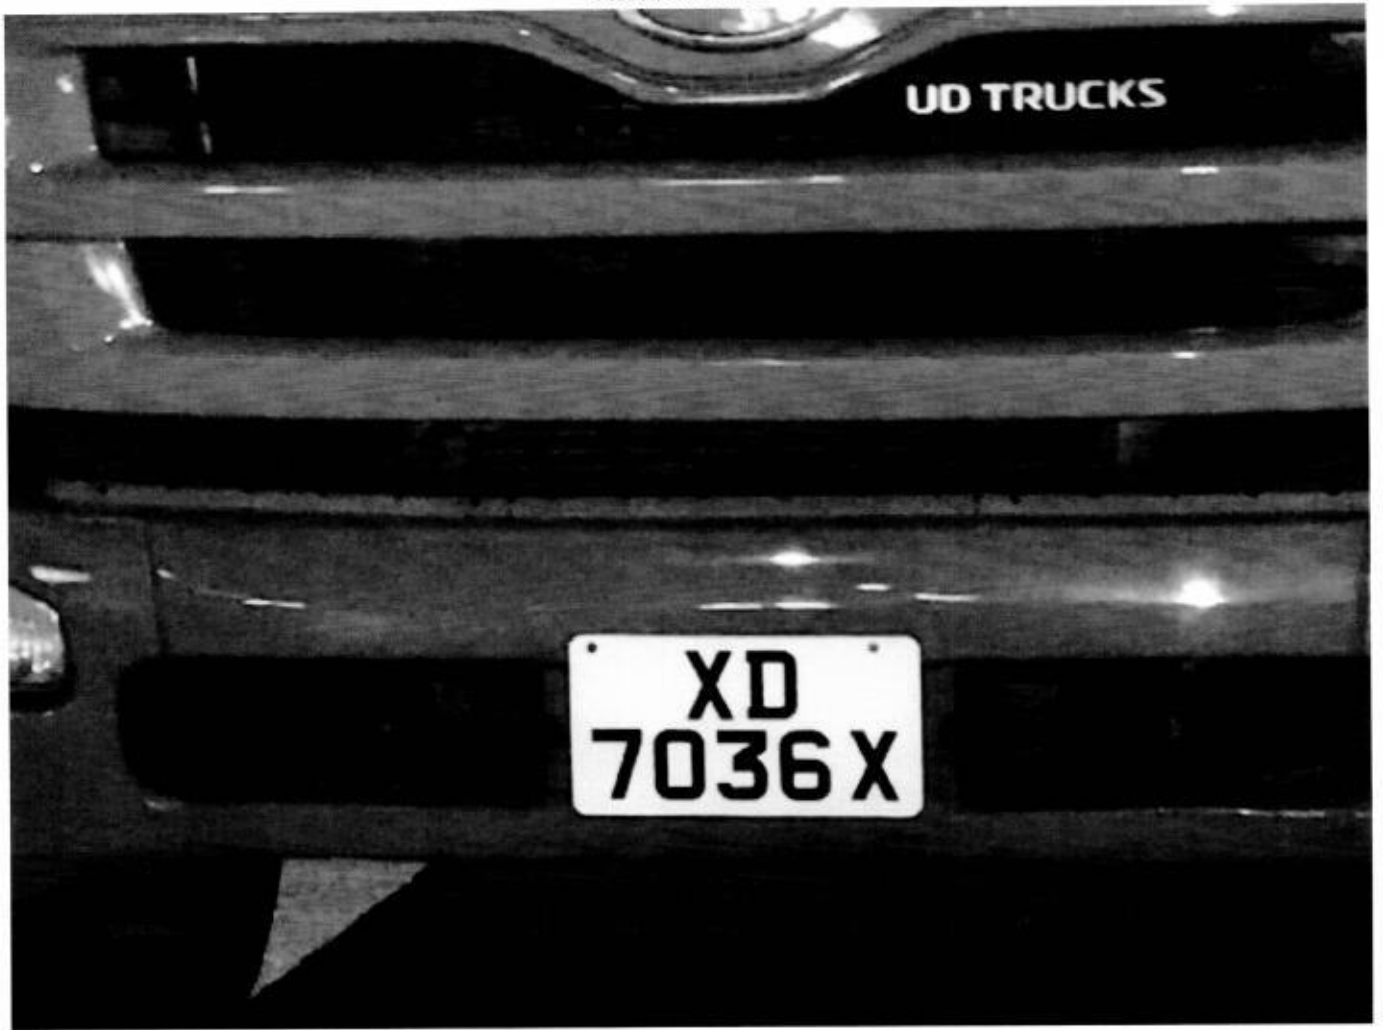
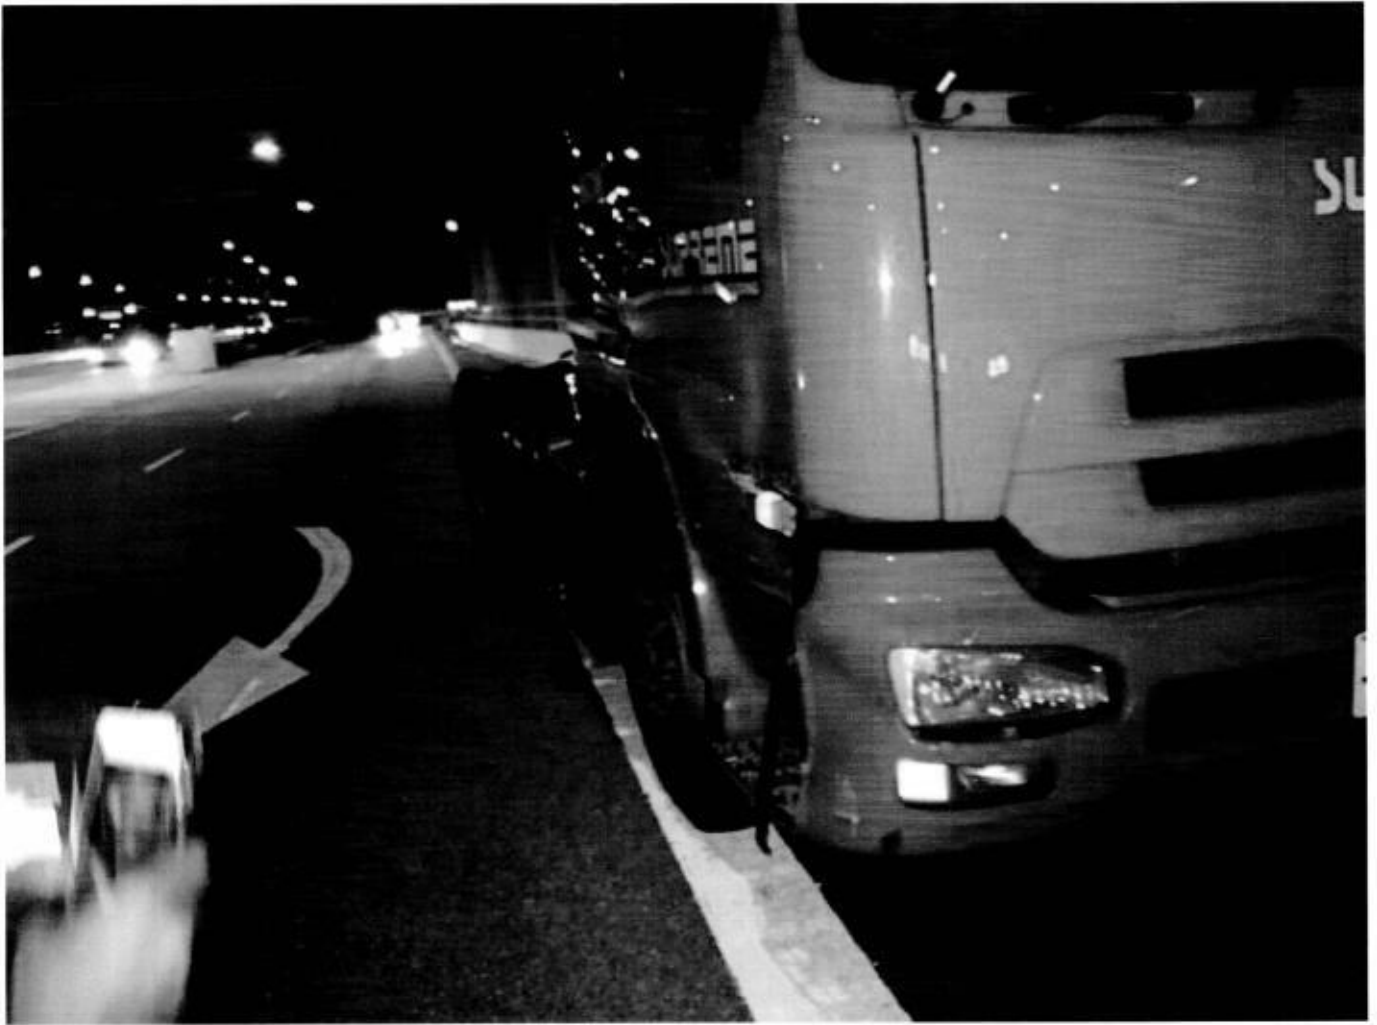
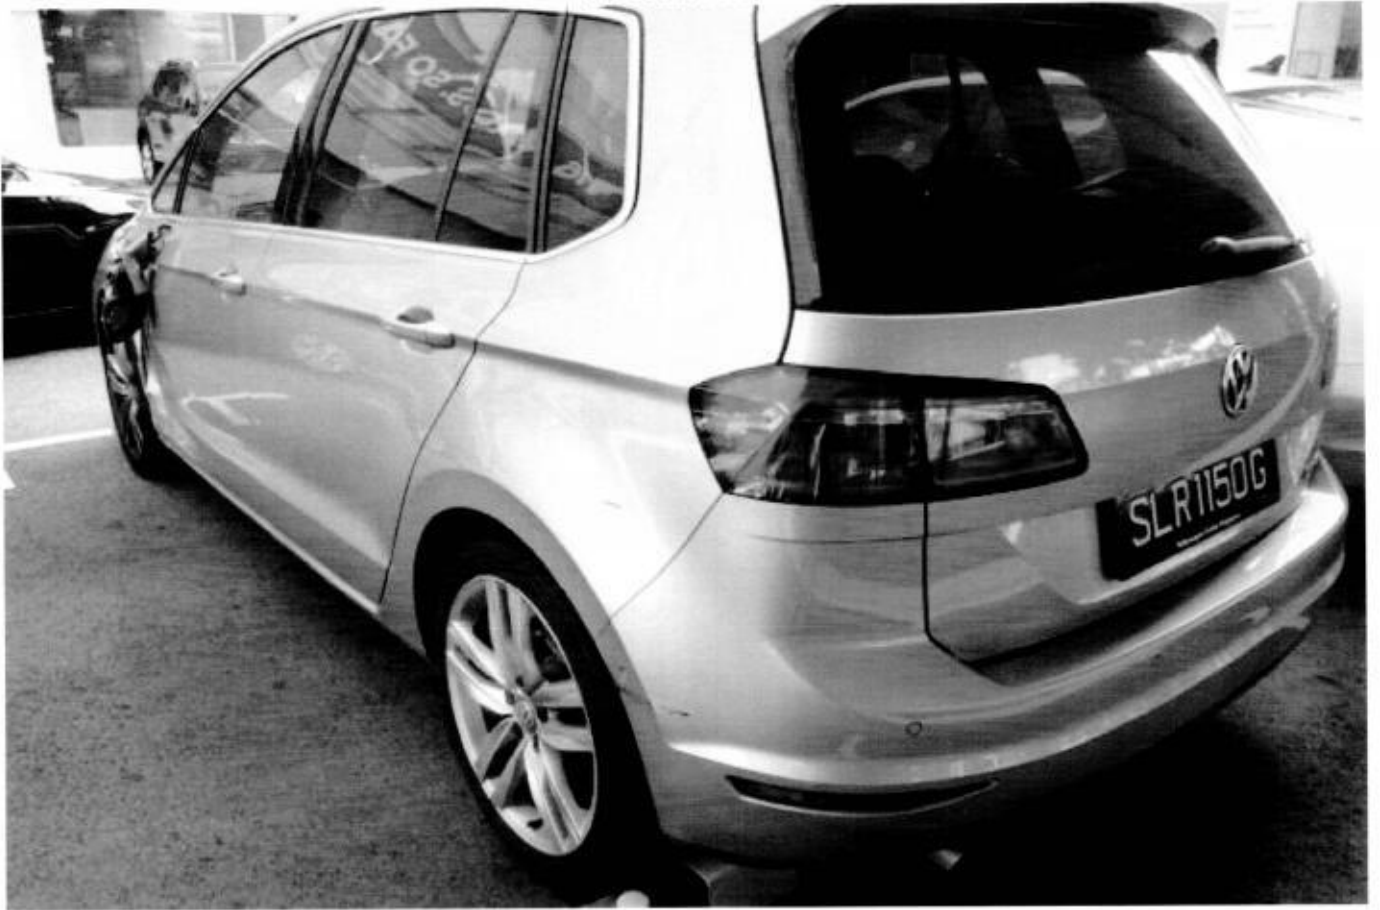
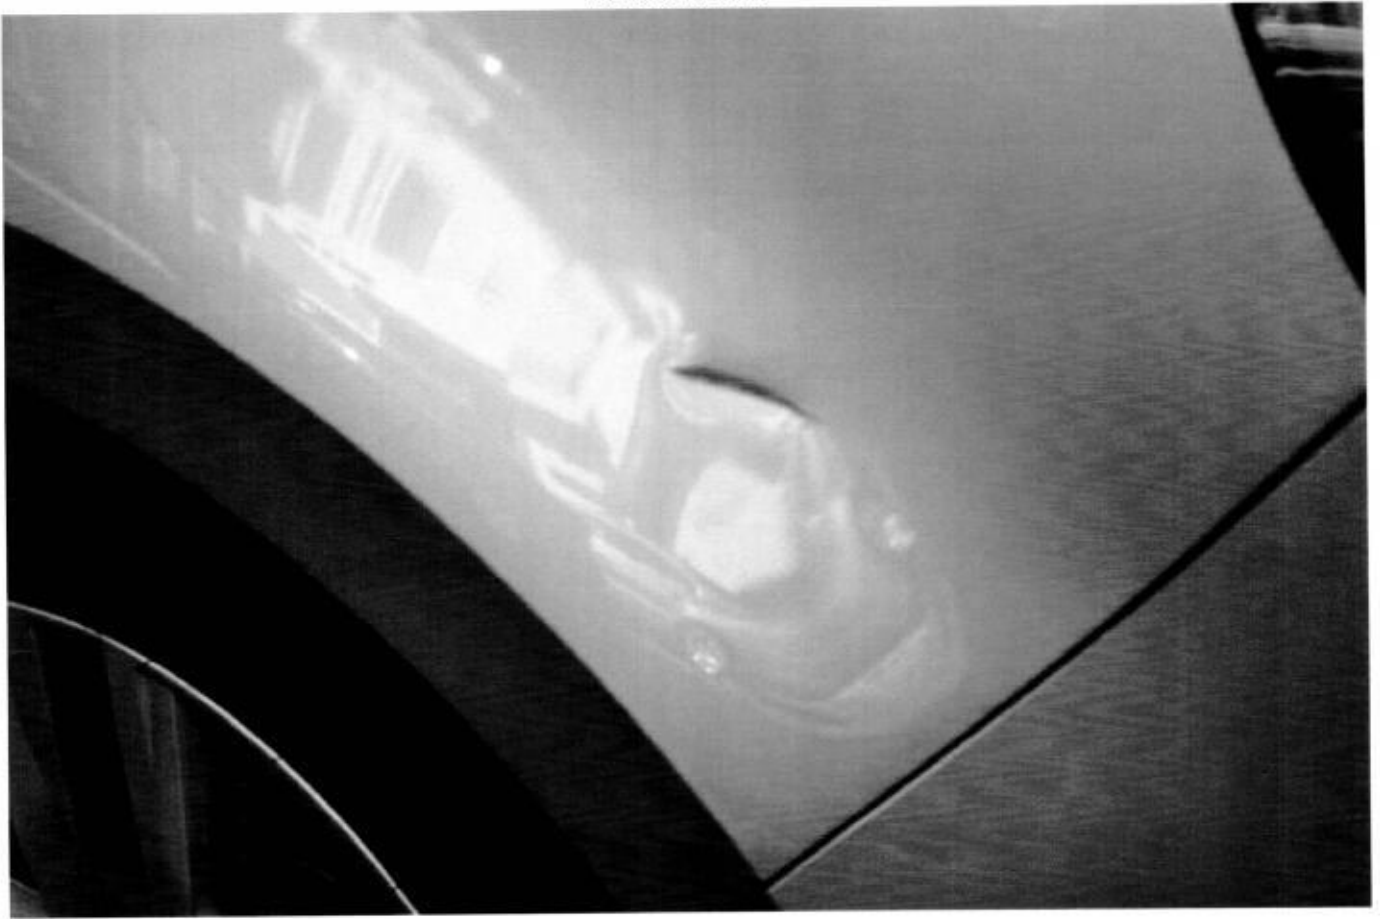
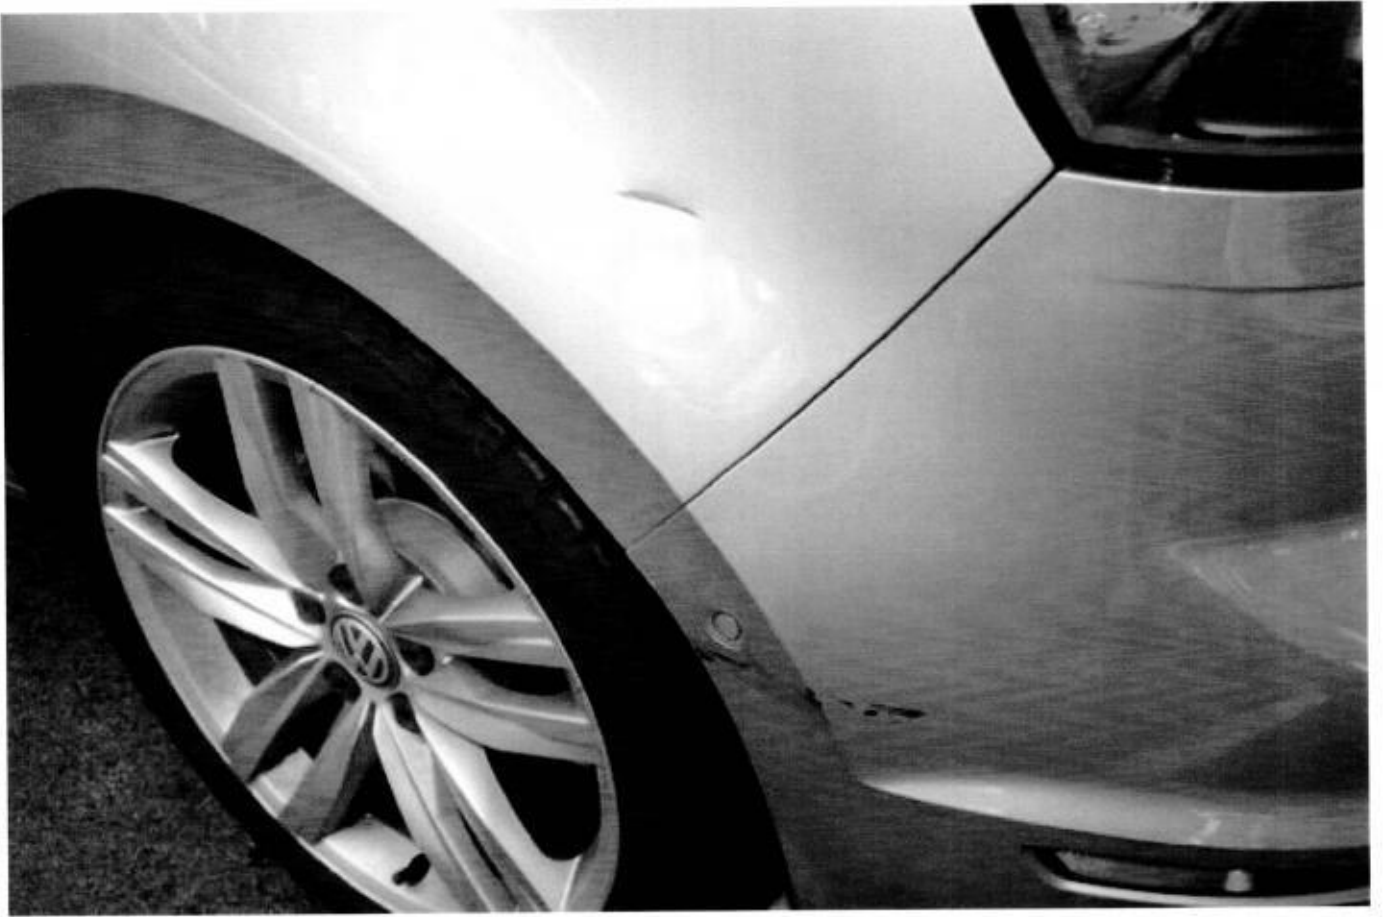
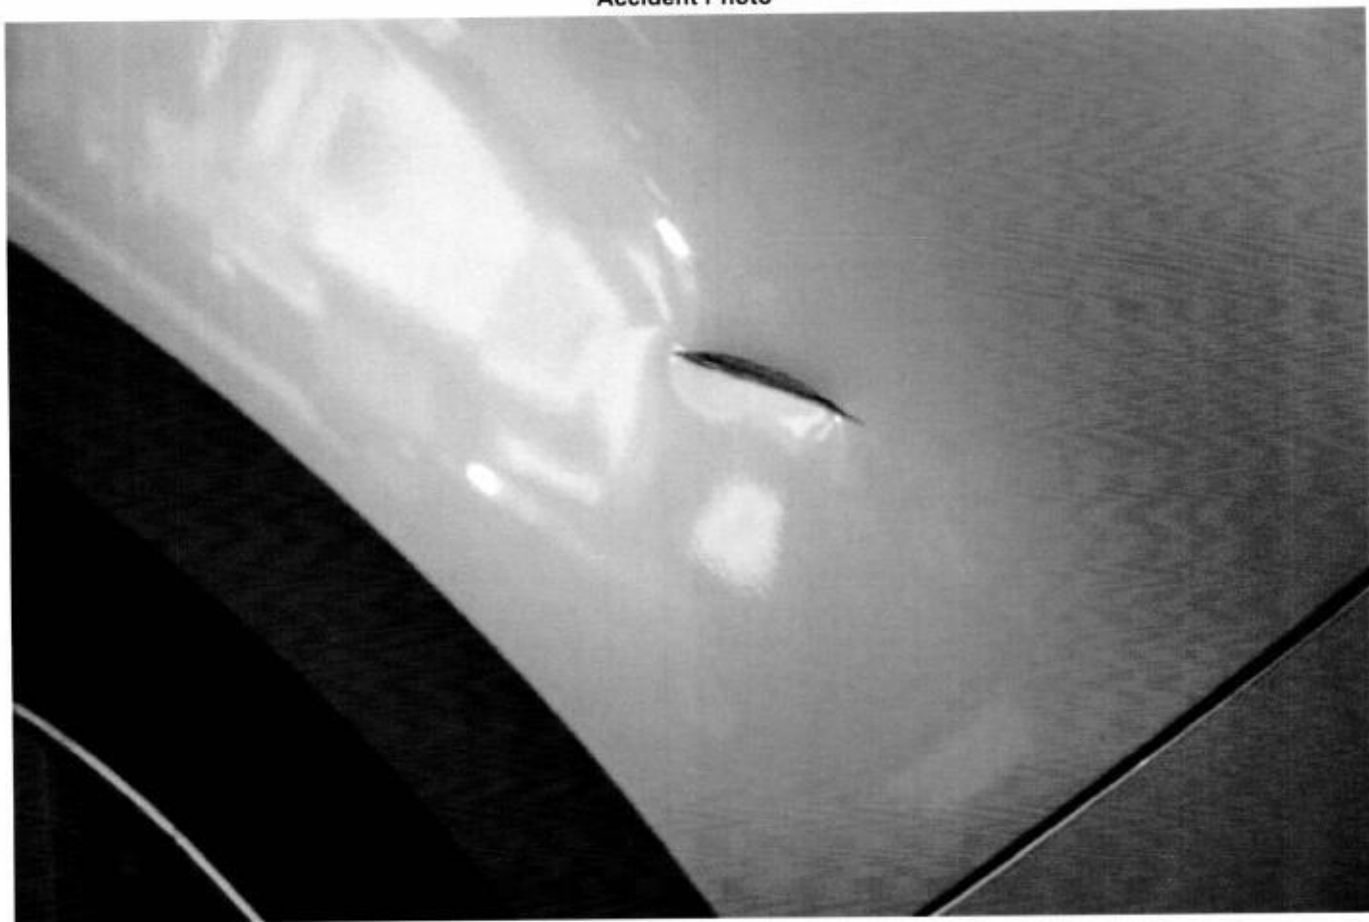
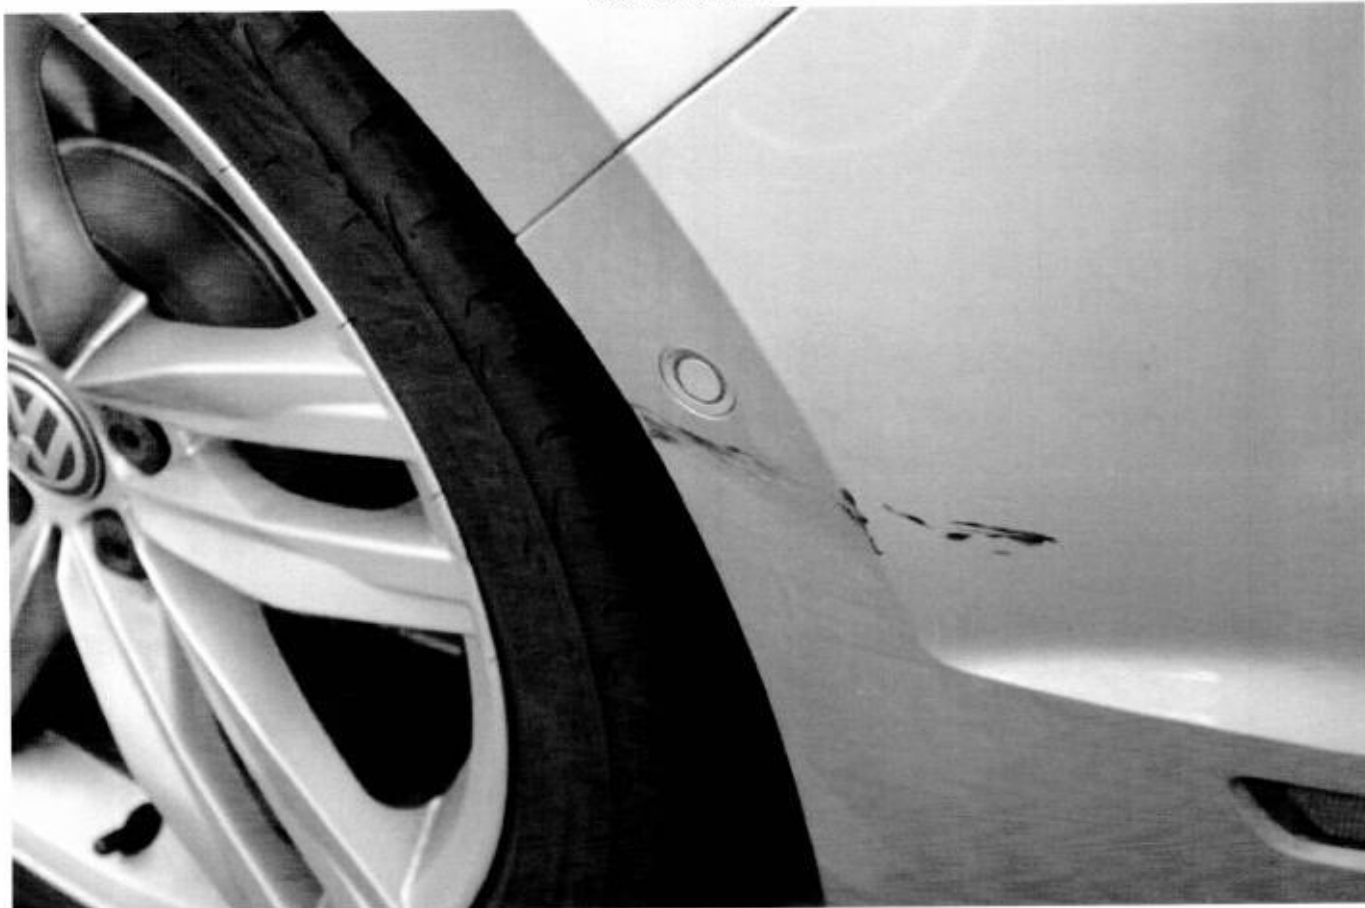
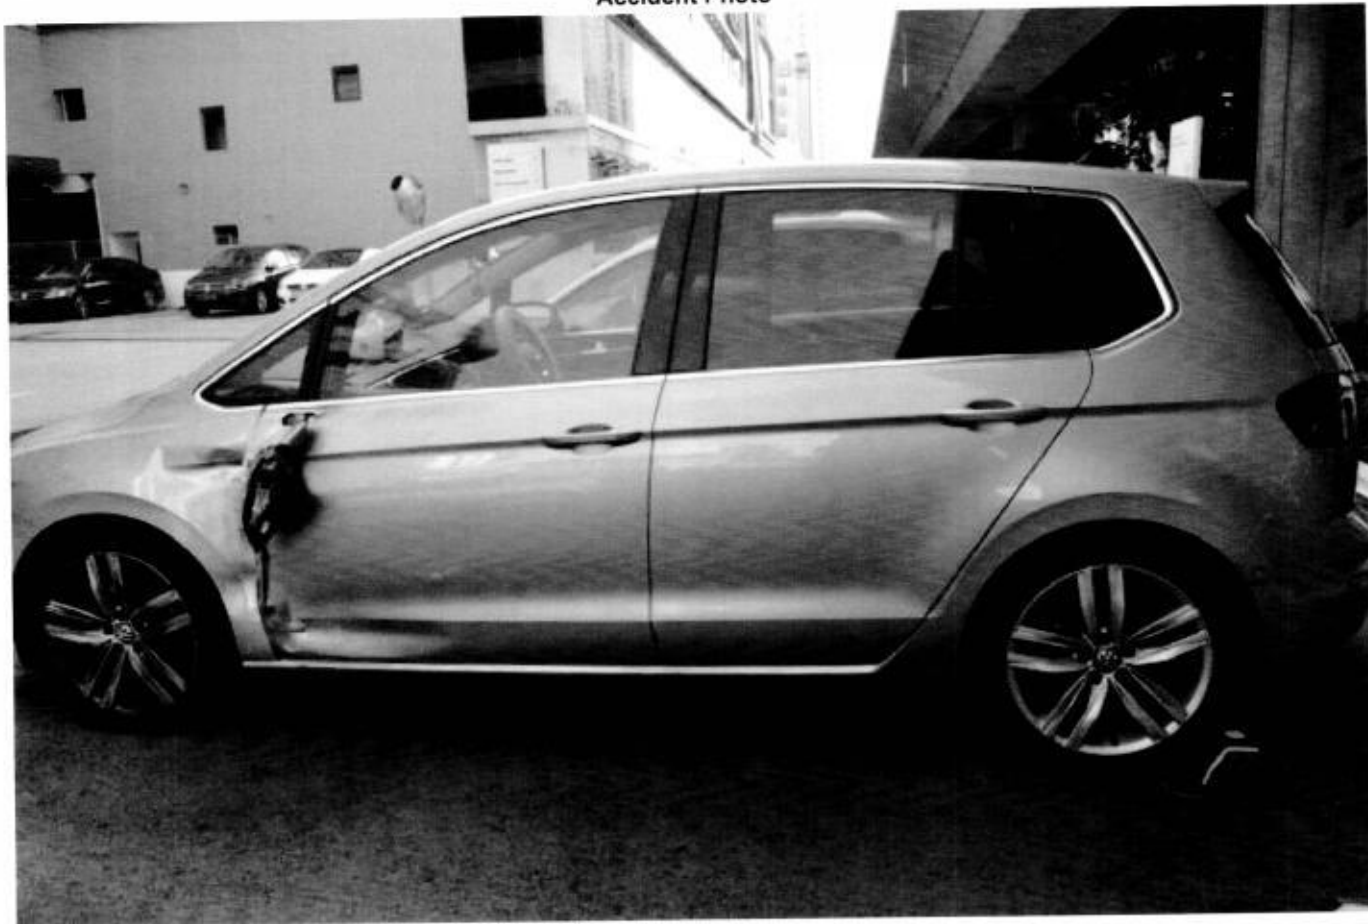
At the time of inspection, we noted that the vehicle has sustained an impact damages on the o/s front portion(s). For more detail of the damages, please see photograph attached.
