From: Jaslin Kok (LKK Auto)
Sent: Friday, 4 December 2020 1:43 PM
To: Md Noor, Norsiah
Cc: Admin A
Subject: RE: Ref: CC4/AIG19021982/Qra3 | AIG REF : 1332732668SG | ACCIDENT INVOLVING SMM4554U AND SLM8718A ON 20/09/2019

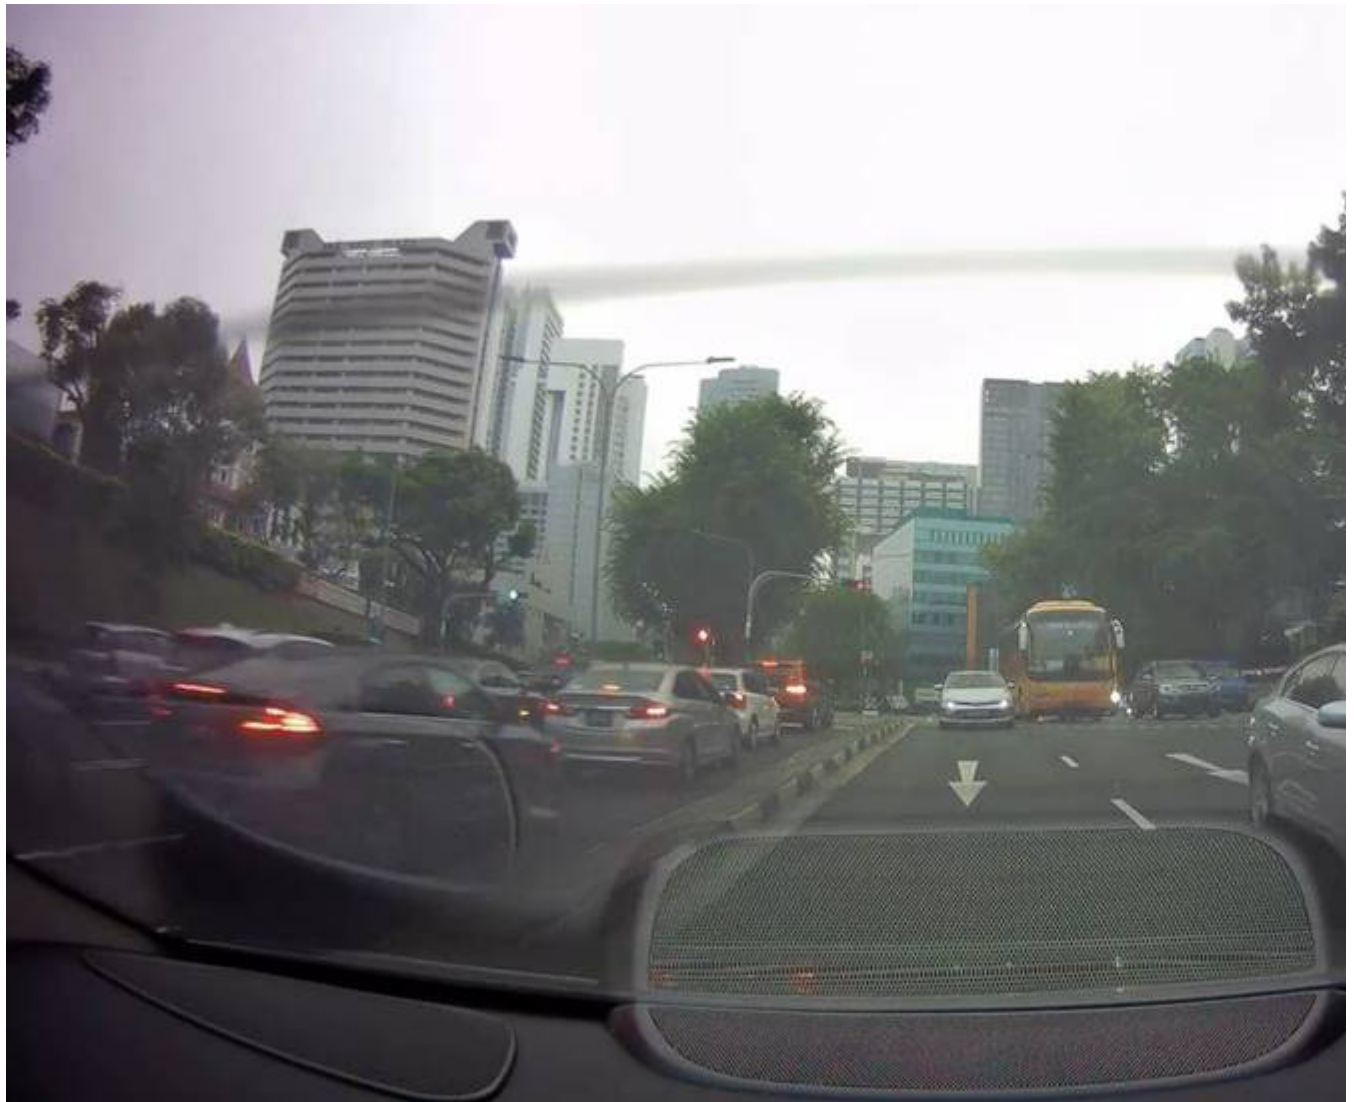
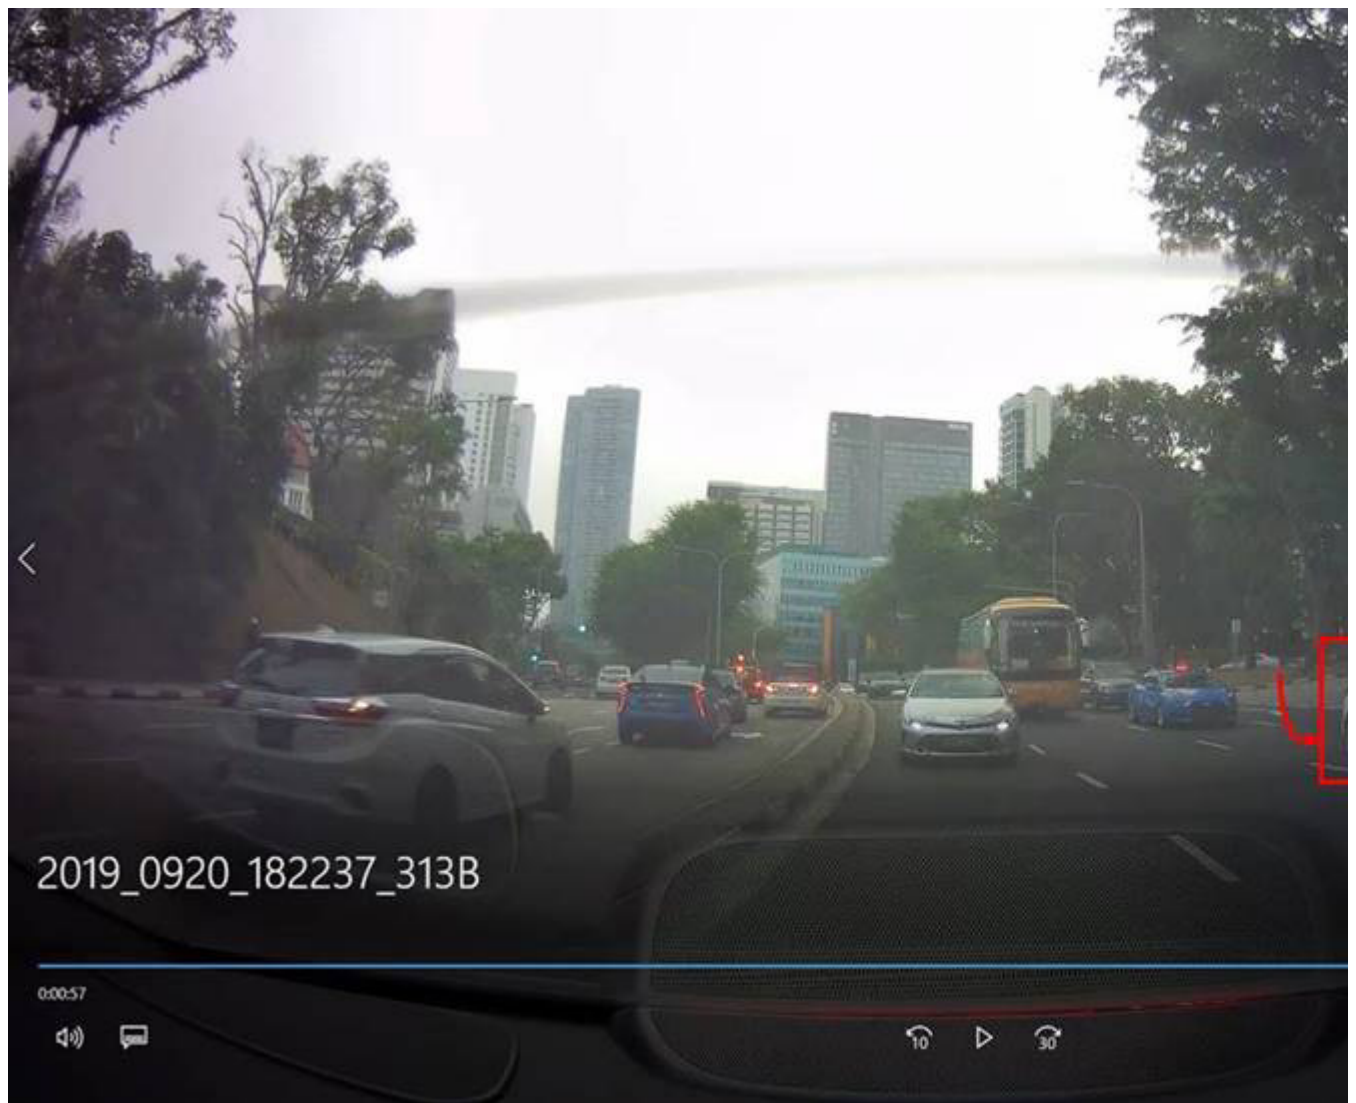
1. SLM8718A was filtering right across two lanes from the left most lane from behind. They have a clear view of our car filtering left yet the driver continue with the filtering to collide with us.

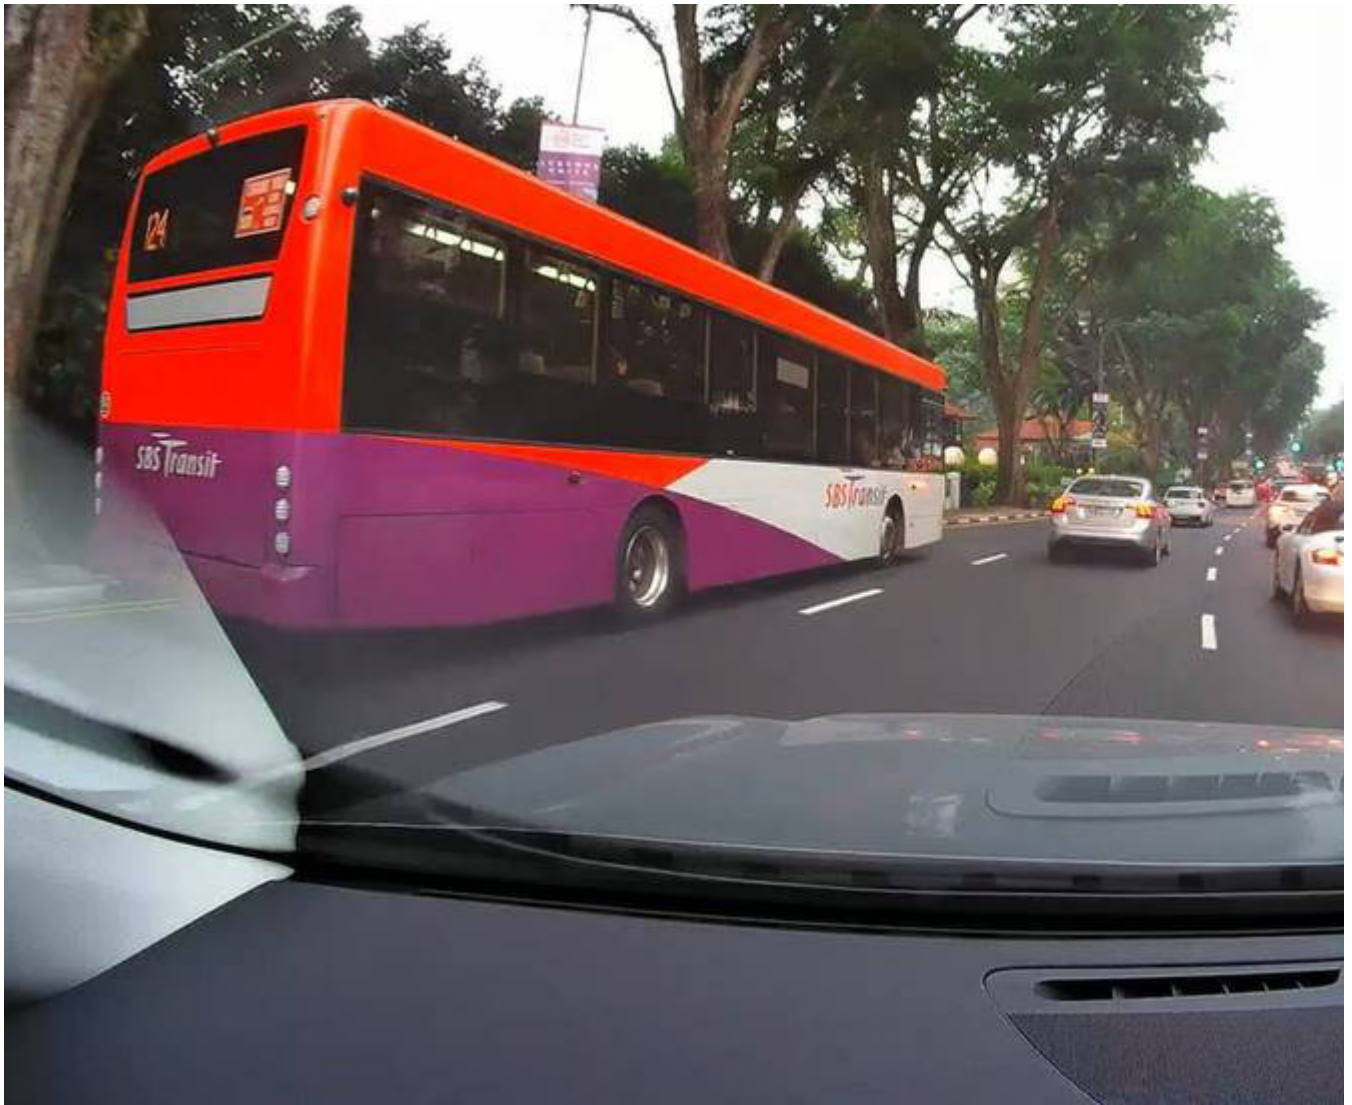
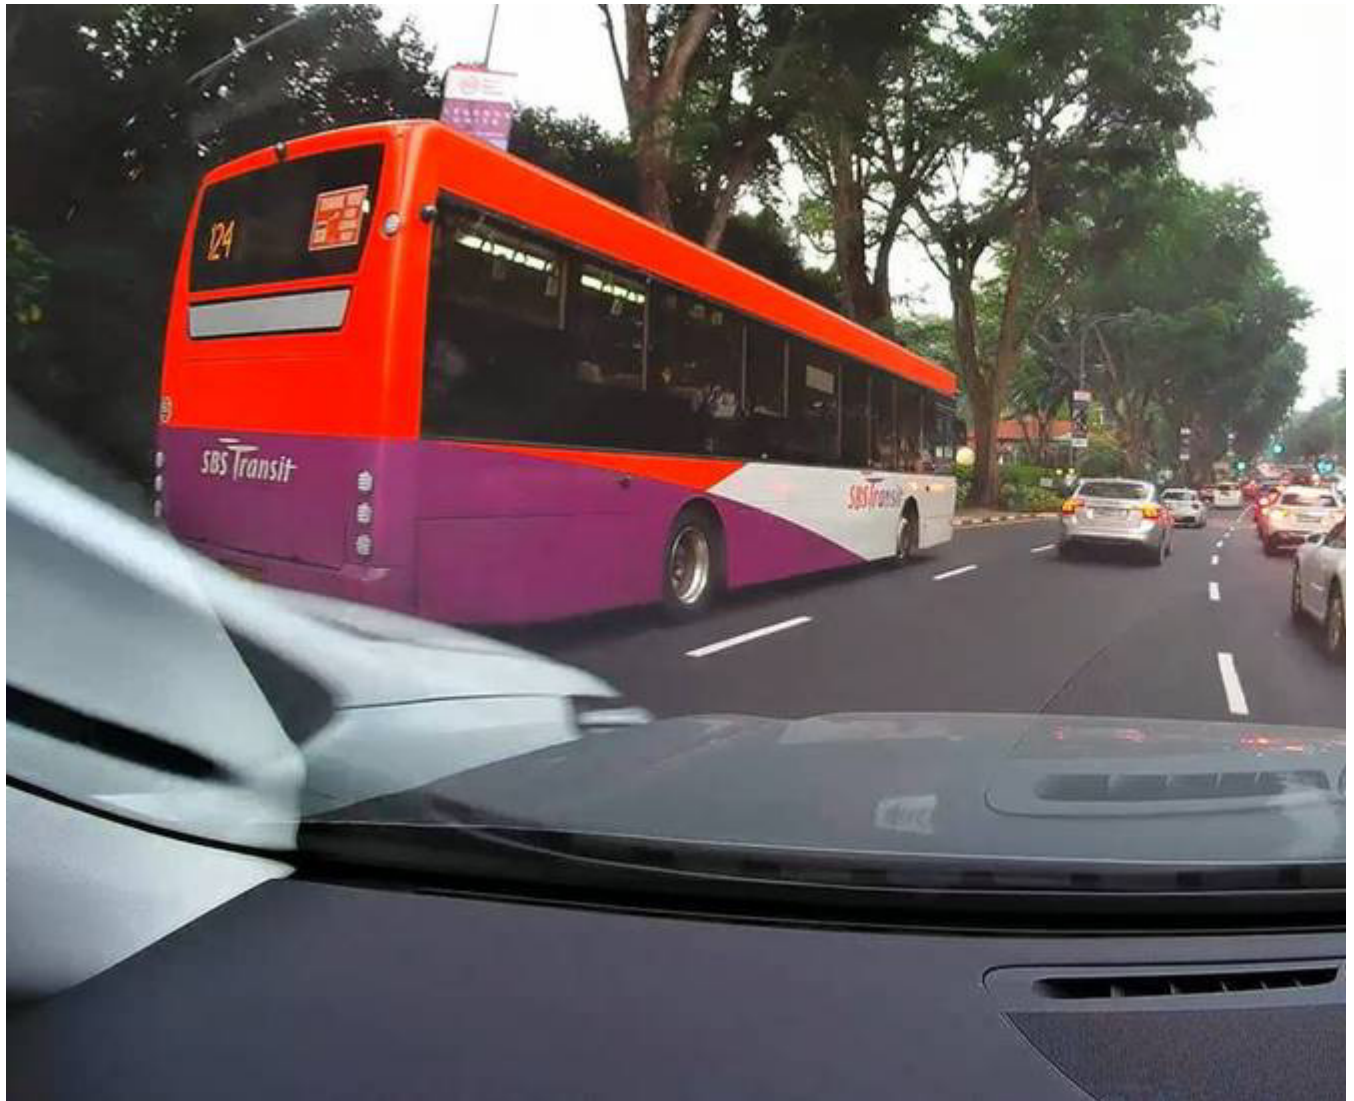
2. Based on the video (which we will attached separately due to the file size), we have already started signaling and made our intentions very clear to SLM8718A unless the driver of SLM8718A is not watching the road traffic. I understand the driver of SLM8718A is a private hire driver and she could be pre-occupied with the hire-riding apps with potential bookings at hand and is distracted from the roads.
3. My car has already filtered more than half way into the left lane before SLM8718A came in to collide with my car as seen in the picture below.

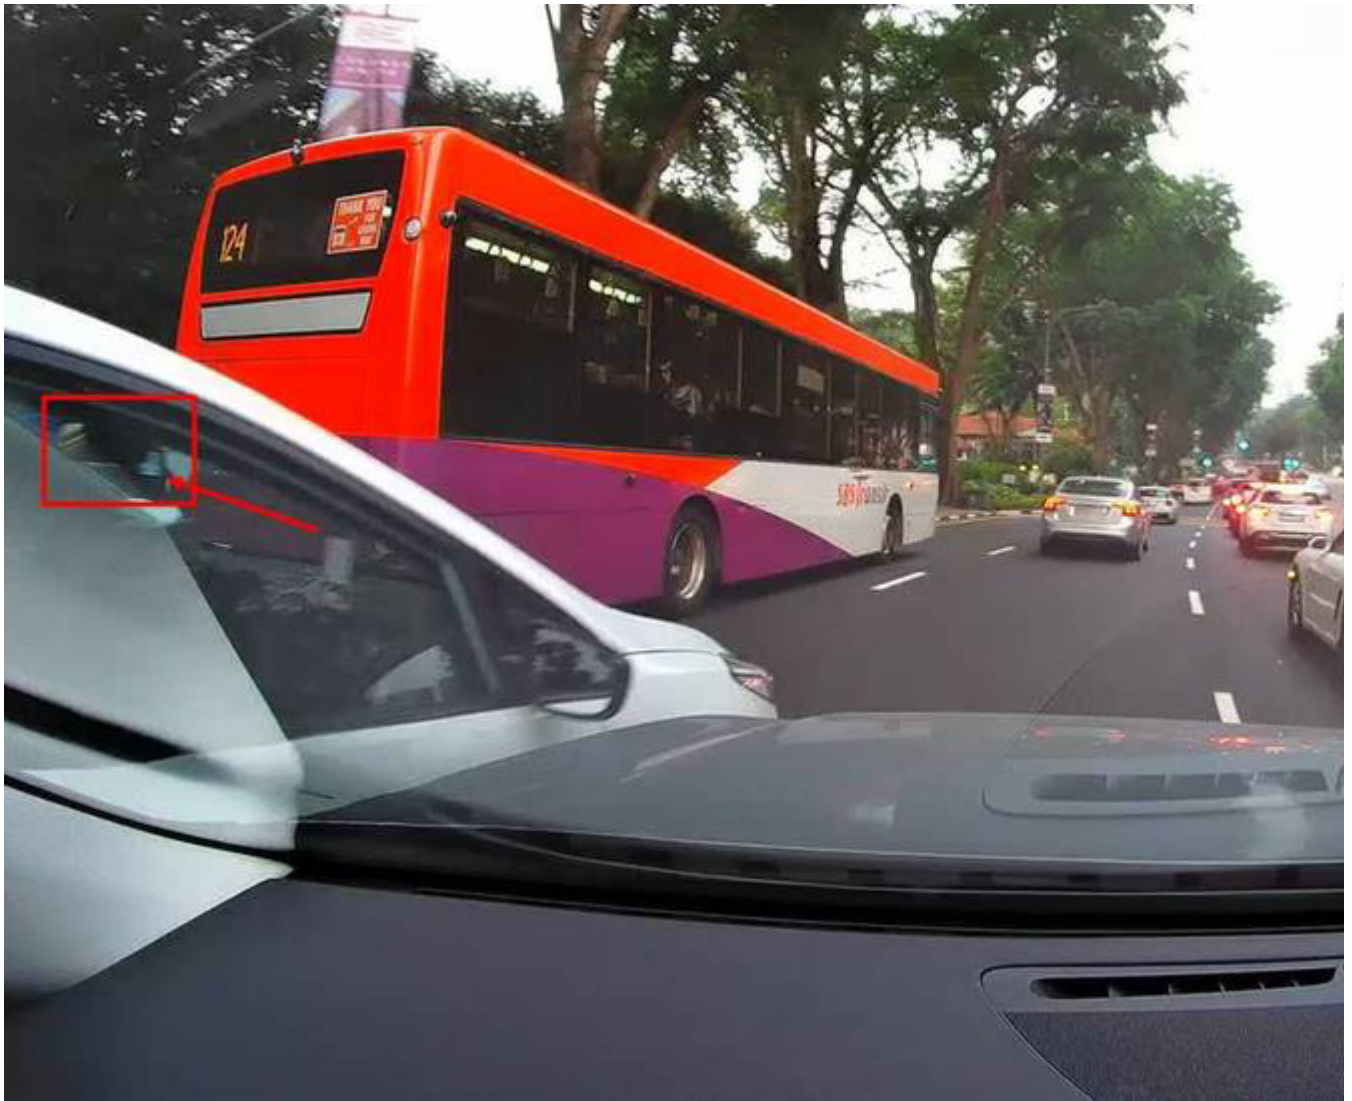
4. SLM8718A has a front view camera installed. If they feel that they have a legitimate claim, I would like to request for a copy of their front cam video prior to collision which I am confident will show that SLM8718A has a full view of my car's signaling and making the filtering.
