| PRE-REPAIR INSPECTION REPORT | | | | |
| Insured Veh. | FBK 2310K | Veh. Inspected | SLX 5599M | |
| Make & Model | MERCEDES BENZ E250 CGI A | c.c | 1796 | |

### PHOTOGRAPHS FOR VEHICLE NO. SLX 5599M

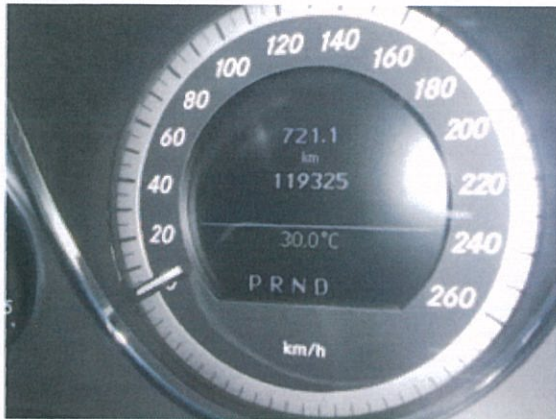
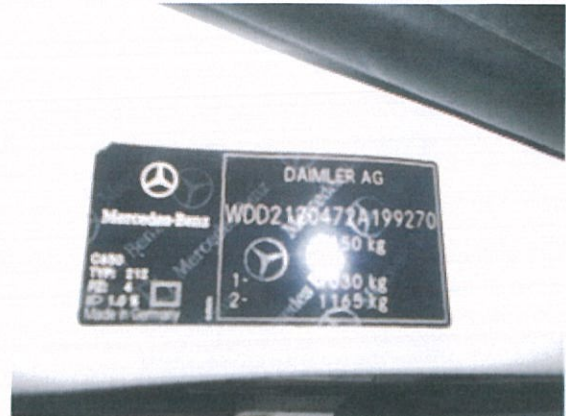
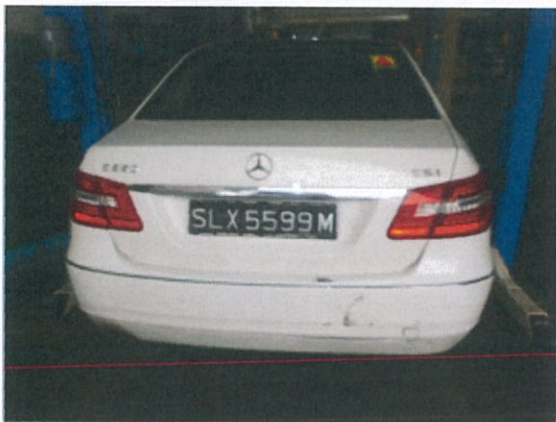
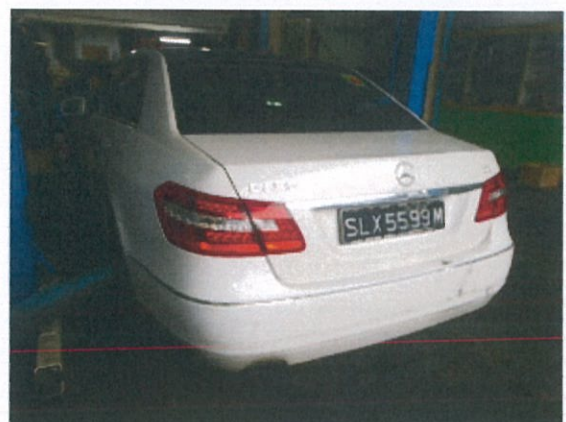
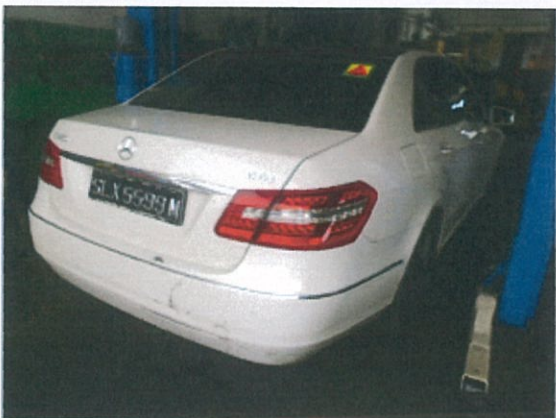
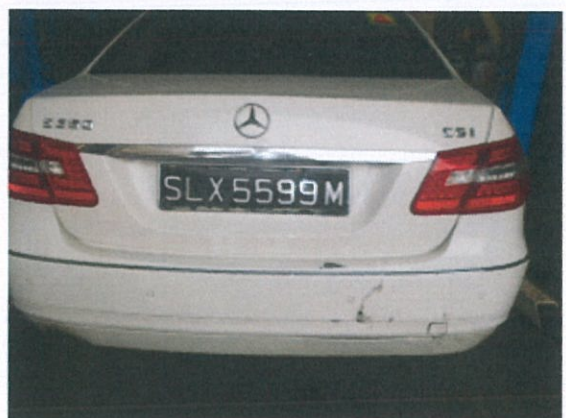
### INSPECTION

| PRE-REPAIR INSPECTION REPORT | | | | |
|---|---|---|---|---|
| THE VEHICLE SUSTAINED DAMAGES AT THE REAR PORTION.<br>DAMAGES SEE DETAILS. | | | | |
