From: YONG ANDREW <ctyong99@hotmail.com>
Sent: Tuesday, 22 June 2021 2:22 PM
To: Jaslin Kok (LKK Auto)
Cc: Admin A
Subject: Re: Accident involving SKP6755B & GBD2807G along/at Marine Parade Rd (Near Nallur Rd junction on 14 /08/2020

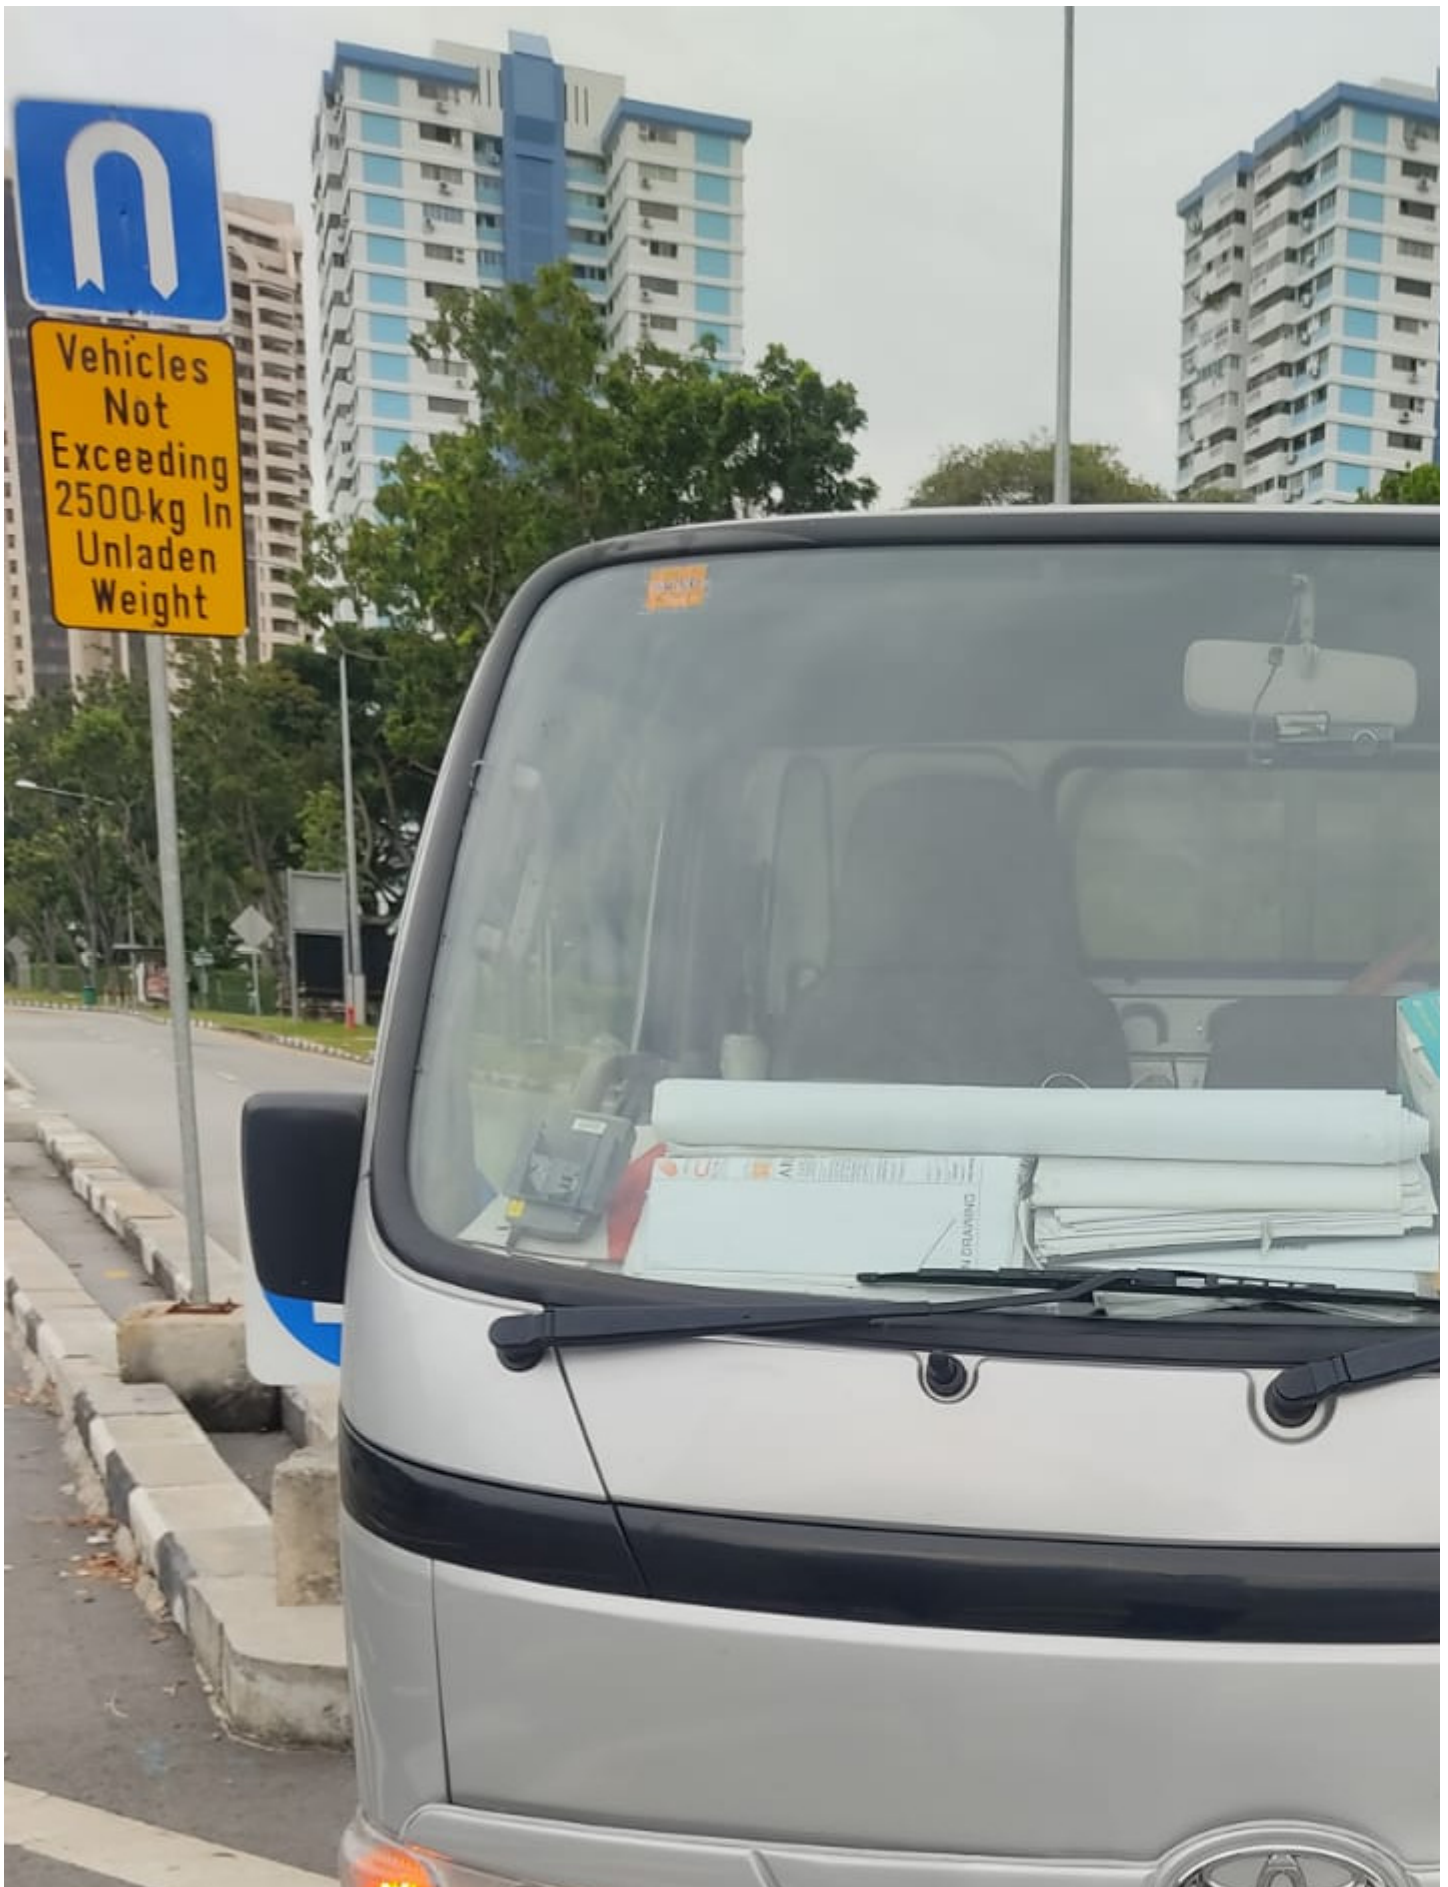
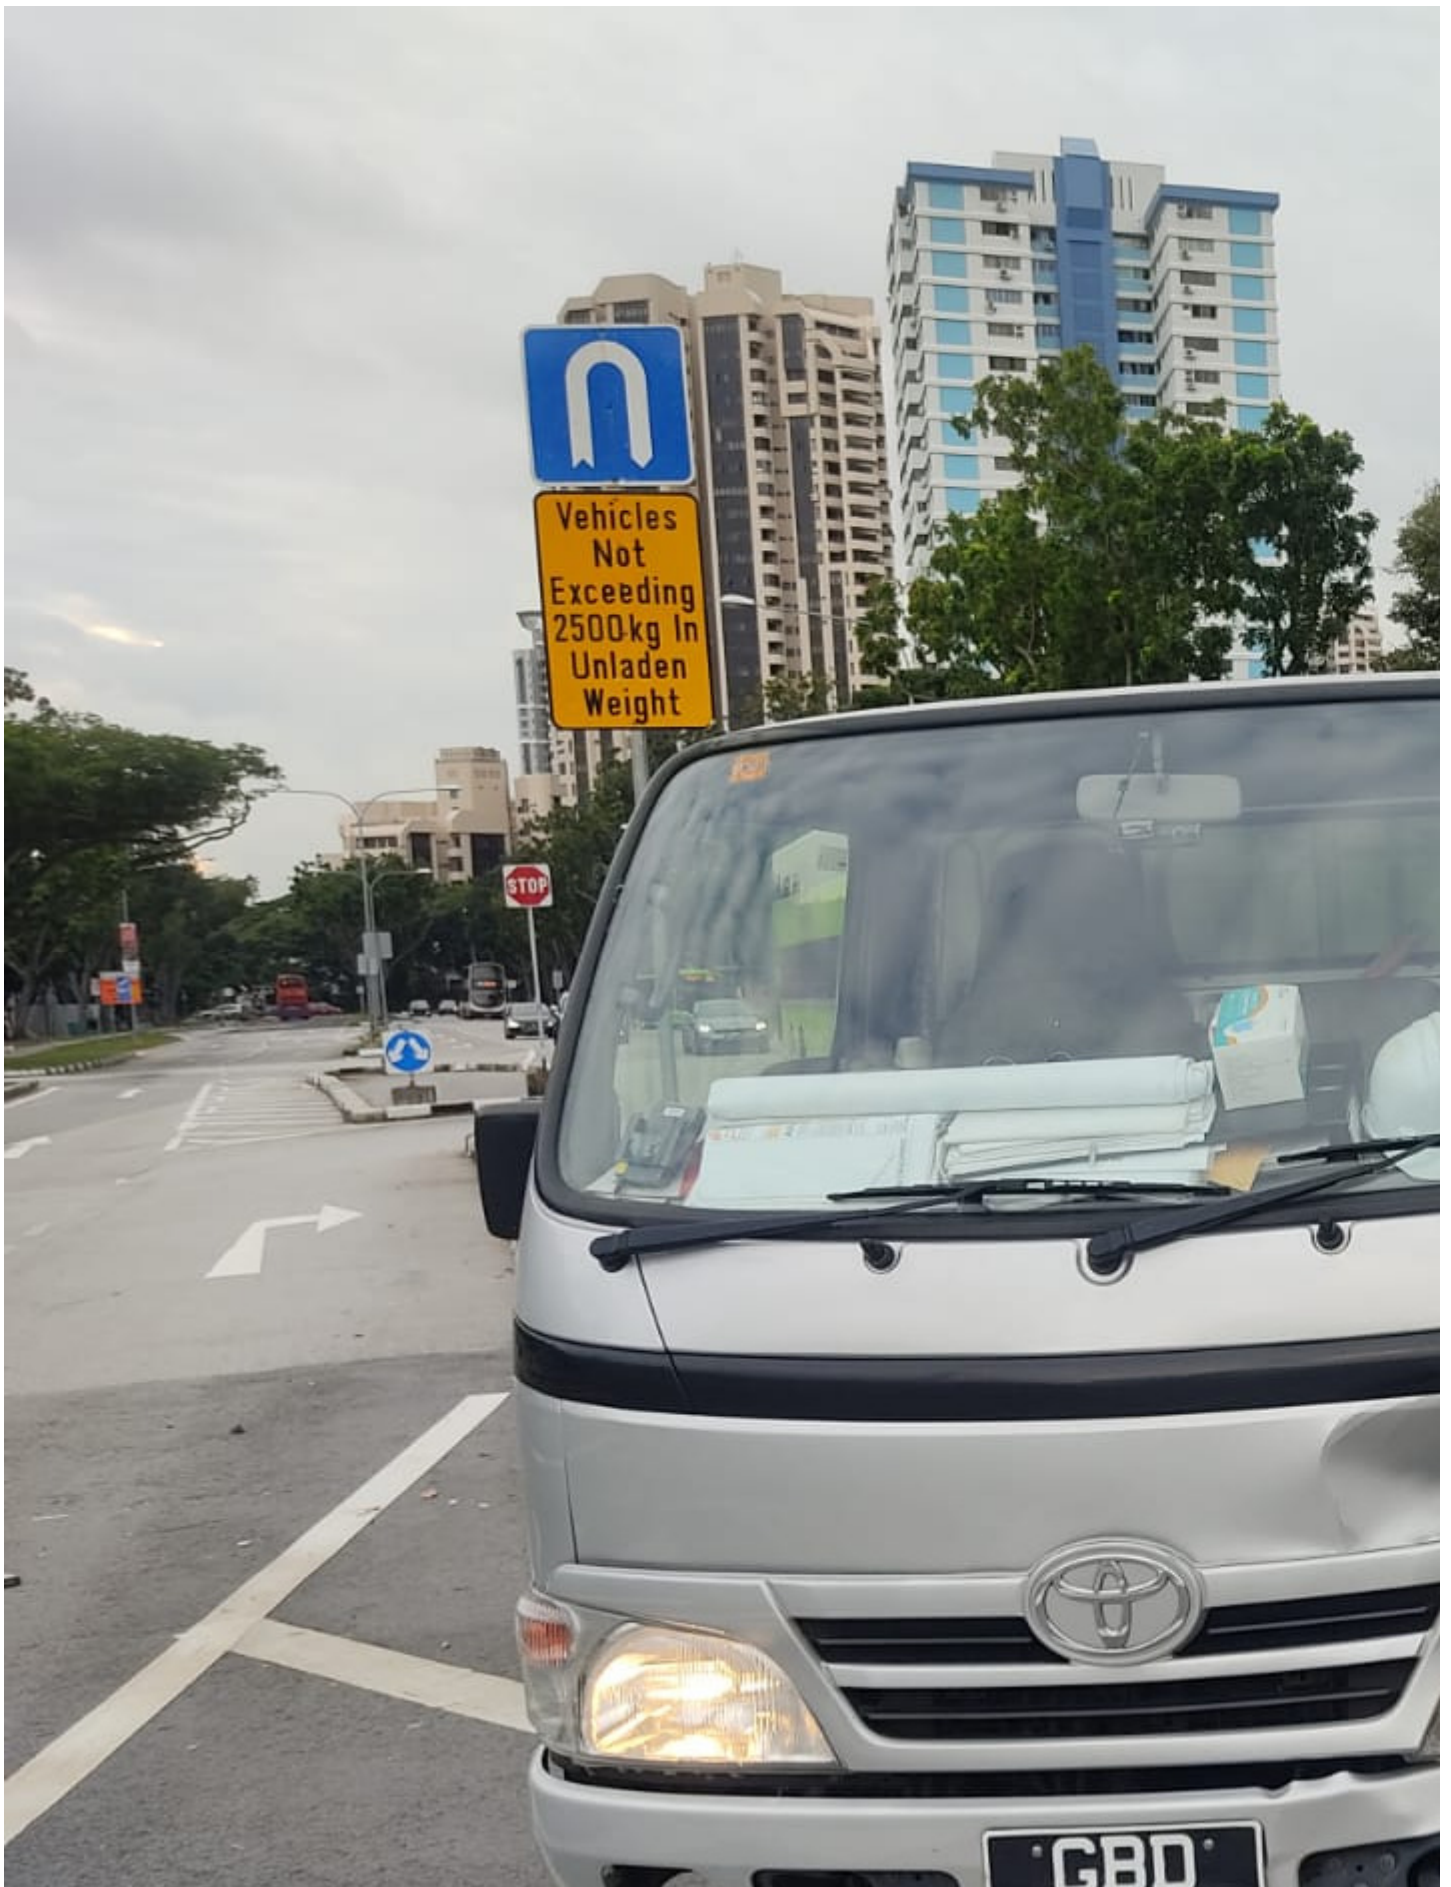
Thirt party turning from Nallur road to collide with my car is 20 meter or less. The driver is having his tea while driving and is in a rushing manner. The vehicle is runing on moderate speed (not slow speed), one hand on wheel, the other holding tea bag. When he noticed my car, he can't adjust his vehicle quickly and rammed into my car. His tea spilled through his vehicle to the road. Please see Photo attached. Two patches of yellowish liquid can be seen on the road under his vehicle. The third party vihicle did not suffer any oil

leak.
