Report Reference : **TP / 19019-12/MY / 2019**

THIRD PARTY SURVEY

ACCIDENT HAPPENED ON 4 Dec 2019

Registration No	: SLQ 333 H	Engine No	: 27091031229353
Model	: Mercedes Benz CLA180	Mileage	: 37389
Year / Capacity	: 2017/1595	Colour	: White
Chassis No	: WDD1179422N485805

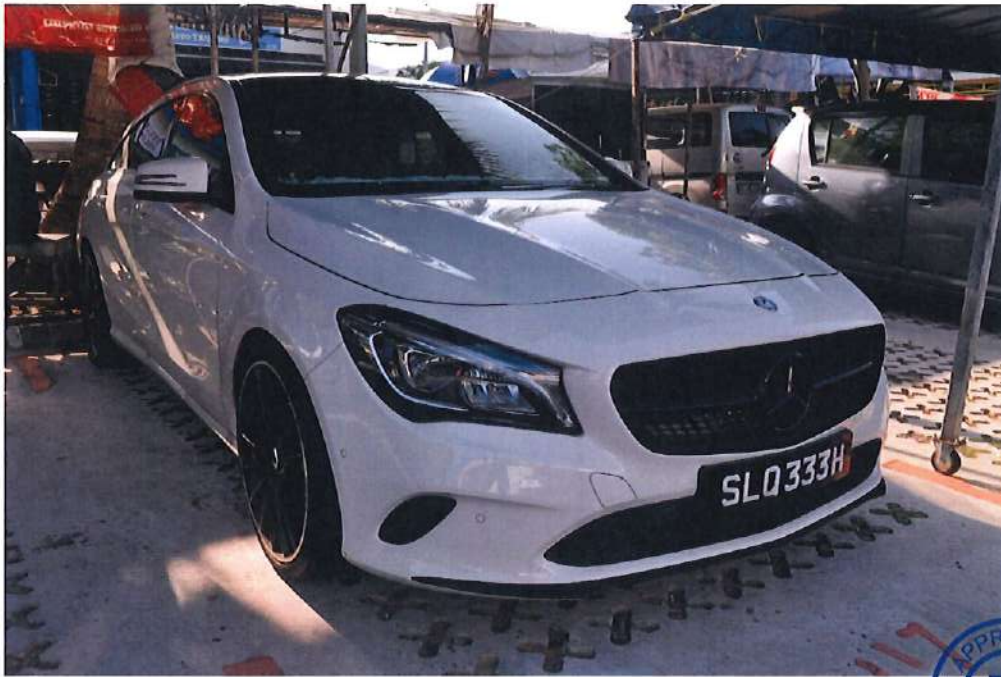
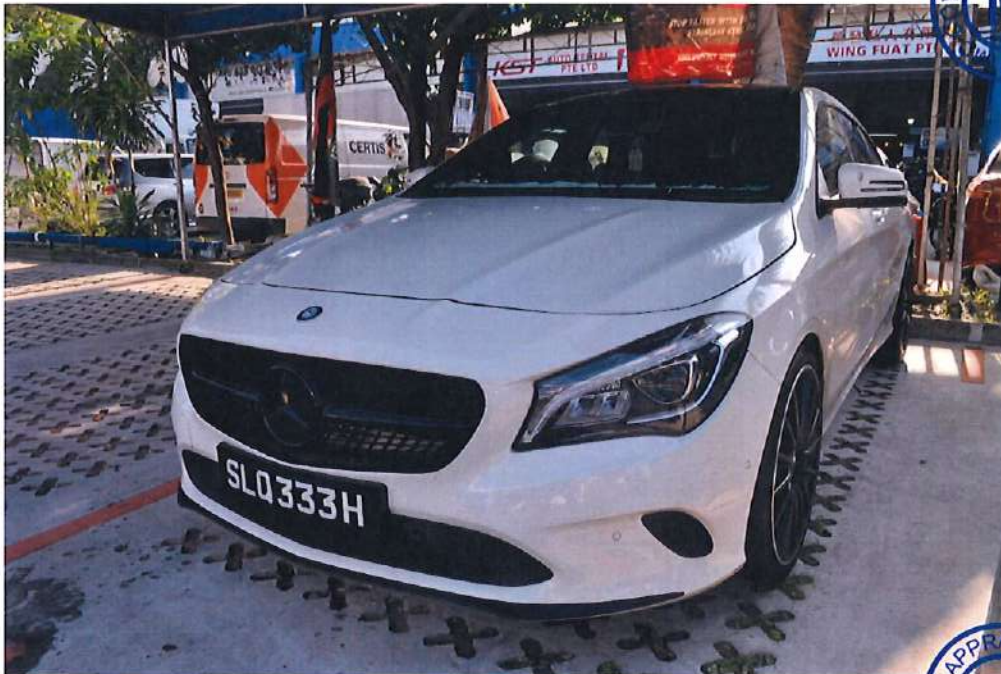
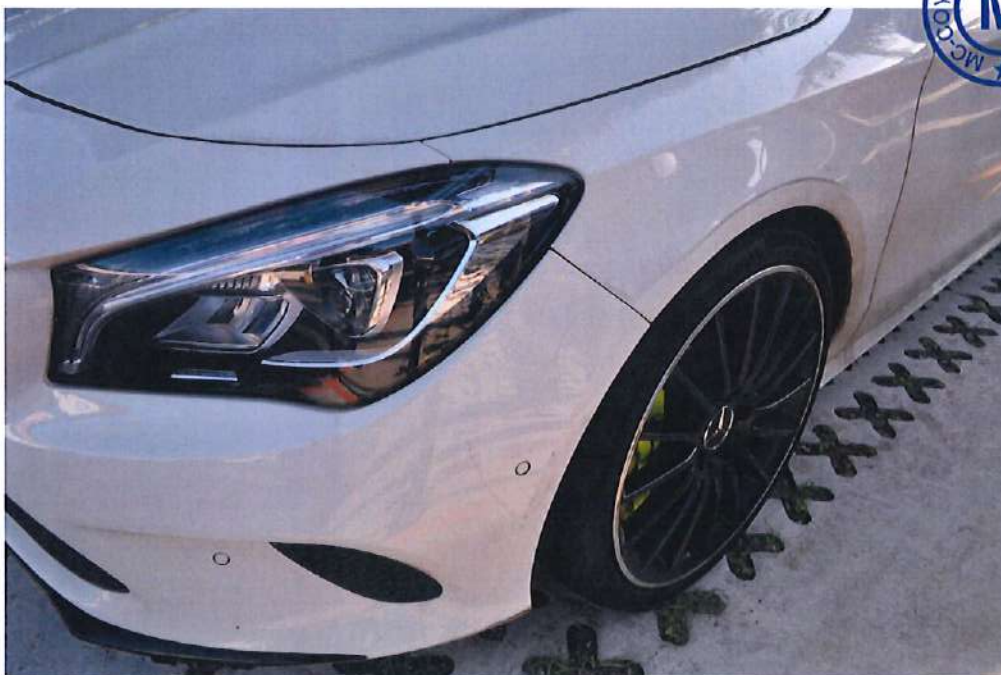
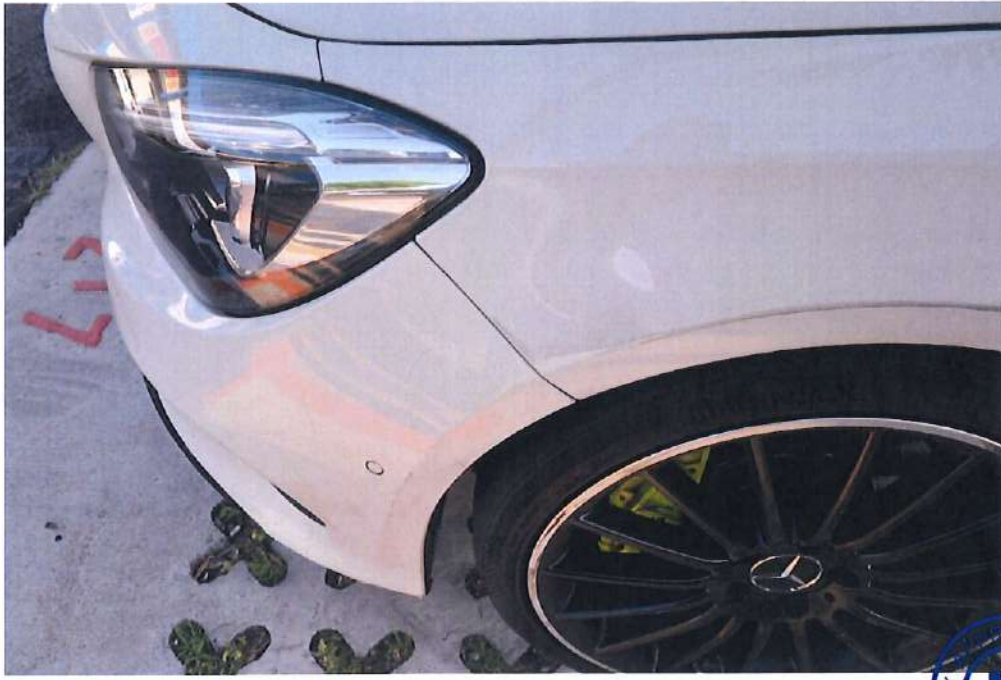
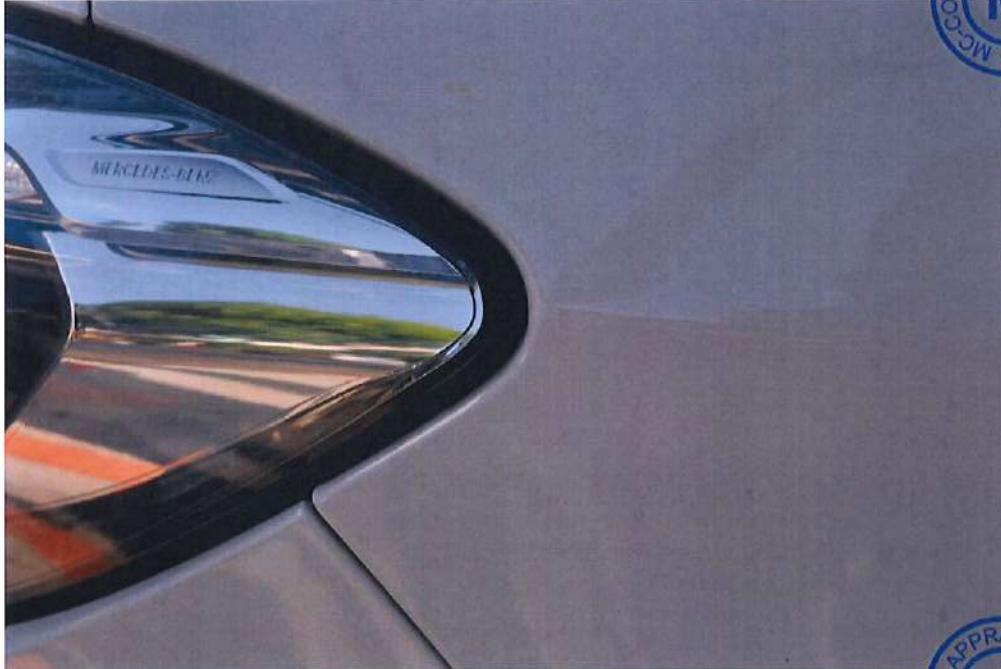
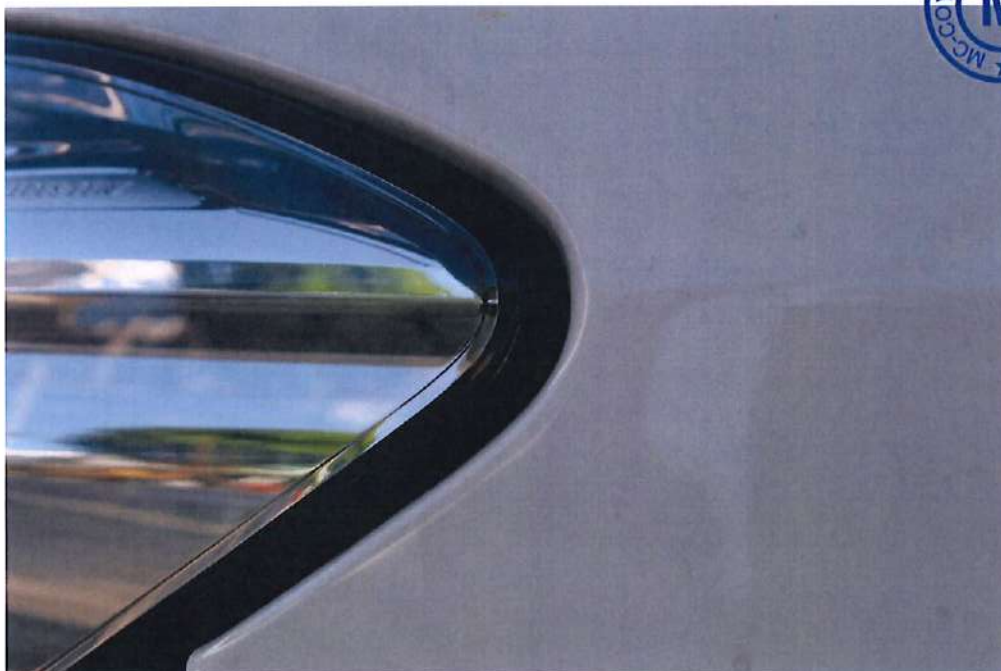
At the time of inspection, we noted that the vehicle has sustained an impact damages on the front n/s portion(s). For more detail of the damages, please see photograph attached.
