Your Ref: TP/IP/08195/2021
Our Ref : CI/TPD21005547/N

22 July 2021

INSPECTION REPORT OF MOTORCYCLE FE 35C

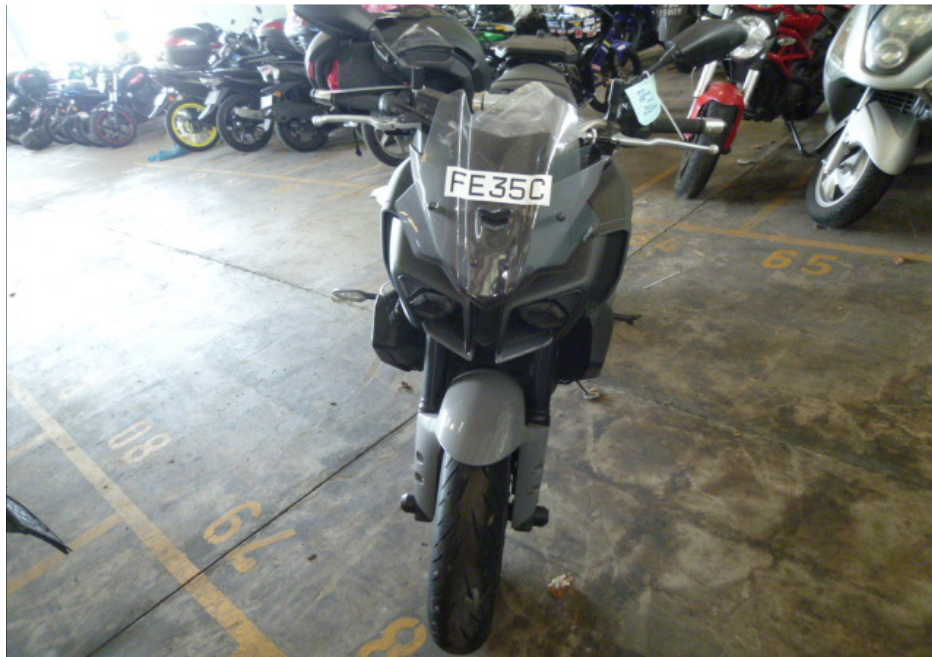
Photo 1 shows a general view of the frontal portion of the Motorcycle at the time of our inspection. The Motorcycle was observed to have sustained damages at its frontal portion and left body. The mileage of the Motorcycle could not be recorded at the time of our inspection as there was no ignition key.

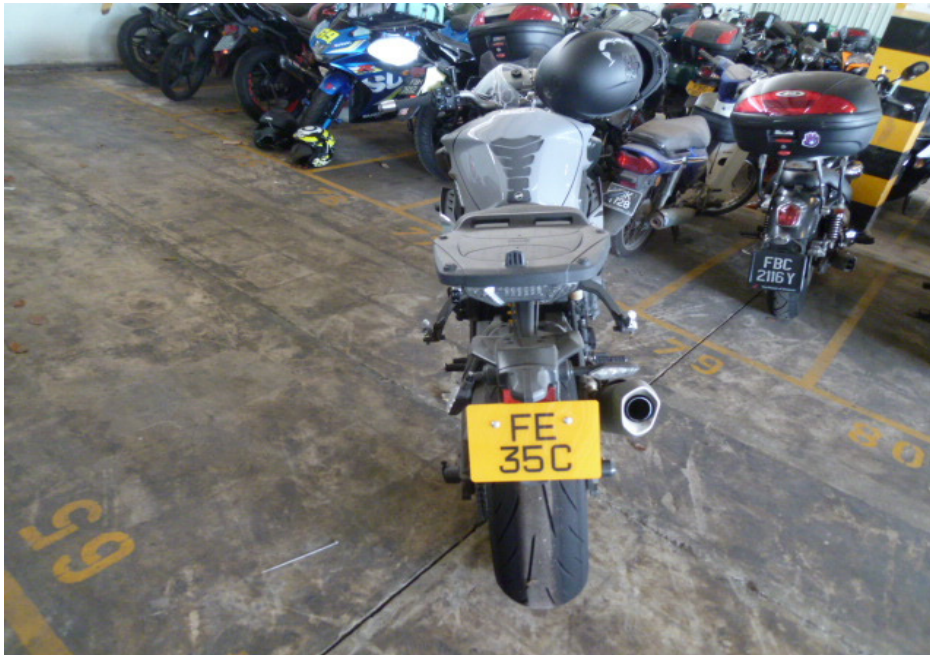
Photo 2 shows a general view of the rear portion of the Motorcycle at the time of our inspection. The Motorcycle was observed to have sustained damages at its frontal portion and left body.

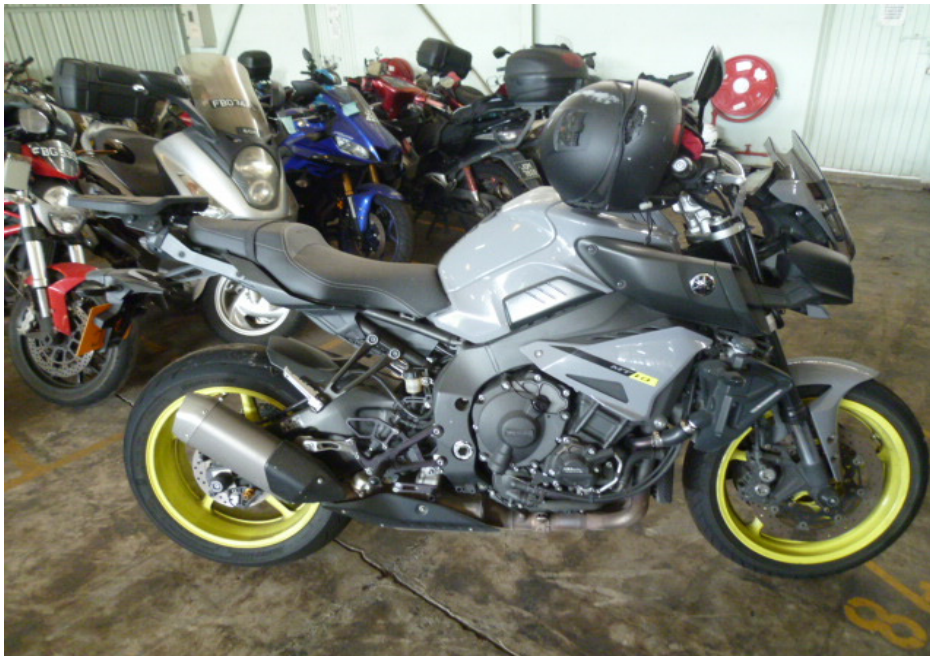
Photo 3 shows a general view of the right body of the Motorcycle at the time of our inspection. The Motorcycle was observed to have sustained damages at its frontal portion and left body.

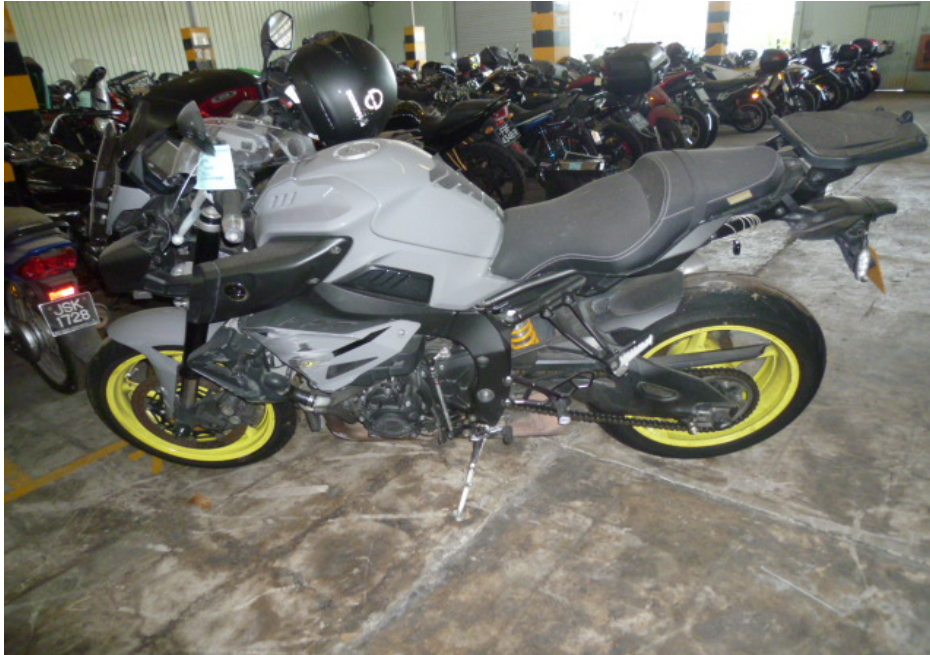
Photo 4 shows a general view of the left body of the Motorcycle at the time of our inspection. The Motorcycle was observed to have sustained damages at its frontal portion and left body. The body parts that were found to have been damaged include its head cowling, front mudguard, left cowling, left radiator cover, left signal lamps, clutch lever, left side mirror and left front footrest, amongst others.

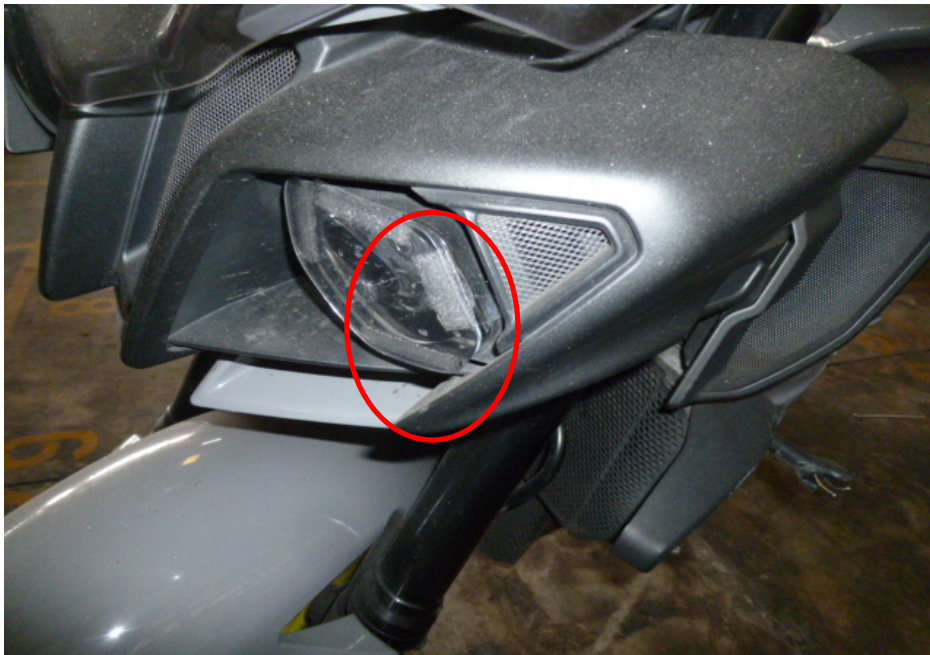
Photo 5 shows a close up view of the head cowling was amongst the body parts of the Motorcycle that had sustained damage as a result of the accident (circled).

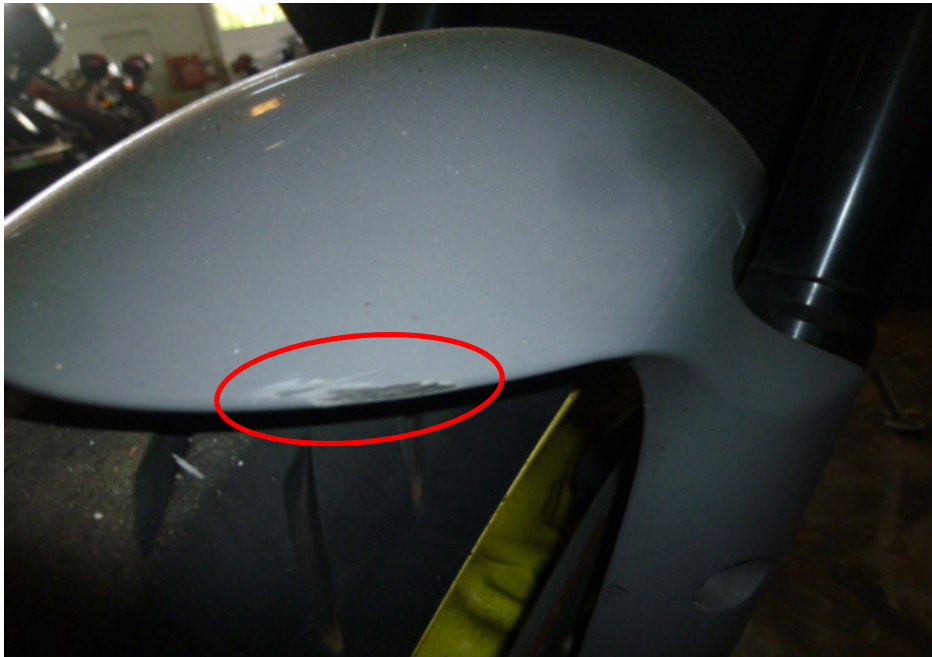
Photo 6 shows a closer view of the front mudguard which was amongst the body parts at the front body of the Motorcycle that had sustained damage as a result of the accident (circled).

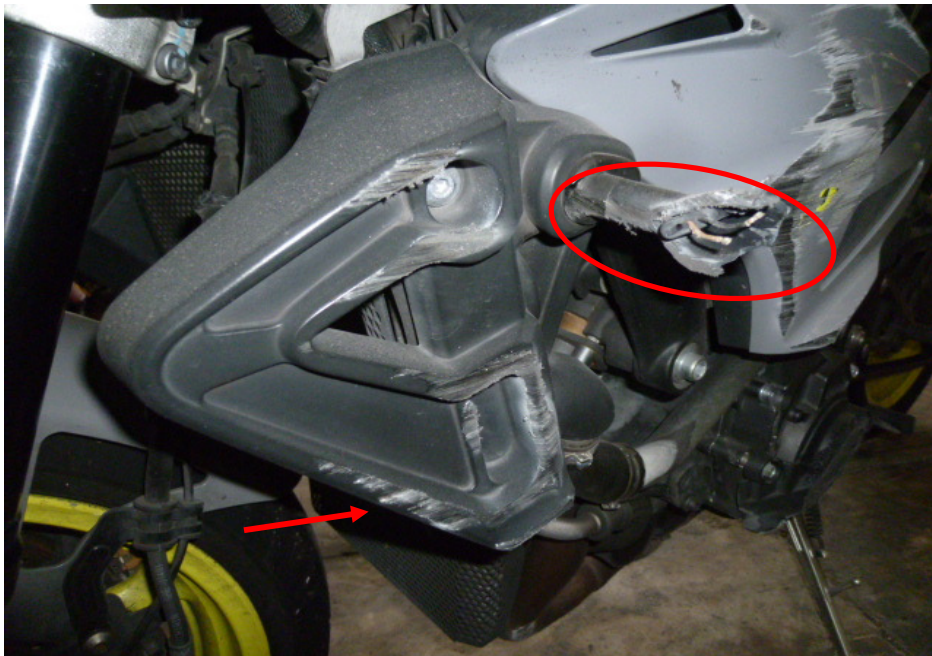
Photo 7 shows a closer view of the broken left front signal lamp (circled) and left radiator cover (arrowed) of the Motorcycle that had sustained damages of grazing nature as a result of the accident.

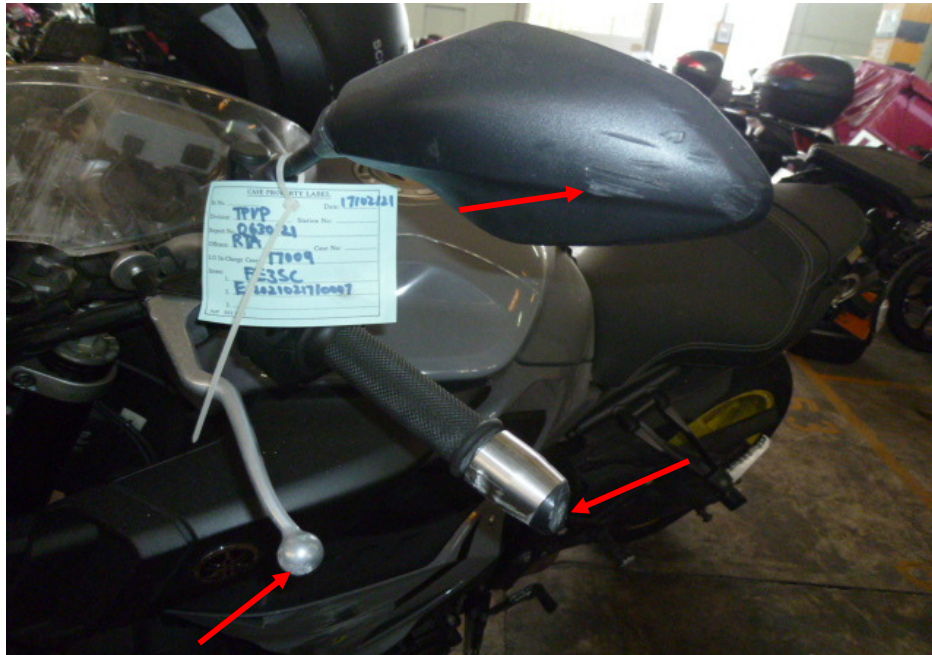
Photo 8 shows a closer view of the left handlebar end, clutch lever and left side mirror (arrowed) which were amongst the body parts of the Motorcycle that had sustained damage as a result of the accident.

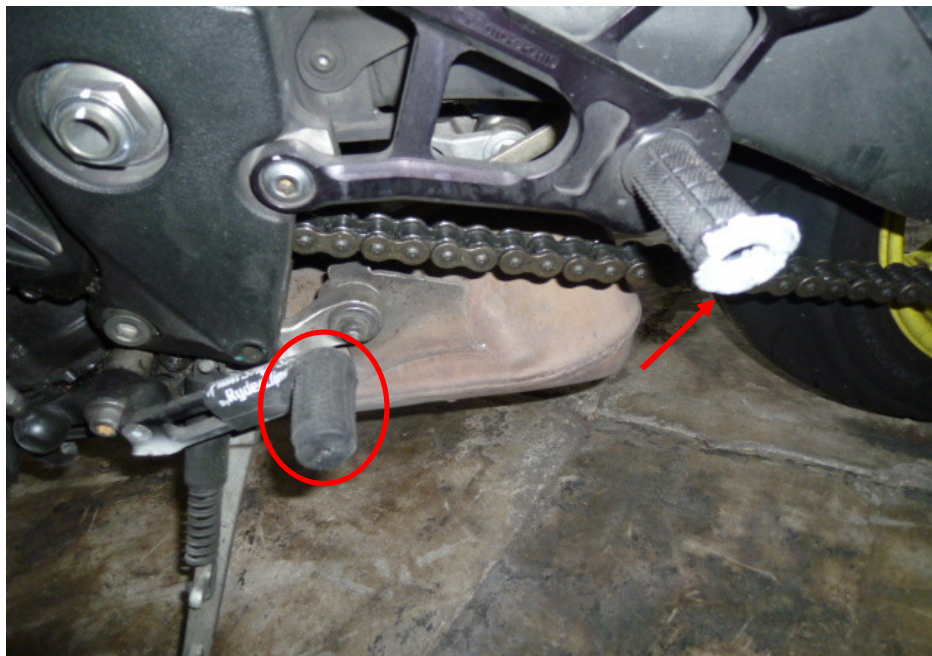
Photo 9 shows a closer view of the gear shift pedal (circled) and left front footrest (arrowed) which were amongst the body parts of the Motorcycle that had sustained damage as a result of the accident.

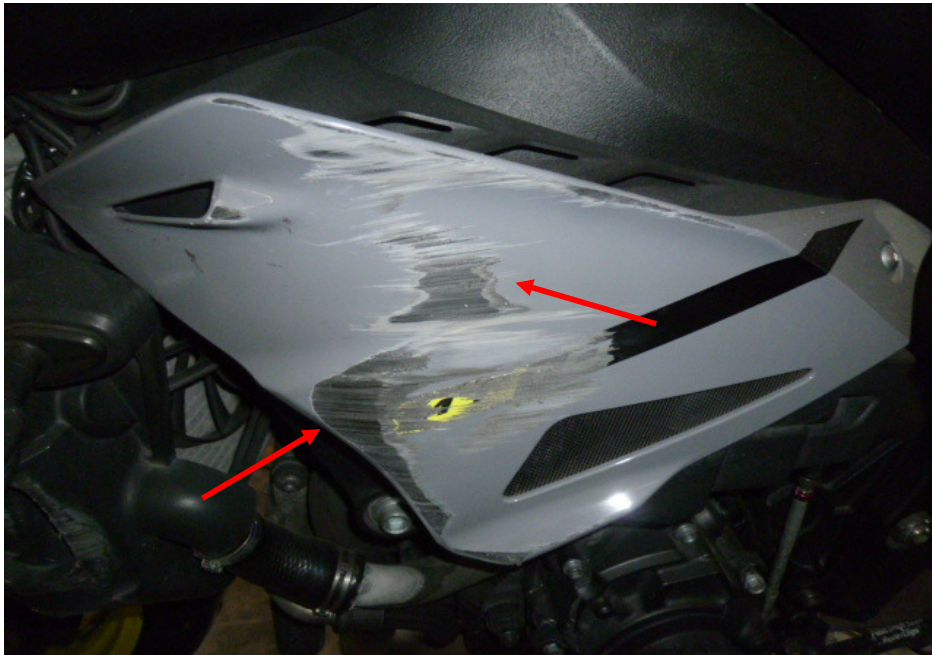
Photo 10 shows a closer view of the left cowling which was amongst the body parts of the Motorcycle that had sustained damages of grazing nature as a result of the accident (arrowed).

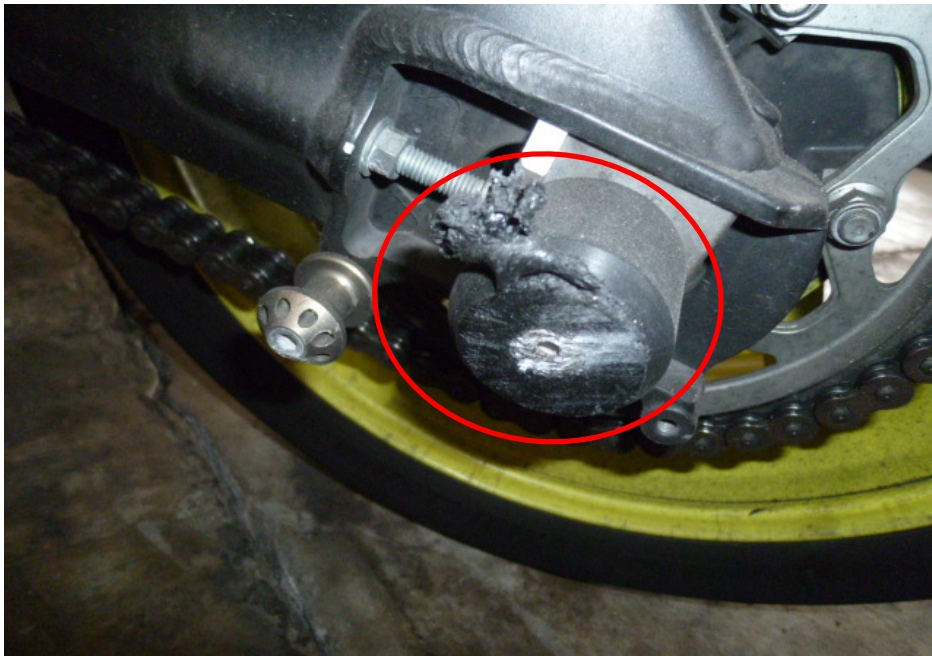
Photo 11 shows a closer view of the left rear axle slider (circled) which was amongst the body parts of the Motorcycle that had sustained damages of grazing nature as a result of the accident.

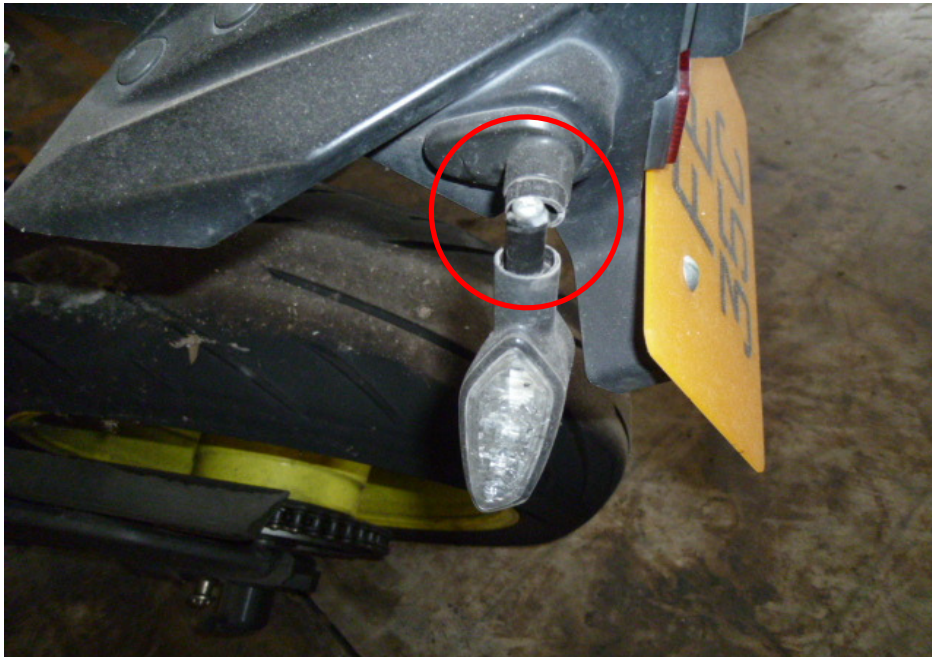
Photo 12 shows a closer view of the dislodged left rear signal lamp of the Motorcycle as a result of the accident (circled).

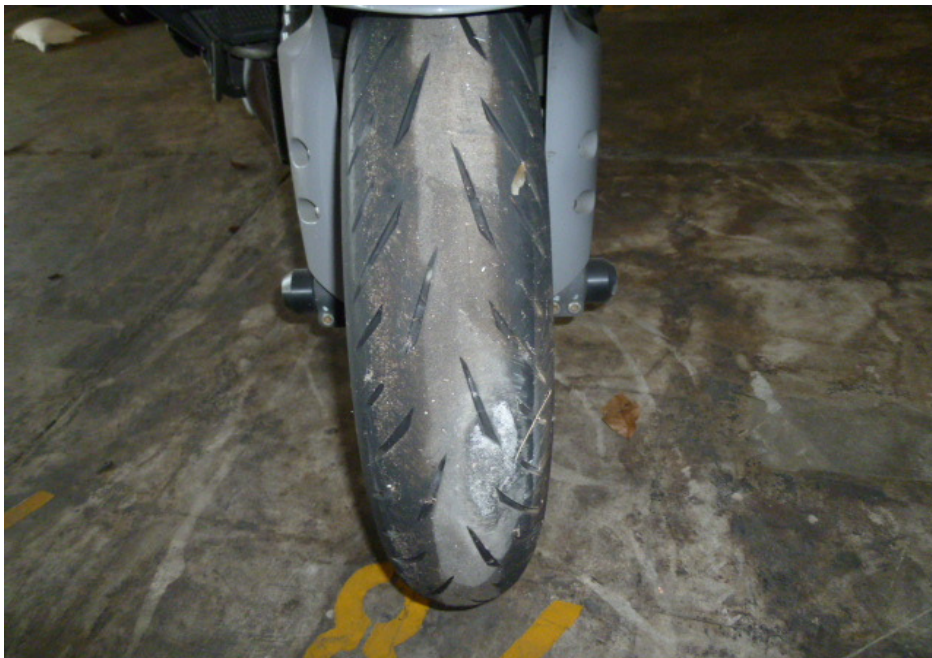
Photo 13 shows the condition of the Motorcycle's front tyre. The front tyre was observed to be in serviceable condition with remaining tread depth of approximately 4mm. There was no tear, burst mark(s) and/or punctured hole(s) on the sidewalls as well as across the tread of the front tyre.

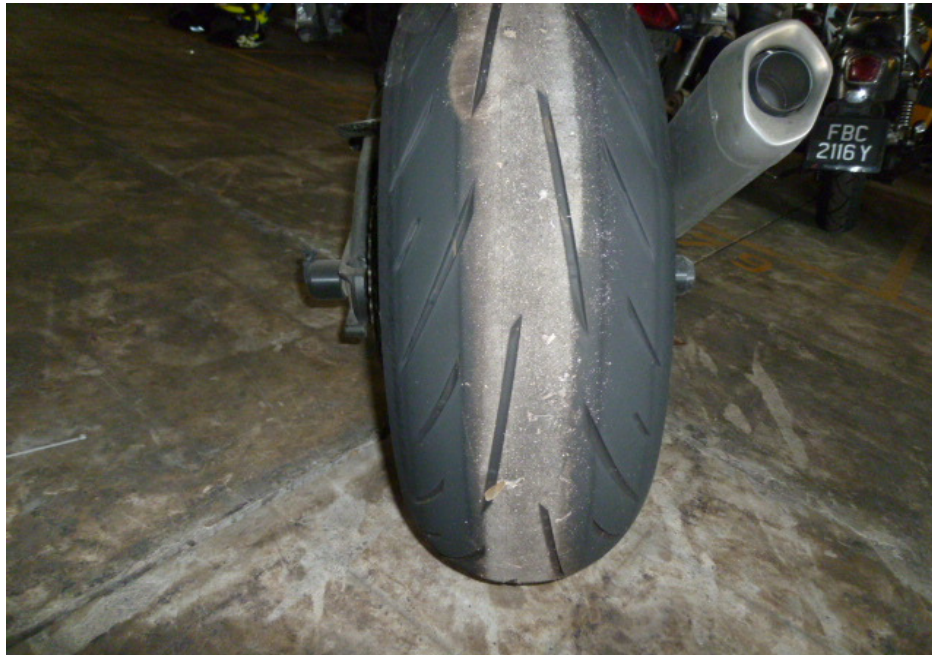
Photo 14 shows the condition of the Motorcycle's rear tyre. The rear tyre was observed to be in serviceable condition with remaining tread depth of approximately 3mm. The tyre was also observed to be sufficiently inflated for vehicular operation. We did not observe any tear, burst mark(s) and/or punctured hole(s) on the sidewalls as well as across the tread of the rear tyre.

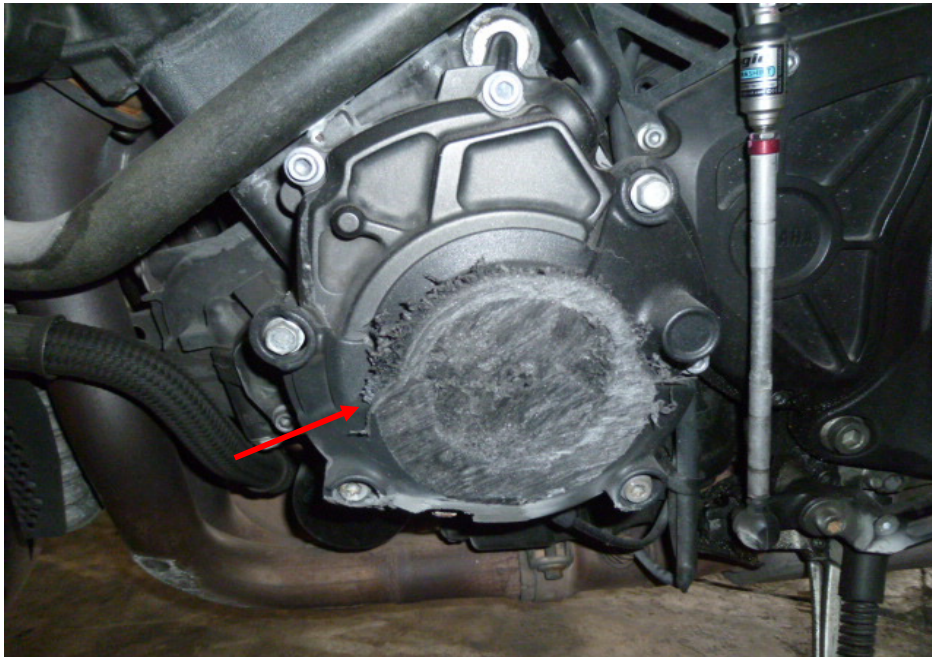
Photo 15 shows the left side of the engine of the Motorcycle at the time of our inspection. The various left engine components had sustained damage of grazing nature as a result of the accident (arrowed) however the engine components were still intact. There was also no fluid leak and/or fluid stain found around the left engine area of the Motorcycle.

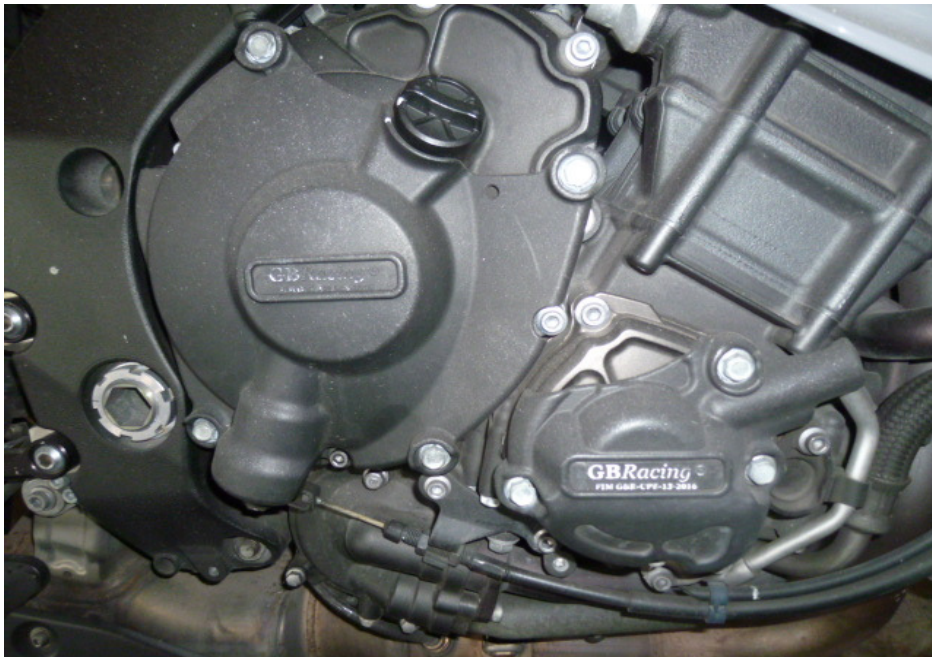
Photo 16 shows the right side of the engine of the Motorcycle at the time of our inspection. The various engine related parts and components were found to be intact with no visible damage. There was also no sign(s) or indication(s) of fluid leak observed around the right engine area of the Motorcycle.

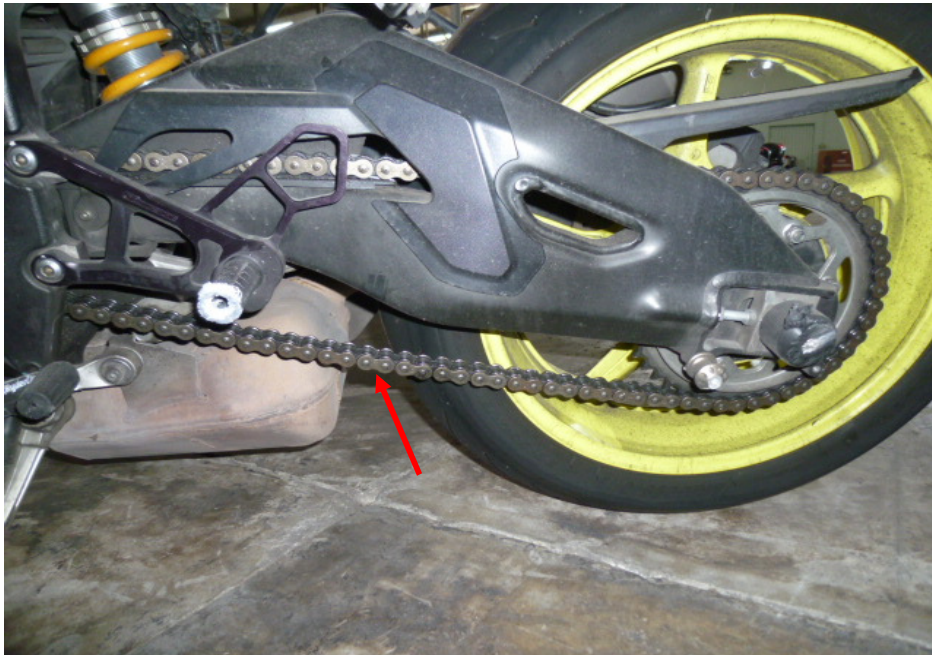
Photo 17 shows the general view of the gear train (arrowed) of the Motorcycle, which was observed to be intact with no misalignment. It was also adequately lubricated for operating purposes.

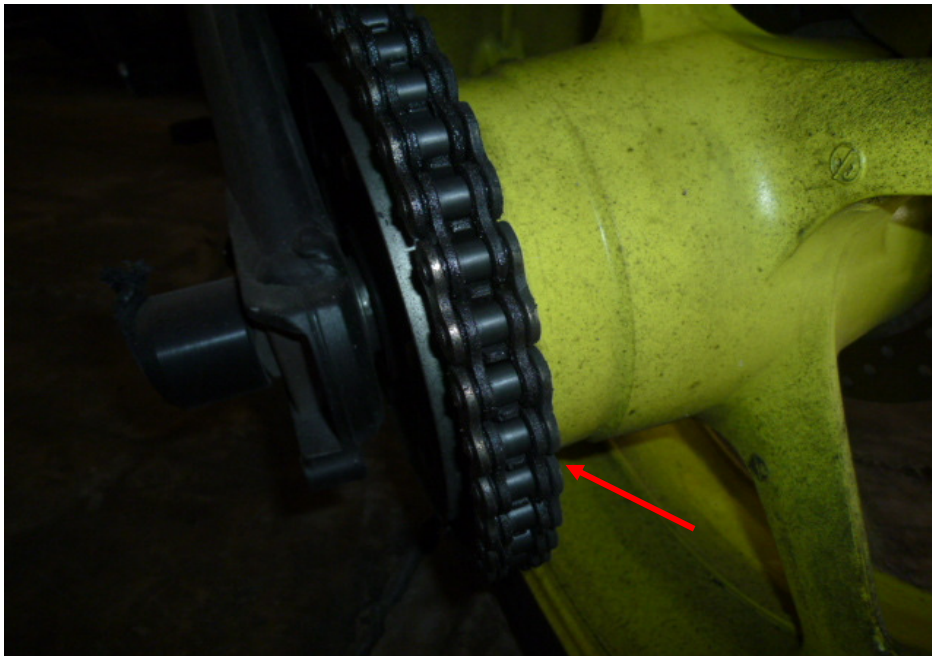
Photo 18 shows a closer view of the gear train (arrowed) of the Motorcycle, which was observed to be intact with no misalignment. It was also adequately lubricated for operating purposes.

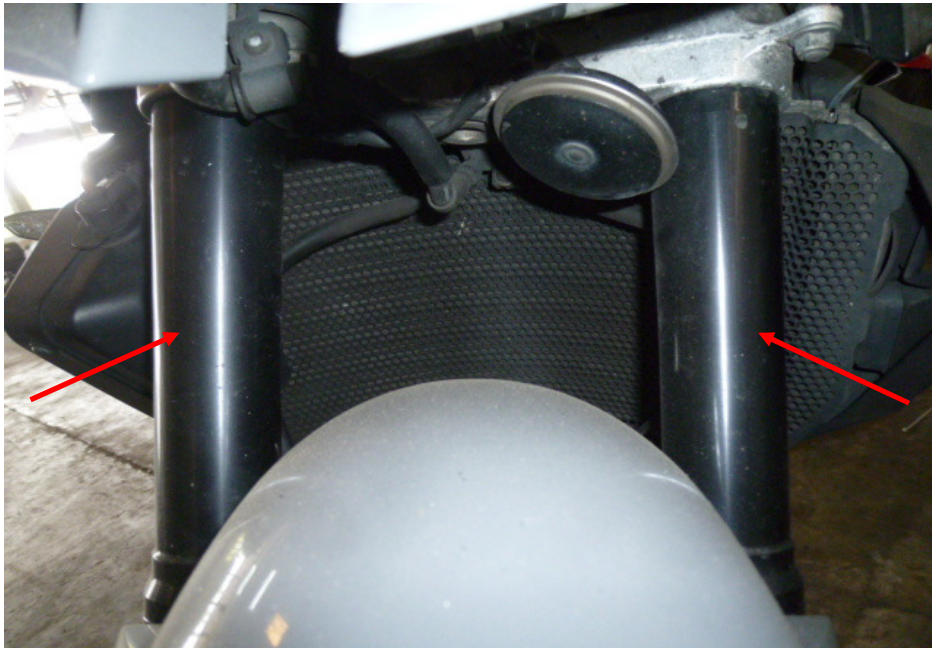
Photo 19 shows the front fork (arrowed) of the Motorcycle. The front fork and fork bracket of the Motorcycle were both found to be intact and undamaged. Turning the Motorcycle's handle bar towards the left and right did not produce any abnormal free play and/or resistance. The steering system of the Motorcycle was in serviceable condition at the time of our inspection.

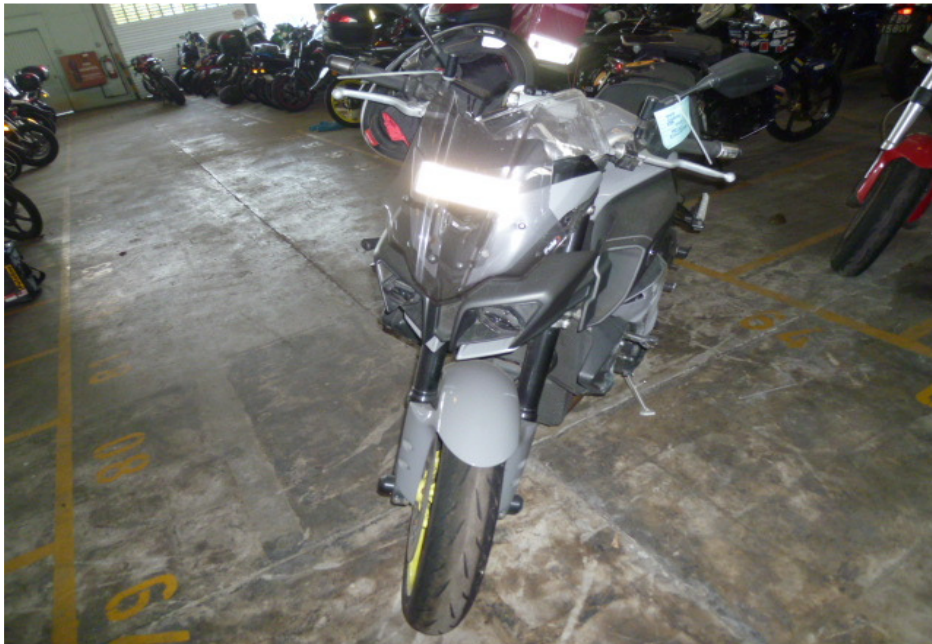
Photo 20 shows the front wheel of the Motorcycle turned towards its full left. Turning the Motorcycle's handle bar towards the left and right did not produce any abnormal free play and/or resistance. This would indicate that the steering system of the Motorcycle was in serviceable condition at the time of our inspection.

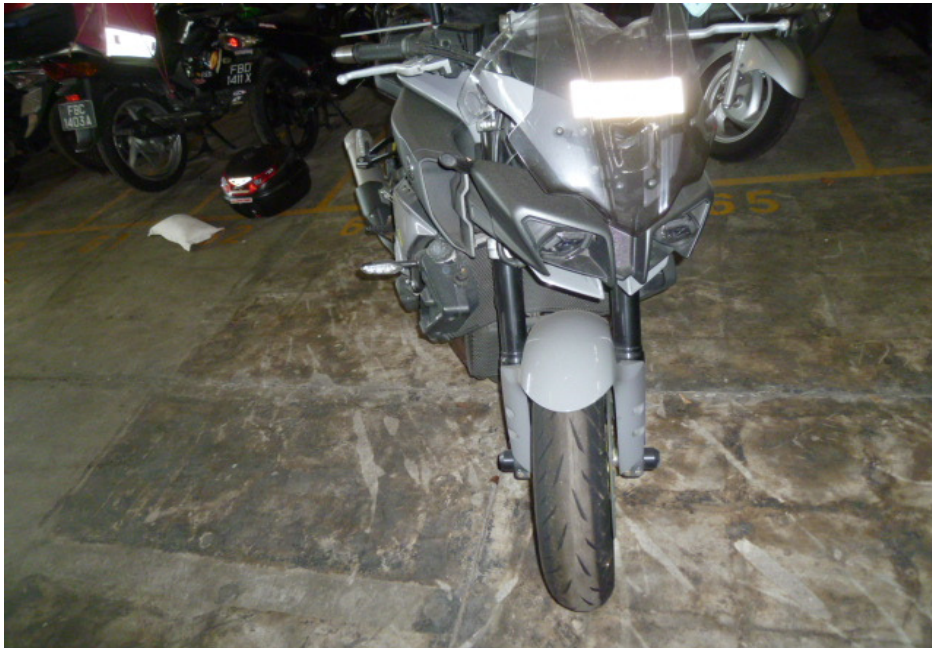
Photo 21 shows the front wheel of the Motorcycle turned towards its full right. Turning the Motorcycle's handle bar towards the left and right did not produce any abnormal free play and/or resistance. This would indicate that the steering system of the Motorcycle was in serviceable condition at the time of our inspection.

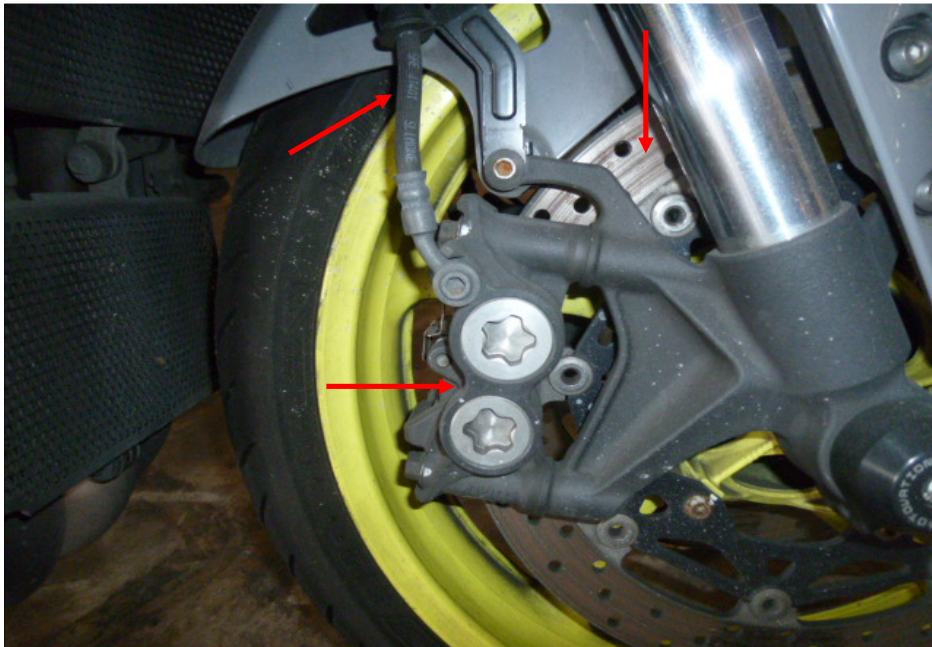
Photo 22 shows a close up view of the front brake caliper, front brake disc and front brake hose (arrowed) at the right side of the Motorcycle's front wheel, which are all part of the components in the hydraulic front brake system of the Motorcycle. Our visual checks of these various components had revealed all to be intact with no visible damage. No leakage of brake fluid was also observed.

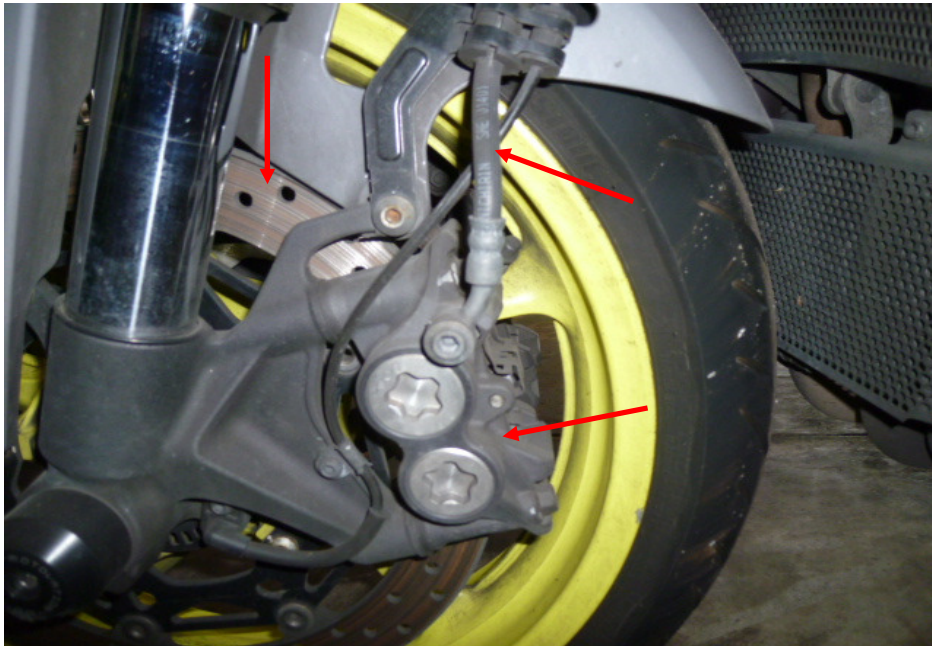
Photo 23 shows a close up view of the front brake caliper, front brake disc and front brake hose (arrowed) at the left side of the Motorcycle's front wheel, which are all part of the components in the hydraulic front brake system of the Motorcycle. Our visual checks of these various components had revealed all to be intact with no visible damage. No leakage of brake fluid was also observed.

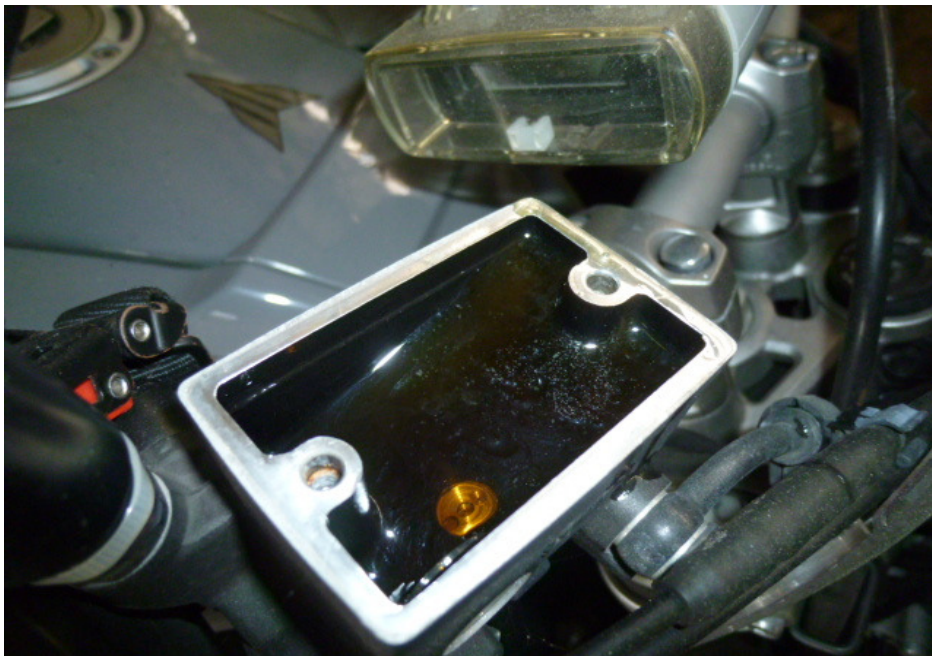
Photo 24 shows the brake fluid reservoir for the front brake of the Motorcycle. The brake fluid was observed to be of sufficient level for operational purposes and without contamination.

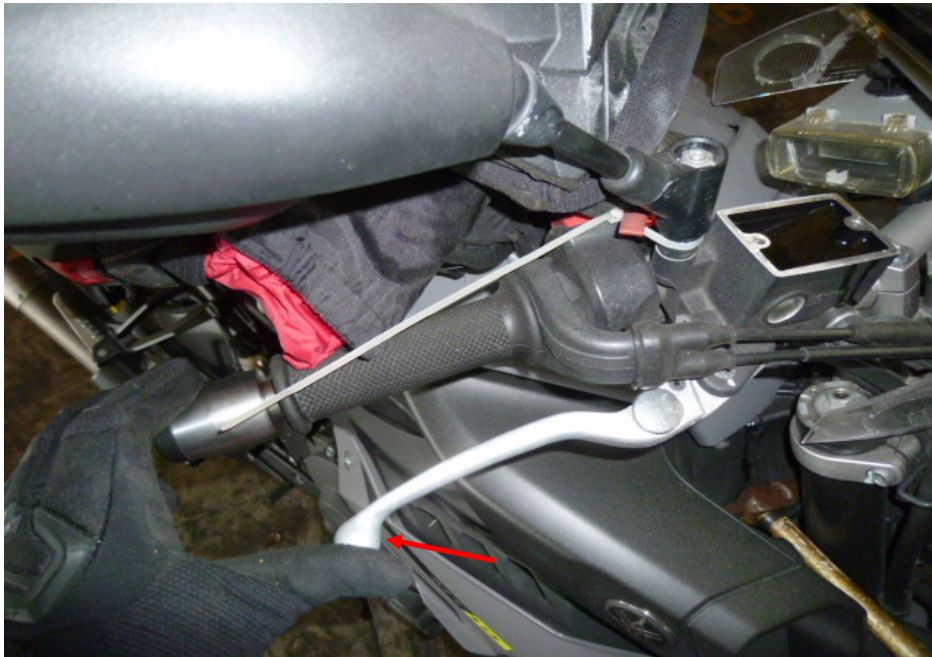
Photo 25 shows the front brake lever being depressed. There was some resistance felt (spongy like feel) upon pressing the front brake lever (arrowed). This would indicate that there is no leakage of pressure/vacuum in the brake system.

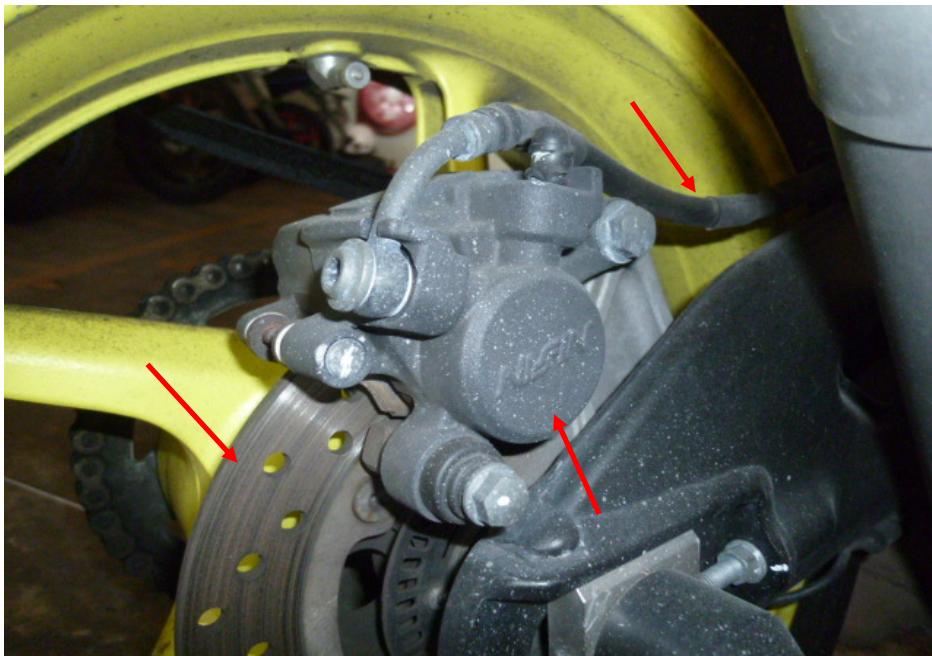
Photo 26 shows a close up view of the rear brake caliper, rear brake disc and rear brake hose (arrowed) of the Motorcycle, which are all part of the components in the hydraulic rear brake system of the Motorcycle. Our visual checks of these various components had revealed all to be intact with no visible damage. No leakage of brake fluid was also observed.
