Memorandum for Billing for Accident Recoveries

JOB MEASUREMENT SHEET

TR302N/C62.005.000/YR3/BRMSL-00282/Q1169

Sembawang Road

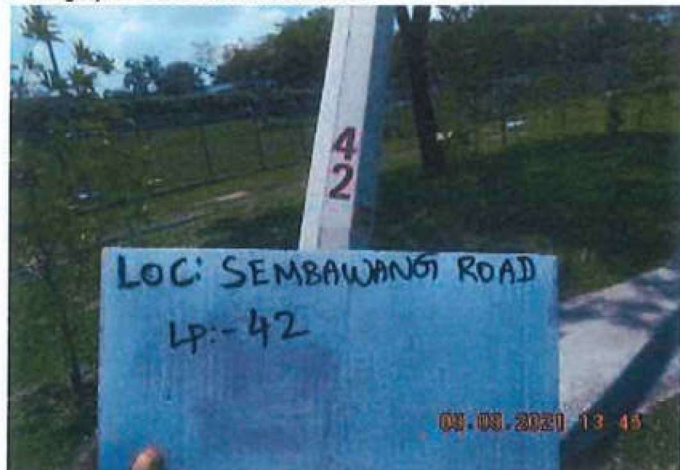
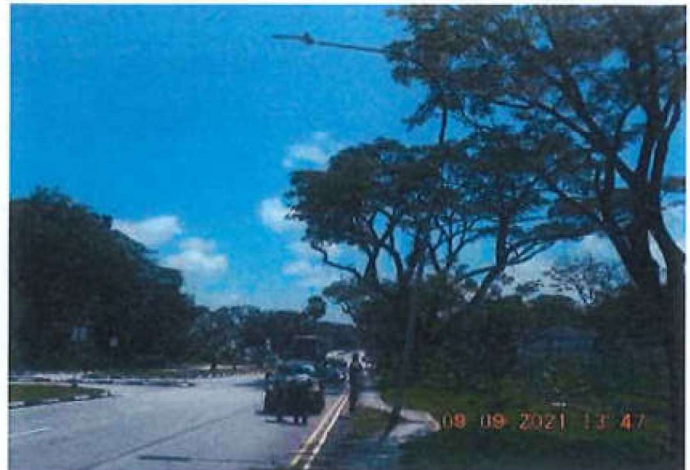
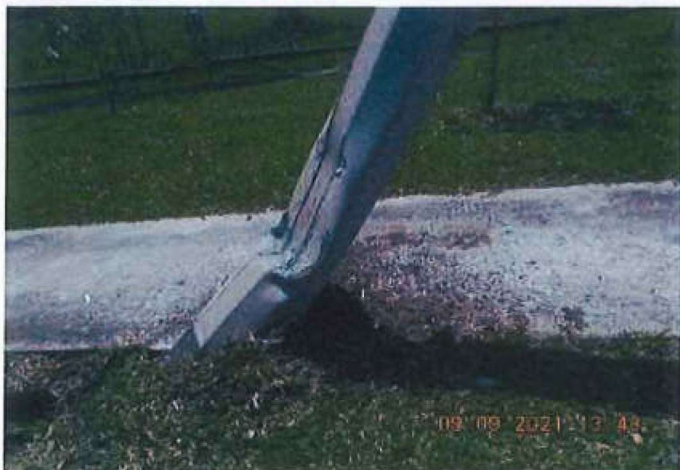
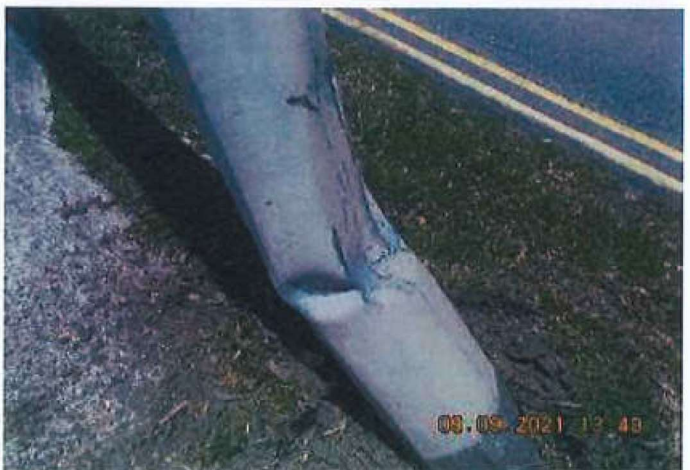
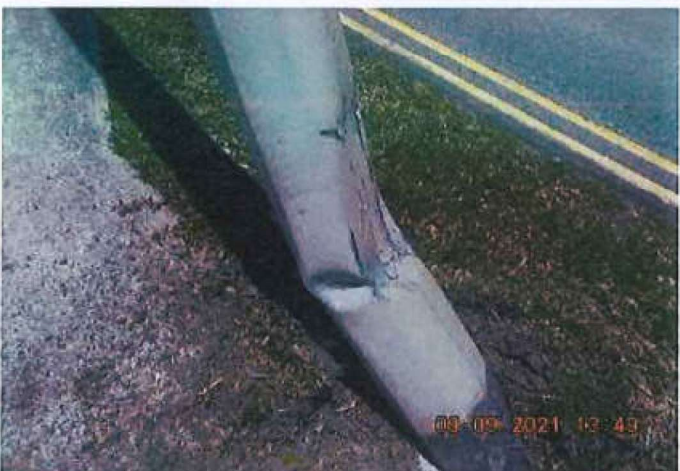
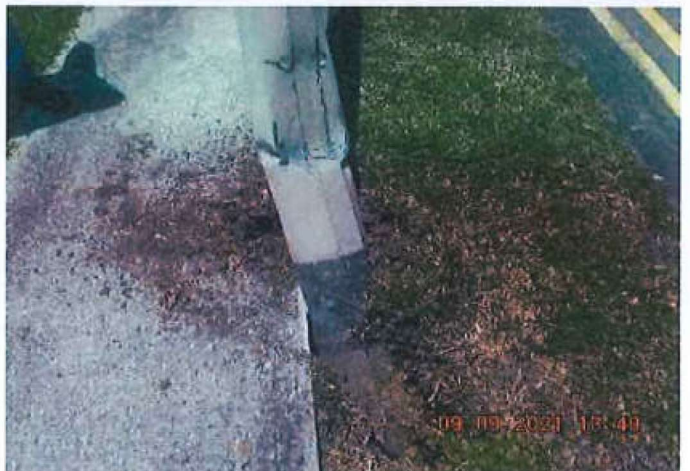
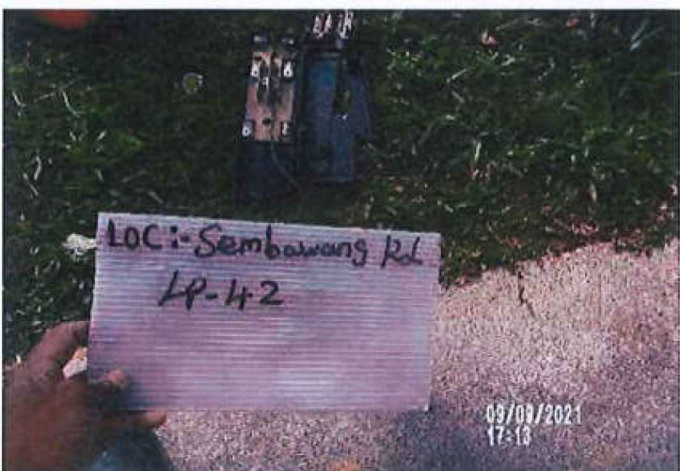
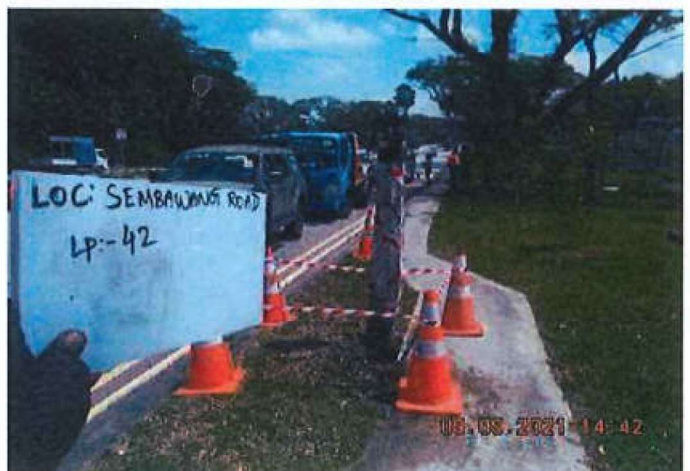
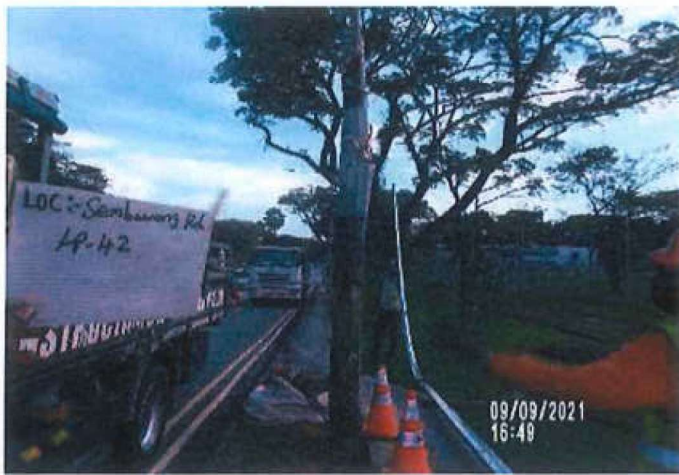
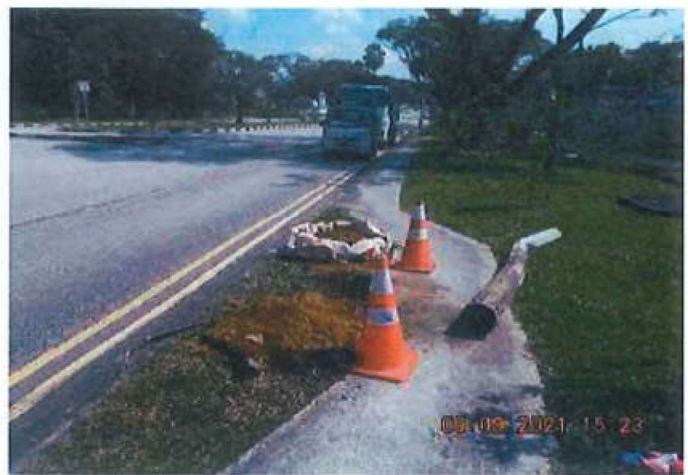
LP ID: LP 42 (ACCIDENT)

Action Taken / Recommendation: Checked and found lamp pole slanted, damaged due to accident caused by vehicle no: 34373MID at Lp42 along Sembawang Road. Temporary torched and removed damaged pole top portion at Lp42. (Replacement of 10m pole and 3m arm at Sembawang Road, Lp42 completed.)

Photographs Before Installation Work

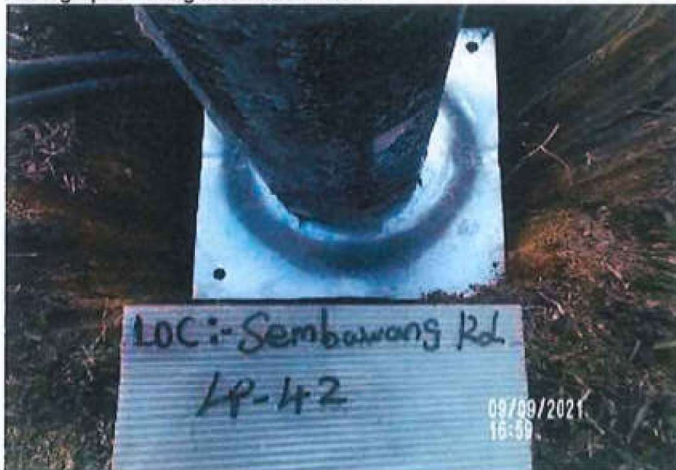
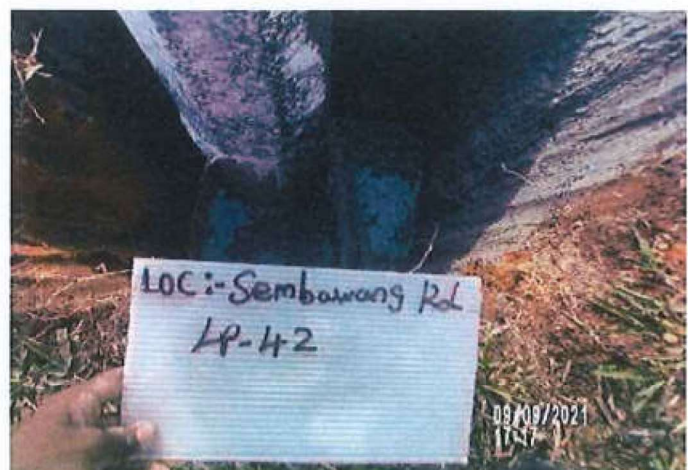
LP ID: LP 42 (ACCIDENT)

Photographs During Installation Work

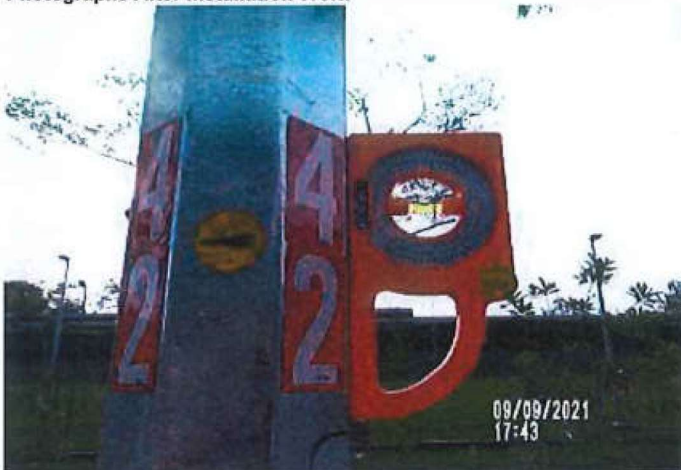
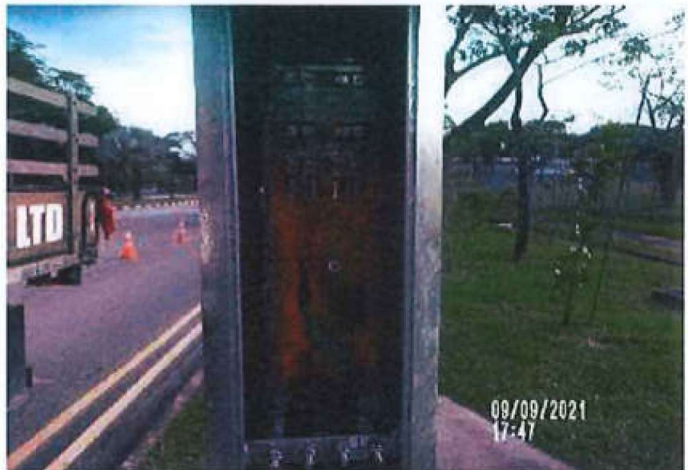
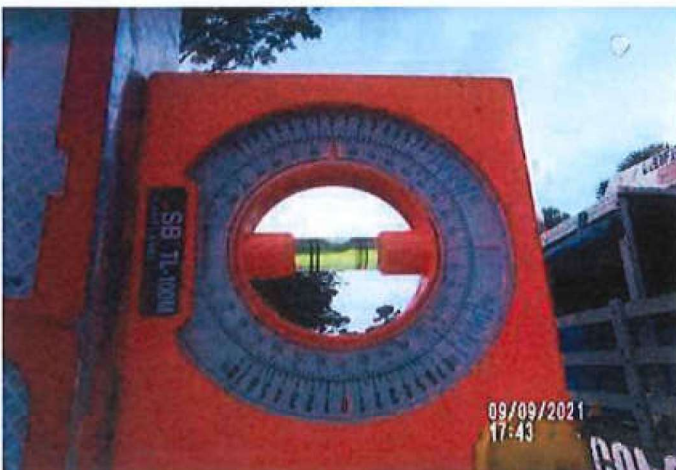
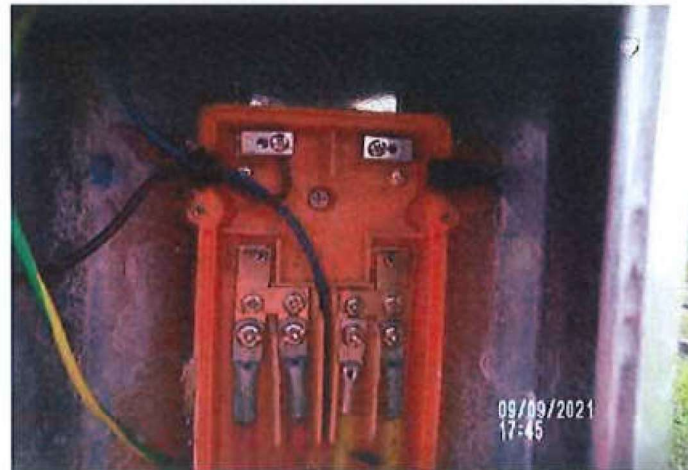
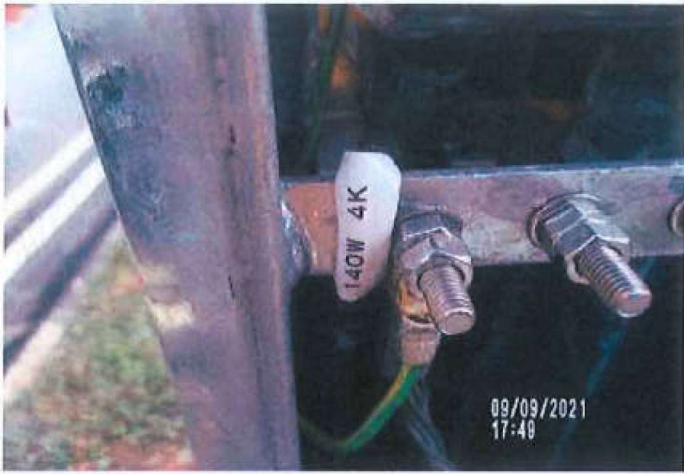
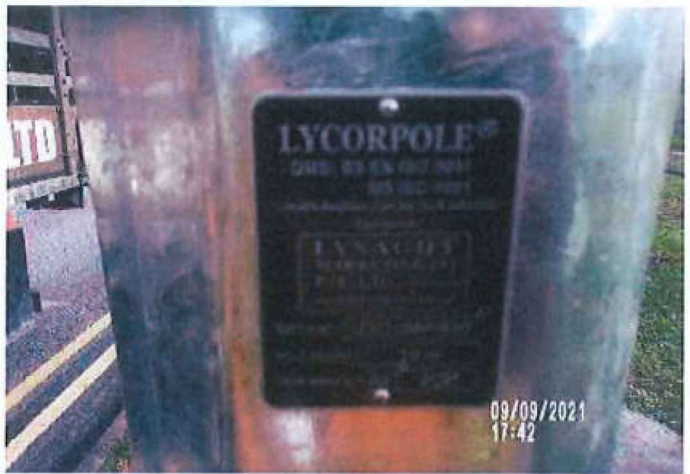
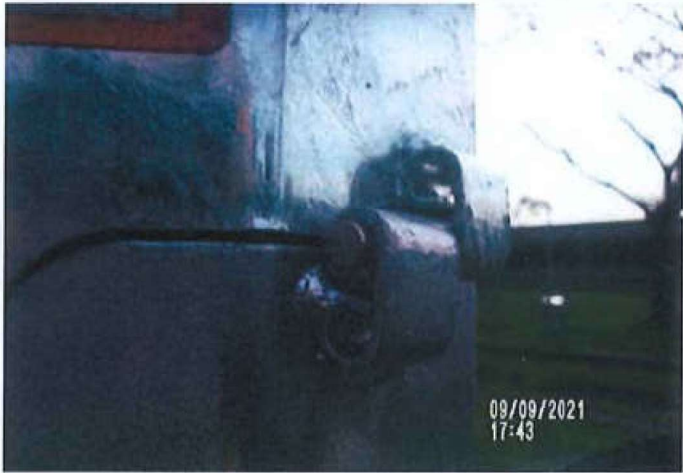
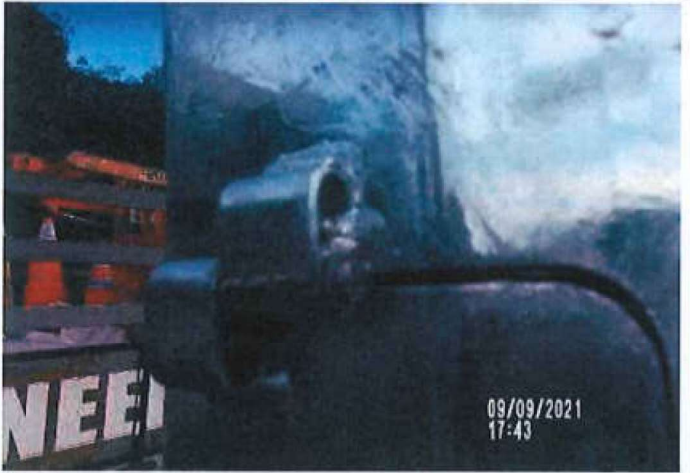
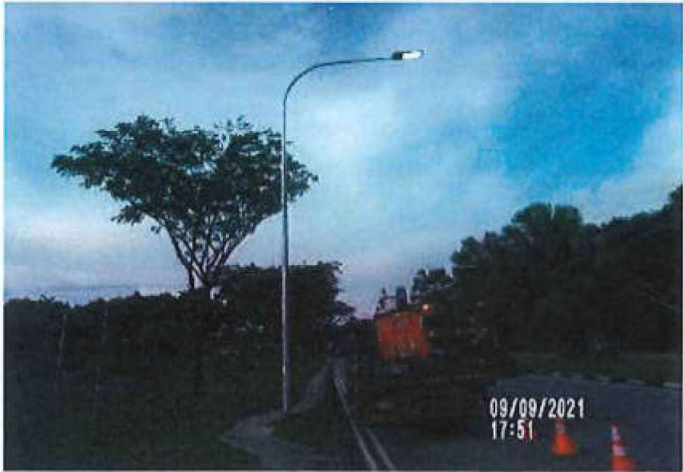
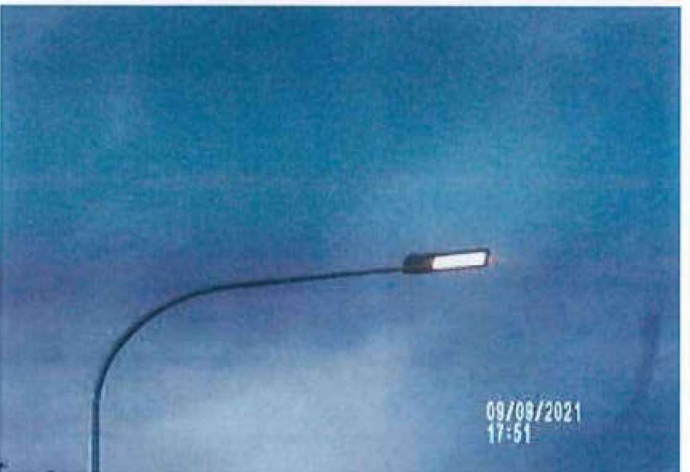
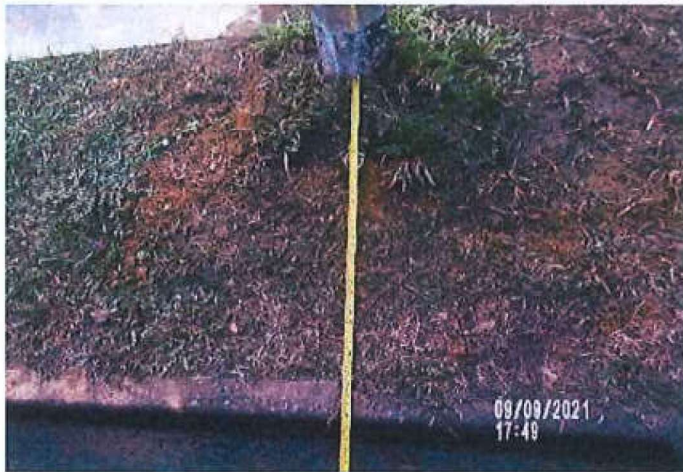
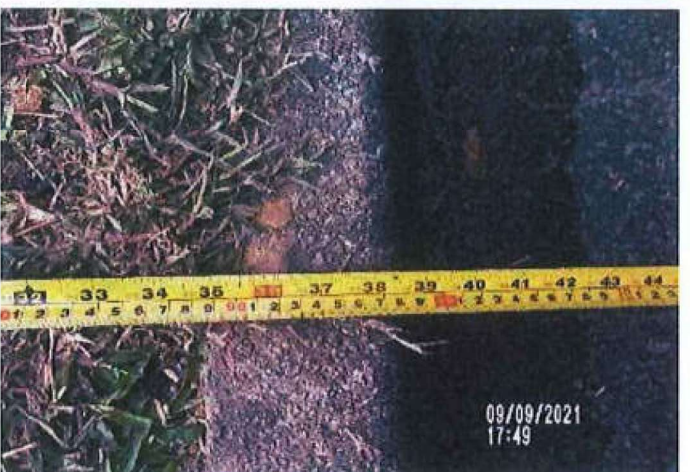
Photographs After Installation Work
