PROPERTY & PERSONAL INJURY CLAIM – CLAIMANT'S NAME: RAZALI BIN RAHMAT
ACCIDENT INVOLVING FBK 6276A ON 26 NOVEMBER 2021 AT ABOUT 1955 HOURS ALONG BUKIT
TIMAH ROAD (IN FRONT OF MAPLE WOOD CONDOMINIUM)

REPORT OF A TRAFFIC ACCIDENT

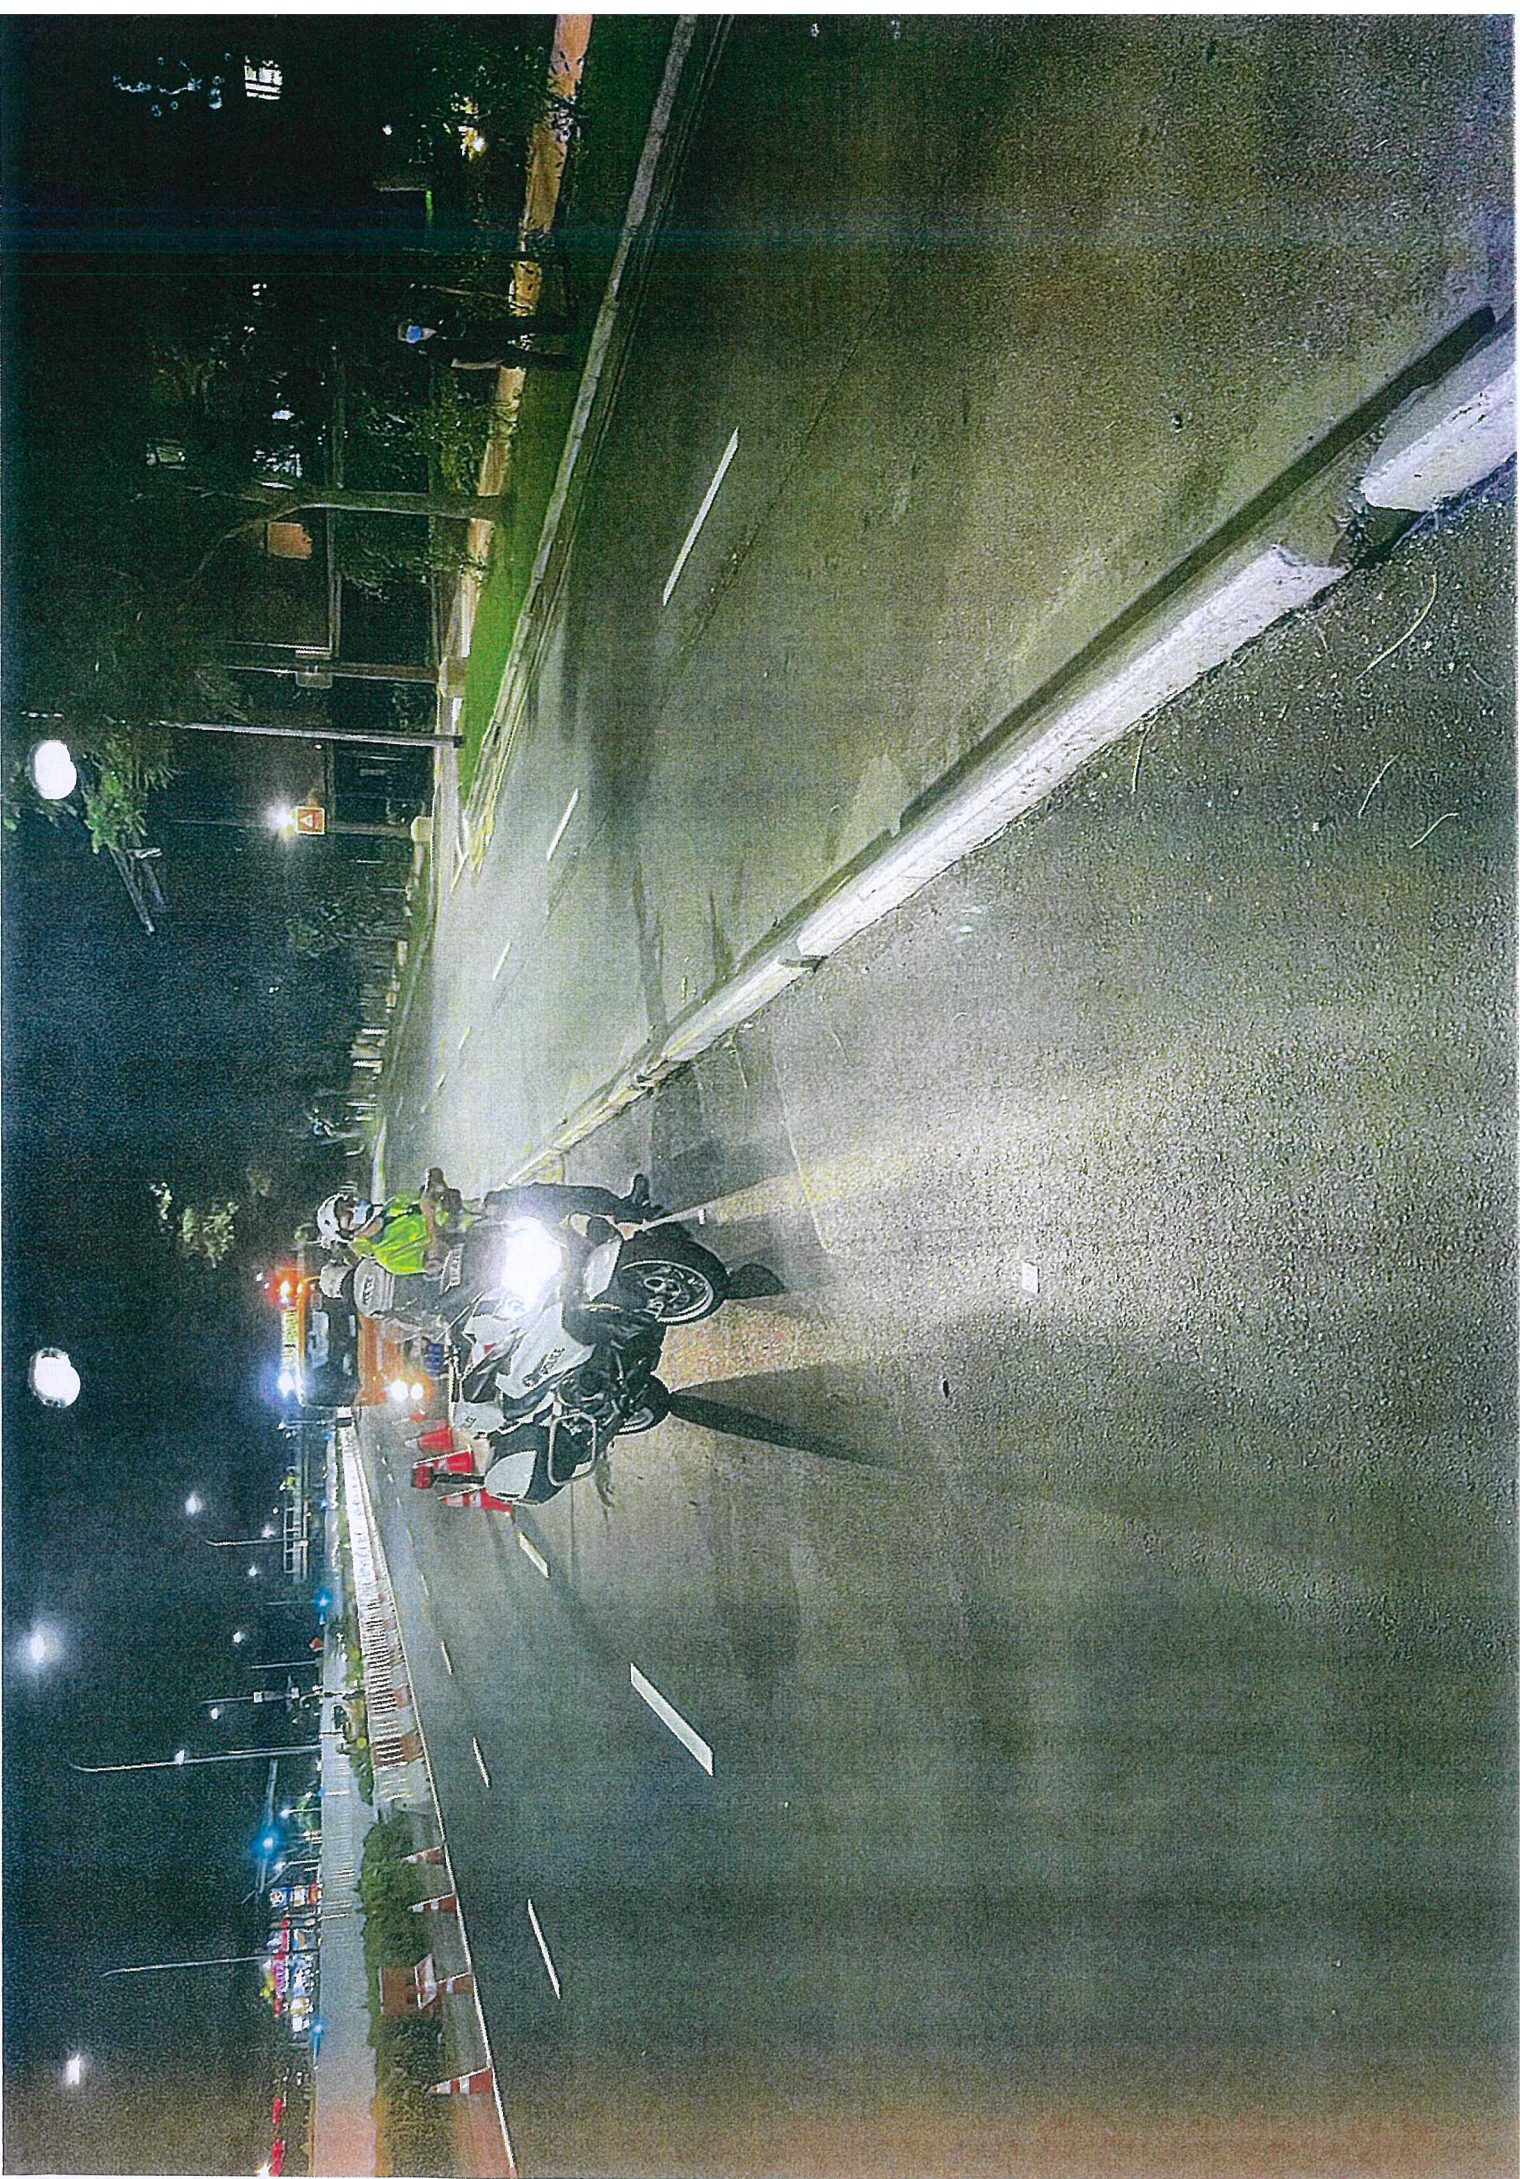
3. There was short and narrow concrete kerb that had been laid between the 3rd and 4th lanes ("the kerb") that had caused our client's motorcycle to be flung off. A photograph taken on the date of the accident at the accident location shows the kerb clearly. The said kerb appeared to have been recently installed and there were no warning signs or cones placed to alert motorists of its presence.
