Your Ref: TP/IP/12238/2022
Our Ref : CI/TPD22005078/P

10th June 2022

MECHANICAL INSPECTION REPORT OF GARBAGE TRUCK, XE 6383U

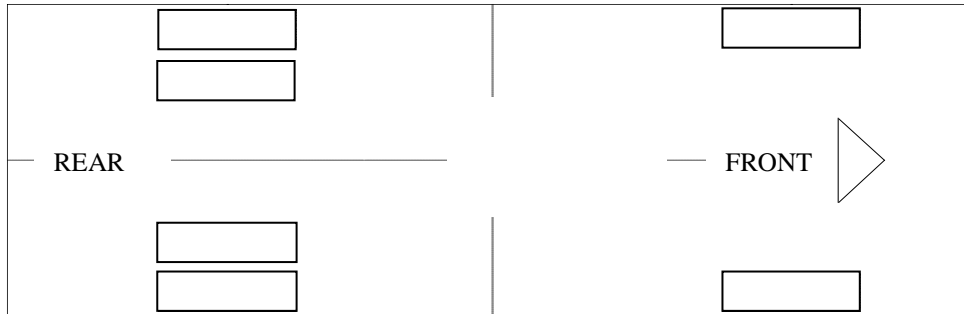
6. The 2 front tyres and 4 rear tyres of the Garbage Truck were observed to be in serviceable condition and sufficiently inflated for vehicular operation. I did not find any tear, cut or burst mark(s) on the outer and the inner sidewalls as well as across the tread of the 6 tyres of the Garbage Truck. The tyre brand, tyre size and remaining tread depth of the 6 tyres of the Garbage Truck were recorded as follows:-

Garbage Truck

Goodyear 295/80R22.5 (12.8mm)

Firenza 295/80R22.5 (10.5mm)

Goodyear 295/80R22.5 (9.4mm)

Firenza 295/80R22.5 (9.8mm)

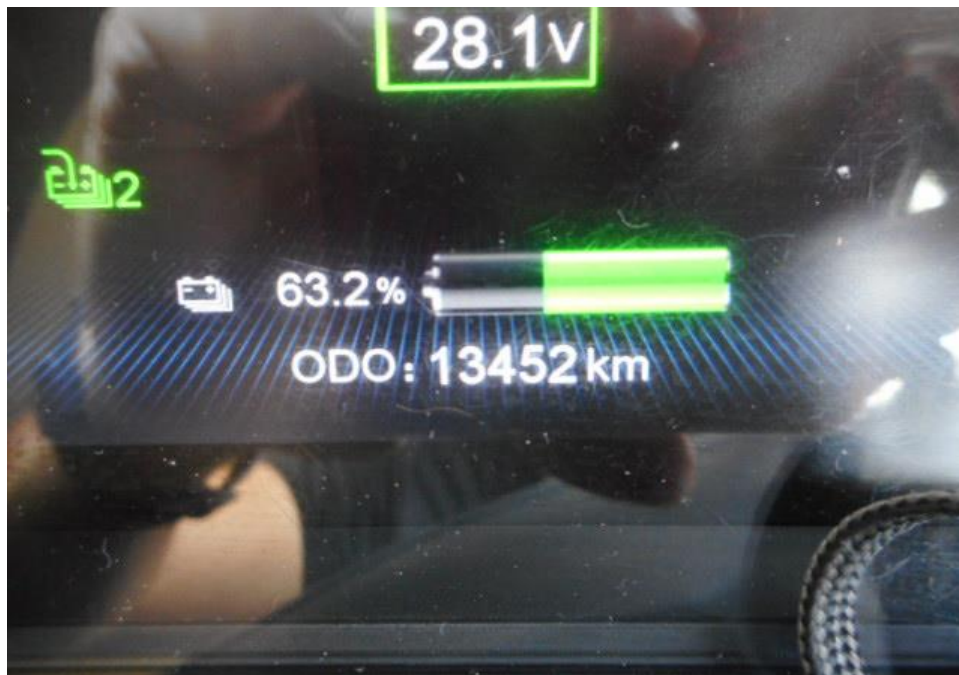
Photo 1 shows a general view of the instrument cluster of the Garbage Truck at the time of my inspection. The mileage of the Garbage Truck was 13,452km

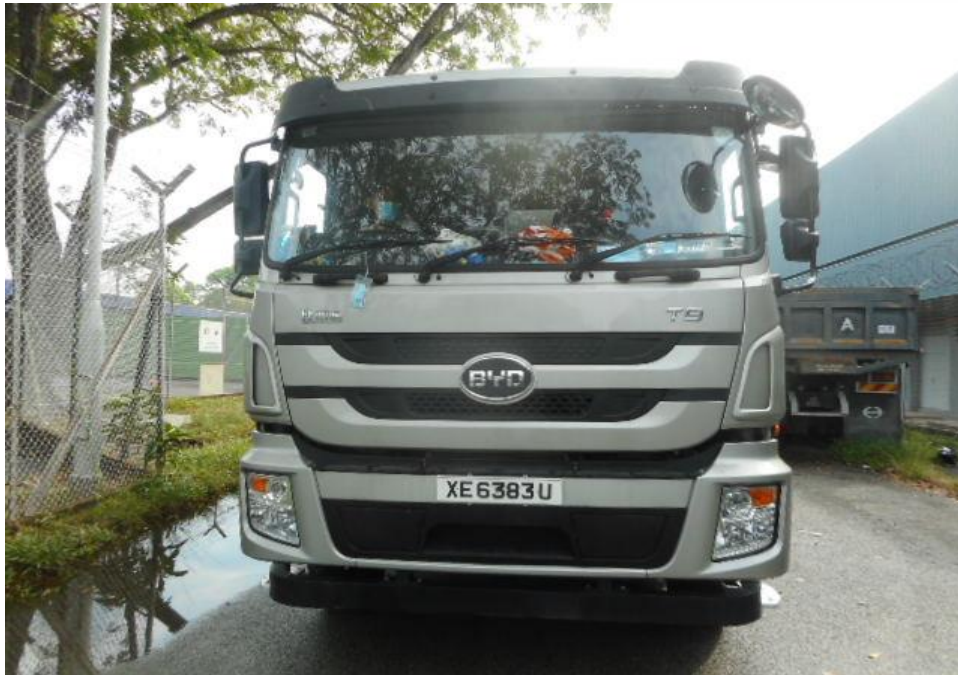
4. The mileage of the Garbage Truck at the time of my inspection was 13,452km.
5. The Garbage Truck was observed to have sustained damage at its front portion. Its front bumper was amongst the body part that were damaged as a result of the accident.

Photo 2 shows a general view of the front body of the Garbage Truck at the time of my inspection. The front portion of the Garbage Truck was observed to sustained damage at the time of inspection. Its front bumper was amongst the body parts that were damaged as a result of the accident.

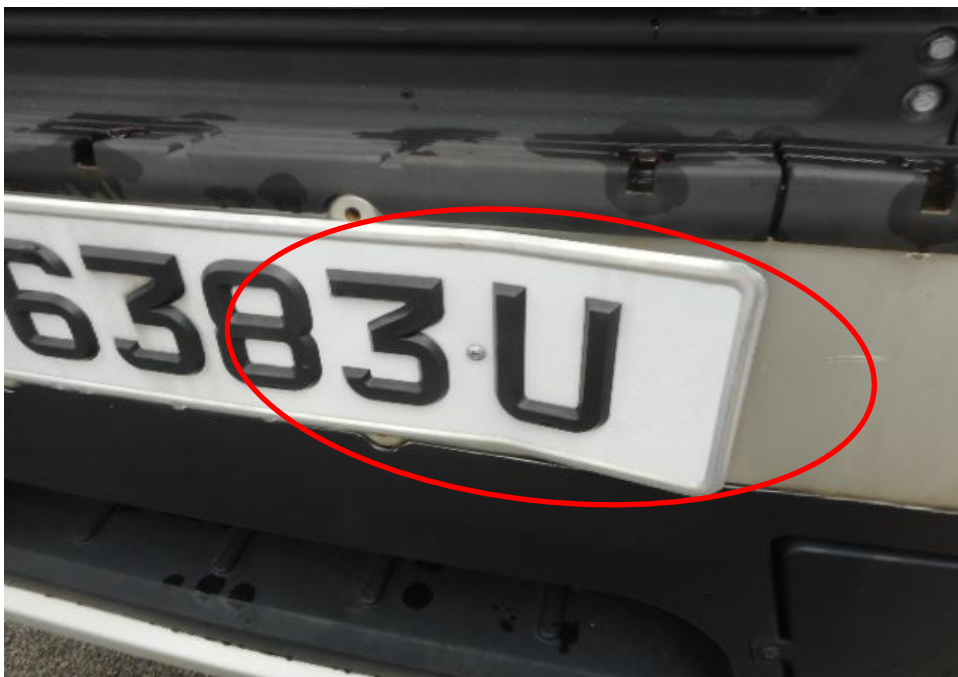
Photo 3 shows a close up view of the right body of the Garbage Truck at the time of my inspection. The front portion of the Garbage Truck was observed to sustained damage at the time of inspection. Its front number plate (circled) was amongst the body parts that were damaged as a result of the accident.

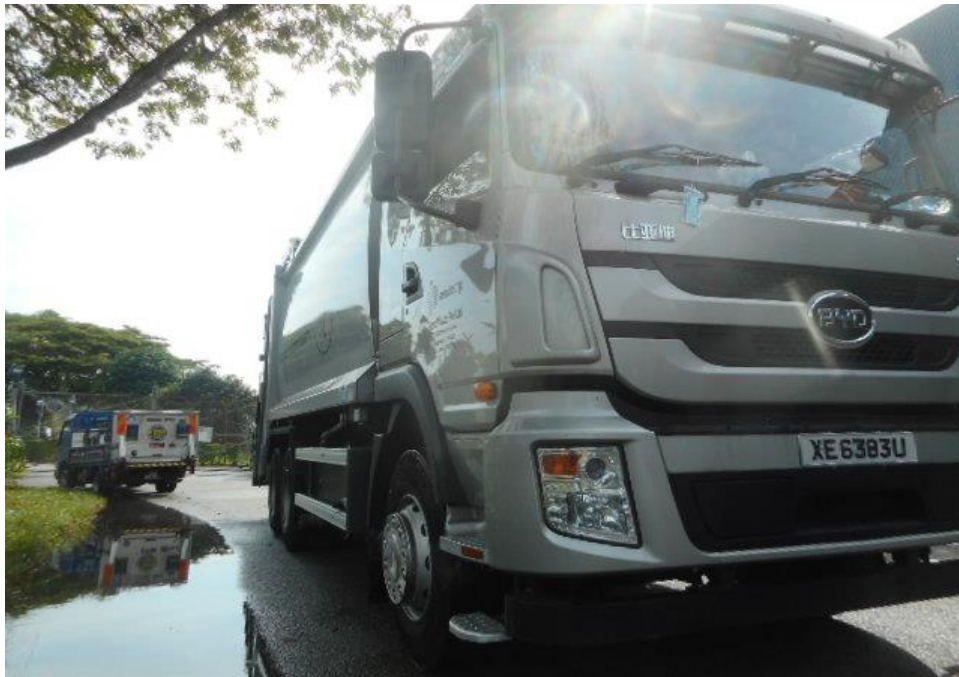
Photo 4 shows a general view of the right body of the Garbage Truck at the time of my inspection. The right portion of the Garbage Truck was observed to be intact and unaffected by the accident.

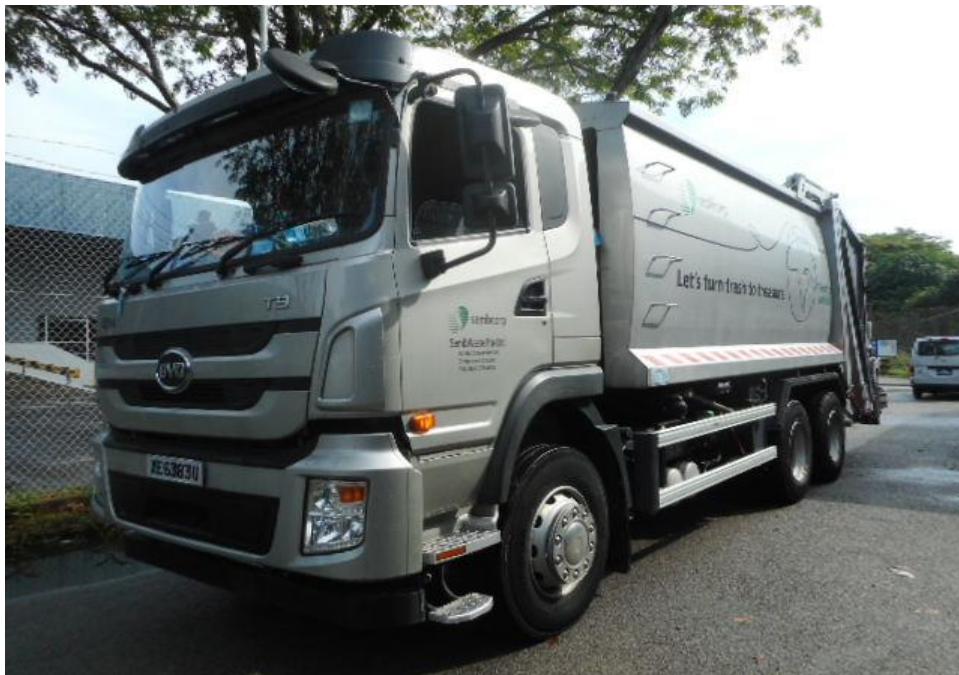
Photo 5 shows a general view of the left body of the Garbage Truck at the time of my inspection. The left portion of the Garbage Truck was observed to be intact and unaffected by the accident.

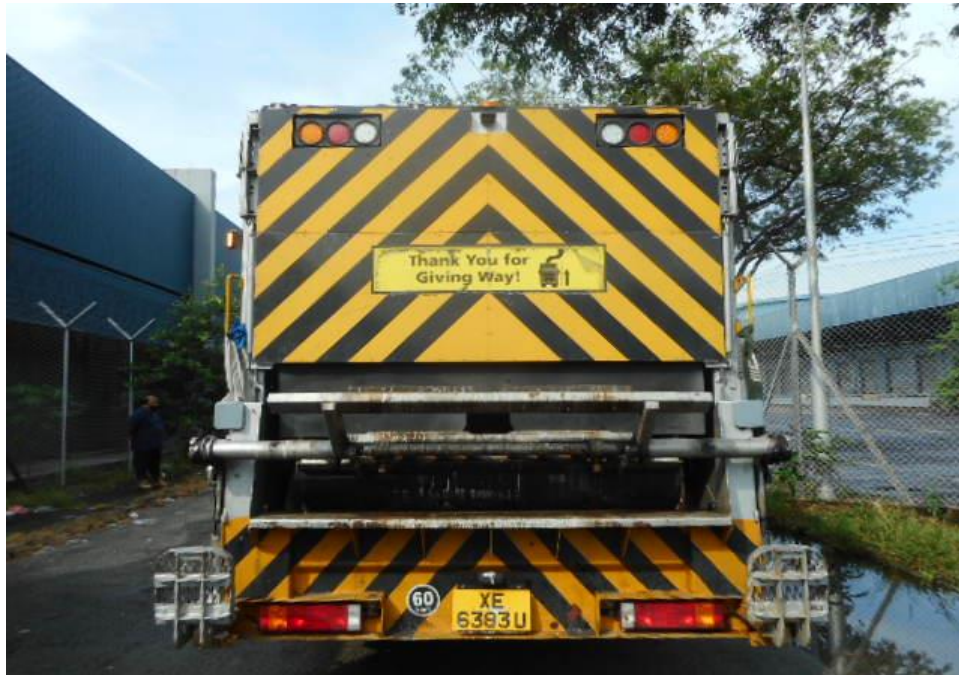
Photo 6 shows a general view of the Garbage Truck's rear body at the time of my inspection. The rear of the Garbage Truck was observed to be intact and unaffected by the accident.

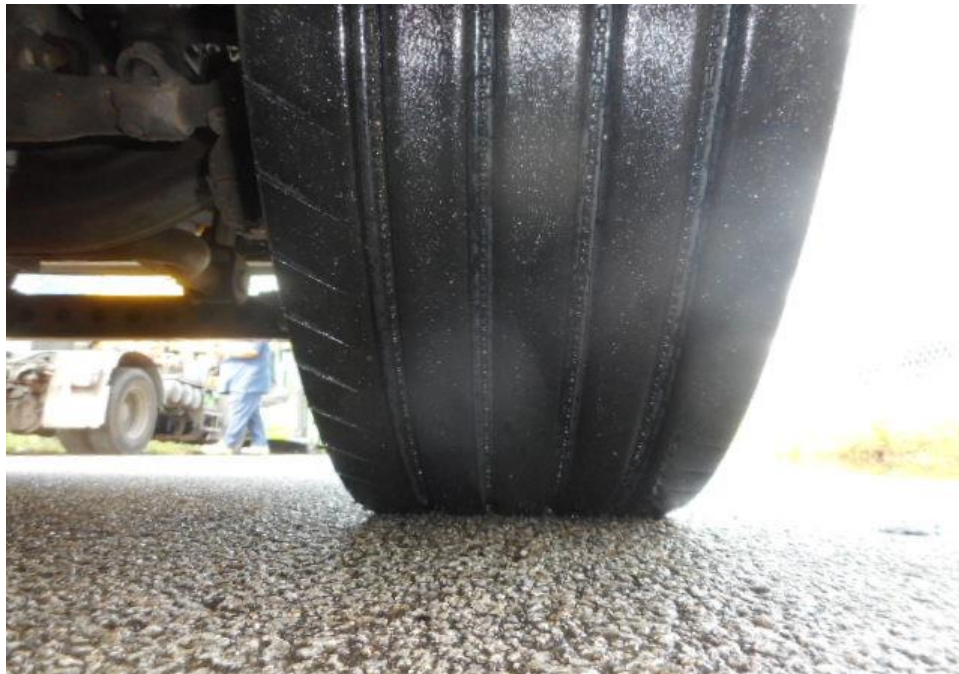
Photo 7 shows the condition of the front right tyre of the Garbage Truck, which was observed to be in serviceable condition with remaining tread depth of approximately 9.8mm. The tyre, which was wrapped around standard steel wheel rim, was also observed to be sufficiently inflated for vehicular operation. There was no tear, cut or burst mark(s) on the outer and the inner sidewalls as well as across the tread of the 6 tyres that were fitted on the Garbage Truck.

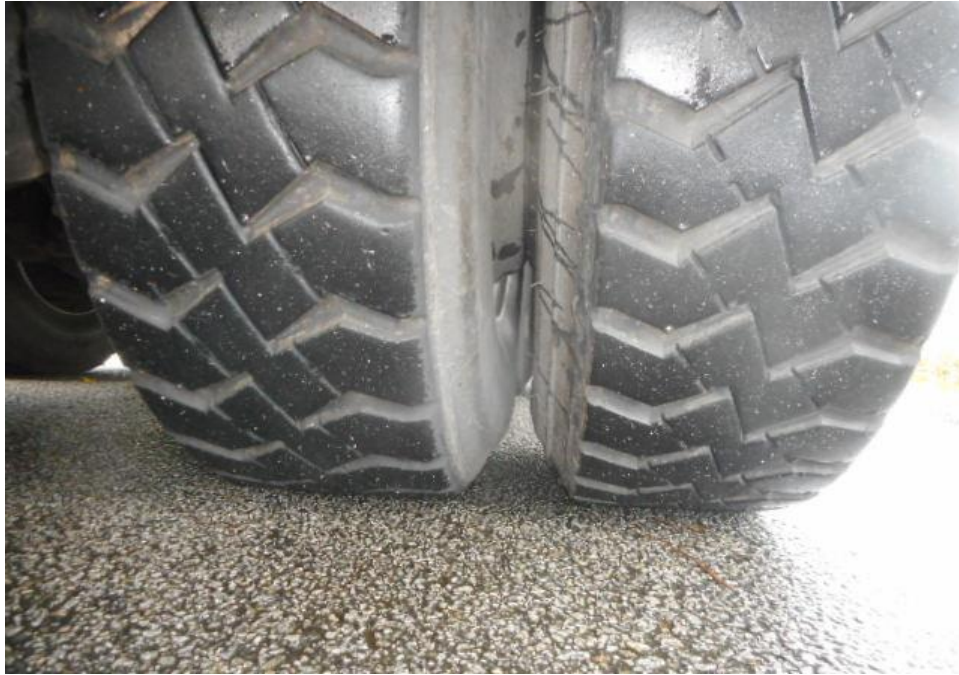
Photo 8 shows the condition of the rear right tyre of the Garbage Truck, which was observed to be in serviceable condition with remaining tread depth of approximately 9.4mm. The tyre, which was wrapped around standard steel wheel rim, was also observed to be sufficiently inflated for vehicular operation.

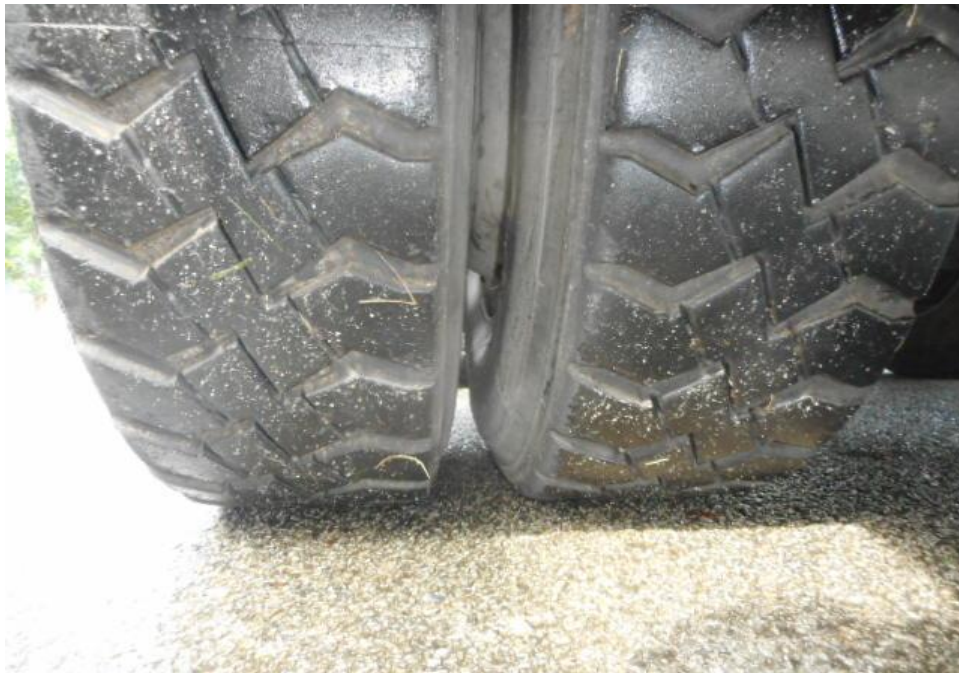
Photo 9 shows the condition of the rear left tyres of the Garbage Truck, which was observed to be in serviceable condition with remaining tread depth of approximately 12.8mm. The tyres, which were wrapped around standard steel wheel rim, were also observed to be sufficiently inflated for vehicular operation. There was also no damage found on all 6 steel wheel rims of the Garbage Truck.

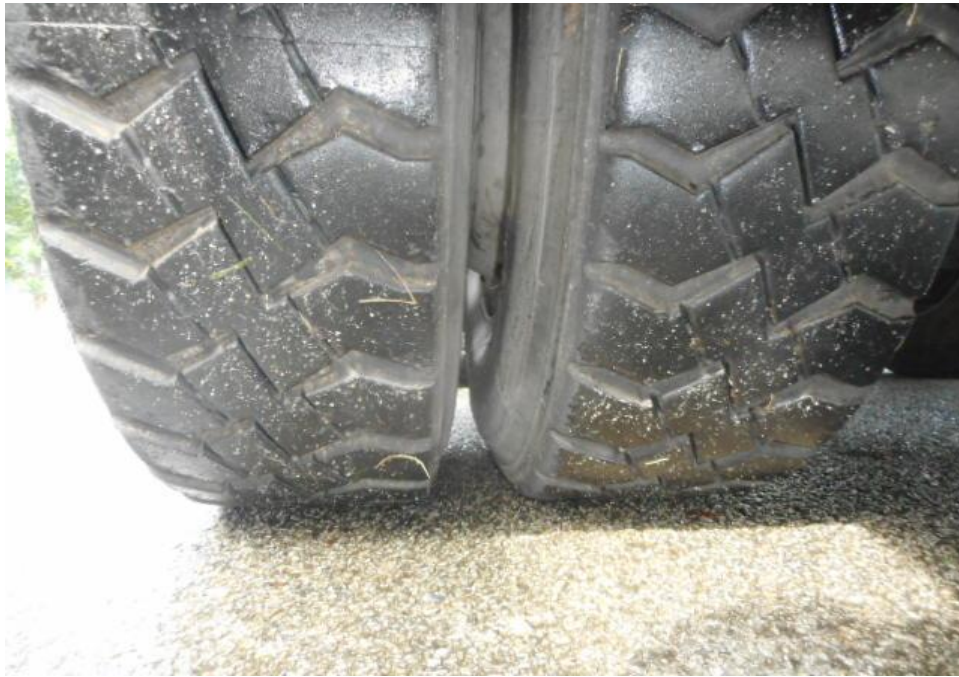
Photo 10 shows the condition of the front left tyres of the Garbage Truck, which were observed to be in serviceable condition with remaining tread depth of approximately 10.5mm. There was also no tear, cut or burst mark(s) on the outer and the inner sidewalls as well as across the tread of the 6 tyres that were fitted on the Garbage Truck.

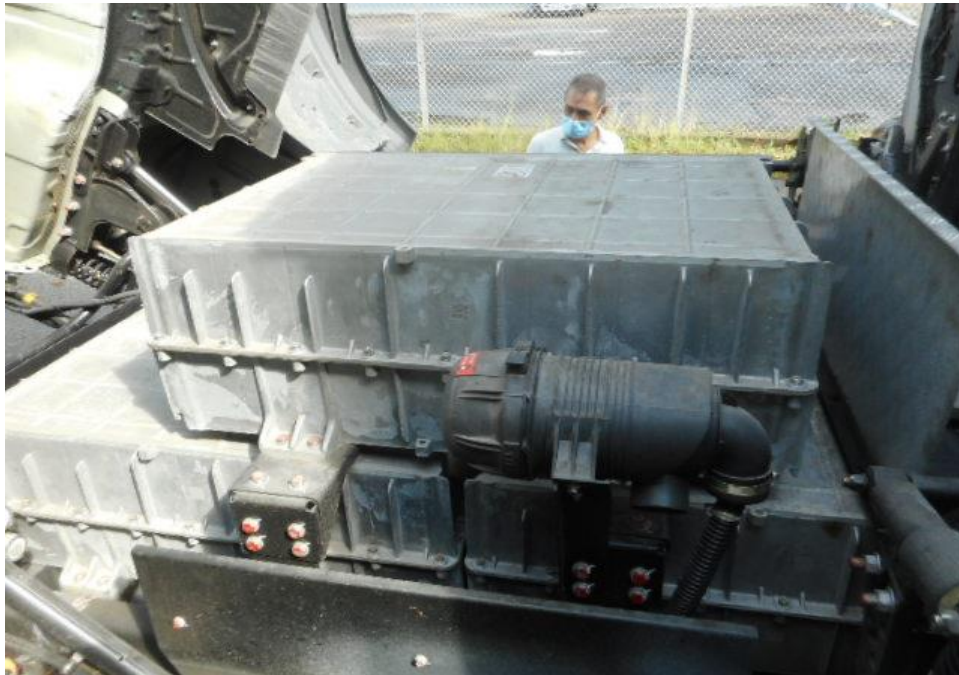
Photo 11 shows a general view of the Garbage Truck's electric motor compartment, which was accessed by lifting the front cabin of the Garbage Truck. The various parts and components inside the electric motor compartment were unaffected by the accident. There was also no sign(s) or indication(s) of fresh fluid leakage and/or fluid stain within the electric motor compartment

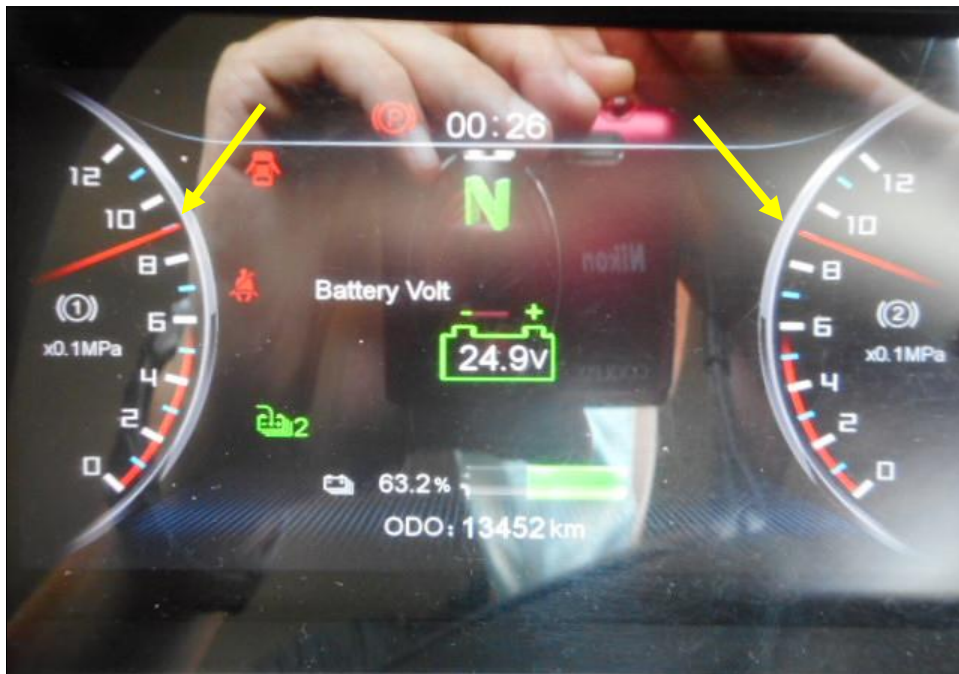
Photo 12 shows the air in the air brake cylinders of the Garbage Truck at the time of my inspection. The air in the cylinder was observed to be of sufficient level (arrowed) & serviceable at the time of the accident.

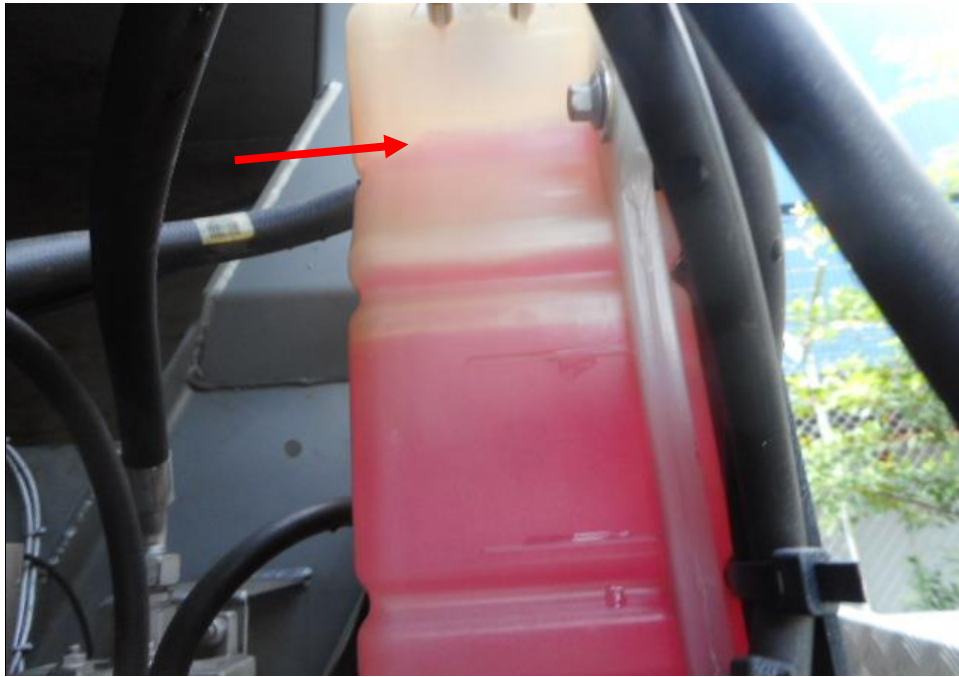
Photo 13 shows the electric motor coolant reservoir of the Garbage Truck at the time of my inspection. The electric motor coolant was observed to be of sufficient level (arrowed) and without any visible contamination.

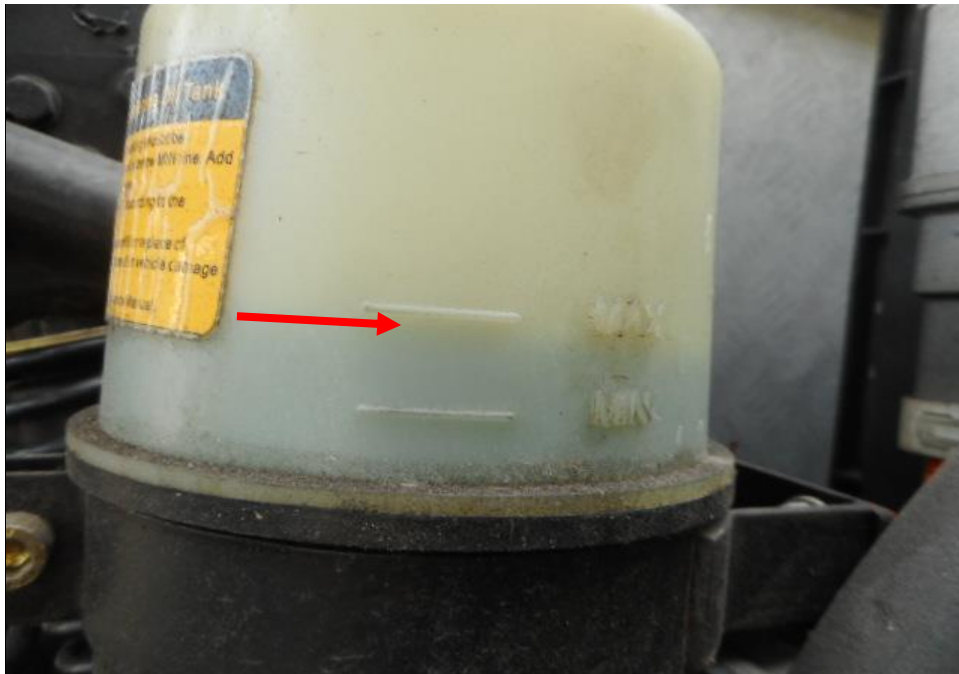
Photo 14 shows the power steering fluid reservoir of the Garbage Truck at the time of my inspection. The power steering fluid was observed to be of sufficient level (arrowed) and without any visible contamination.

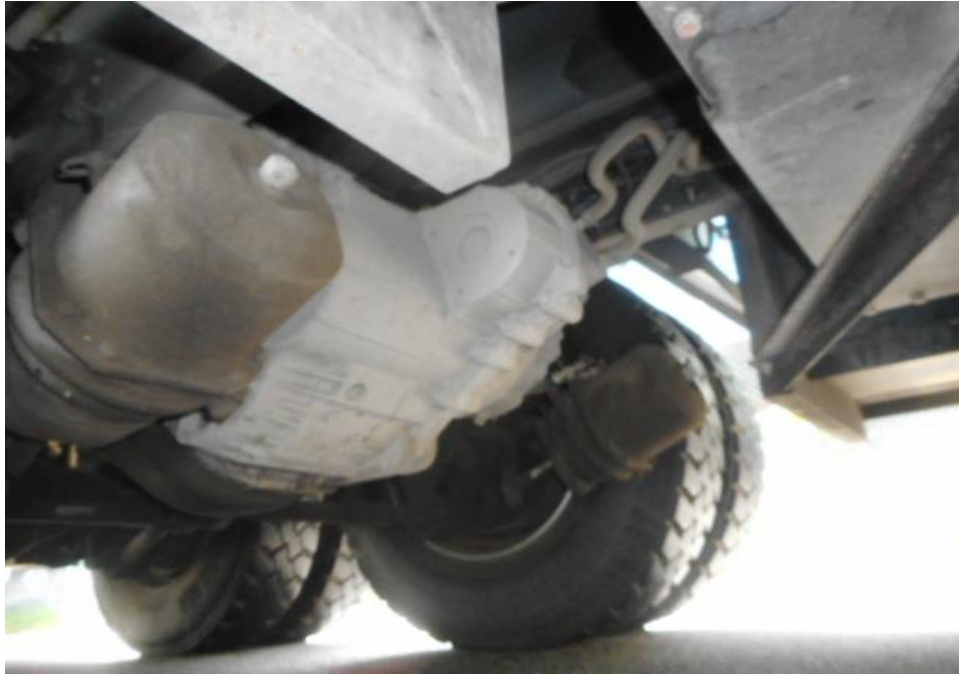
Photo 15 shows the undercarriage of the Garbage Truck, at the area where the electric motor housing located. I did not find any sign(s) or indication(s) of fluid leak, however old fluid stain(s) was observed on the underside of the Garbage Truck.

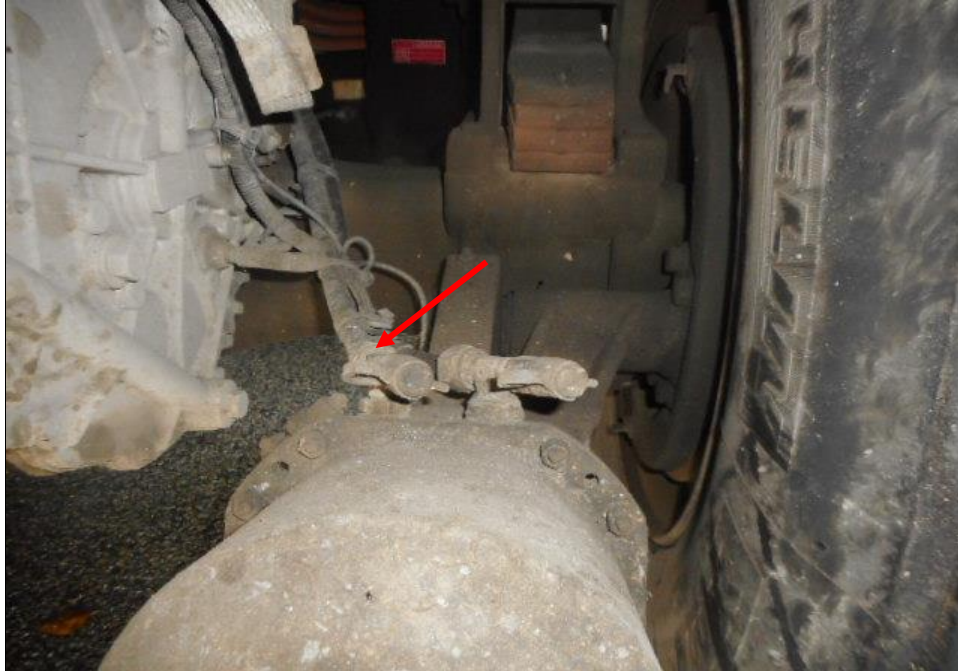
Photo 16 shows the brake pipe (arrowed) at the rear right wheel of the Garbage Truck. I did not observe any leakage of brake fluid at the time of my inspection of the Garbage Truck. My static tests of the Garbage Truck's braking system, along with my visual examination of the various mechanical components in the braking system, had indicated that there was no internal leakage of pressure/vacuum. Hence the braking system of the Garbage Truck was likely to be in serviceable condition at the material time of accident.

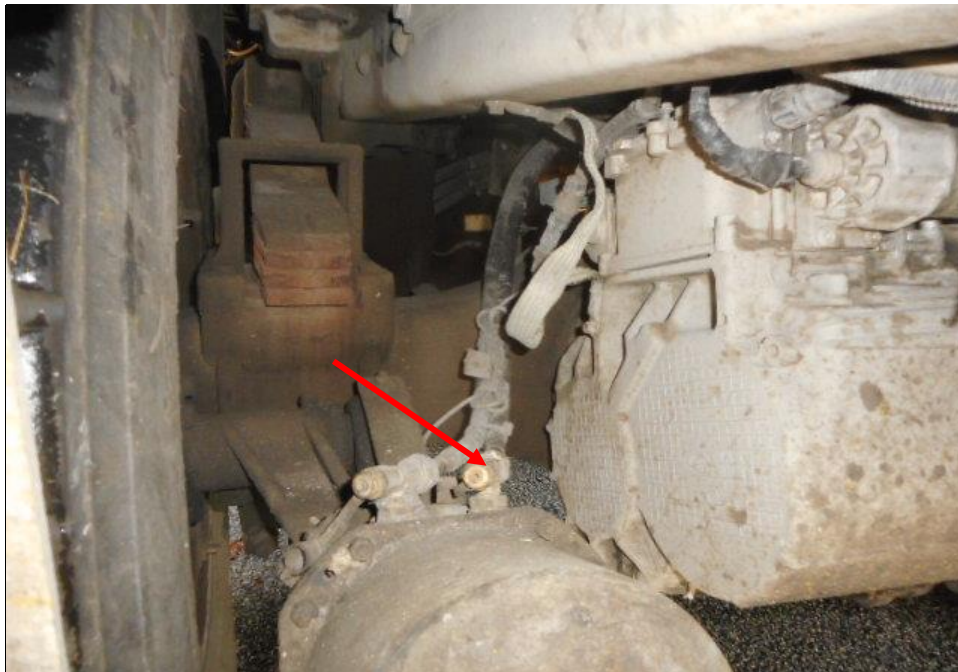
Photo 17 shows the brake pipe (arrowed) at the rear left wheel of the Garbage Truck. I did not observe any leakage of brake fluid at the time of my inspection of the Garbage Truck. My static tests of the Garbage Truck's braking system, along with my visual examination of the various mechanical components in the braking system, had indicated that there was no internal leakage of pressure/vacuum. Hence the braking system of the Garbage Truck was likely to be in serviceable condition at the material time of accident.

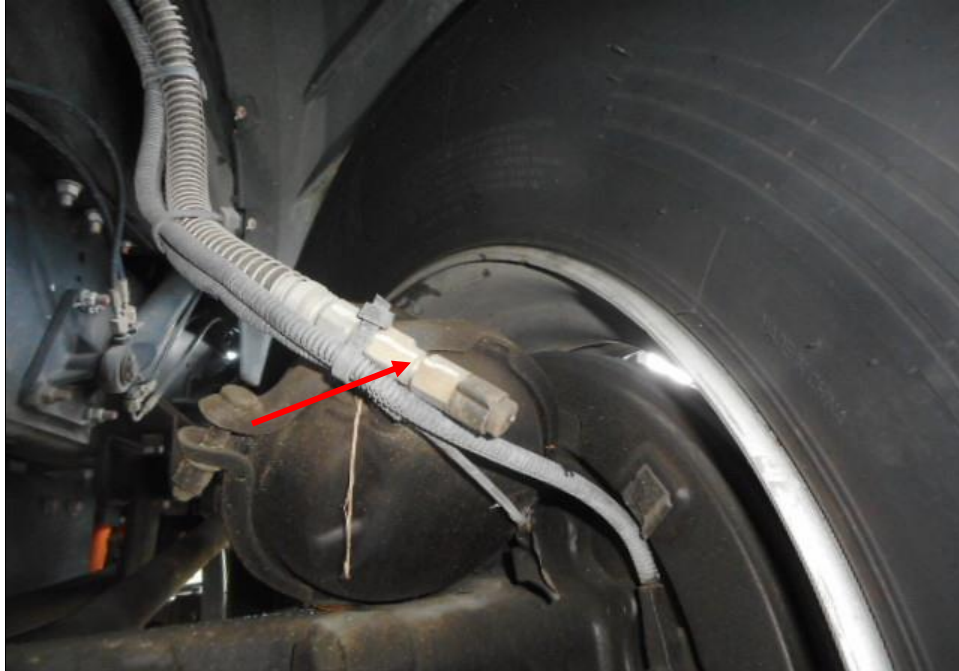
Photo 18 shows the brake pipe (arrowed) at the front right wheel of the Garbage Truck. I did not observe any leakage of brake fluid at the time of my inspection of the Garbage Truck. My static tests of the Garbage Truck's braking system, along with my visual examination of the various mechanical components in the braking system, had indicated that there was no internal leakage of pressure/vacuum. Hence the braking system of the Garbage Truck was likely to be in serviceable condition at the material time of accident.

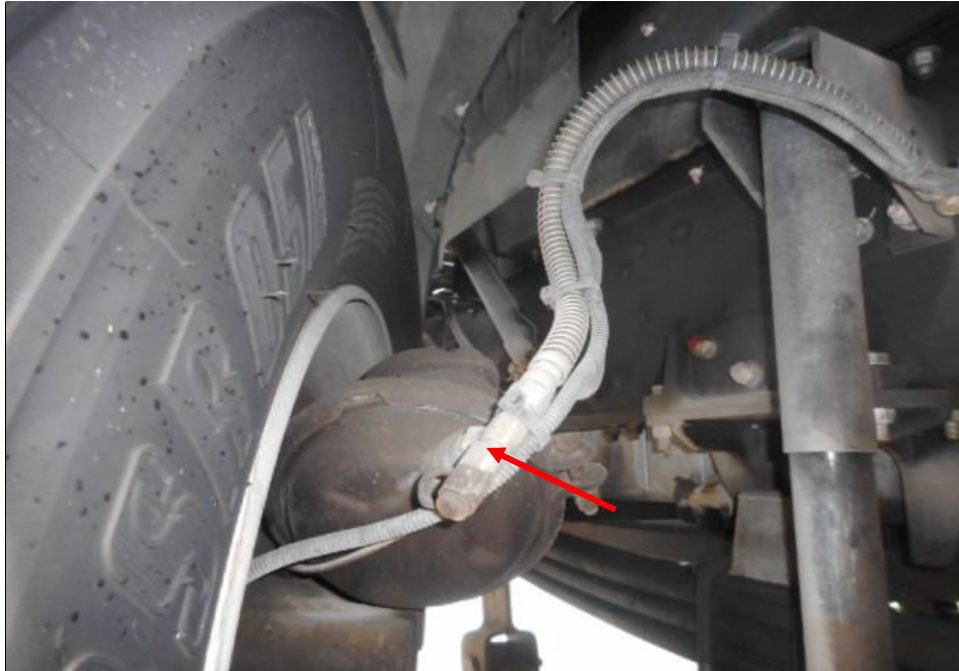
Photo 19 shows the brake pipe (arrowed) at the front left wheel of the Garbage Truck. I did not observe any leakage of brake fluid at the time of my inspection of the Garbage Truck. My static tests of the Garbage Truck's braking system, along with my visual examination of the various mechanical components in the braking system had indicated that there was no internal leakage of pressure/vacuum. Hence the braking system of the Garbage Truck was likely to be in serviceable condition at the material time of accident.

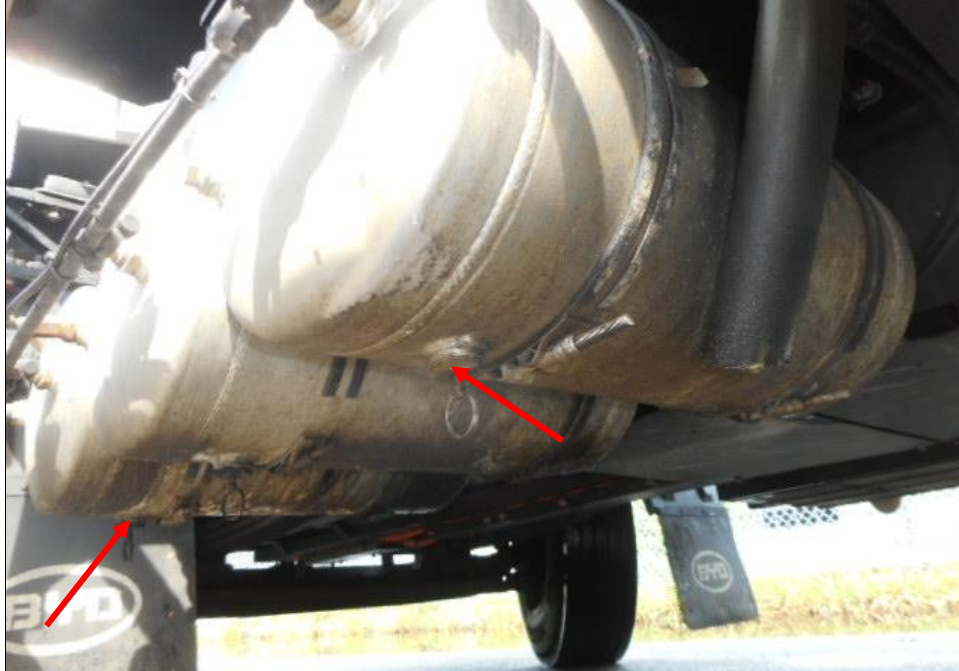
Photo 20 shows the air brake cylinders (arrowed) at the undercarriage of the Garbage Truck. I did not observe any leakage of air brake fluid at the time of my inspection of the Garbage Truck. My static tests of the Garbage Truck's braking system, along with my visual examination of the various mechanical components in the braking system had indicated that there was no internal leakage of pressure/vacuum. Hence the braking system of the Garbage Truck was likely to be in serviceable condition at the material time of accident.

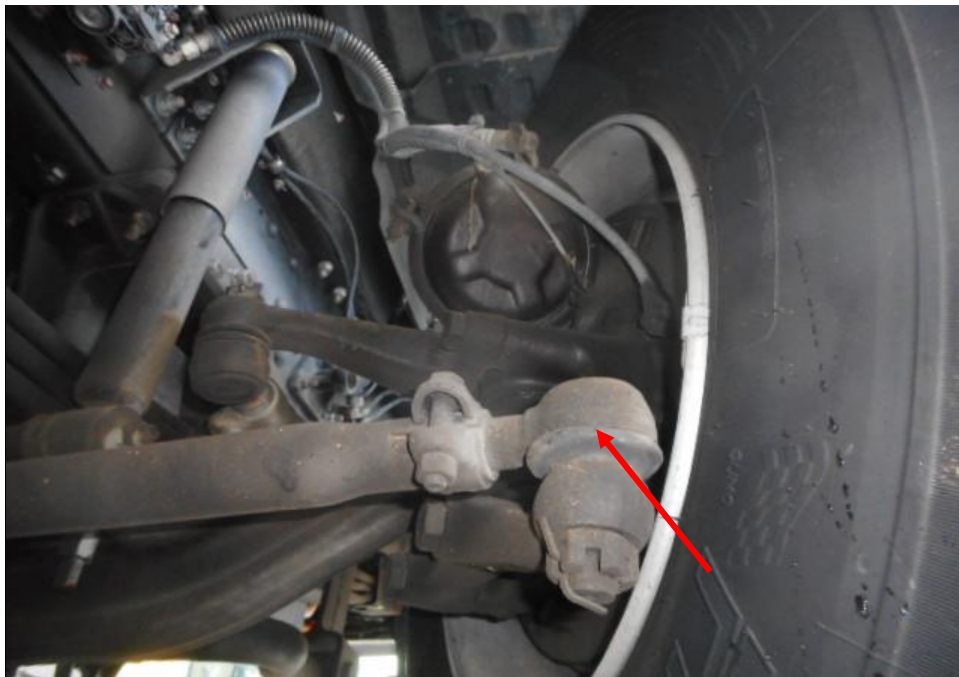
Photo 21 shows the various undercarriage components at the front right wheel of the Garbage Truck, in particular the steering tie rod end (arrowed). The various steering components were all found to be intact, suggesting that the steering system of the Garbage Truck was likely to be in serviceable condition at the material time of accident. There was also no sign of fluid stain(s) observed on the various undercarriage components.

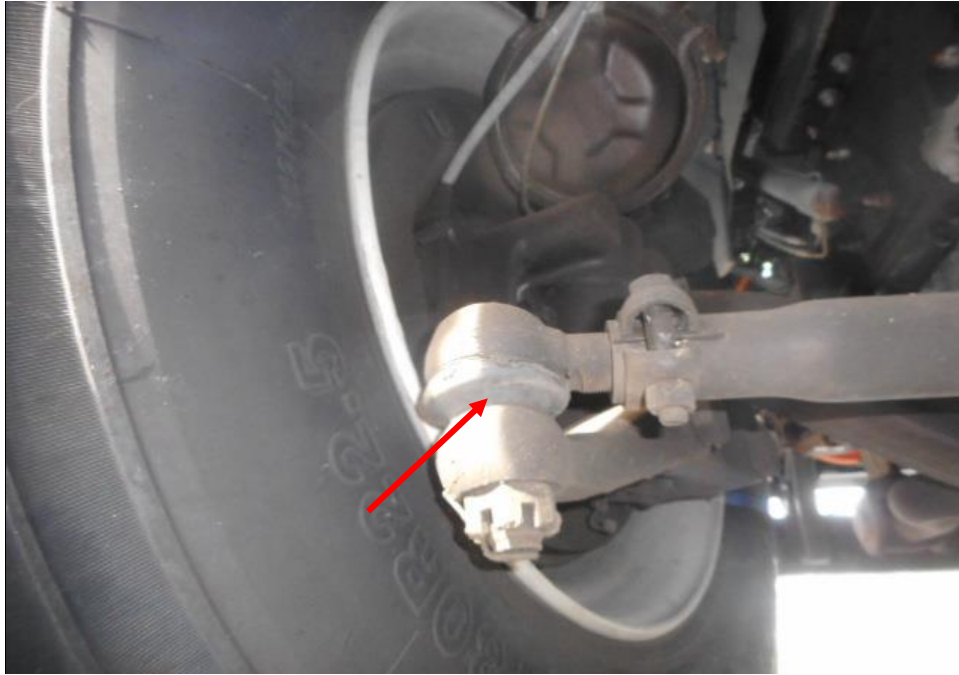
Photo 22 shows the various undercarriage components at the front left wheel of the Garbage Truck, in particular the steering tie rod end (arrowed). The various undercarriage components of the Garbage Truck were all found to be intact without any visible damage. There was also no sign of fluid stain(s) observed on the various undercarriage components.

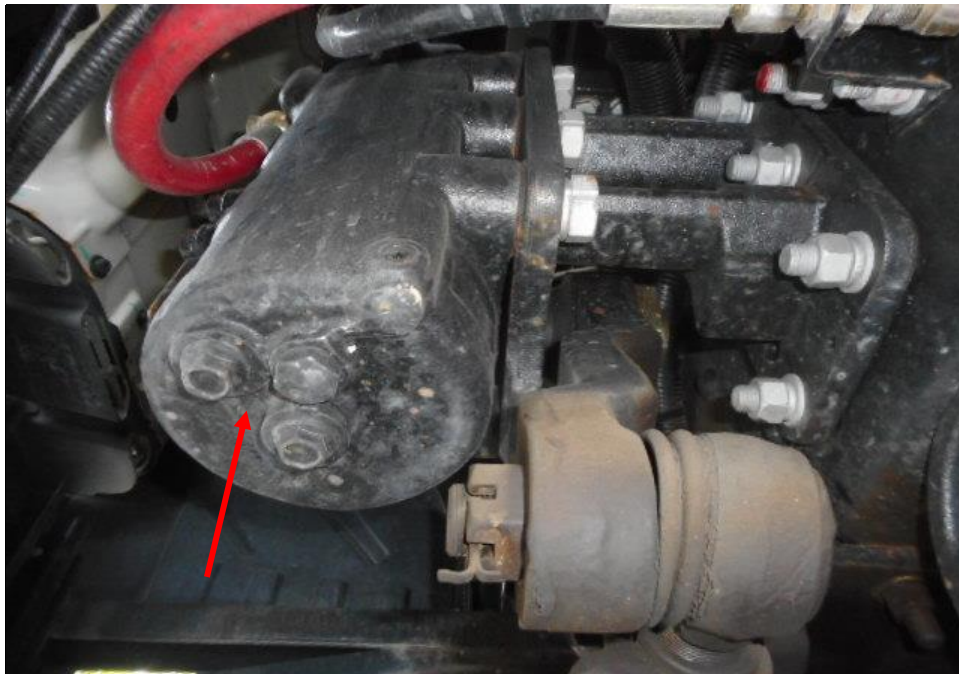
Photo 23 shows the steering box component (arrowed) at the undercarriage of the Garbage Truck was found to be intact without any visible damage. There was also no sign of fluid stain(s) observed on the various undercarriage components.

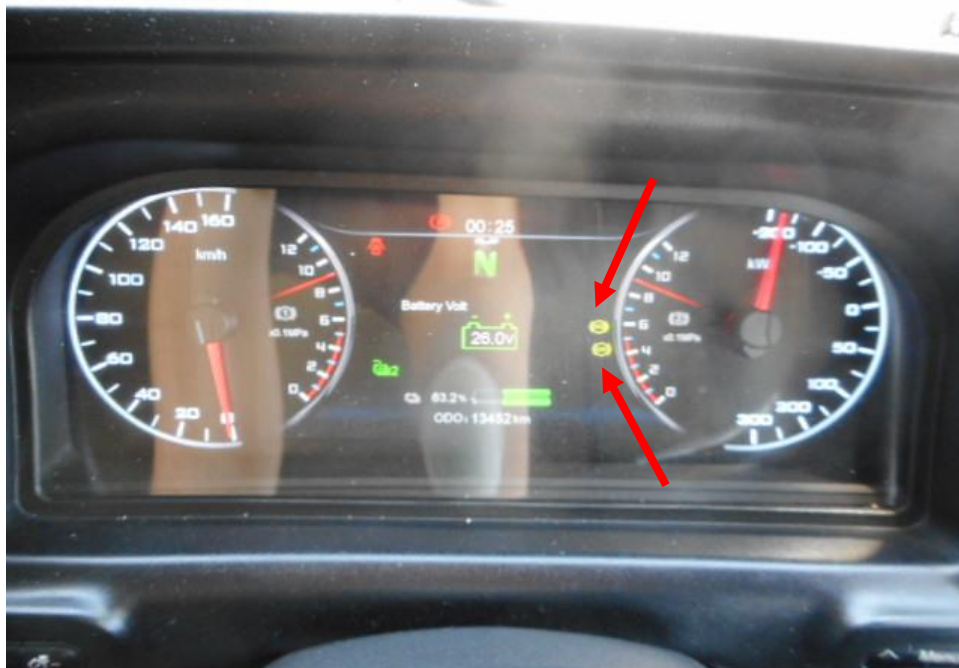
Photo 25 shows the warning light for Anti-Lock Brake System (ABS) and Anti-Slip Regulation (ASR) (arrowed) appearing on the instrument panel of the Garbage Truck during the self-test of its various electronic operating panel systems when its electric motor was cranked.

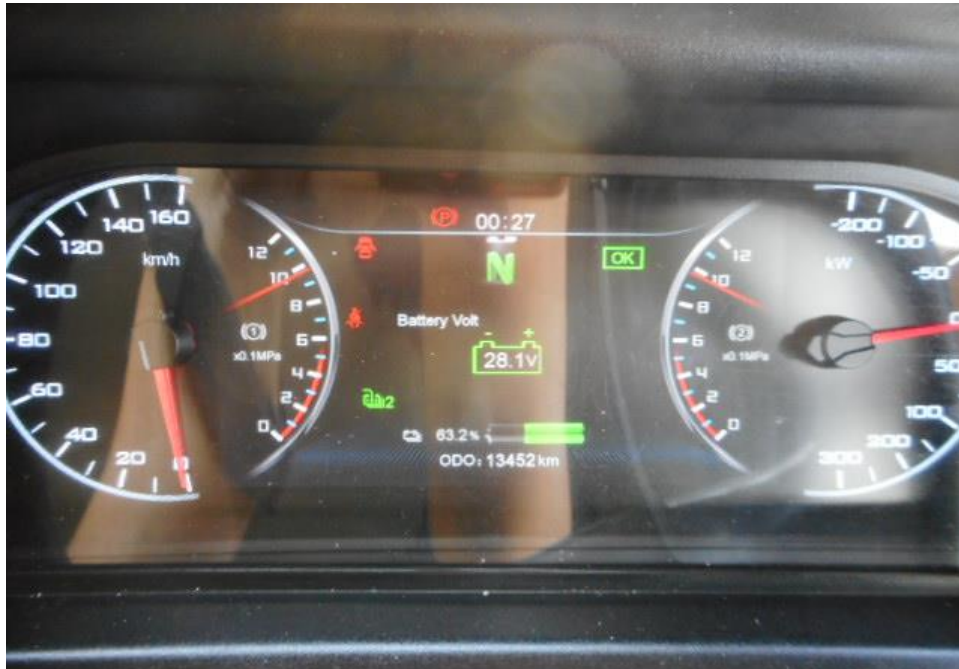
Photo 26 shows no warning lights illuminated on the instrument panel of the Garbage Truck after the electric motor was cranked. This would suggest that there was no abnormality to the electronic operating system of the Garbage Truck, like the ABS, ASR and etc.
