# JDJ APPRAISAL

## Vehicle Inspection Report

Our Reference No. : 2022-1150  
Your Reference No. : Not Advised  
Claim Type : Third Party Claim  
Assignment Given By : LBL Construction Pte Ltd  
Address : 5037, Ang Mo Kio Industrial  
Park 2. # 01-391  
Singapore 569540

Registration No. : WC 2187 T  
Date : 18/07/2022  
Date Of Survey : 13/06/2022  
Date Of Accident : 04/06/2022  
Survey Conduct At : RS Auto Services  
Address : 160, Sin Ming Dr. # 06-01  
Sin Ming Autocity S ( 575722 )

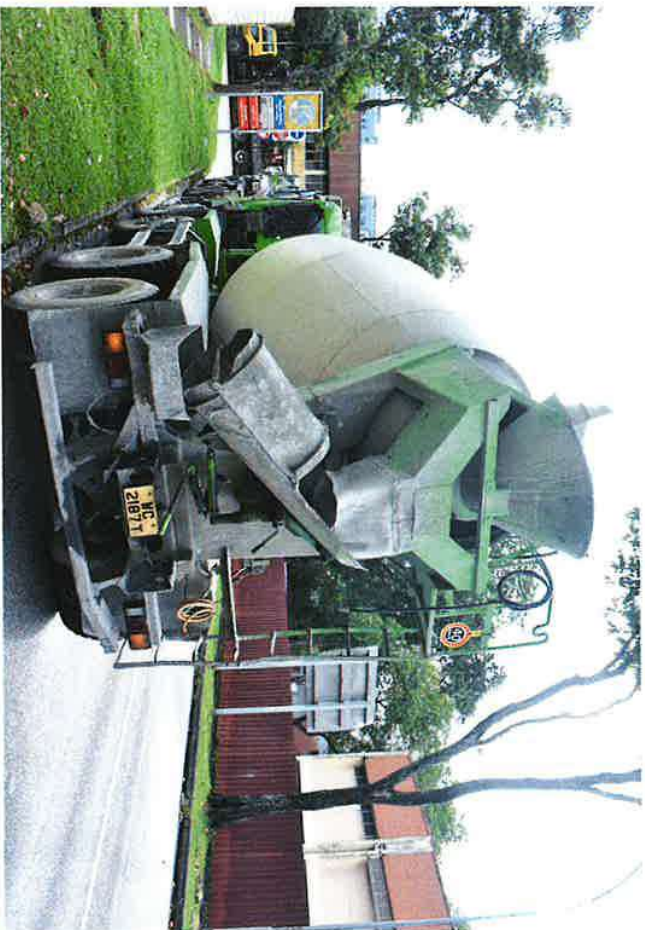
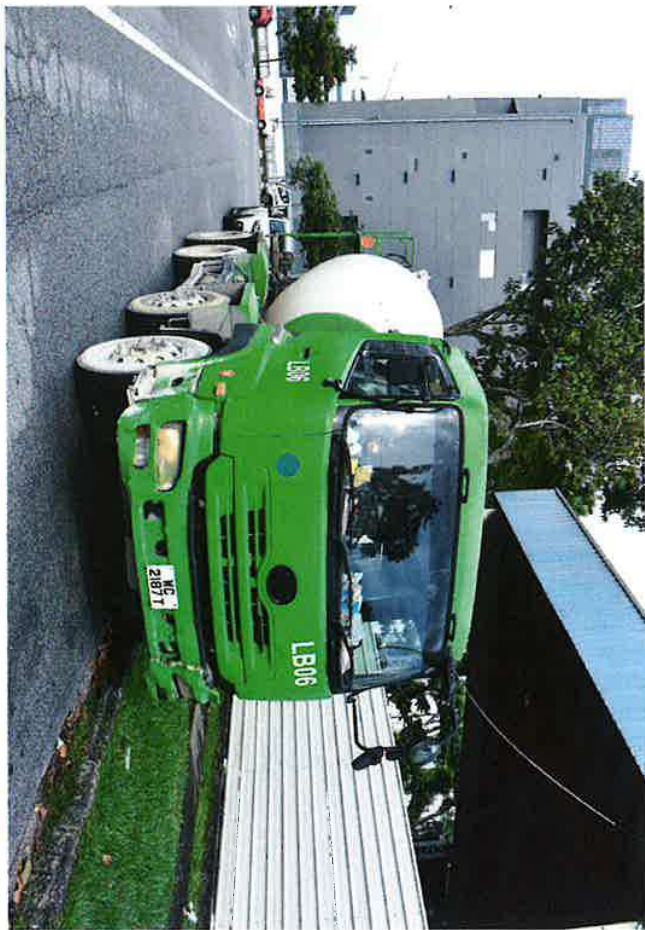
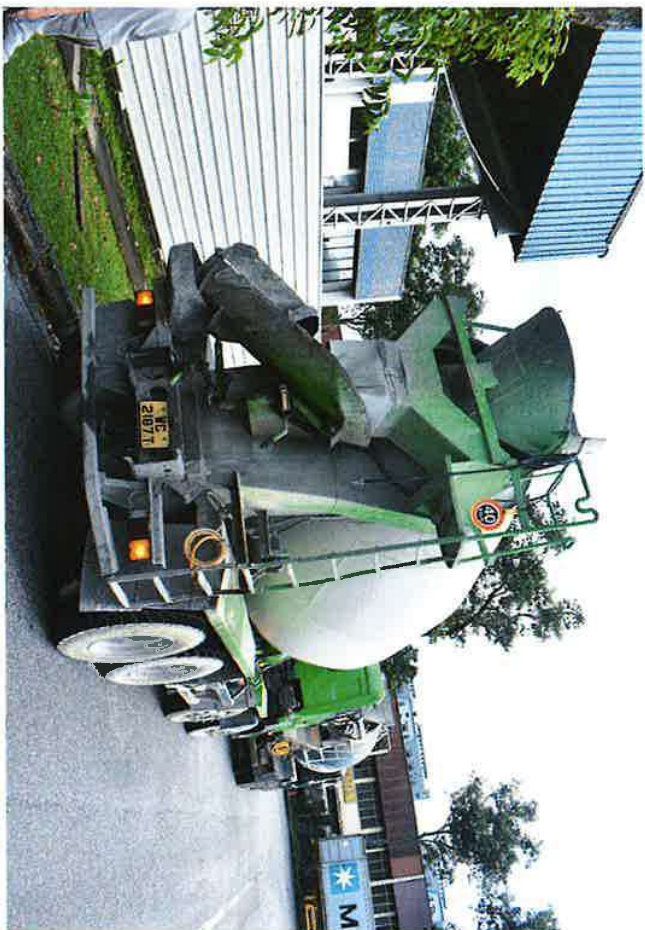
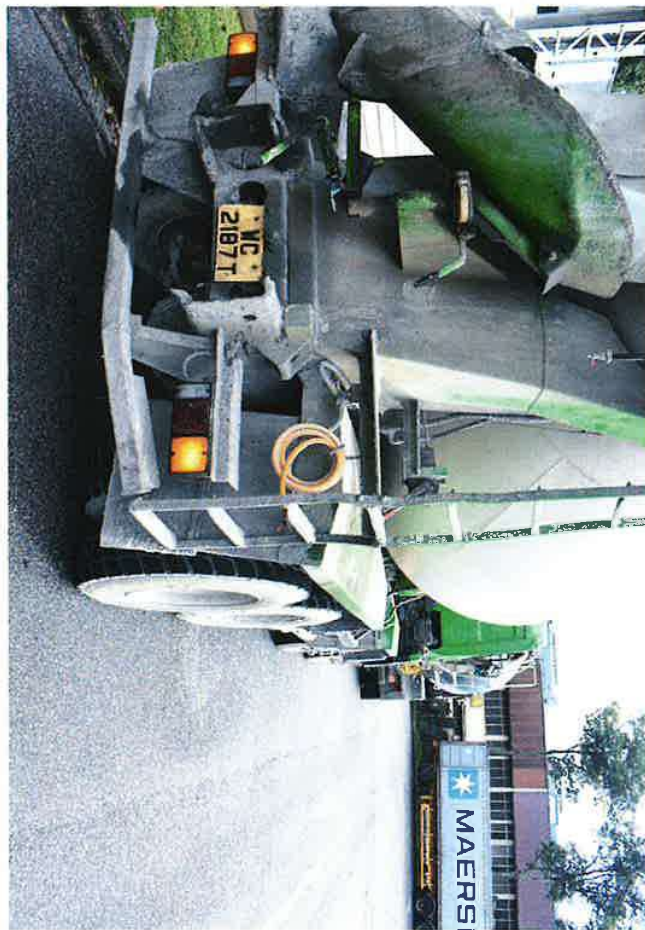
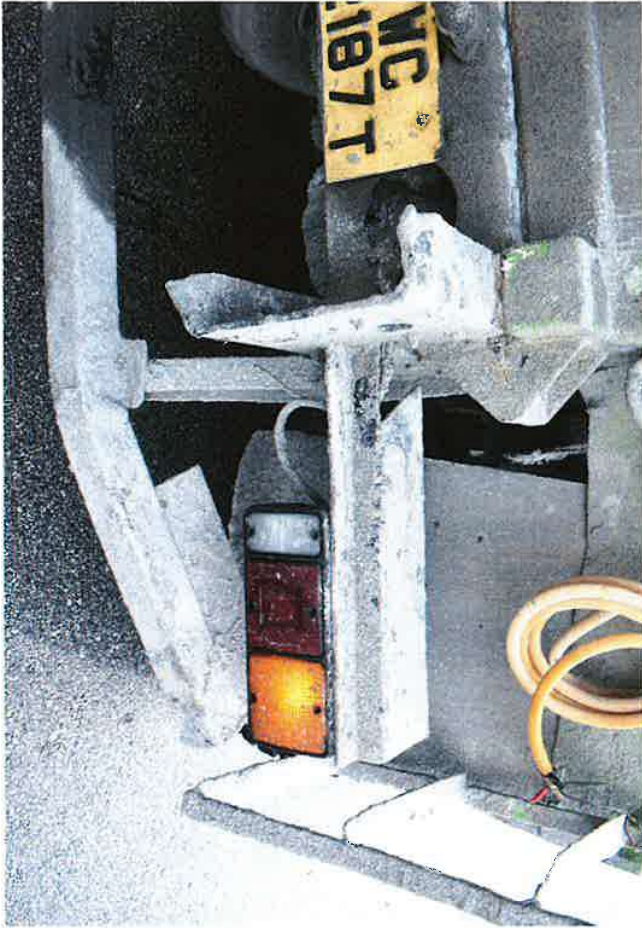
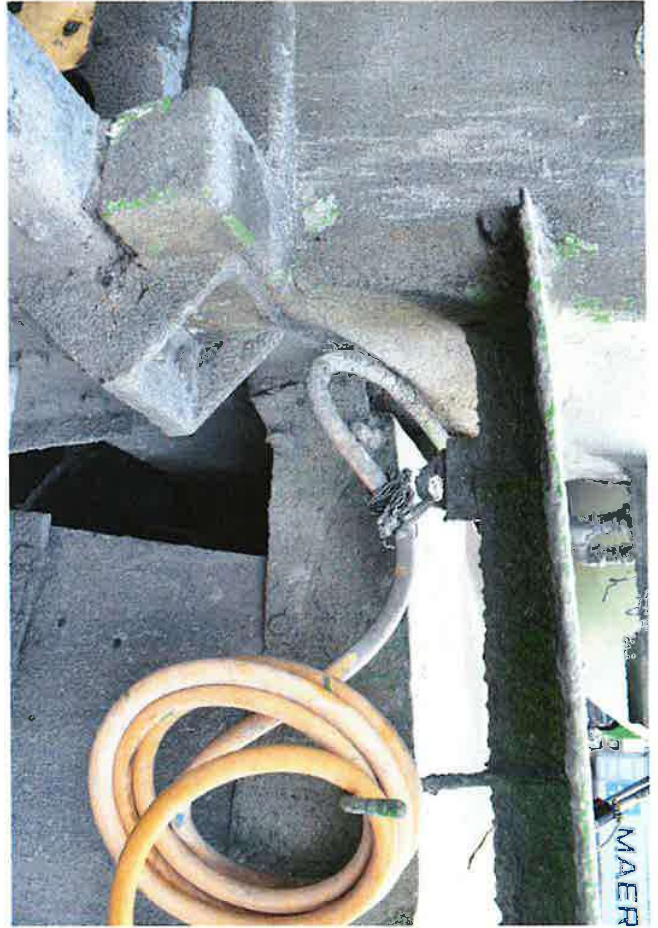
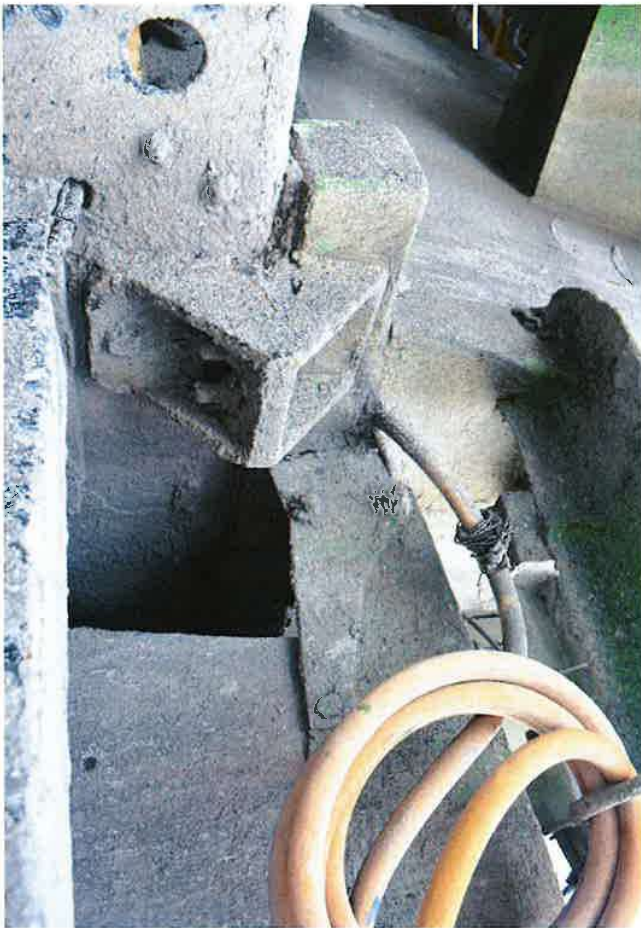
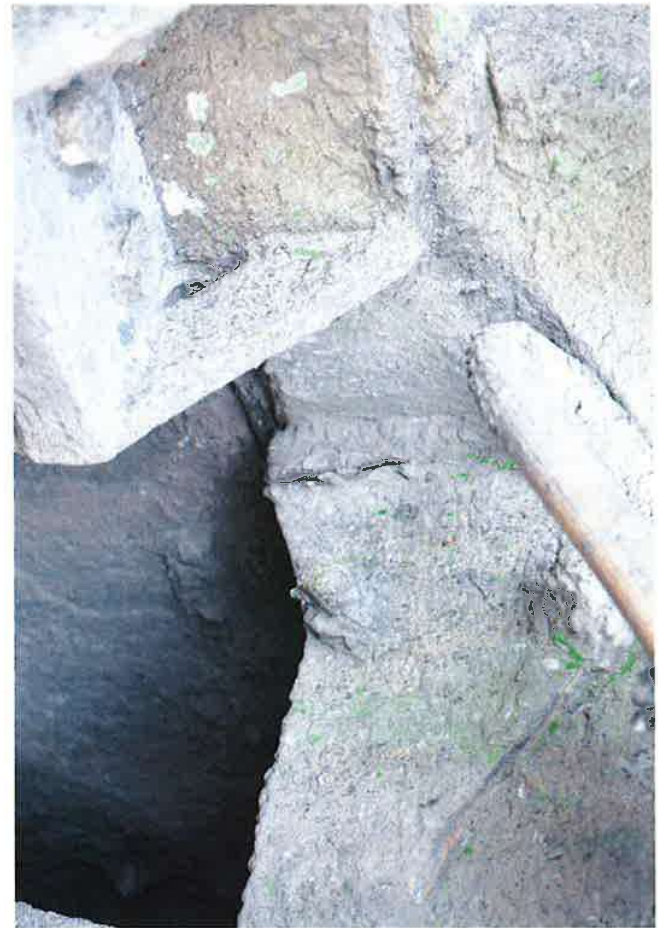
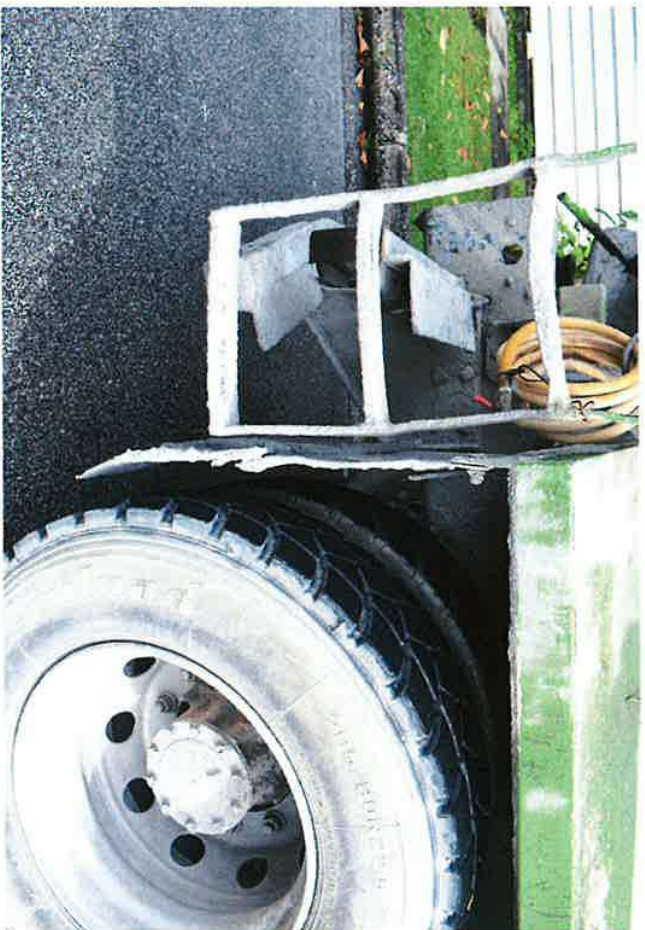
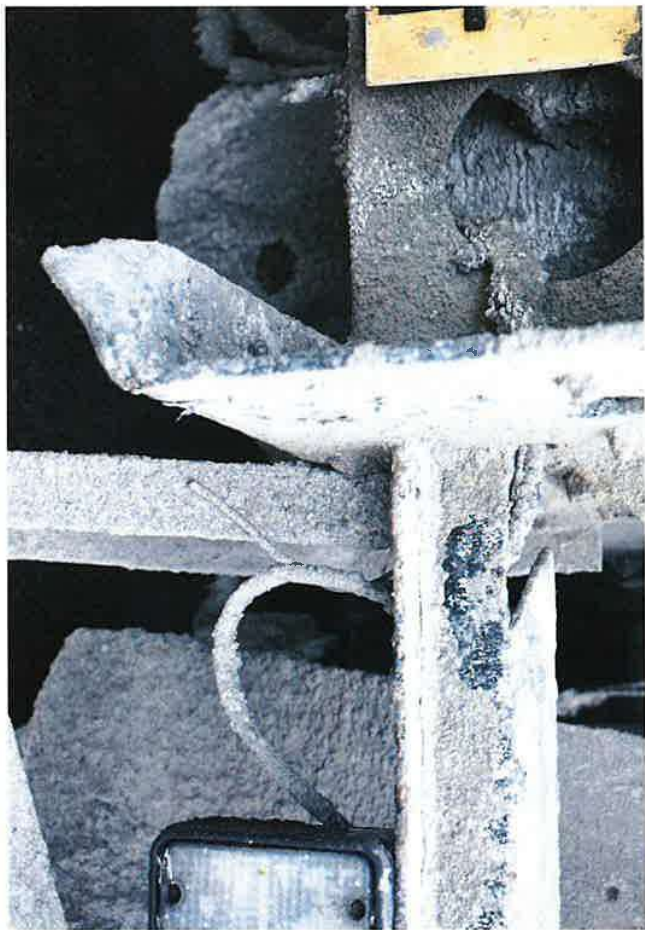
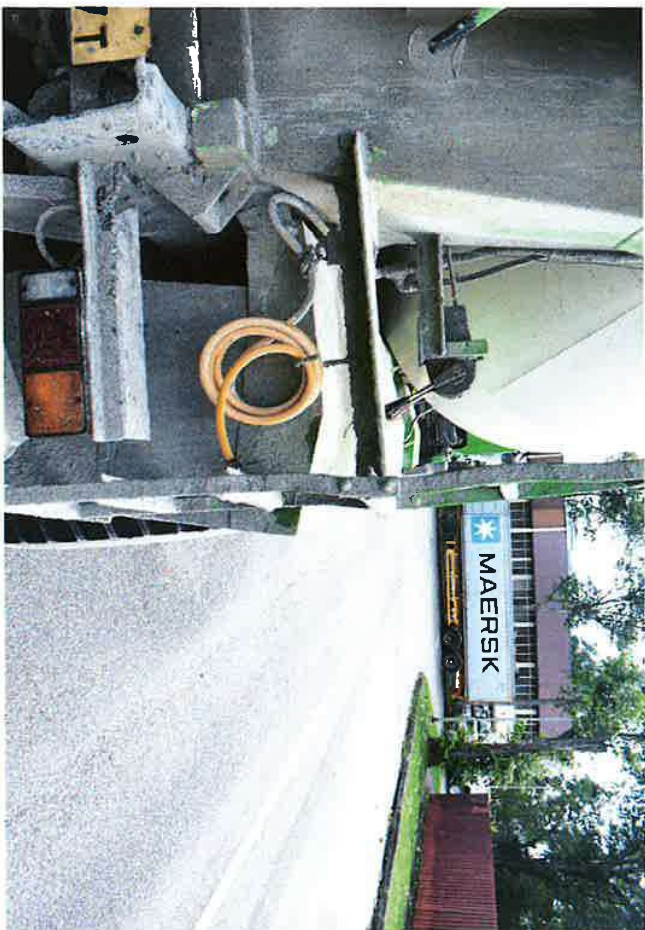
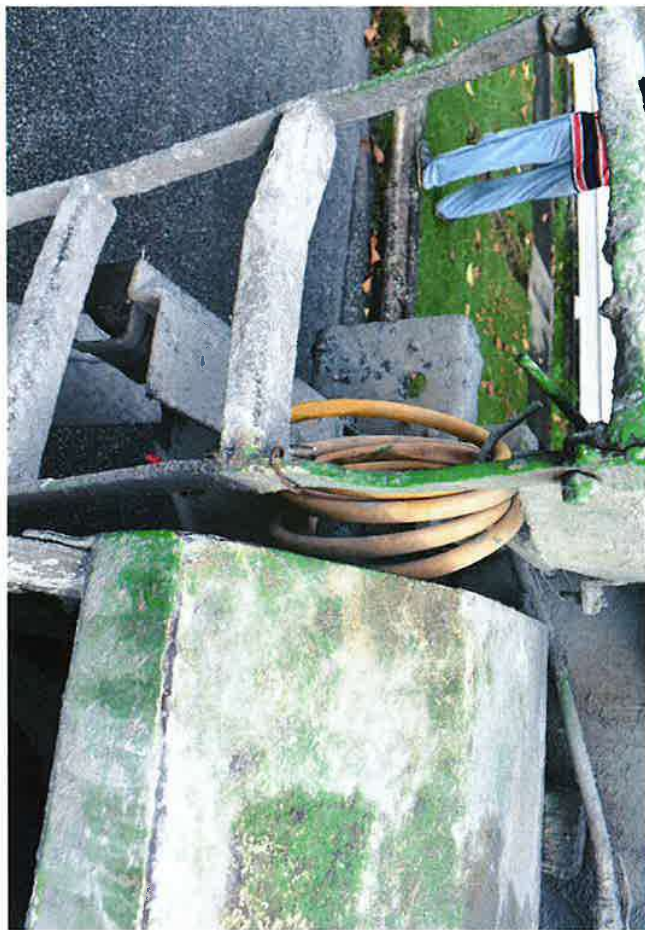
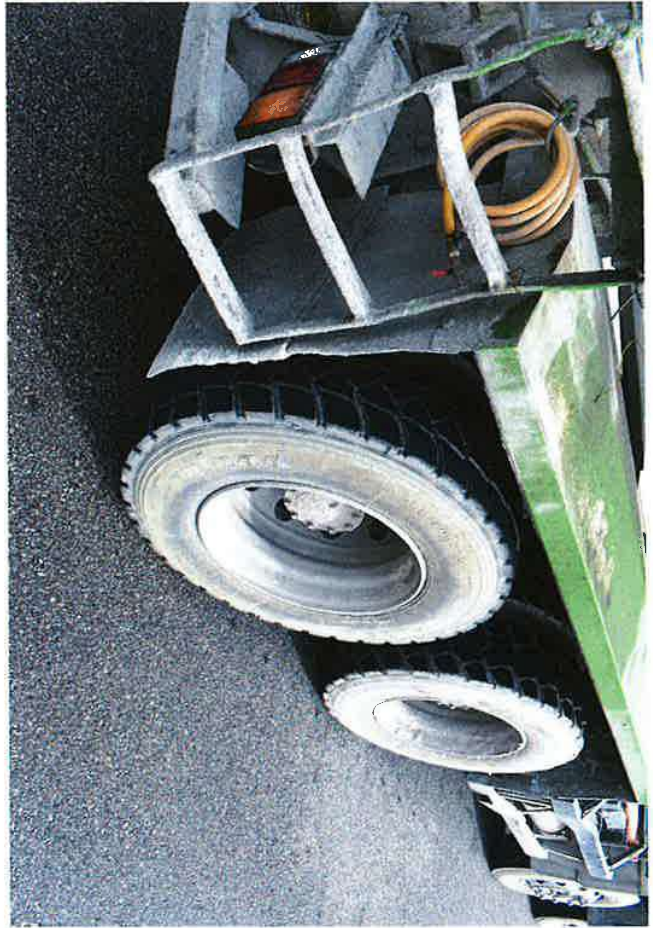
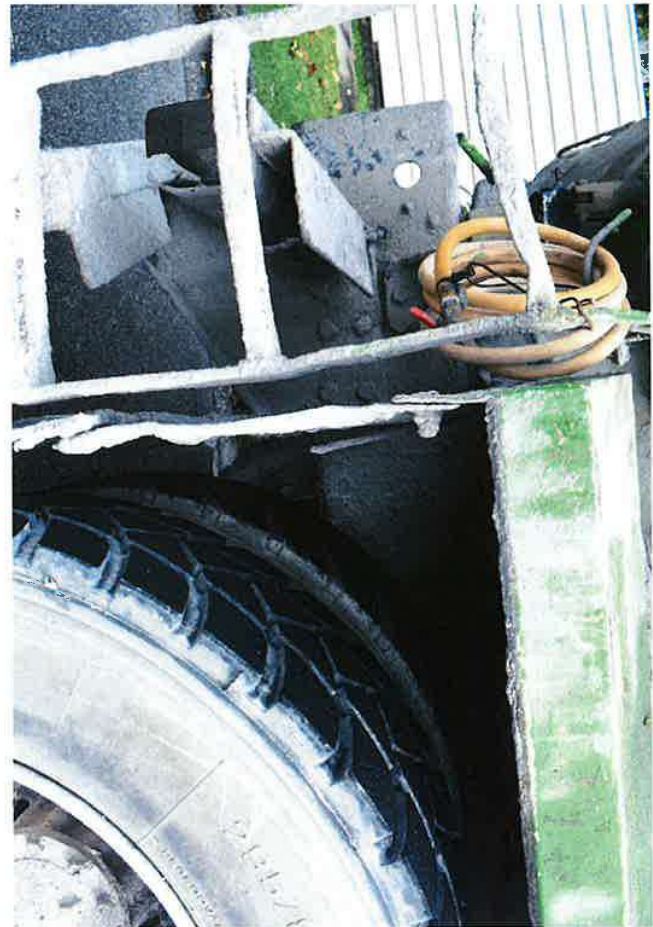
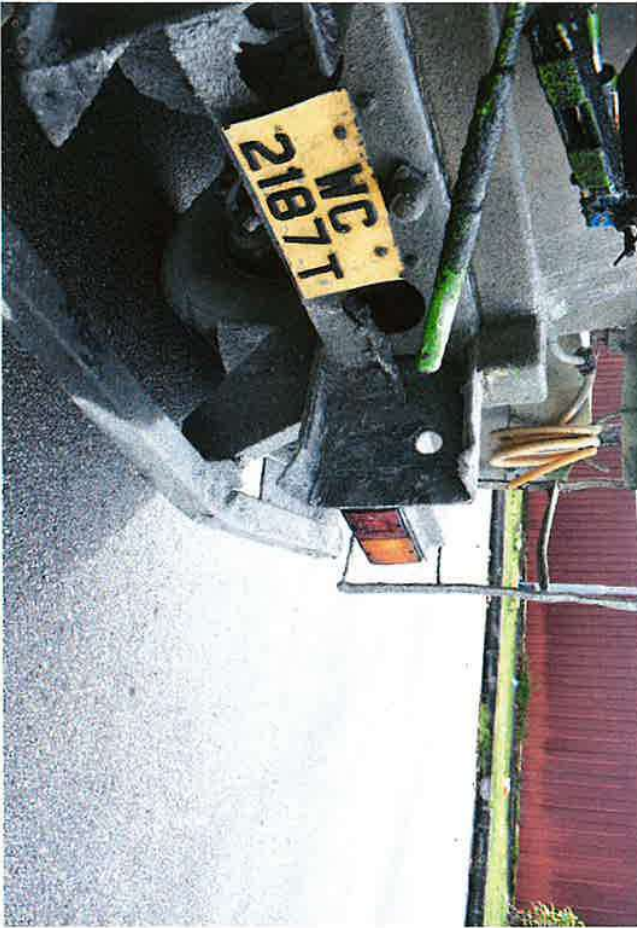
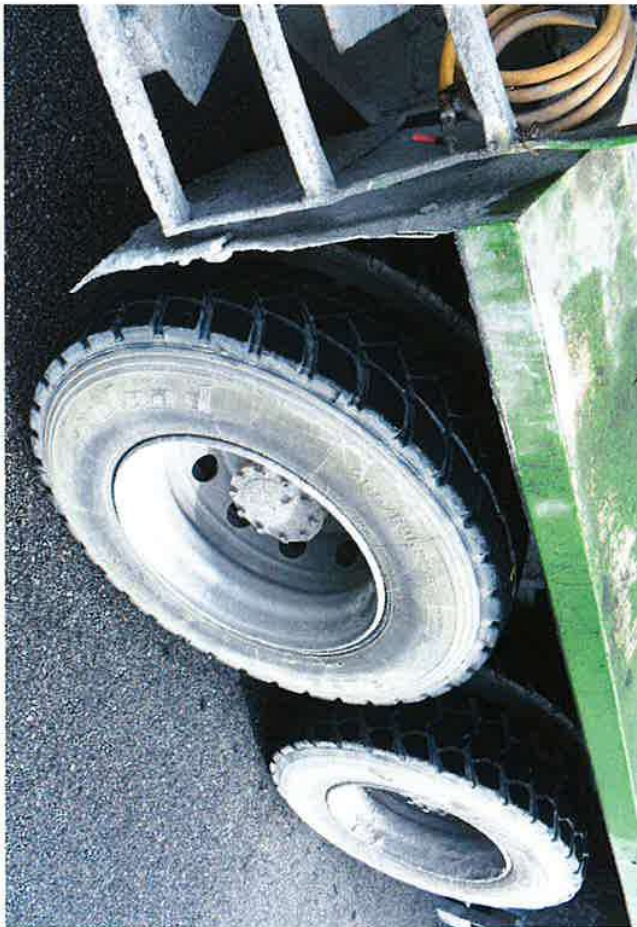
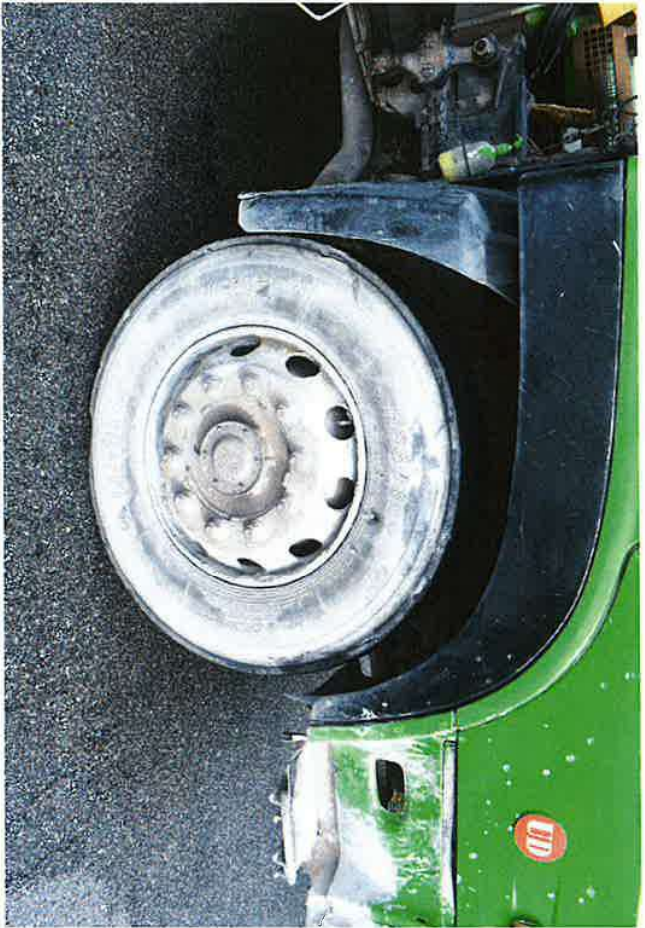
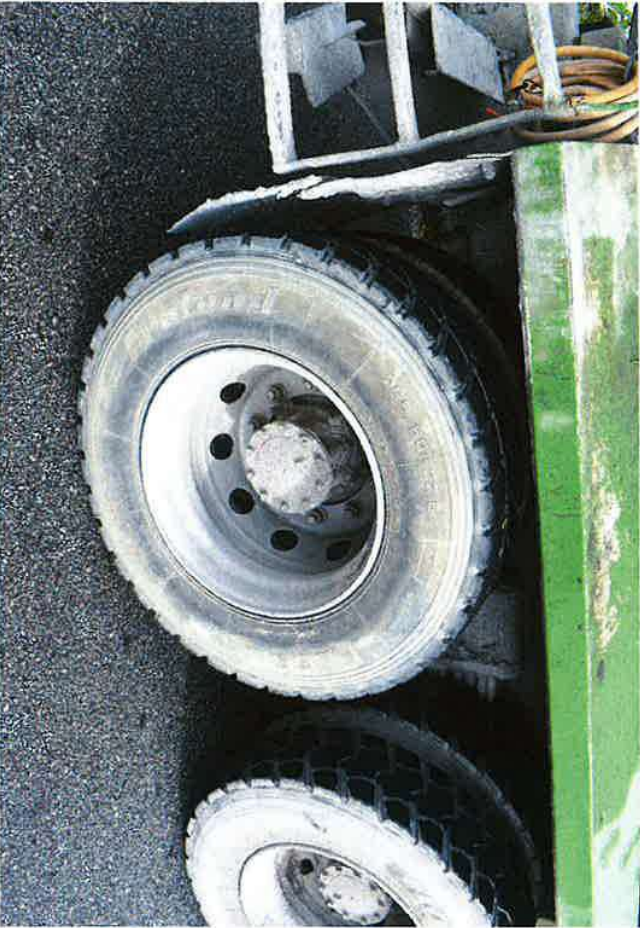
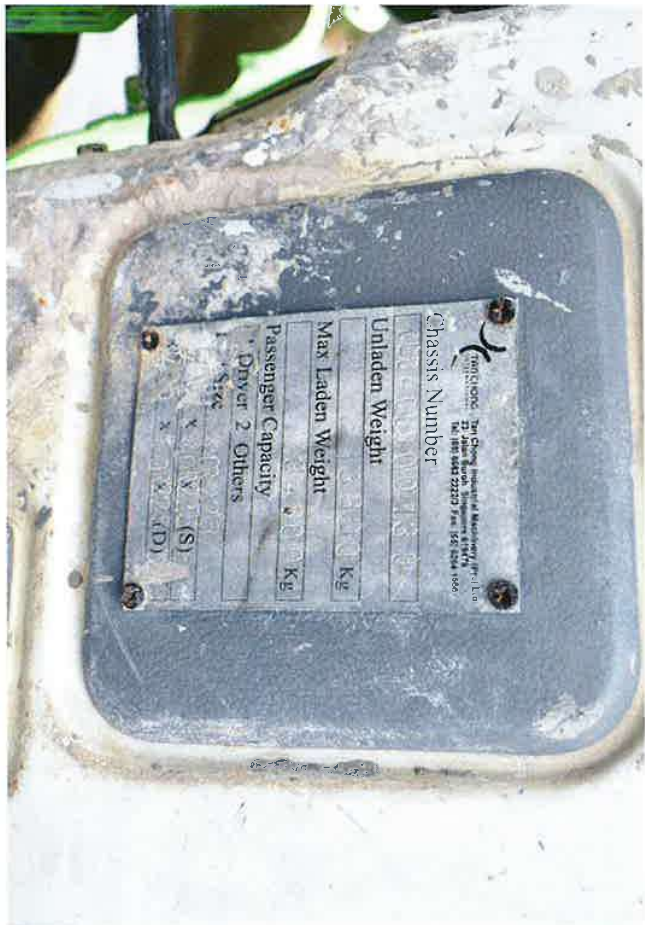
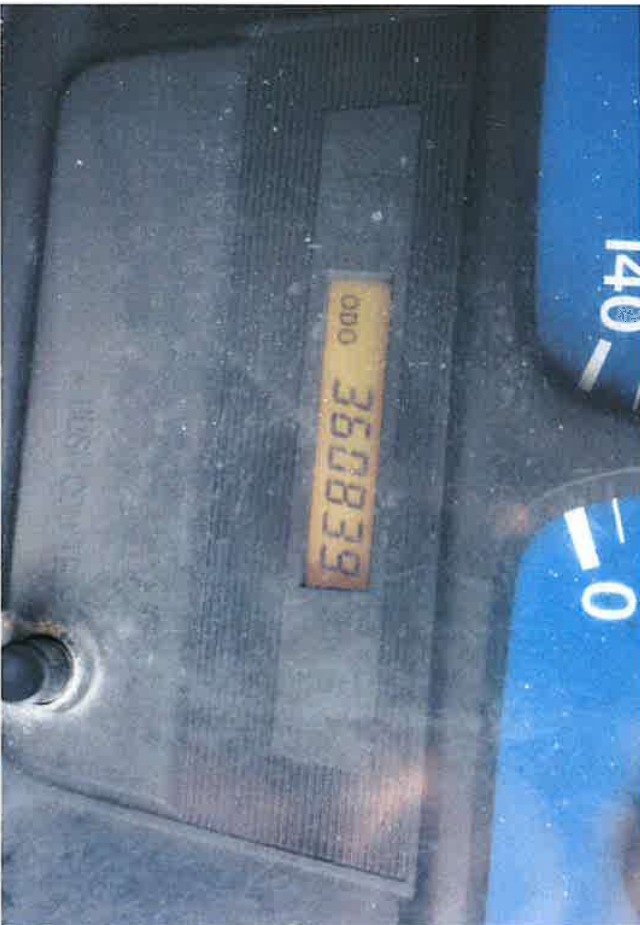
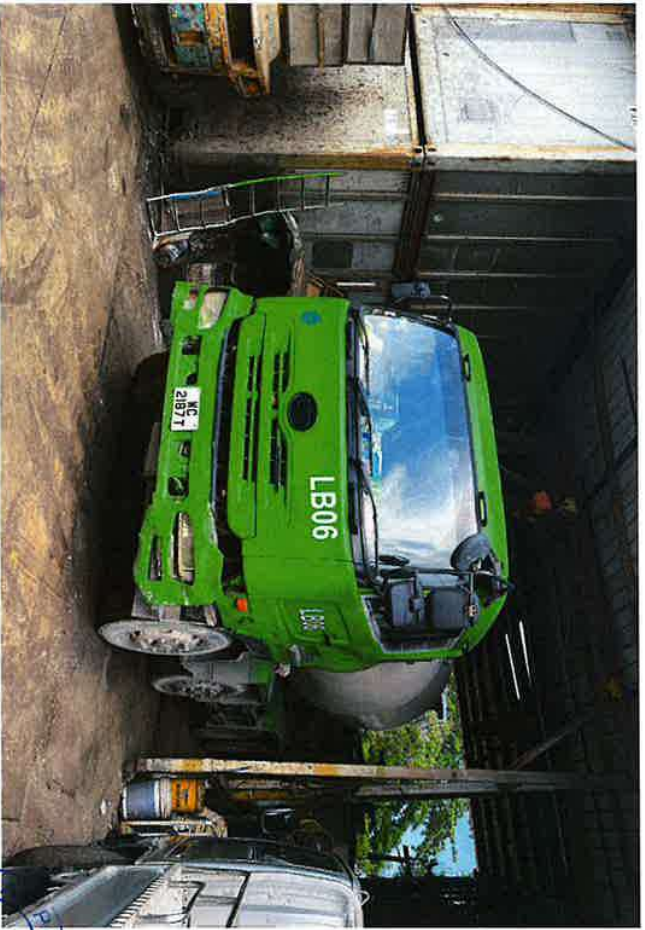
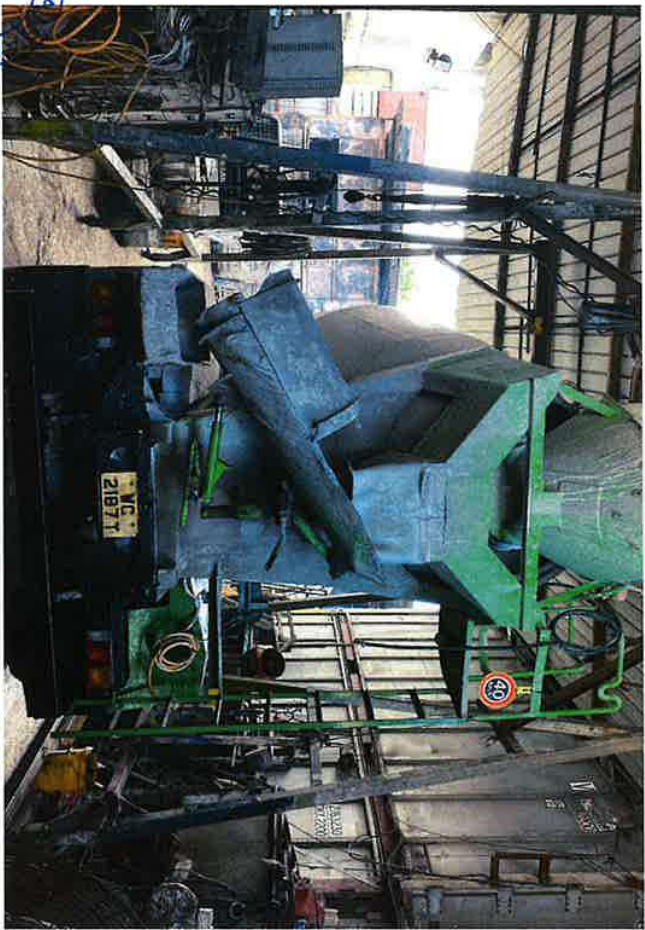
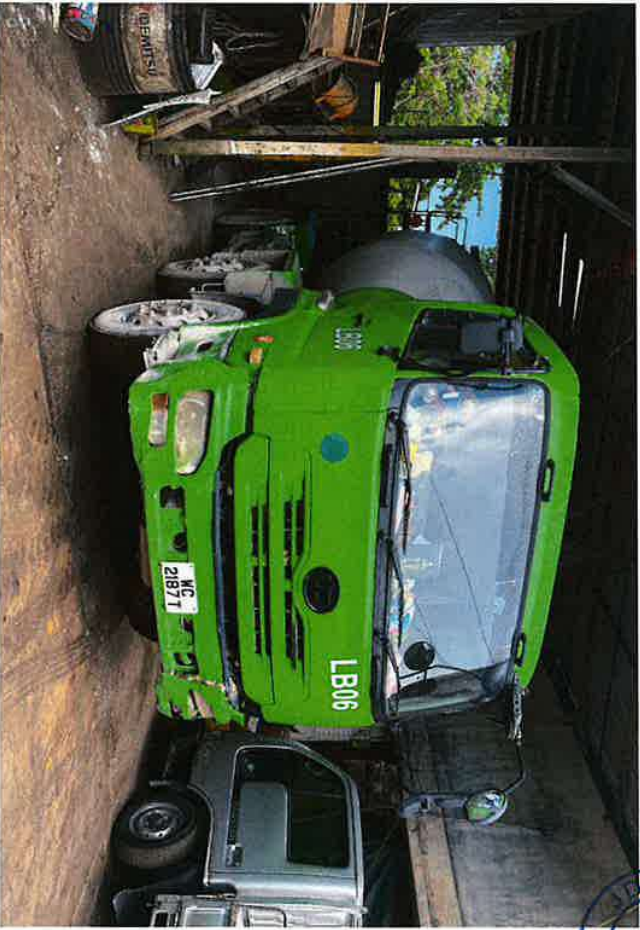
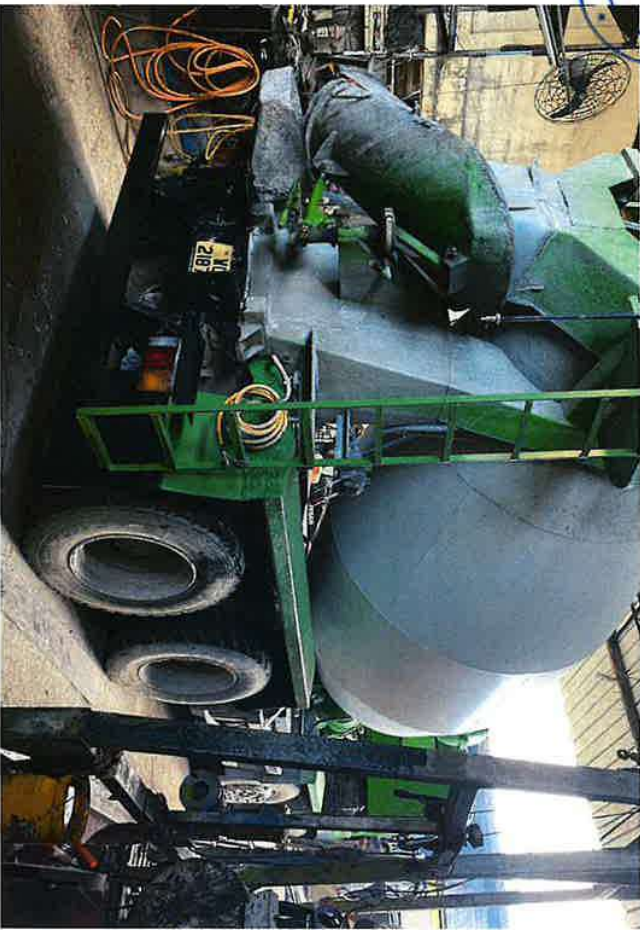
The accident affected damage area , rear right wheelarch panel, mudflap, bracket, rear right laddar, taillamp bracket right rear safety bar etc  
( For more detail of the damages, please refer photographs attached )

The general damage are rear right wheelarch panel, mudflap, brackets, rear right laddar, taillamp bracket right, rear safety bar etc for being damage.

M/s RS Auto Services estimated repair cost is \$ 19,138.50 and we have revised and adjusted the cost to \$ 18,708.50 on a part by part basis.

Recommend Lump Sum Repair \$ 14,900.00
