LKK Auto Consultants Pte Ltd

19-96	07198-R	
	Affiliated to Federation Internationale Des Experts En Automobile			
MS	STRIDES PREMIER	AUTOMOTIVE SERVICES PL.	Ref:	CS/SMR24080198/Uqp3m4
		DUSTRIAL PARK E4 SINGAPORE	Date:	27/08/2024
	757705		Code:	SMR
1.		Policy Particulars :- T	HIRD PARTY CLAI	M
	Insured Veh.	SHB 5859B	Veh. Inspected	SLJ 3287A
	Policy No.	-	Coverage	0
	Claim No.	TAX/08/24/2033	Excess	\$0.00
	Assign From	HUA YEN	Assign Date	13/08/2024
2.		Vehicle I	Details	
	Make & Model	HONDA CIVIC 1.6 VTI (A)	C.C	1597
	Engine No.	R16B21600836	Year of Reg.	05/12/2016
	Chassis No.	MRHFC5650GT000598	Colour	SILVER
	Odometer	139936 KM	Steering	IN ORDER
	Brakes	IN ORDER	General	GOOD
	Modification(s)	RIMS: SPORTS RIM		
3.		Conditions	of Tyres	
		Size	Make	Balance (mm)
	R/H Front Tyre	215/55R16	YOKOHAMA	6
	L/H Front Tyre	215/55R16	YOKOHAMA	6
	R/H Rear Tyre	215/55R16	YOKOHAMA	6
	L/H Rear Tyre	215/55R16	YOKOHAMA	6

4. Description of Damages

THE VEHICLE SUSTAINED DAMAGES AT THE FRONT PORTION.

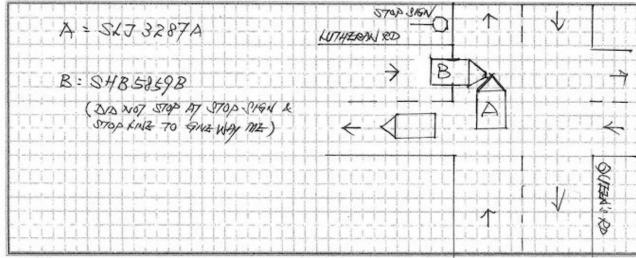
Sketch Plan

Describe Circumstance of the Accident	Olal.	
Occurence date of occident	8 8 2024	
Occurence time (based on car	camera forlege): 1920	HR
Occurence date of accident Occurence date of accident Occurence time (based on car Place of accident: Junction of	Queen's Rd & Lutheran R	d
I was driving along Queen's rd to Upon approaching the junction (from approsite direction) makin Lutheron rd. I slowed down as 2 appro		
Vous confection the instan	I saw a white car	- 4
(lum appresto direction) makin	a great turn to

1. These sed) 1) / / / / /	
T about of dying at I amon	iched the imobice	0
the solute car for late	aking his sight the	10
7 and church street of	hands he solded	-1-
7 0 Cur A CCUR COLOR	1 de la suda de la sud	,
Class Car O (SADS 65 12)	alle de la	6
the white car finished of I proceed slowly straight a I can Car B (SHB 585.9B) Stupping at the STOP sight which we have a result, car B's from	of the complete war	_
Line on The road .	1 - 1 - 2	
I ninked to alert him, wi	ile stopping my car	•
As a result, car b & from	+ (annuside) hit	
anto my front parties.	of my car	-
