# LKK Auto Consultants Pte Ltd

### 1. Policy Particulars :- THIRD PARTY CLAIM

### 2. Vehicle Details

## ADJUSTMENT ON REPAIR COST FOR VEHICLE NO SMD 9806H

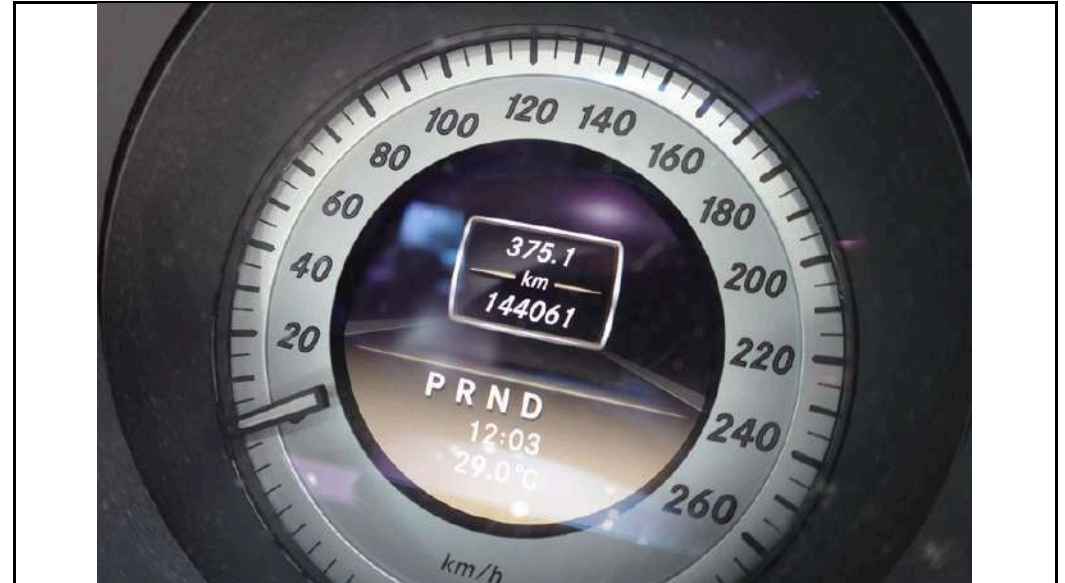
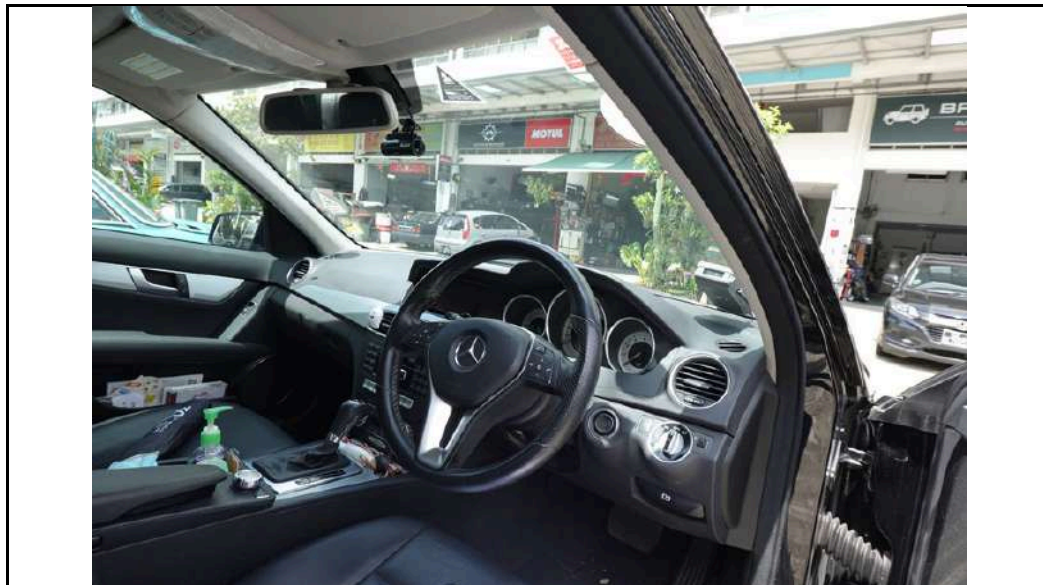
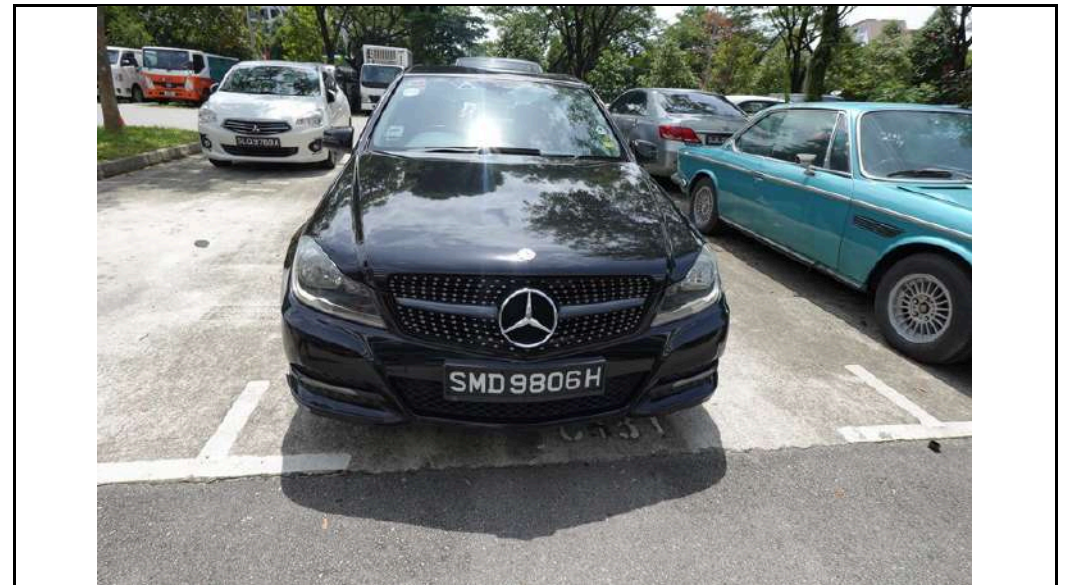
PHOTOGRAPHS FOR VEHICLE NO. : SMD 9806H

THE VEHICLE SUSTAINED DAMAGES AT THE O/S FRONT PORTION. THE UNDERCARRIAGE AFFECTED DUE TO COLLISION.
