**LKK Auto Consultants Pte Ltd**

MS STRIDES PREMIER AUTOMOTIVE SERVICES PL.	Ref:	CS/SMR24060133/Rqh3e2
60 WOODLANDS INDUSTRIAL PARK E4 SINGAPORE 757705	Date:	19/06/2024
	Code:	SMR

4. Description of Damages

ADJUSTMENT ON REPAIR COST FOR VEHICLE NO SBS 3326S

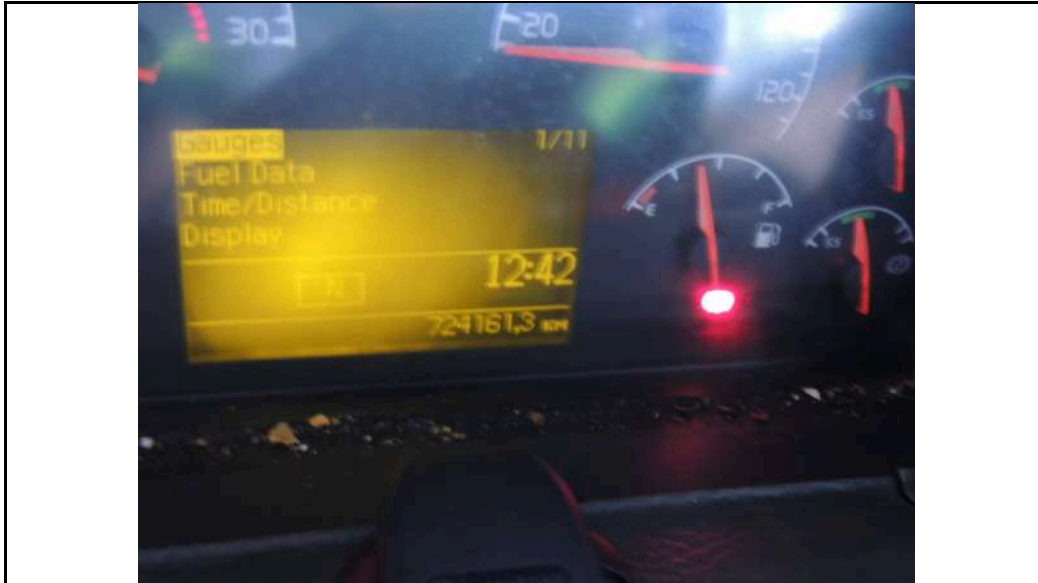
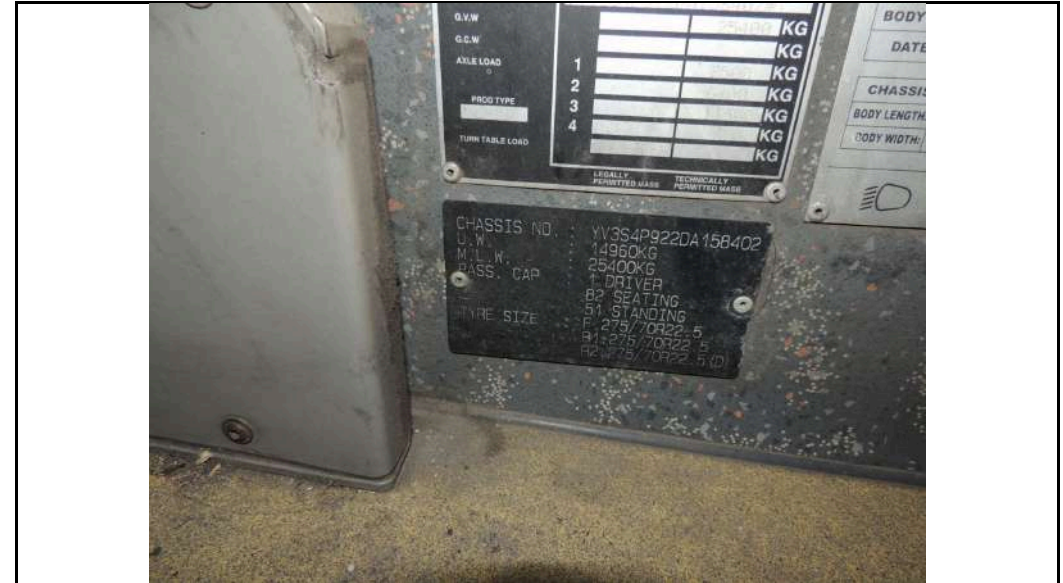
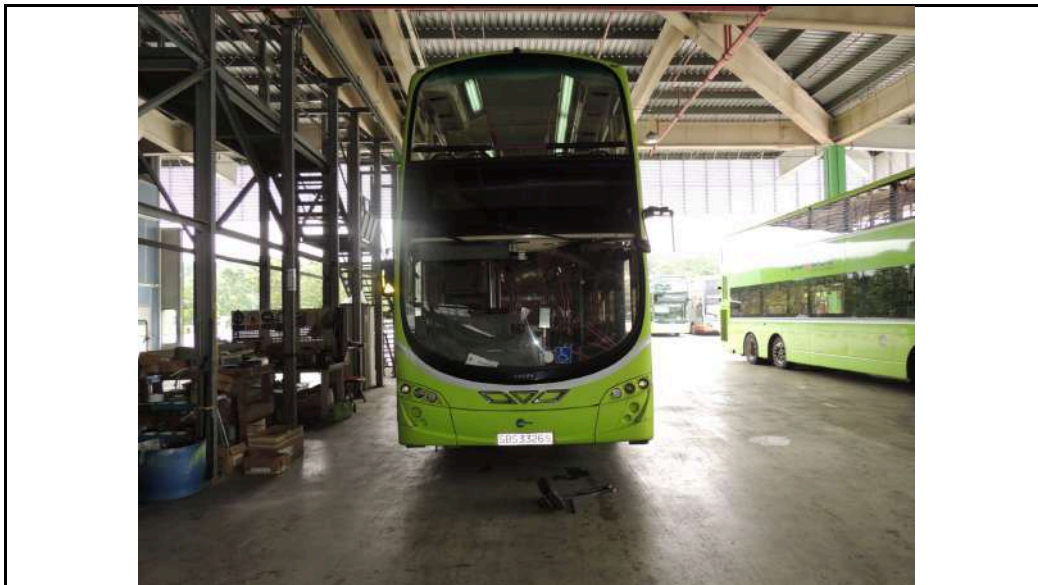
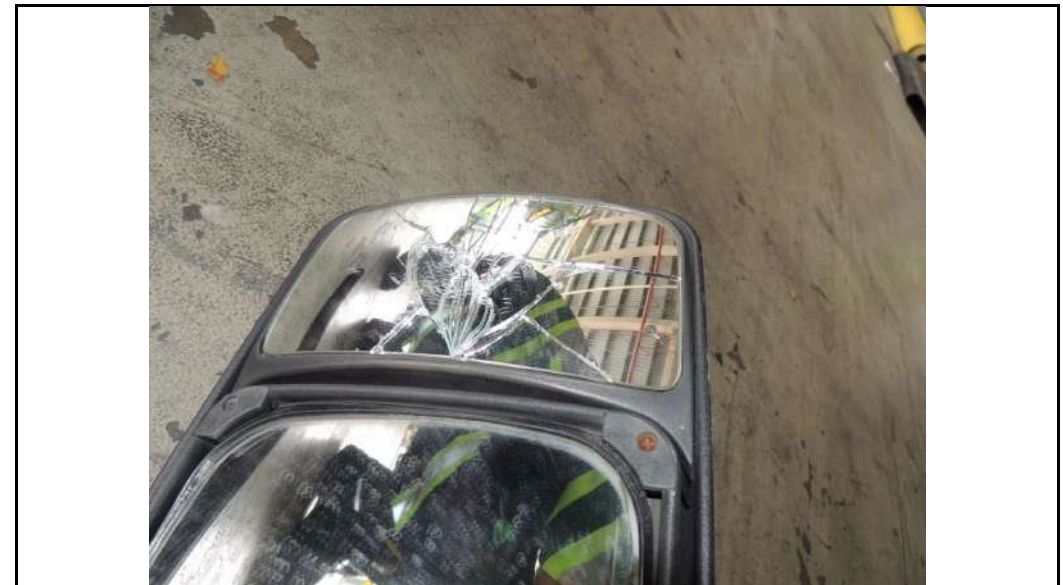
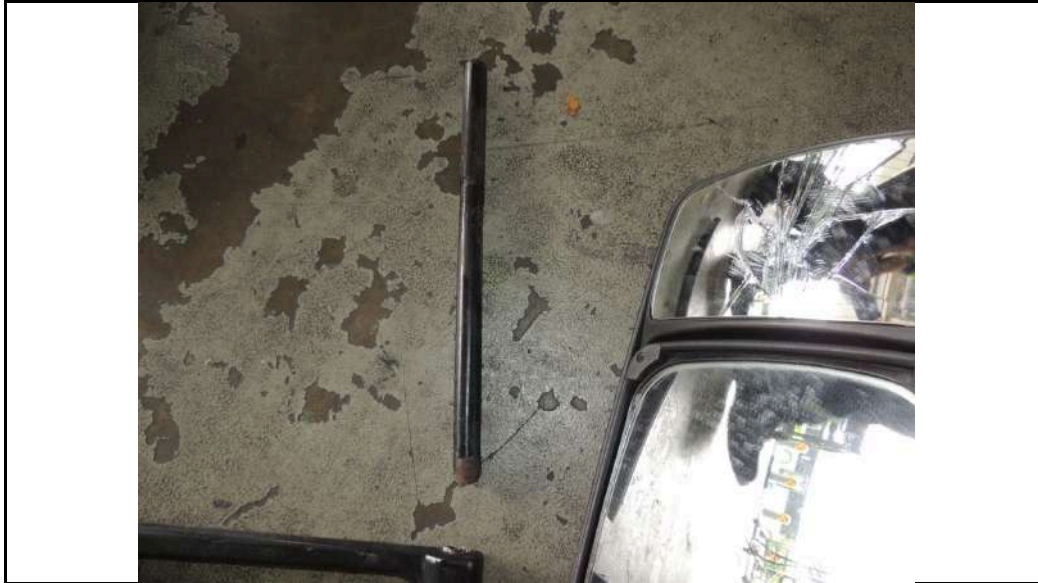
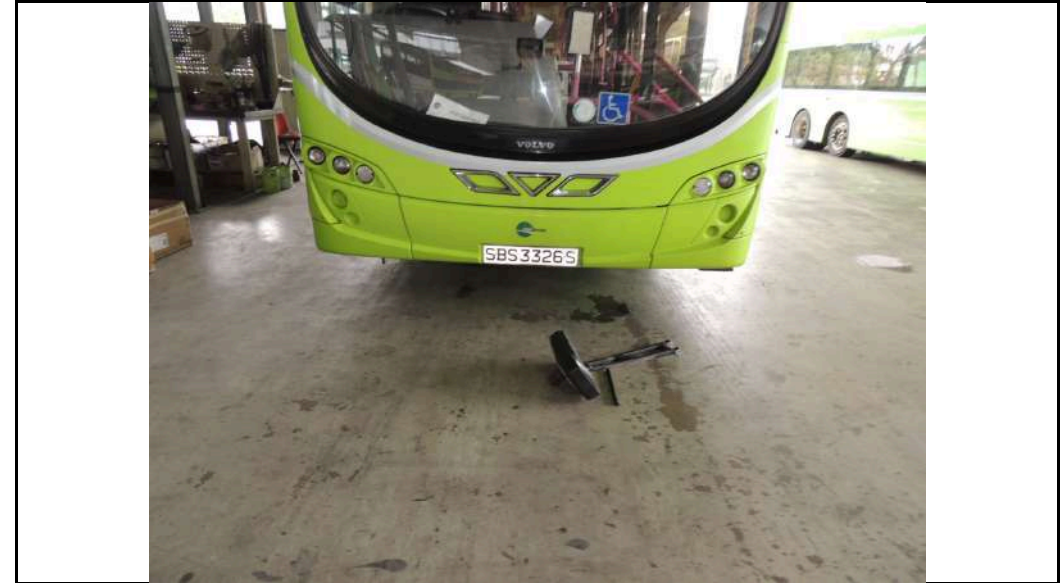
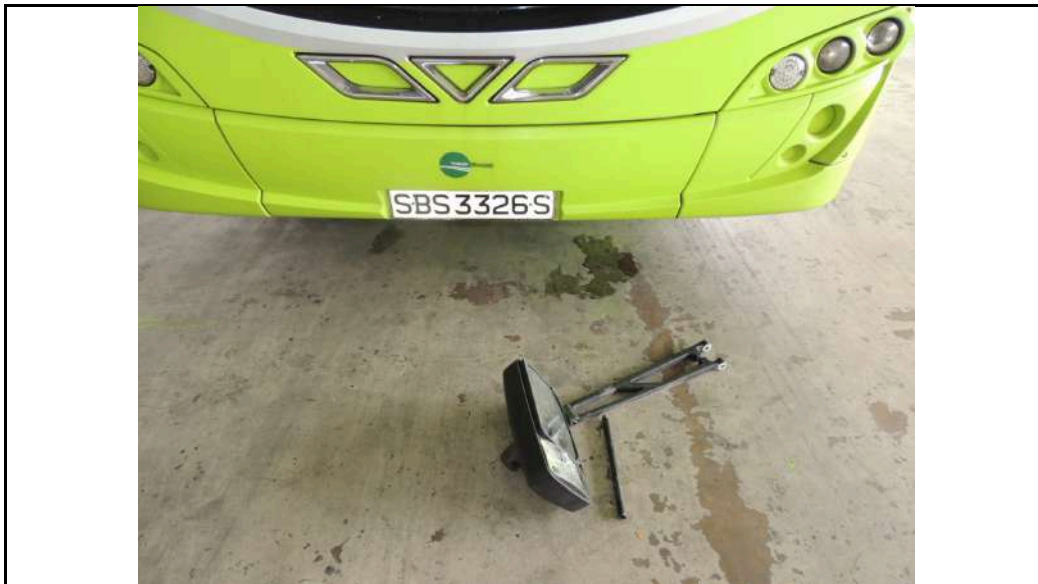
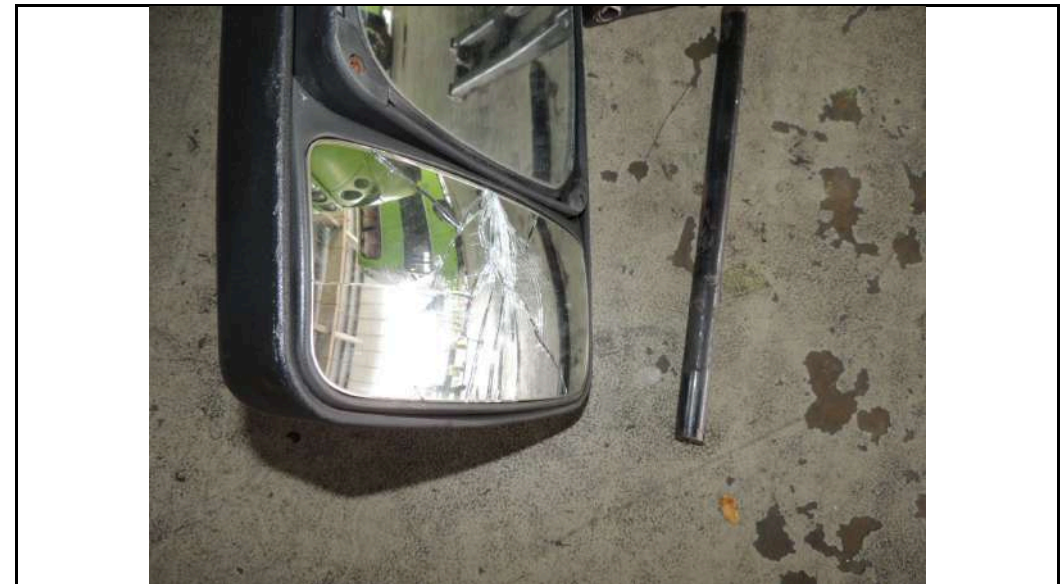
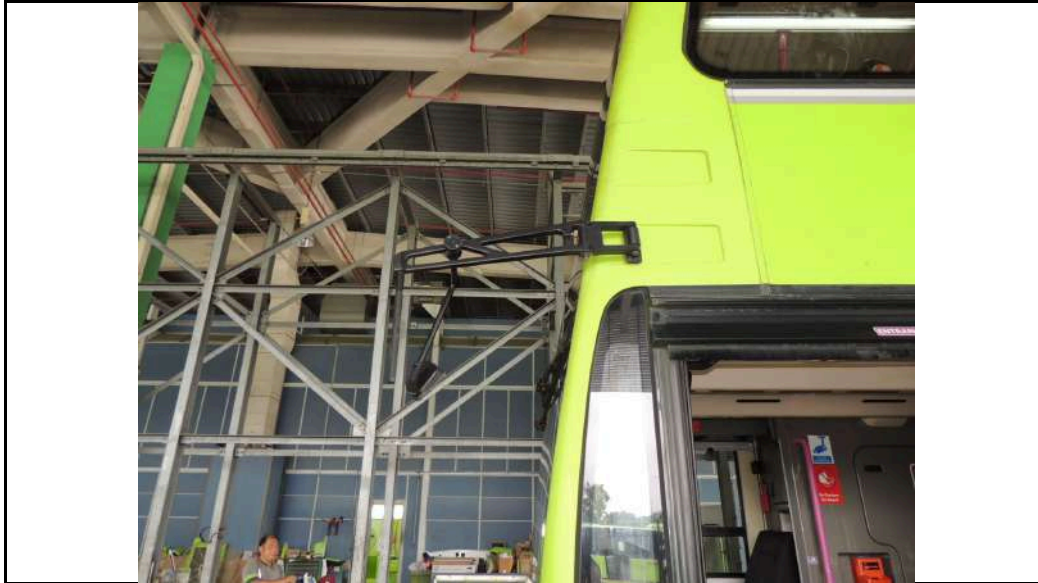
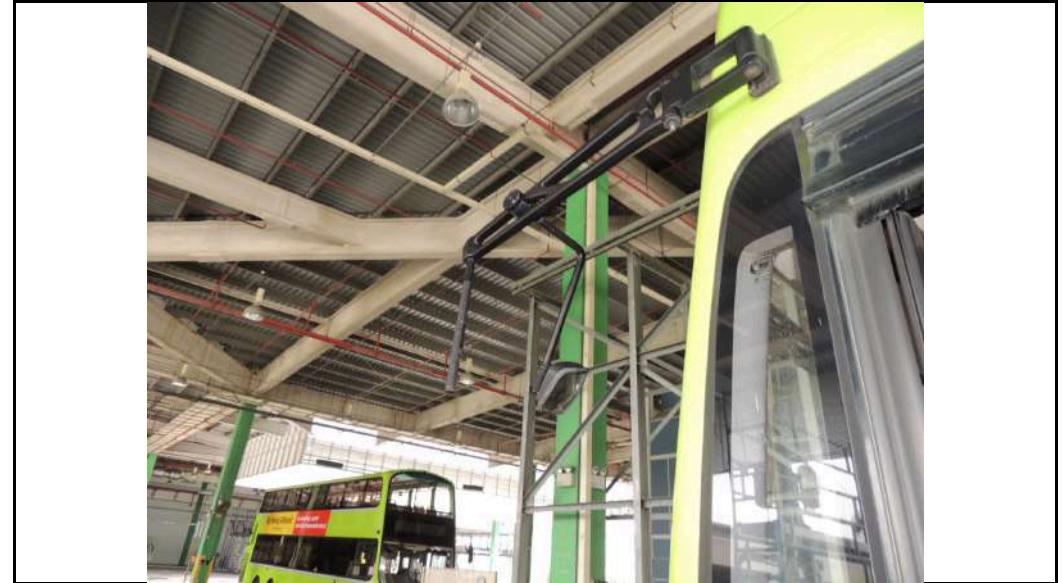
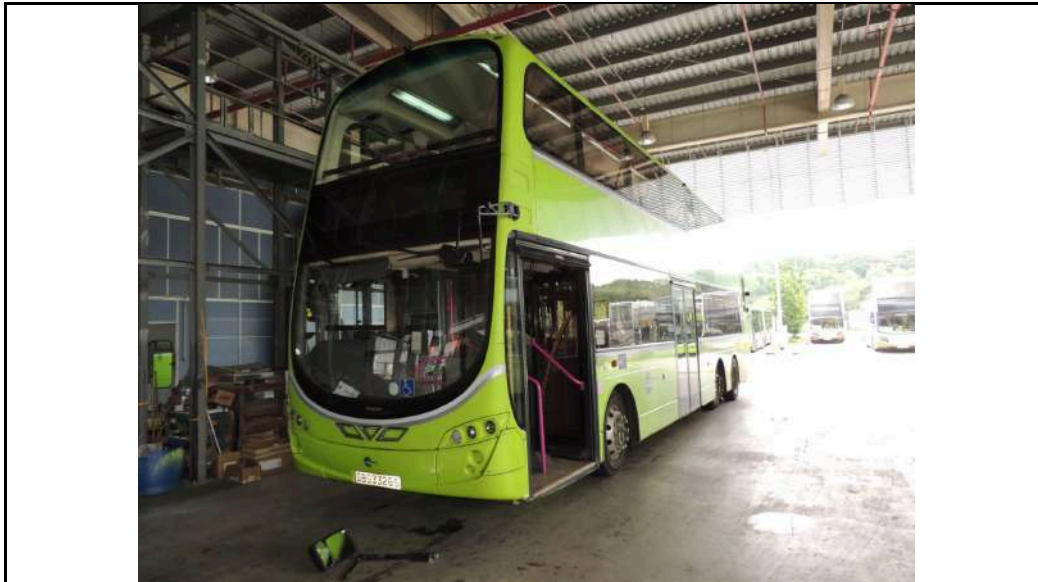
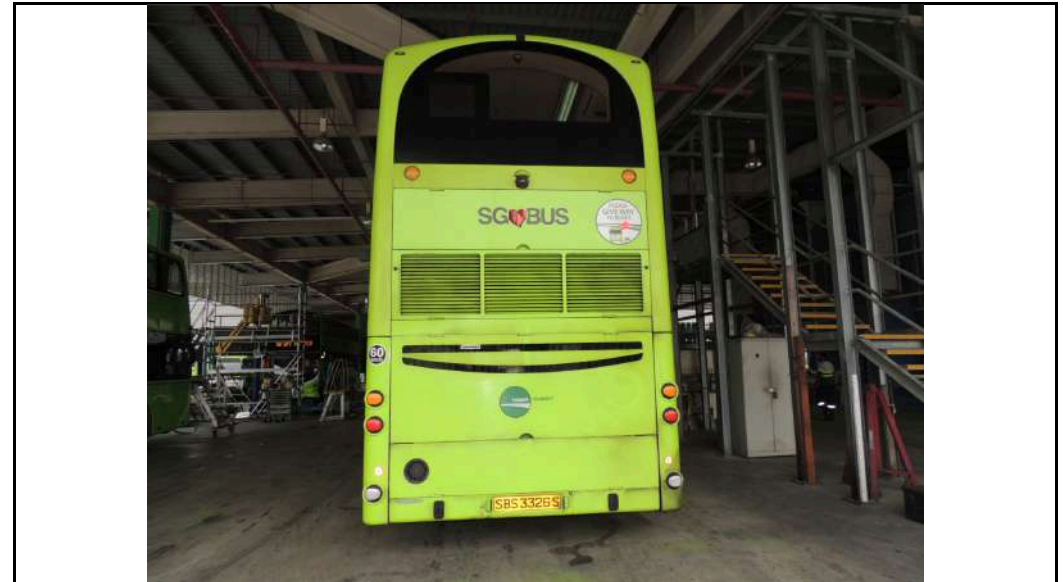
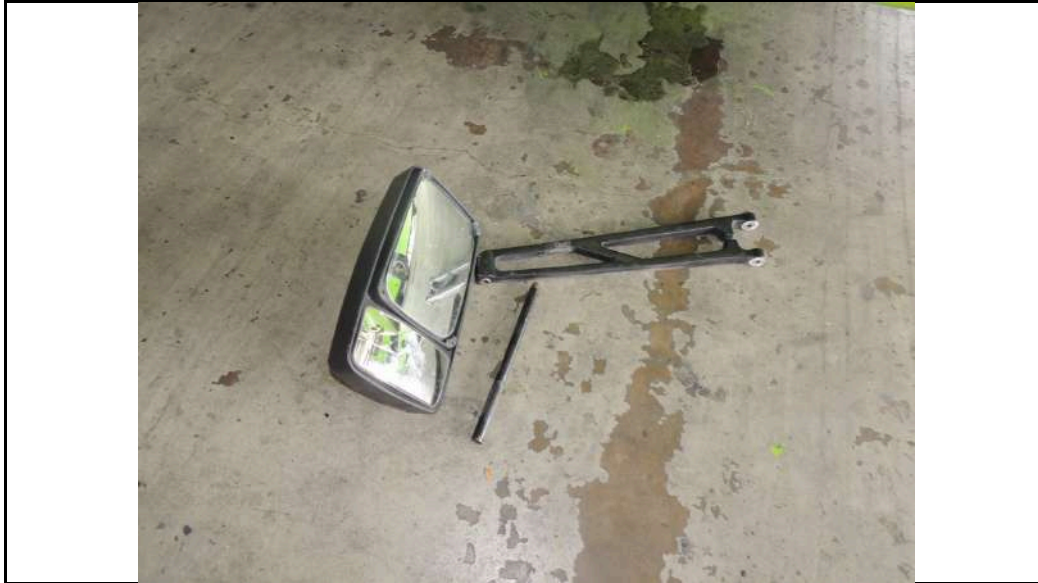
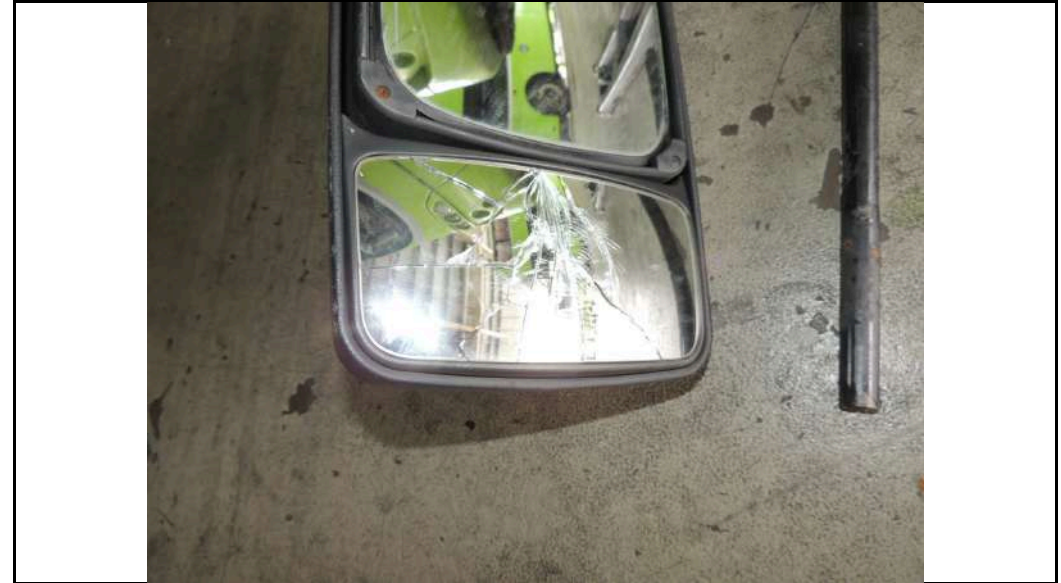
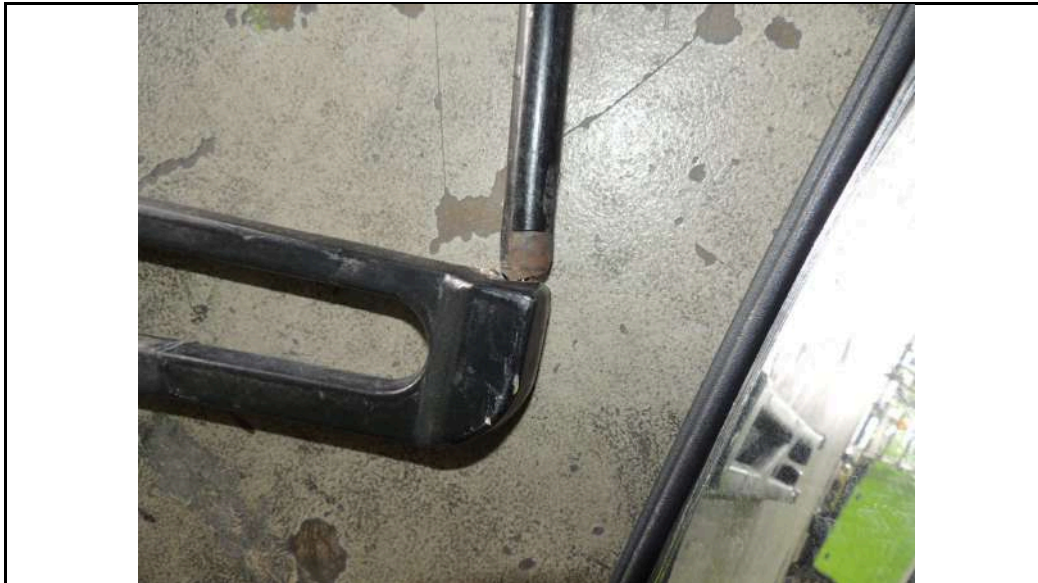
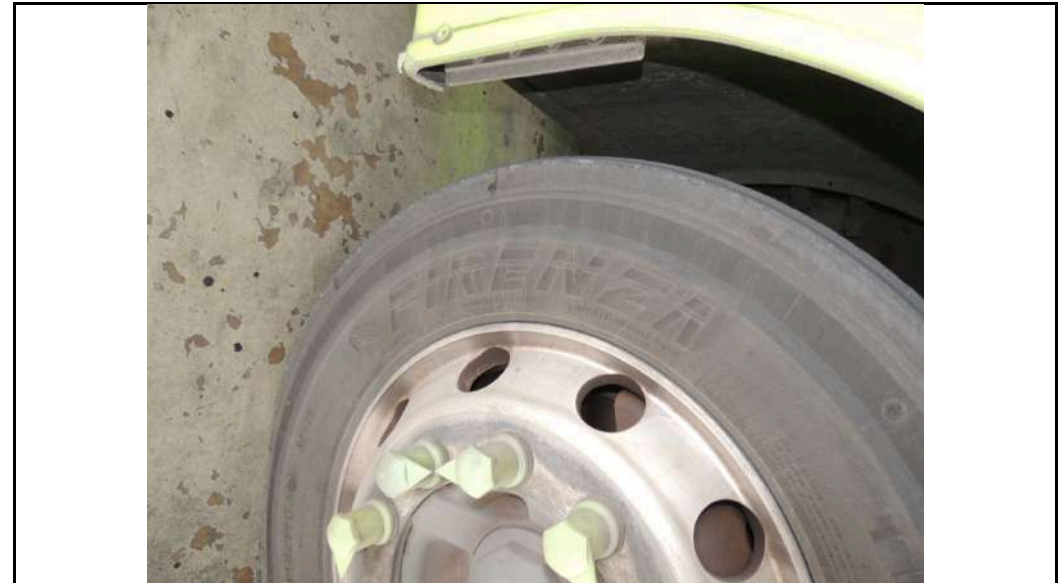
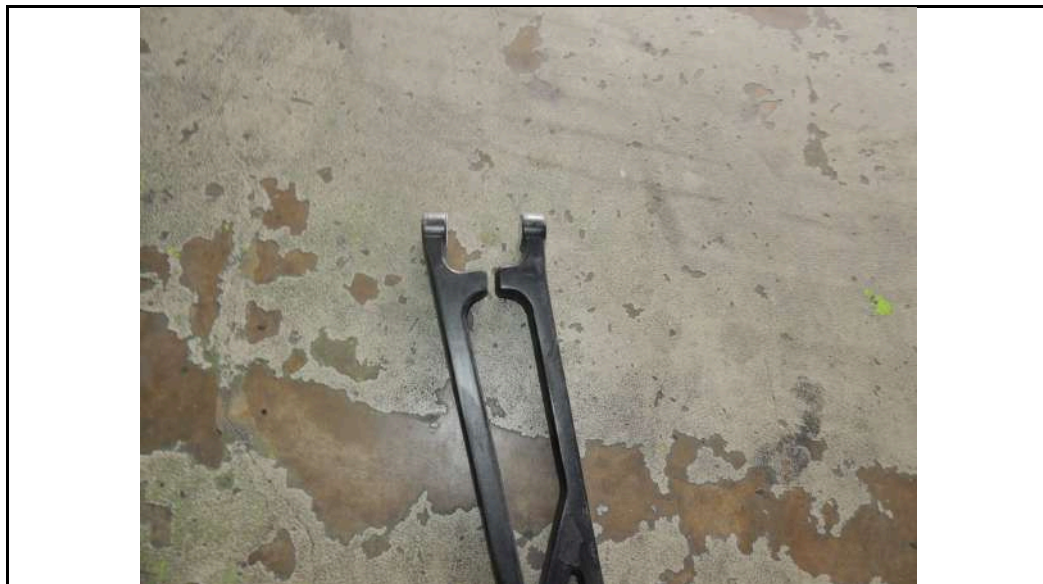
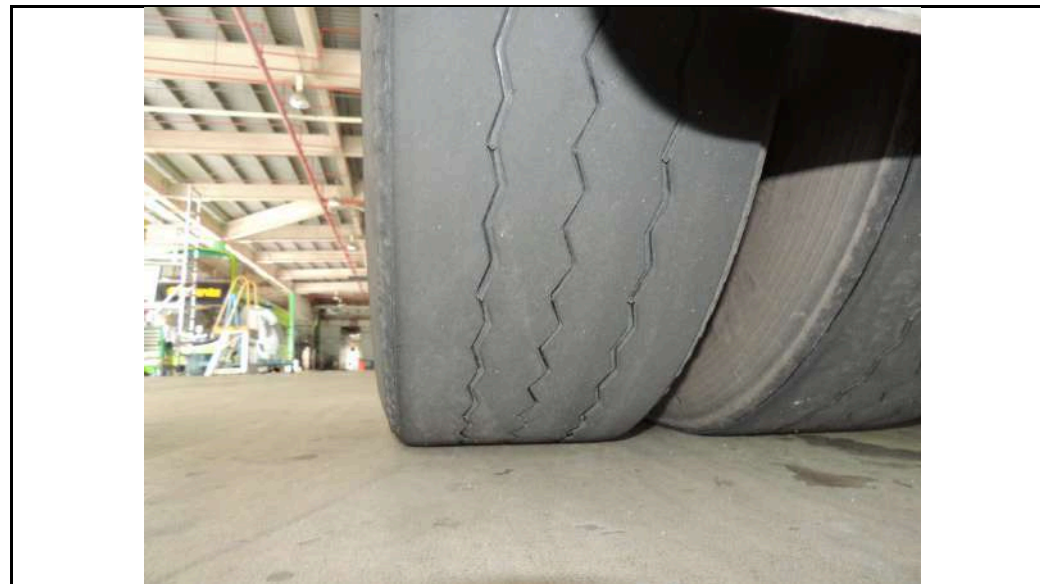
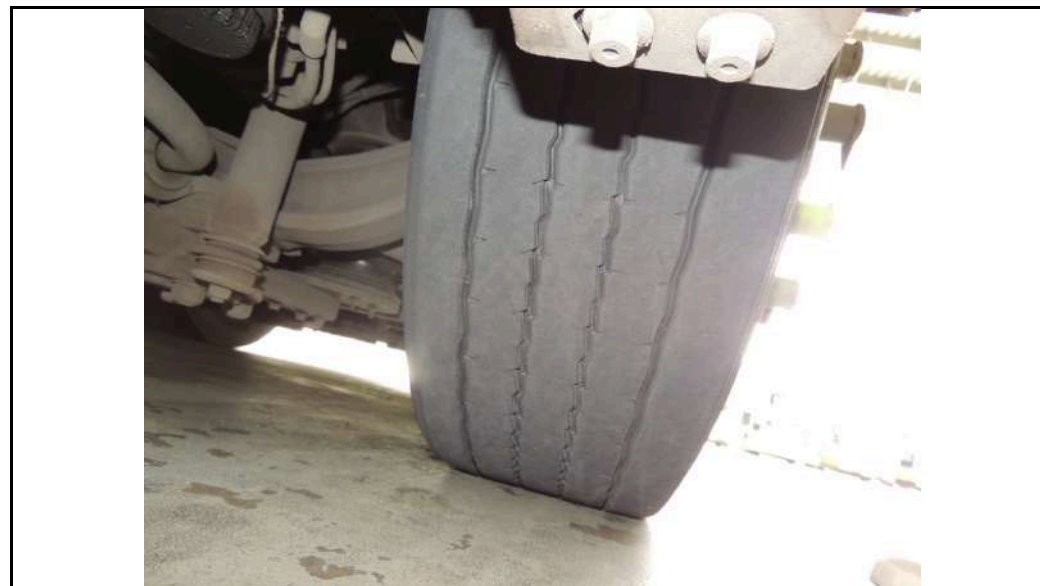
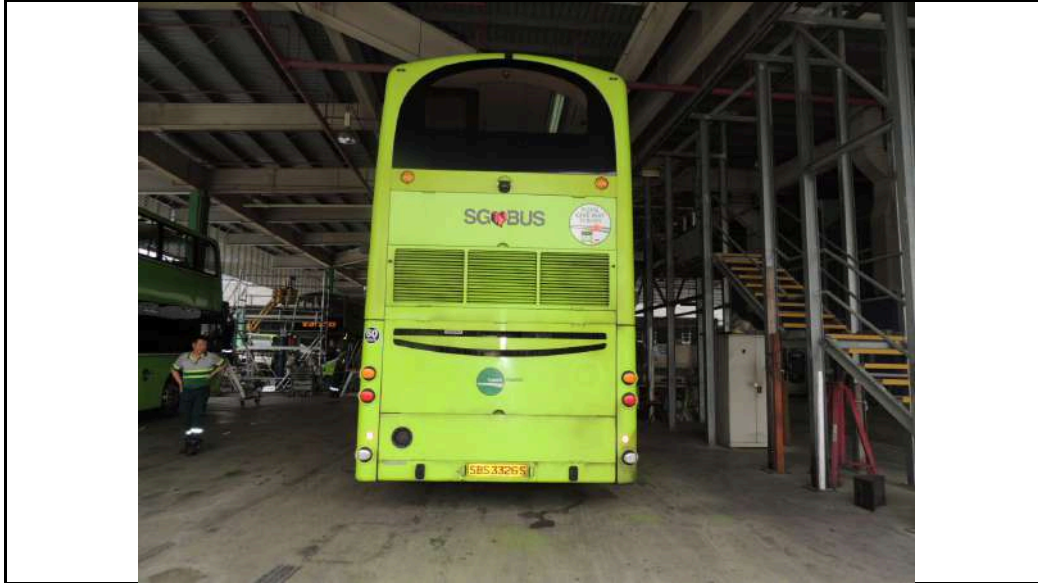
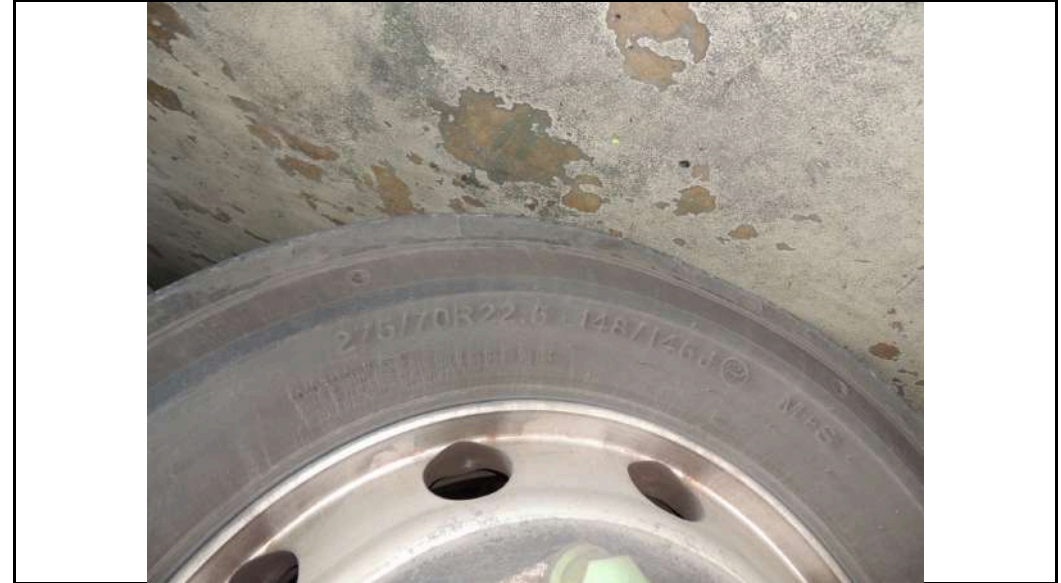
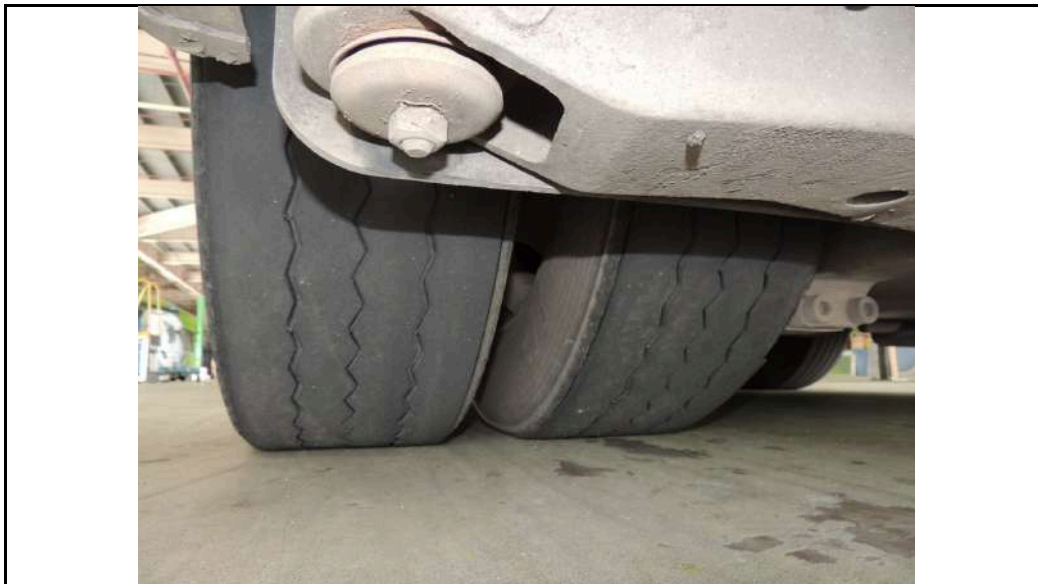
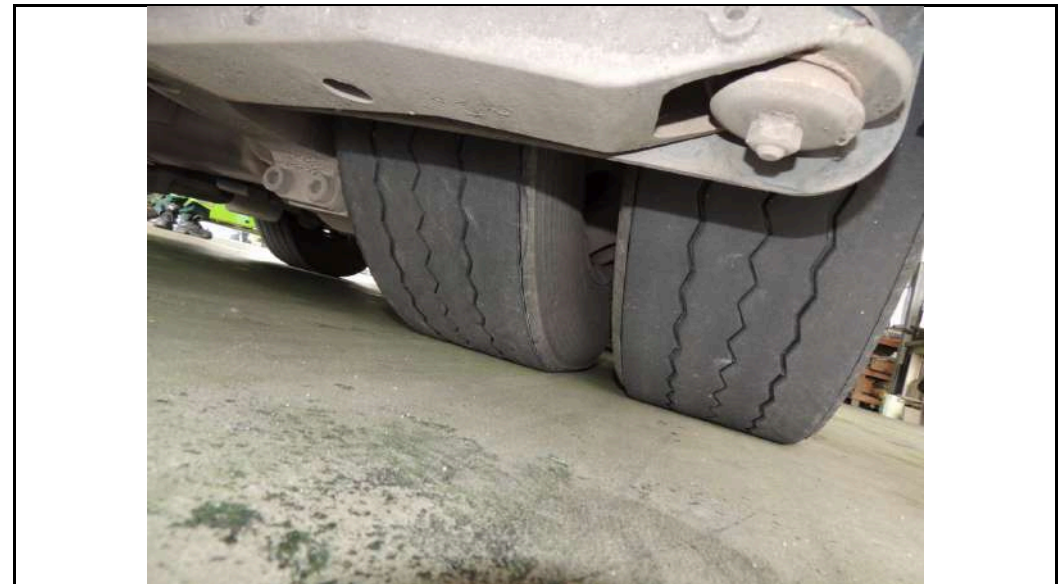
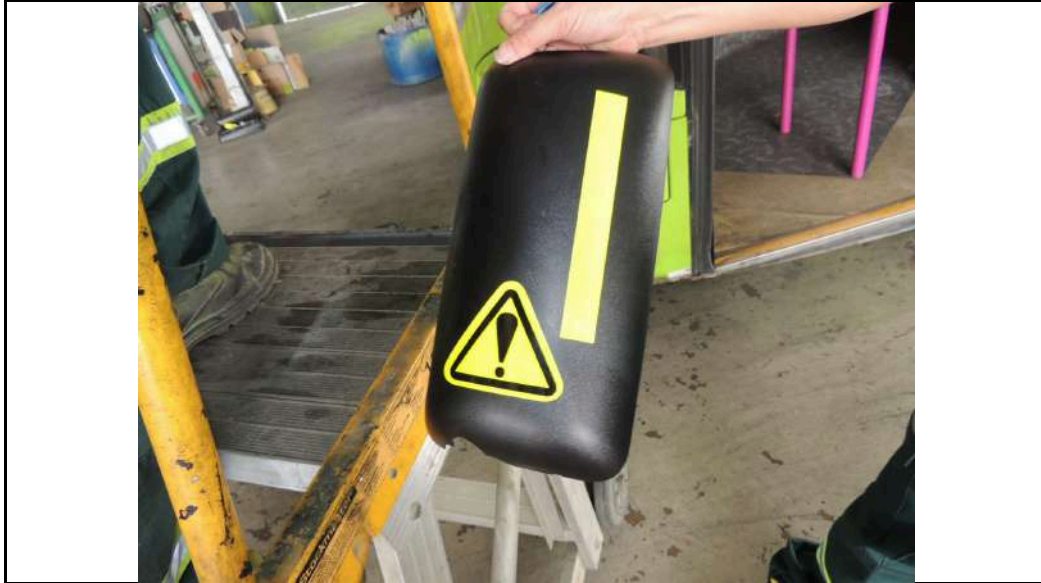
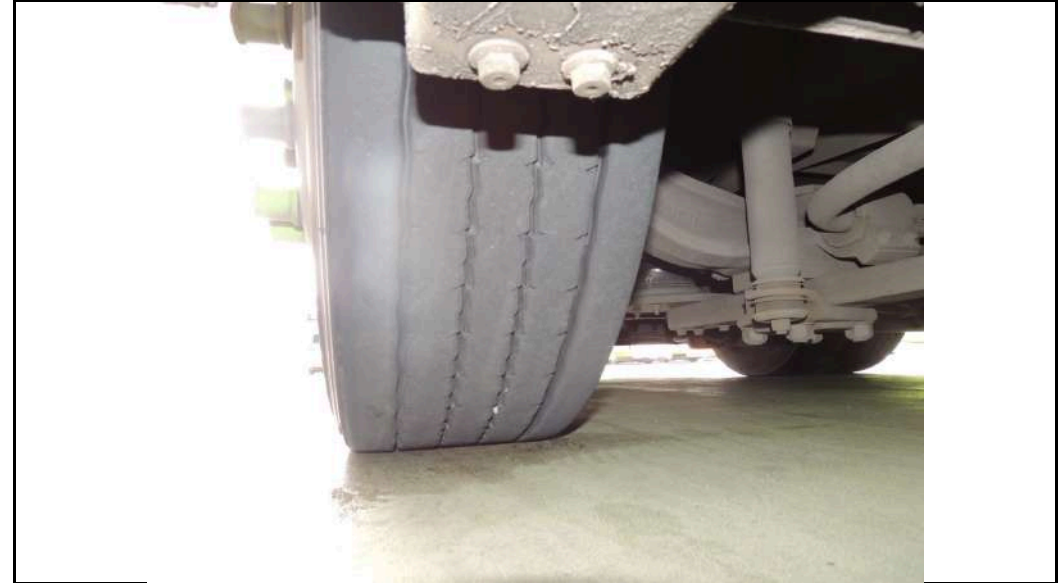
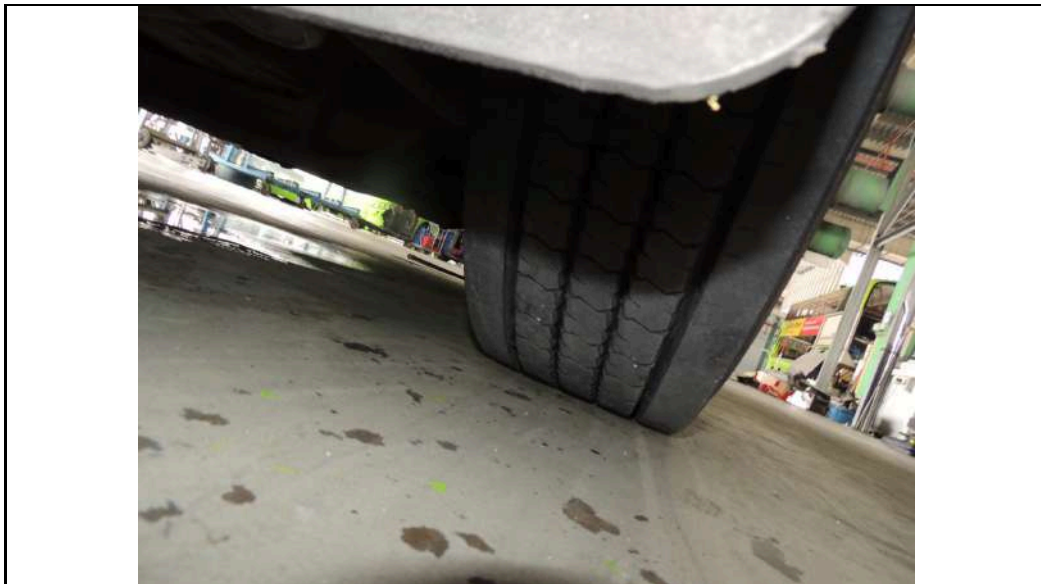
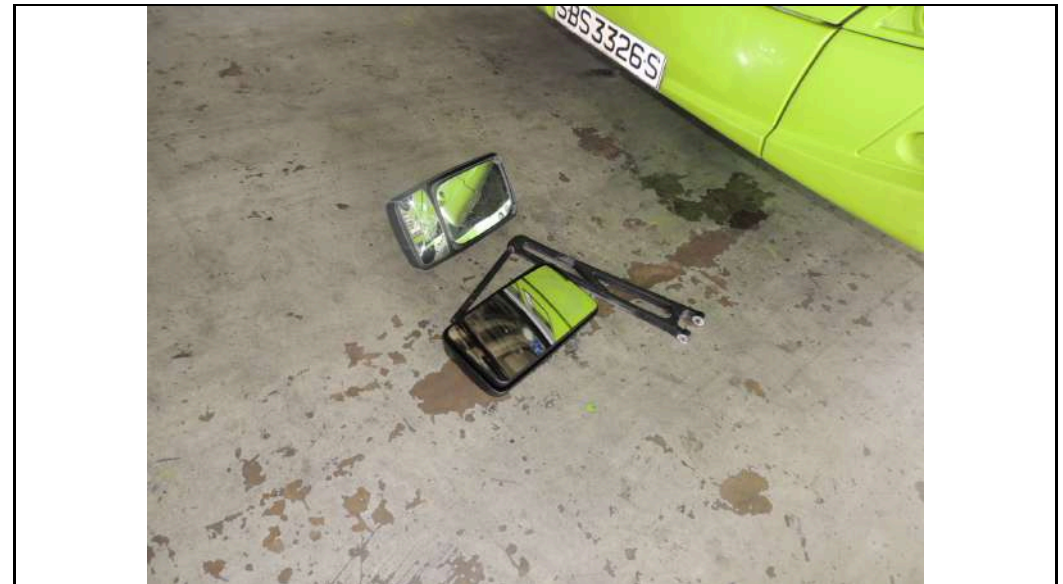
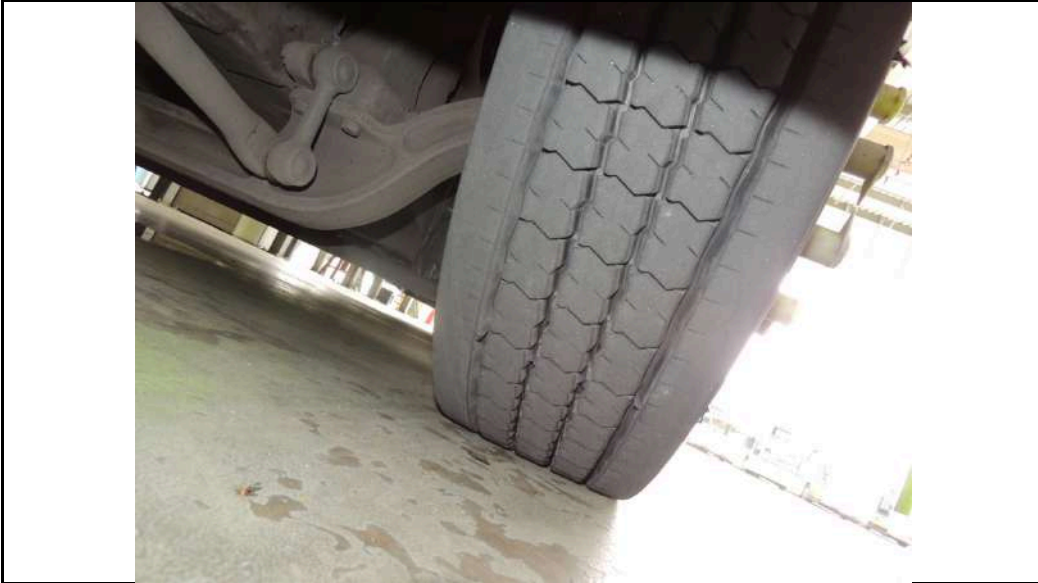
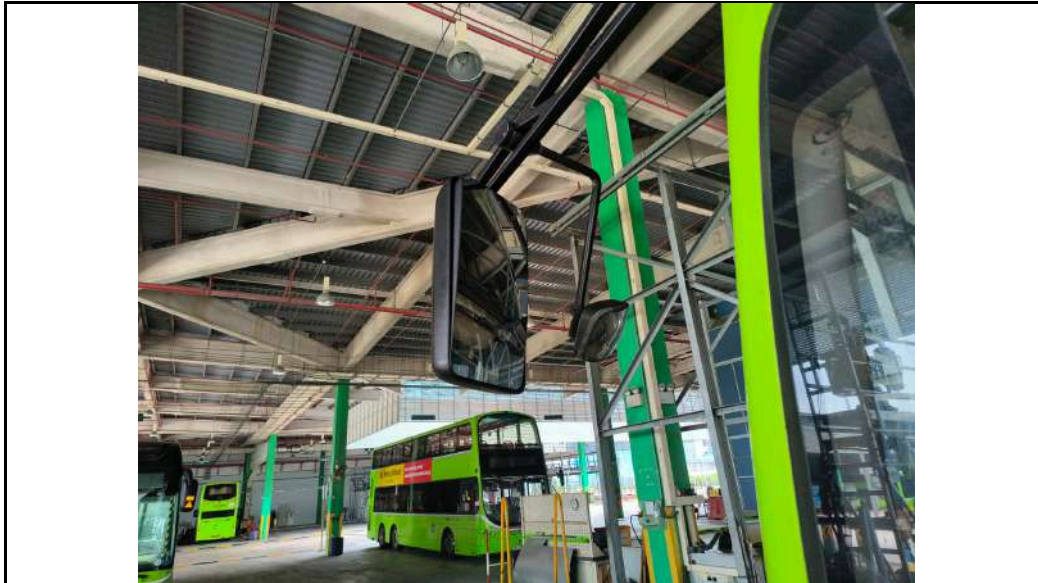
PHOTOGRAPHS FOR VEHICLE NO. : SBS 3326S

THE VEHICLE SUSTAINED DAMAGES AT THE N/S FRONT PORTION.

DAMAGES SEE DETAILS.

REPLACEMENT OF PARTS				
Qty	Description of Parts	Condition	Workshop Estimate (\$)	Our Adjusted (\$)
1	NSF VIEW MIRROR ASSY	CRACKED	\$2,025.96	\$2,025.96
1	THIRD MIRROR VOLVO	NOT NECESSARY	\$141.90	\$0.00
1	MIRROR ARM(THIRD MIRROR)	NOT NECESSARY	\$284.26	\$0.00
2	REFLECTOR STICKER	NECESSARY	\$88.00	\$88.00
			\$0.00	\$0.00
			\$2,540.12	\$2,113.96

Labour				
	Description of Parts	Condition	Workshop Estimate (\$)	Our Adjusted (\$)
	TO DISMANTLE & REPLACE :- DISMANTLE AND REPLACE ITEM NO: 1-4.		\$2,600.00	\$325.00
			\$2,600.00	\$325.00

RECOMMENDED COST OF REPAIRS			\$2,438.96
--	------------------------------------	--	--	-------------------
