**LKK Auto Consultants Pte Ltd**

ADJUSTMENT ON REPAIR COST FOR VEHICLE NO SKT 8525P

Report Ref No: CS/SMR24090017/Kqp3e2

PHOTOGRAPHS FOR VEHICLE NO. : SKT 8525P

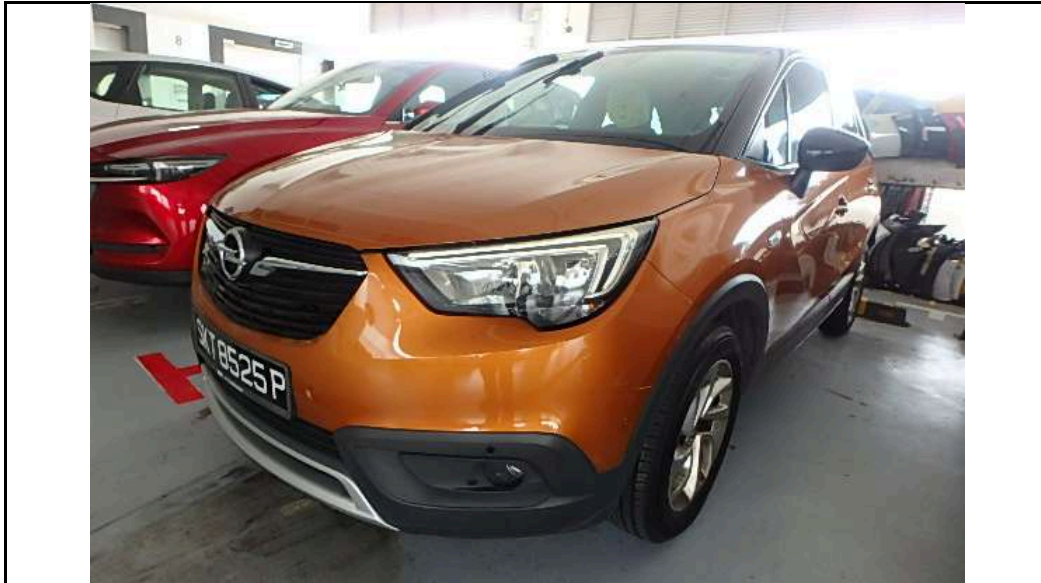
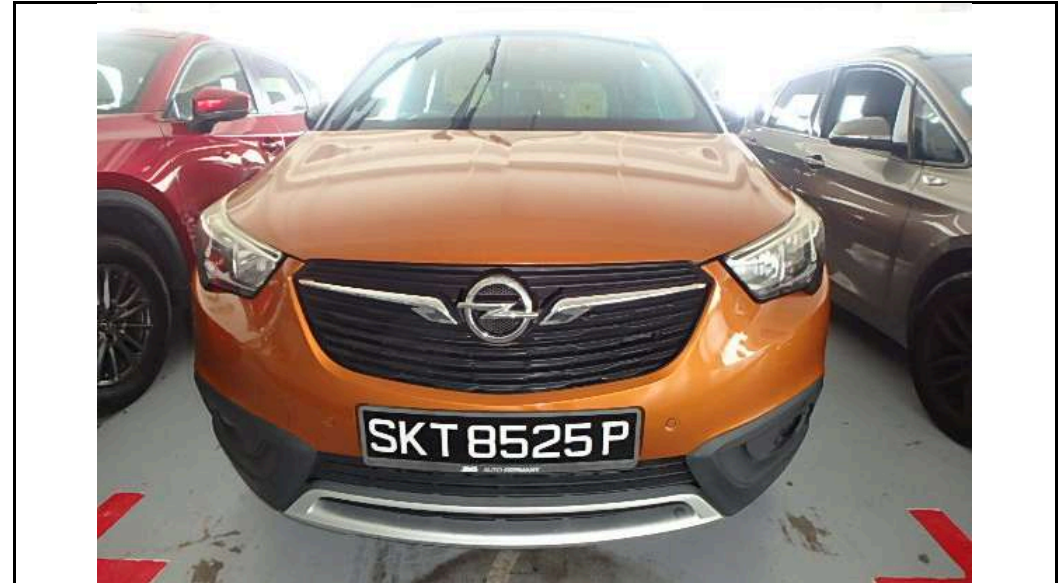
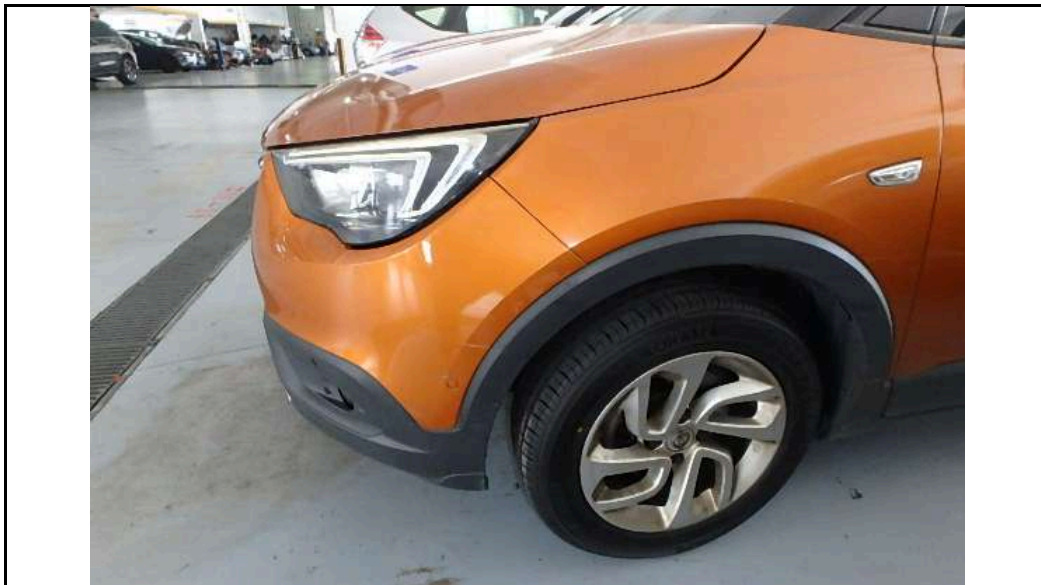
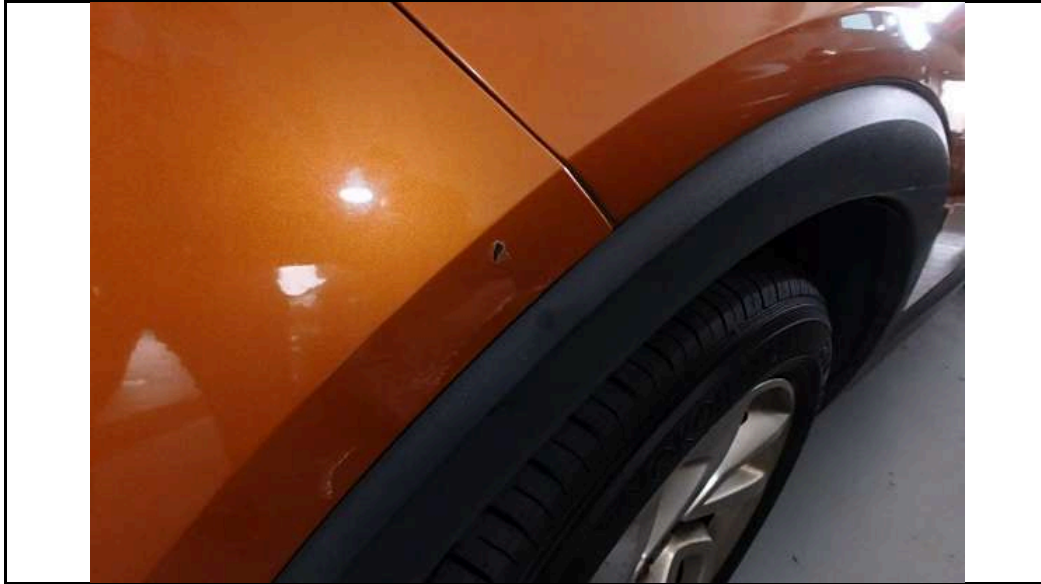
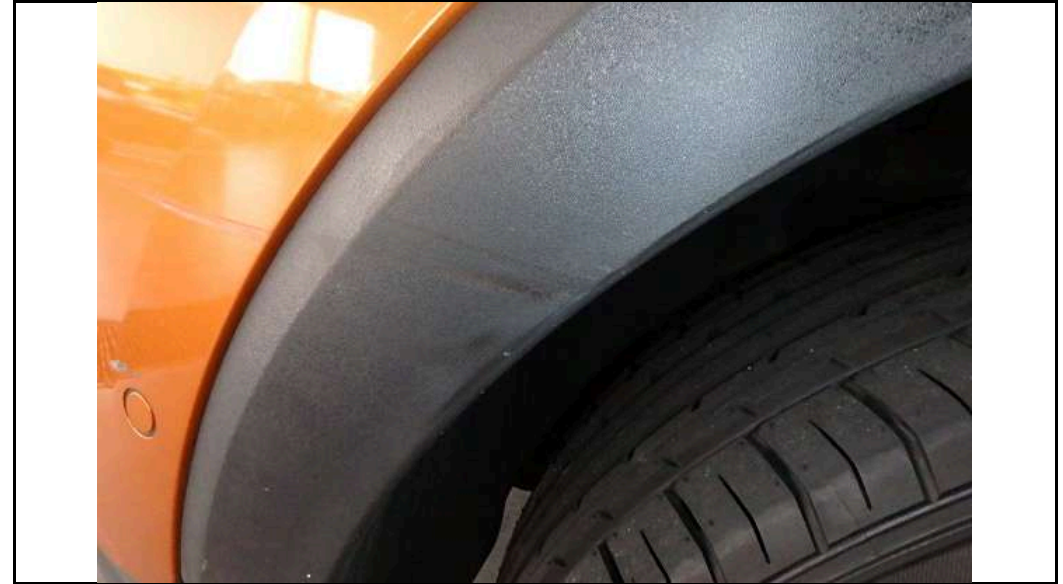
THE VEHICLE SUSTAINED DAMAGES AT THE N/S FRONT BODY.

DAMAGES SEE DETAILS.

REPLACEMENT OF PARTS				
Qty	Description of Parts	Condition	Workshop Estimate (\$)	Our Adjusted (\$)
1	FRONT BUMPER	MTG CRACKED	\$1,831.00	\$1,831.00
1	FRONT BUMPER LH OUTER PARKING SENSOR	SERVICEABLE	\$285.00	\$0.00
1	FRONT BUMPER LOWER PAD	CUT	\$190.00	\$190.00
1	FRONT BUMPER LH SIDE RETAINER	SERVICEABLE	\$72.00	\$0.00
1	LH SIDE MIRROR ASSY	DENTED/CUT	\$810.00	\$810.00
	LESS 10.00% DISCOUNT		(\$318.80)	(\$283.10)
			\$2,869.20	\$2,547.90
Special Nett				
Qty	Description of Parts	Condition	Workshop Estimate (\$)	Our Adjusted (\$)
1	FRONT BUMPER CLIPS (SN)	NECESSARY	\$99.00	\$50.00
			\$99.00	\$50.00
Labour				
	Description of Parts	Condition	Workshop Estimate (\$)	Our Adjusted (\$)
	TO RESET HEADLAMP SYSTEM		\$280.00	\$20.00
	TO REPAIR DAMAGES		\$380.00	\$260.00
	TO SPRAY PAINTING		\$480.00	\$400.00
			\$1,140.00	\$680.00
GRAND TOTAL			\$4,108.20	\$3,277.90
	RECOMMENDED COST OF LUMP SUM REPAIRS (TO ITS PRE-ACCIDENT CONDITION)			\$2,600.00

ESTIMATED NORMAL PERIOD FOR REPAIR: 4 Working Days
