MS STRIDES PREMIER AUTOMOTIVE SERVICES PL.	Ref:	CS/SMR24090119/Kvp3m4
60 WOODLANDS INDUSTRIAL PARK E4 SINGAPORE 757705	Date:	27/09/2024
	Code:	SMR

1. Policy Particulars :- THIRD PARTY CLAIM

ADJUSTMENT ON REPAIR COST FOR VEHICLE NO SNE 8044D

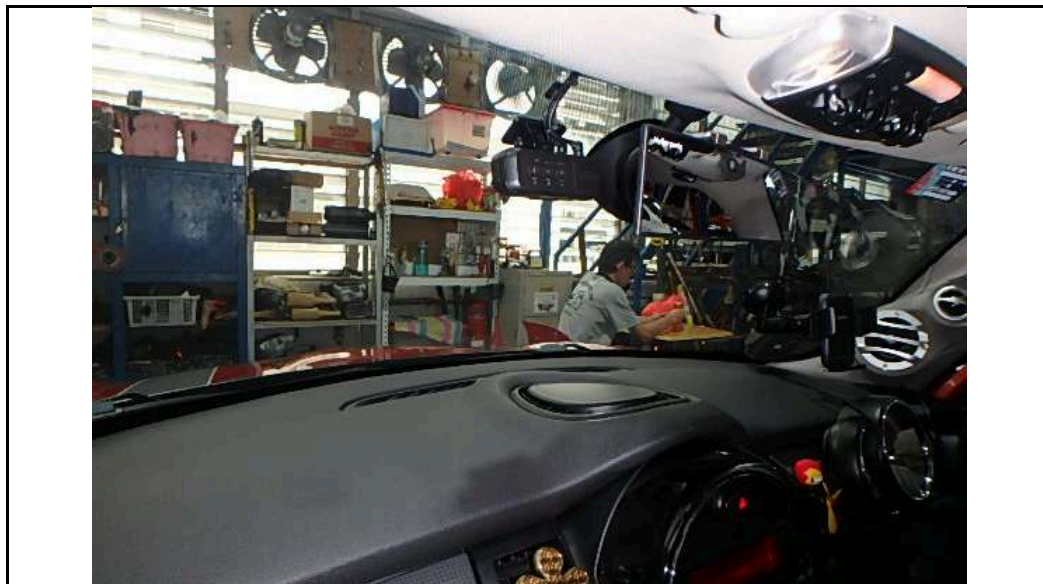
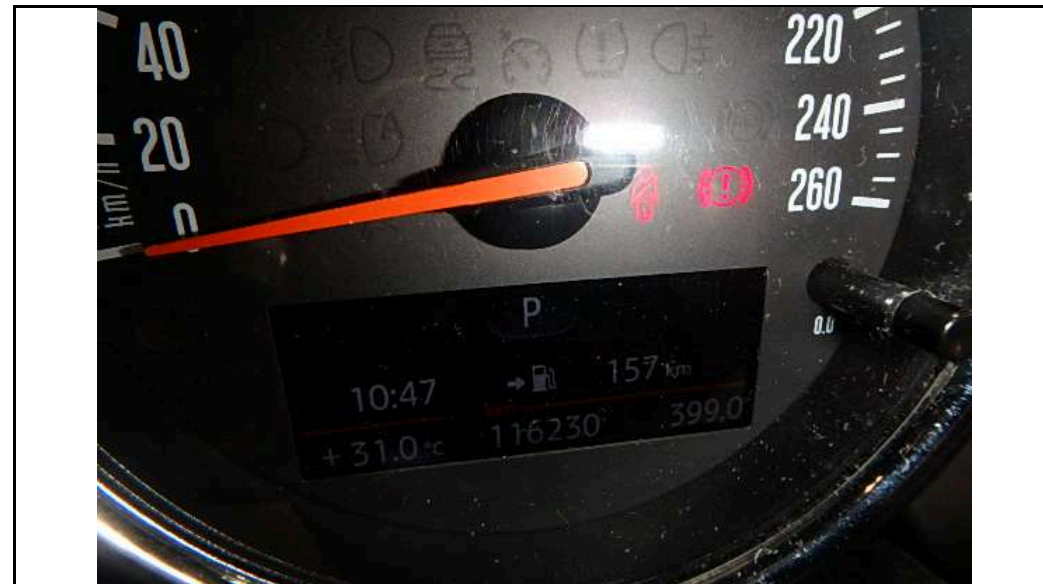
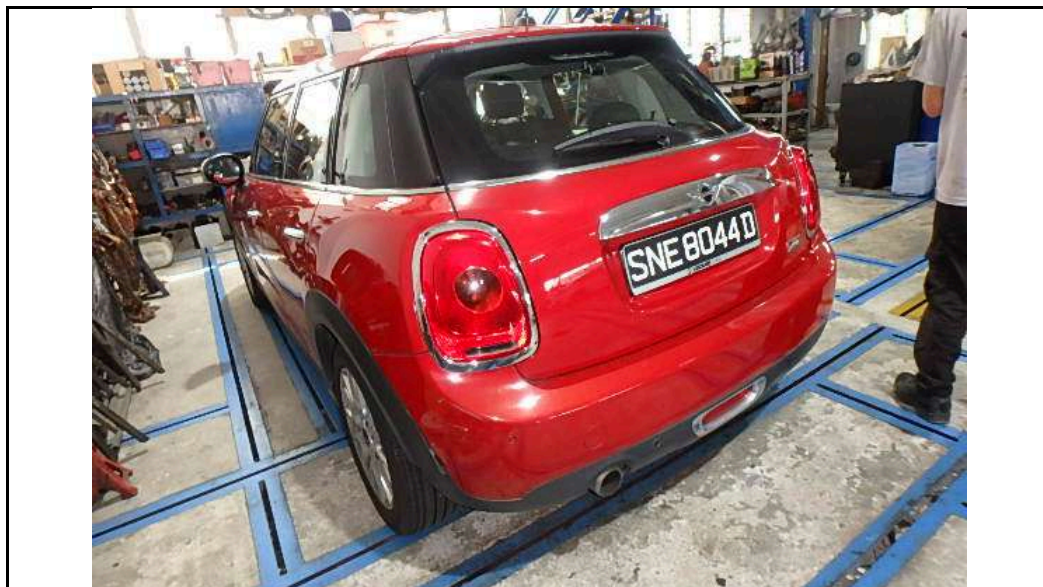
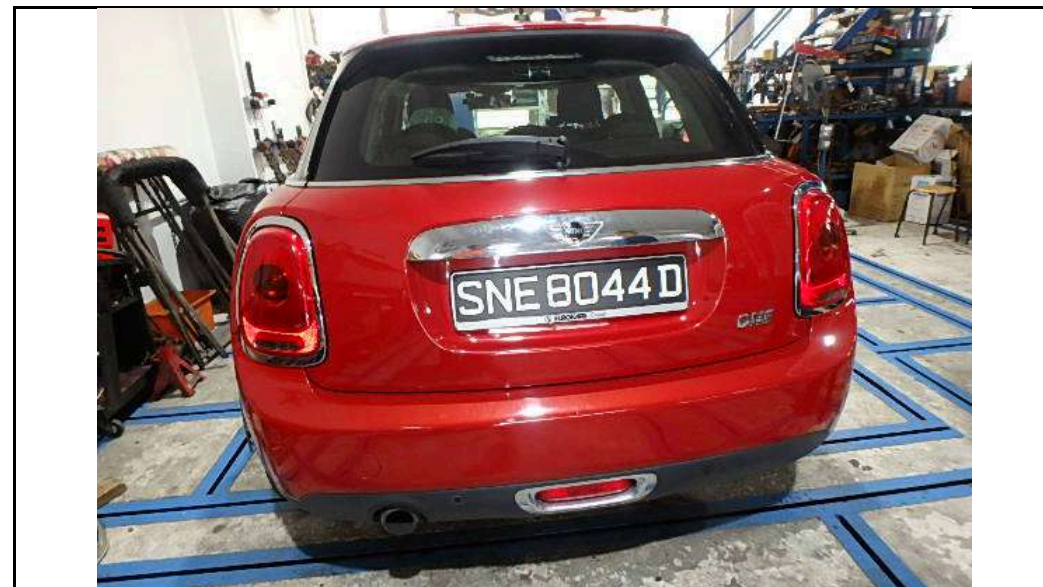
INSPECTION PHOTOS (Page 1 of 3)

THE VEHICLE SUSTAINED DAMAGES AT THE N/S REAR PORTION.

REPLACEMENT OF PARTS				
Qty	Description of Parts	Condition	Workshop Estimate (\$)	Our Adjusted (\$)
1	REAR BUMPER	DENTED/CRACKED	\$1,614.60	\$1,268.70
1	REAR BUMPER SIDE GUIDE LH	CRACKED	\$284.00	\$284.00
1	REAR BUMPER LOWER GARNISH	MTG CRACKED	\$490.00	\$296.40
2	REAR LAMP L/R @\$493.00	O/S SERVICEABLE/ N/S MTG CRAKED	\$986.00	\$410.00
2	REAR LAMP CHROME RIM L/R @\$128.00	N/S SCRATCHED	\$256.00	\$128.00
1	REAR FENDER WHEEL ARCH LH	MTG CRACKED	\$286.00	\$155.20
	LESS 5.00% DISCOUNT		(\$195.83)	(\$127.12)
			\$3,720.77	\$2,415.18
Special Nett				
Qty	Description of Parts	Condition	Workshop Estimate (\$)	Our Adjusted (\$)
1	SET REAR BUMPER CLIPS (SN)	NECESSARY	\$55.00	\$55.00
1	SET REVERSE SENSOR (SN)	SERVICEABLE	\$250.00	\$0.00
			\$305.00	\$55.00
Labour				
	Description of Parts	Condition	Workshop Estimate (\$)	Our Adjusted (\$)
	TO REMOVE & REARRANGE ELECTRICAL WIRINGS, CHECK LIGHTINGS		\$80.00	\$20.00
	TO REMOVE, REPAIR & REPLACE DAMAGED BODYPARTS, REALIGN BODYWORK AND WHERE CONSISTENT TO THE ACCIDENT		\$400.00	\$200.00

PUTTY AND RESPRAY PAINTING ON AFFECTED PORTIONS		\$400.00	\$220.00
	TO REMOVE & RENEW REVERSE SENSOR		\$80.00	\$50.00
	RUST PROOFING ON AFFECTED PORTIONS	NOT NECESSARY	\$100.00	\$0.00
			\$1,060.00	\$490.00
GRAND TOTAL			\$5,085.77	\$2,960.18
RECOMMENDED COST OF LUMP SUM REPAIRS (TO ITS PRE-ACCIDENT CONDITION)				\$2,350.00
Report Ref No: CS/SMR24090119/Kvp3m4

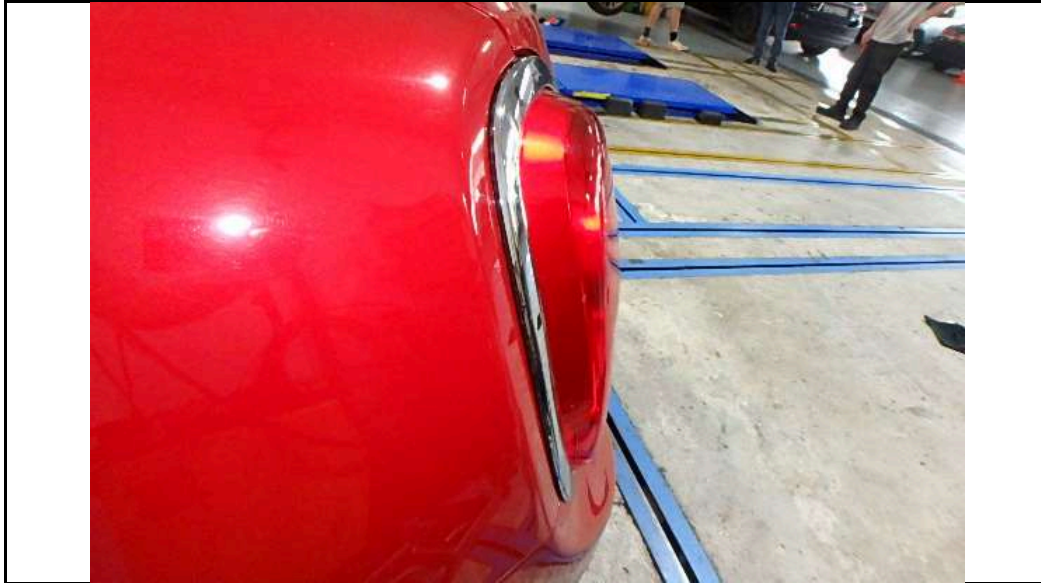
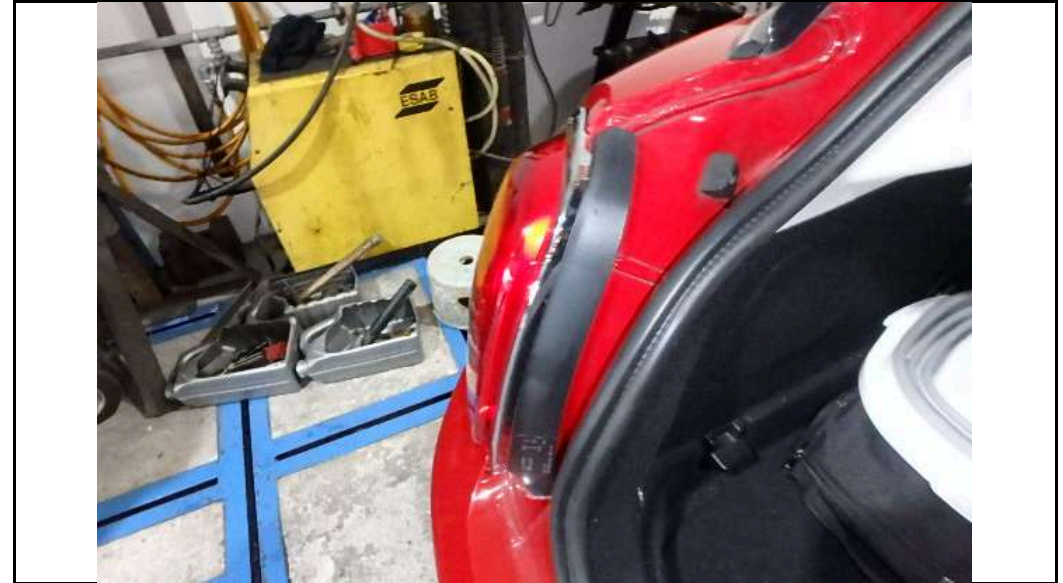
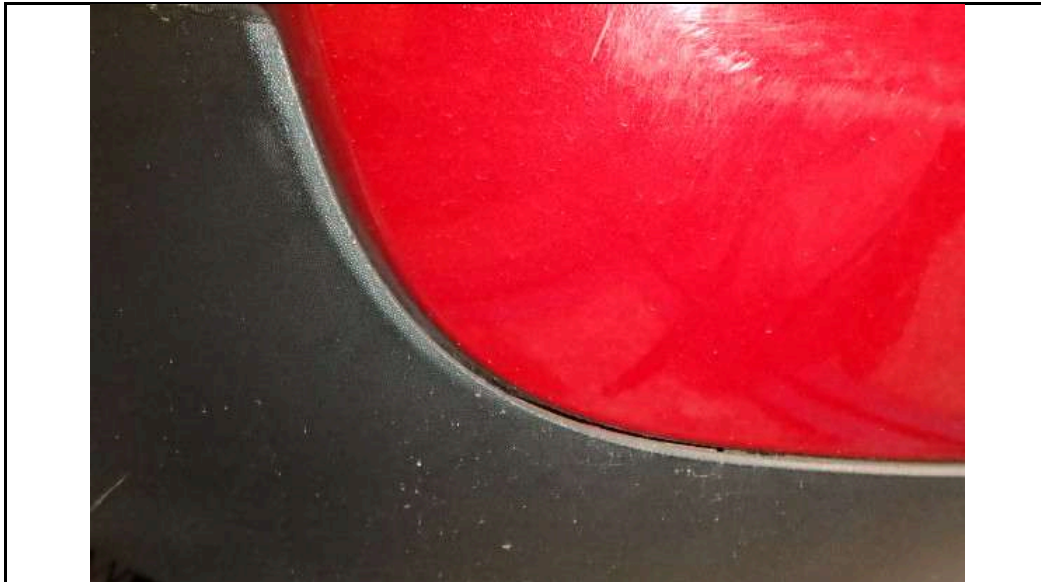
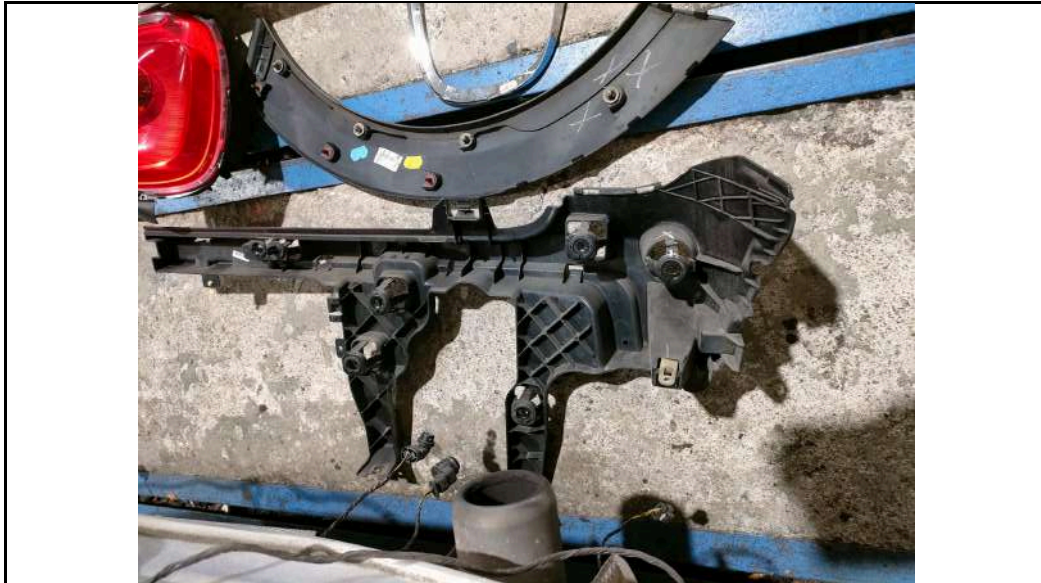
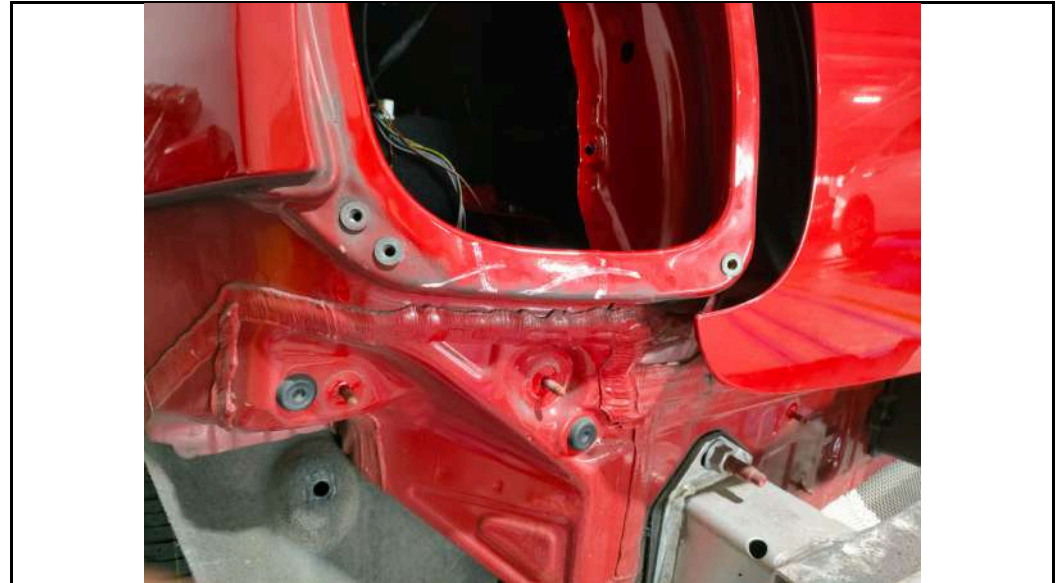
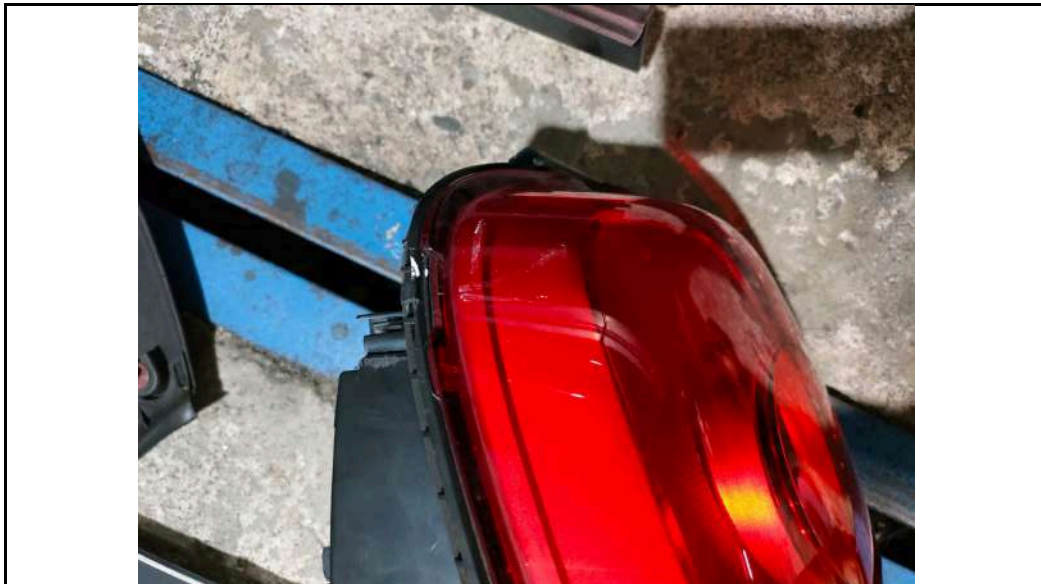
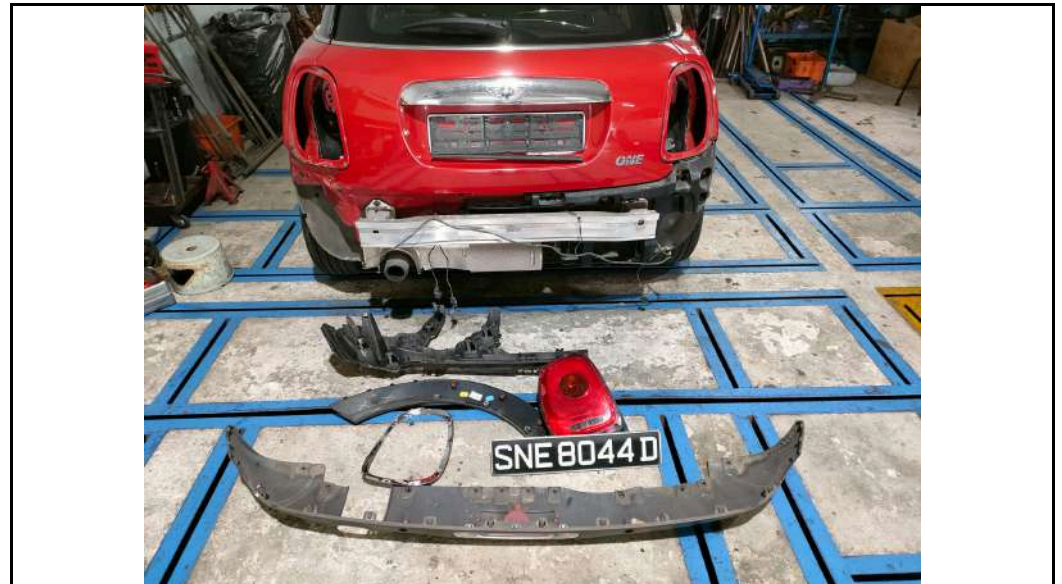
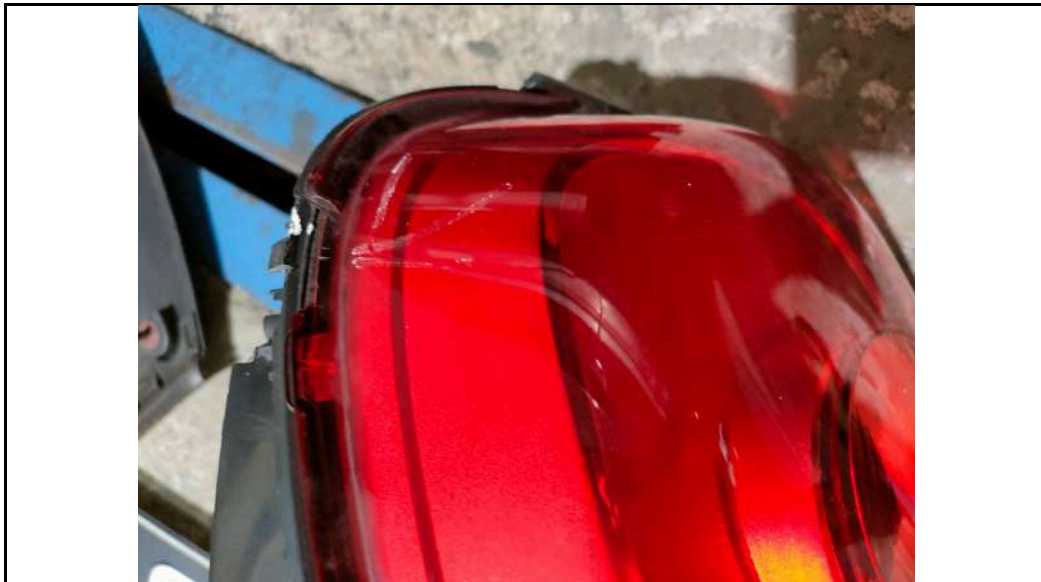
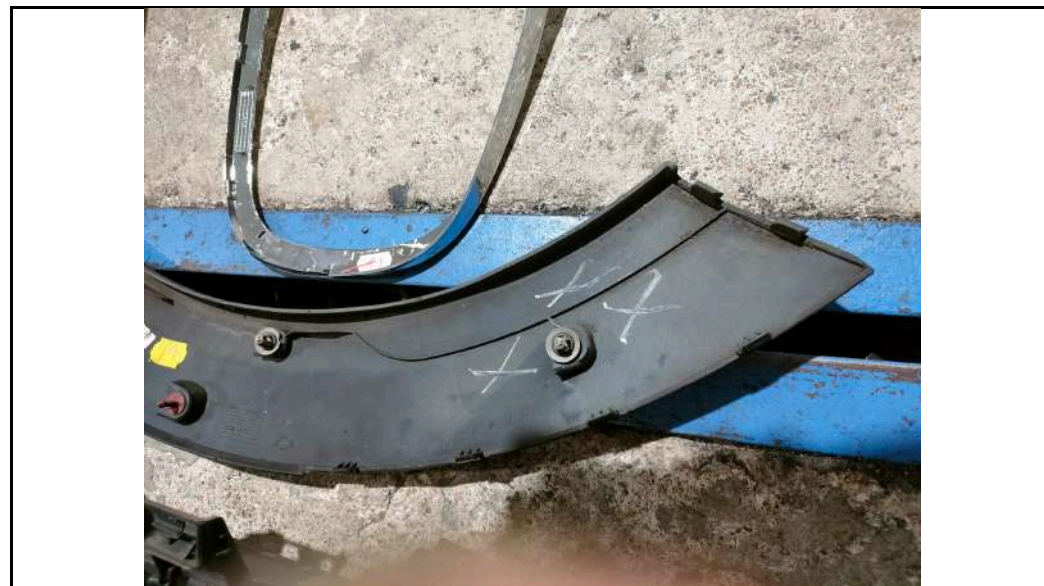
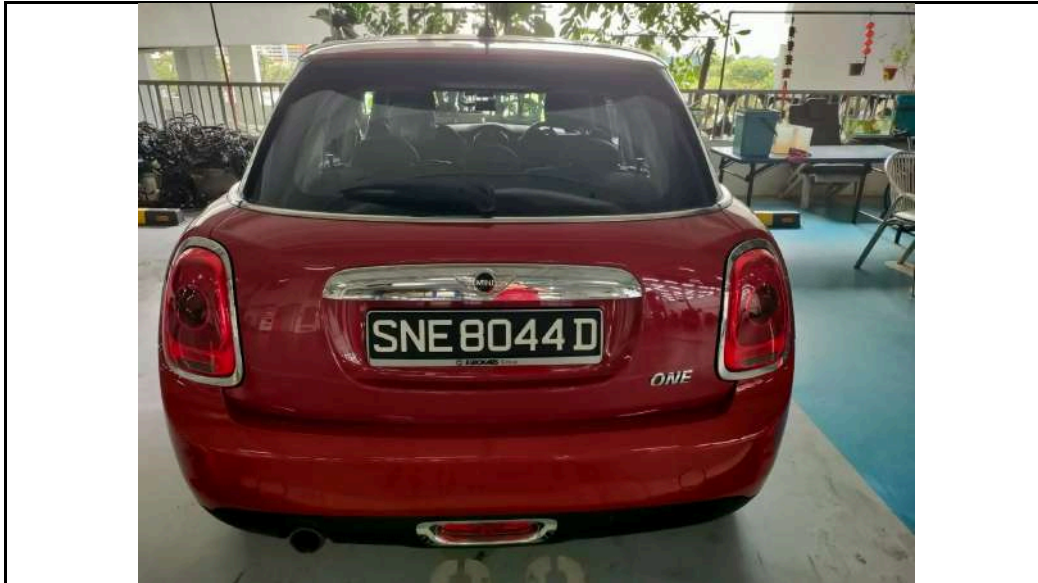
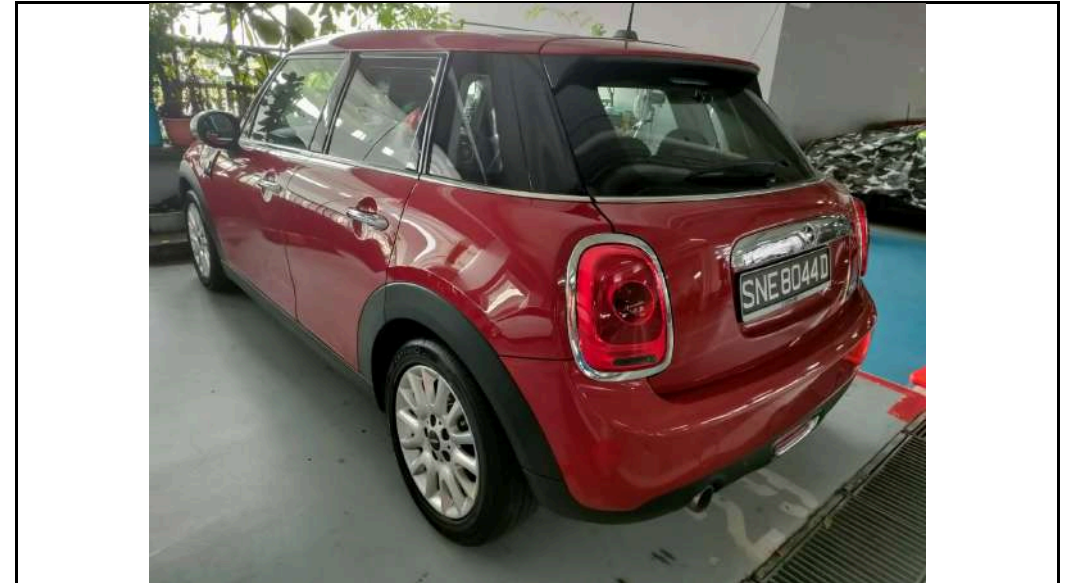
PHOTOGRAPHS FOR VEHICLE NO. : SNE 8044D

DAMAGES SEE DETAILS.
