ACCIDENT INVOLVING SHA4573L AND FBW939Y ALONG UPPER THOMSON ROAD, SINGAPORE SHELL PETROL STATION ON 11 MAY 2024 AT 1950 HOURS

SURVEY REPORT www.vicom.com.sg Company Pegistration No: 19/11/03/20K

VICOM LTD SURVEY REPORT

Annex C: Conclusion

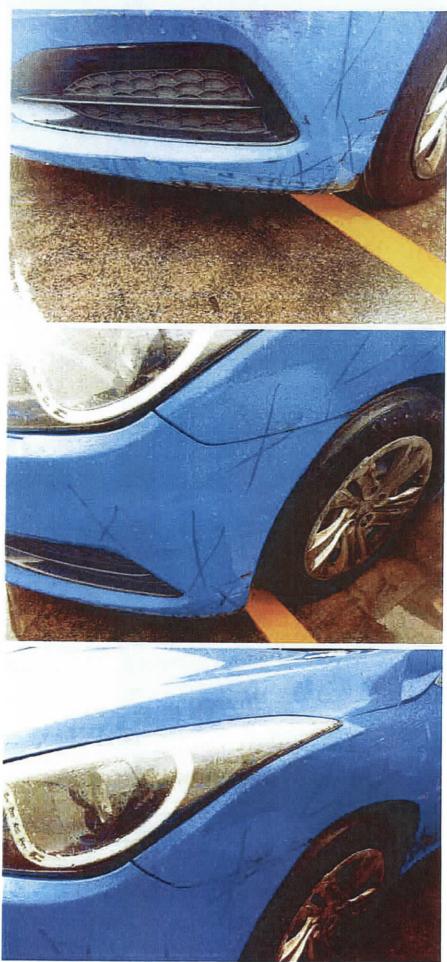
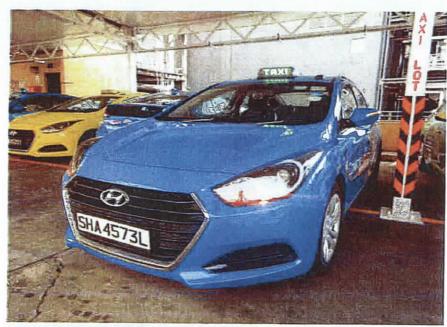
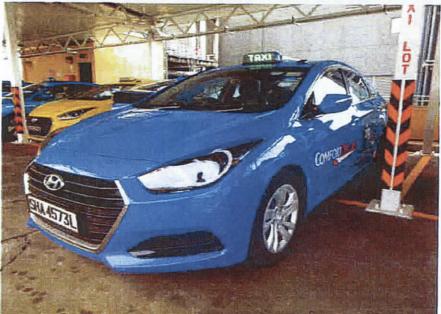
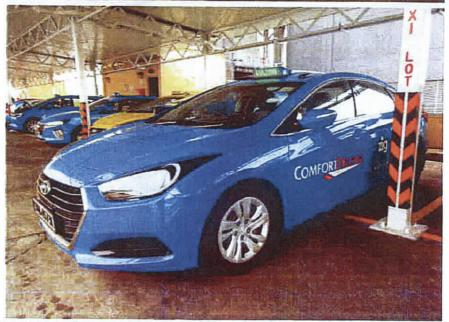
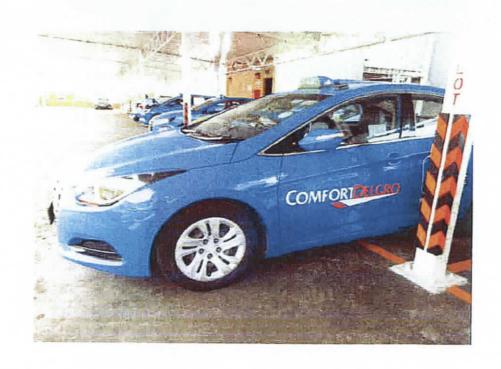
VICOM ASSESSMENT CENTRE VEHICLE No.: SHA4573L ACCIDENT DATE: 11/05/2024

At the place of inspection, we saw this vehicle sustained front nearside damage.

The damage's seen during our survey were at front bumper, n/s headlamp, front n/s fender, bonnet, front n/s wheel, front n/s windscreen glass pillar and surrounding areas. A fuller detailed description of the damages is in Annex A of this survey report.

Comfortdelgro Engineering Pte Ltd (Loyang) estimated a repair cost of S\$9,948.88. We adjusted it to S\$7,037.84.

Accordingly, we recommend repairs to this vehicle be carried out on a lumpsum basis at S\$5,650.00.

The repairs would require a period of 4 working days.
