LKK Auto Consultants Pte Ltd

Affiliated to Federation Internationale Des Experts En Automobile				
STRIDES PREMIER AUTOMOTIVE SERVICES PL 60 WOODLANDS INDUSTRIAL PARK E4SINGAPORE 757705 ATTN: HUA YEN			Ref: CS/SMR24100226/Rqp3e2(N) Date: 20/01/2025 Code: SMR

4. Description of Damages				
	THE VEHICLE SUSTAINED DAMAGES AT THE REAR O/S PORTION. DAMAGES SEE DETAILS.			
5. General Information				
	Accident Date	09/10/2024	Inspection Date	21/10/2024
	Survey held at	MOVA AUTOMOTIVE PTE LTD BLK 1008 BUKIT MERAH LANE 3 #01-04/06/08 . SINGAPORE 159722		
5a. Remarks				
	A)THE INSPECTION WAS CONDUCTED ON A"WITHOUT PREJUDICE" BASIS. B)IN ACCORDANCE TO YOUR INSTRUCTIONS, WE HAVE NOT AUTHORISED REPAIRS.			
5b. Estimate Days of Repair				
	ESTIMATED NORMAL PERIOD FOR REPAIR:		7 Working Days

ADJUSTMENT ON REPAIR COST FOR VEHICLE NO. SMR 2915Z

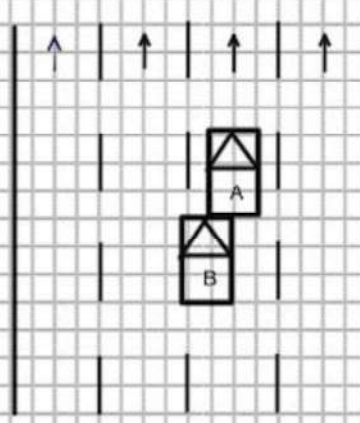
Sketch Plan

I WAS DRIVING ALONG PIE(TUAS) IN LANE 2. SUDDENLY I FELT AND IMPACT FROM THE REAR. I CHECK AND SAW THAT SHB1151K HAS COLLIDED INTO THE REAR OF MY VEHICLE. WE PROCEEDED TO STOP AT THE SIDE OF THE EXPRESSWAY TO TAKE PHOTOS AND EXCHANGE PARTICULARS. NO INJURIES REPORTED.

A - SMR2915Z B - SHB1151K

PIE(TUAS) AFTER TOH GUAN EXIT
