## LKK Auto Consultants Pte Ltd

Vehicle No. SMU 6176Y  
Insured Veh. SHB 223T  
Claim No. TAX/06/24/2046  
Policy No.  
Accident Date 16/06/2024  
Inspection Date 25/06/2024

THE VEHICLE SUSTAINED DAMAGES AT THE REAR PORTION.

## ADJUSTMENT ON REPAIR COST FOR VEHICLE NO SMU 6176Y

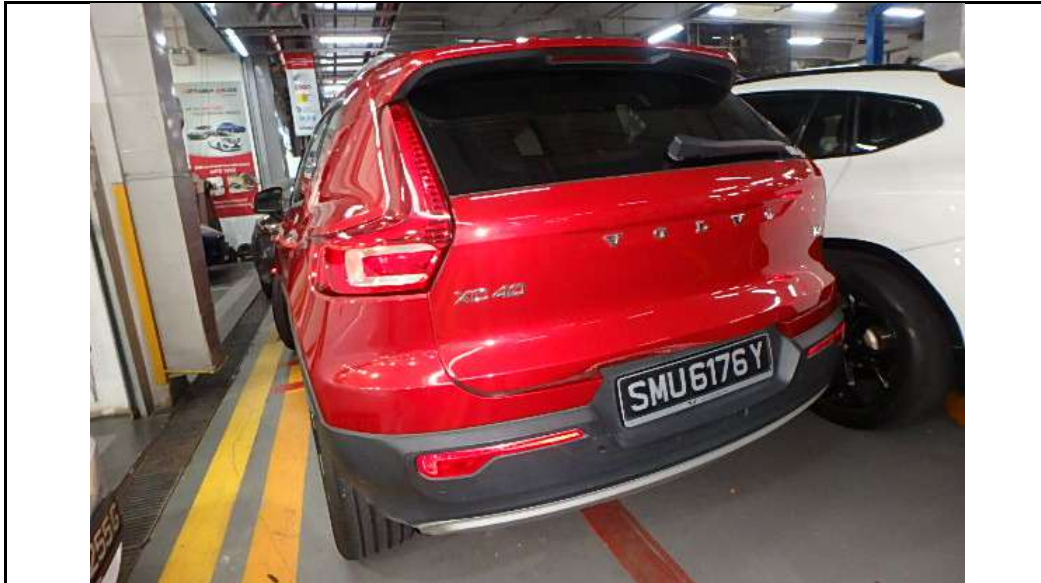
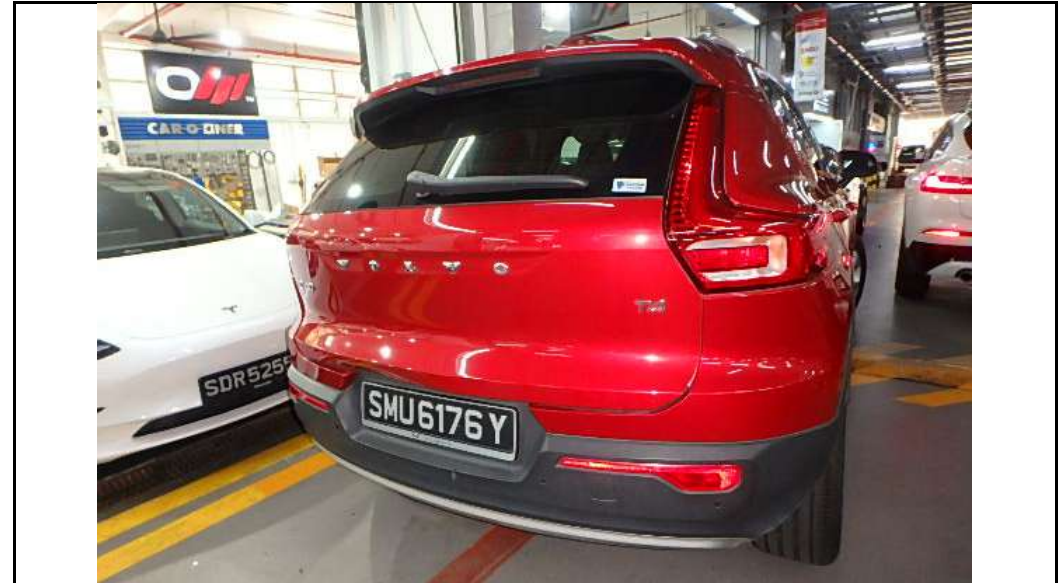
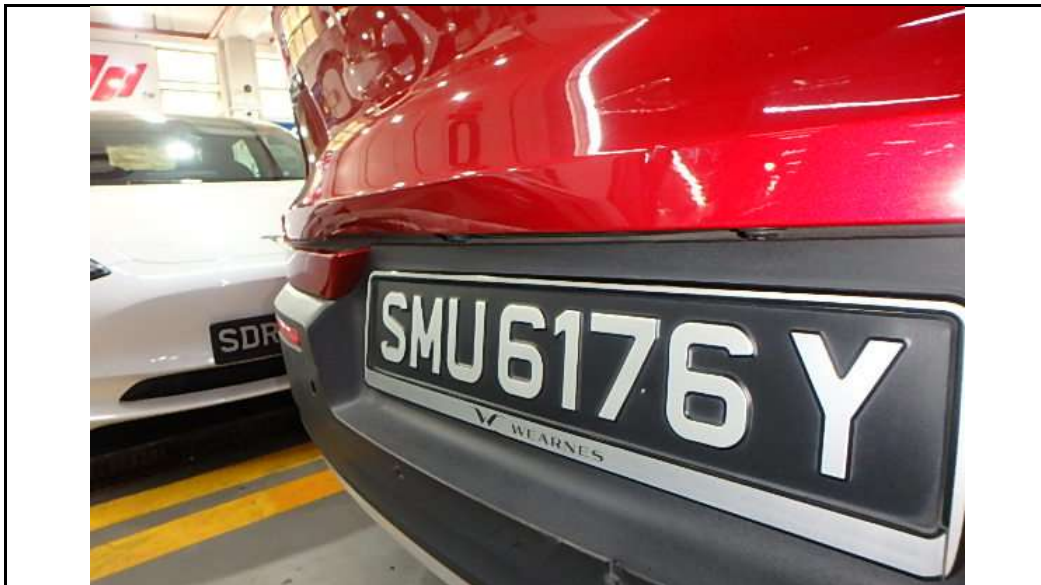
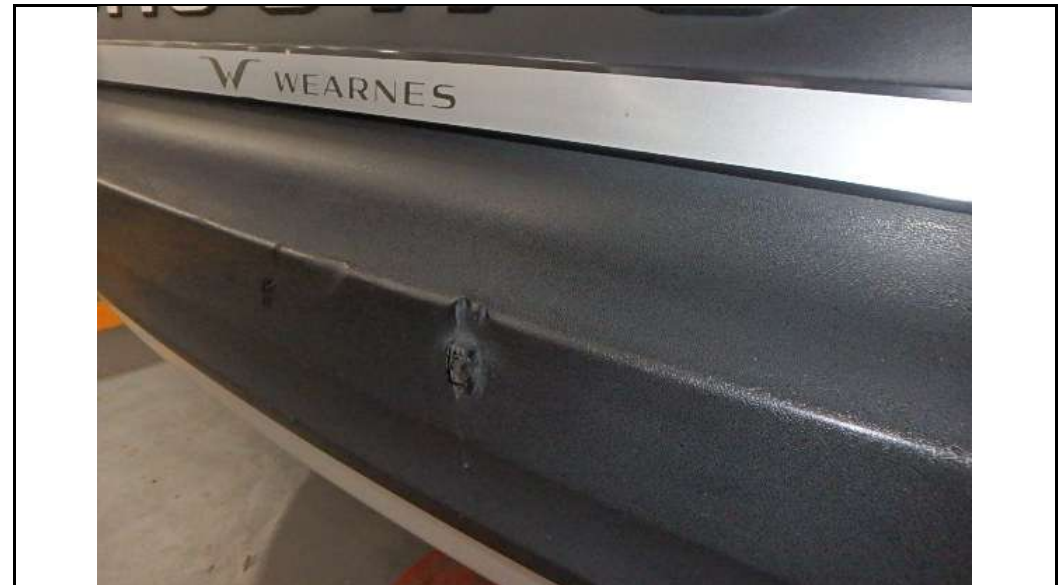
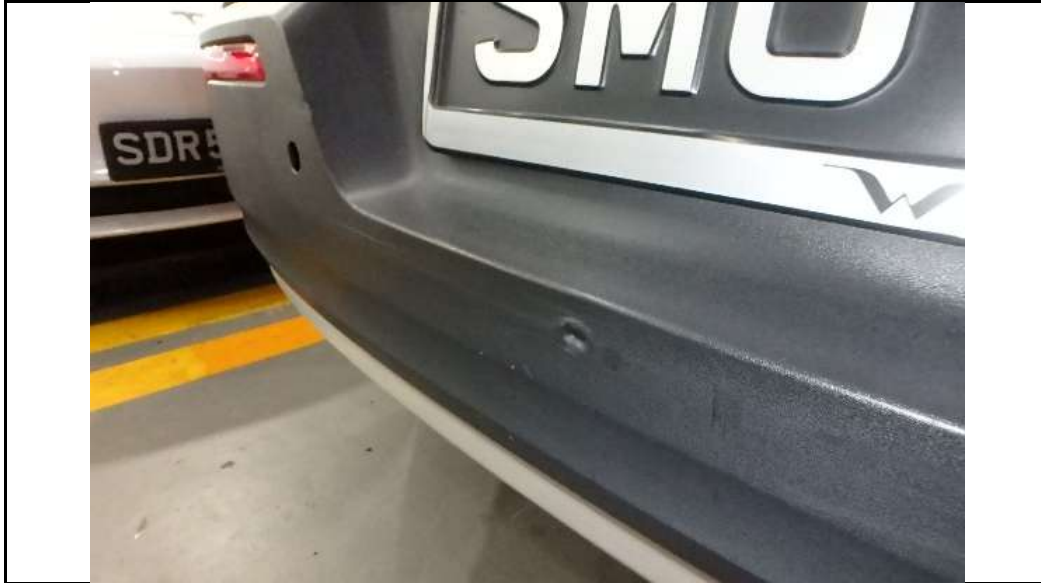
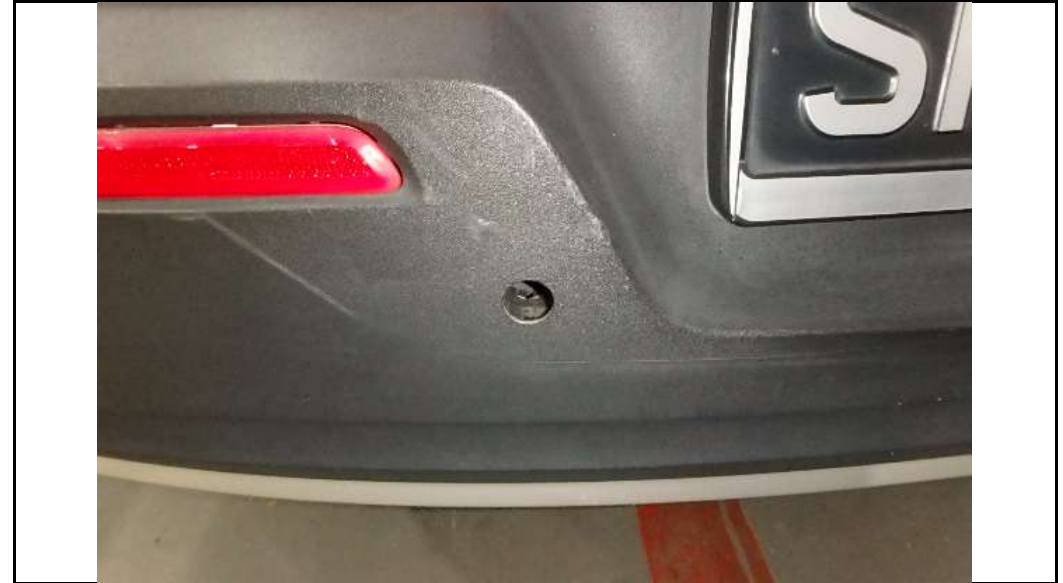
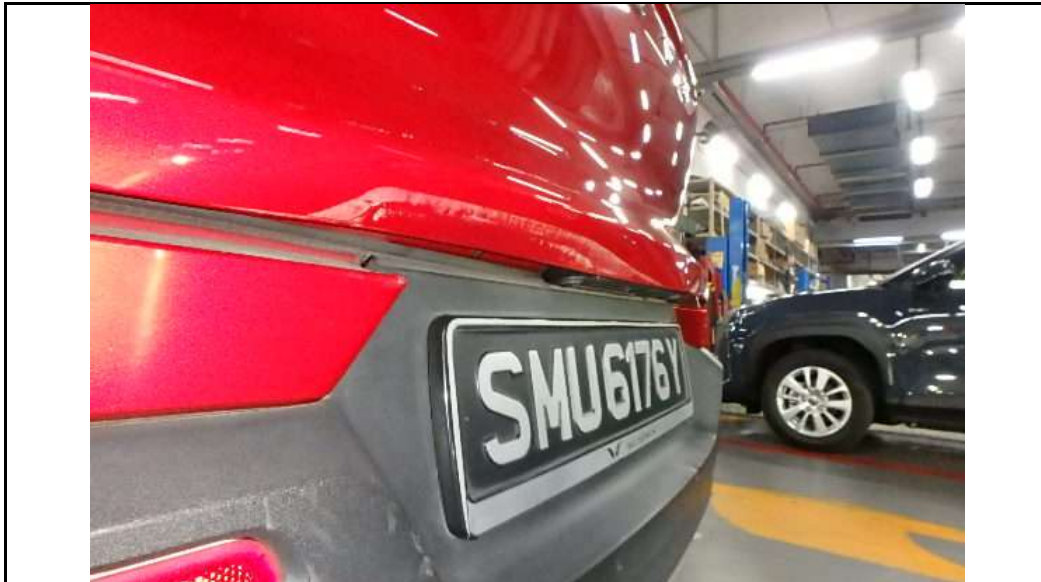
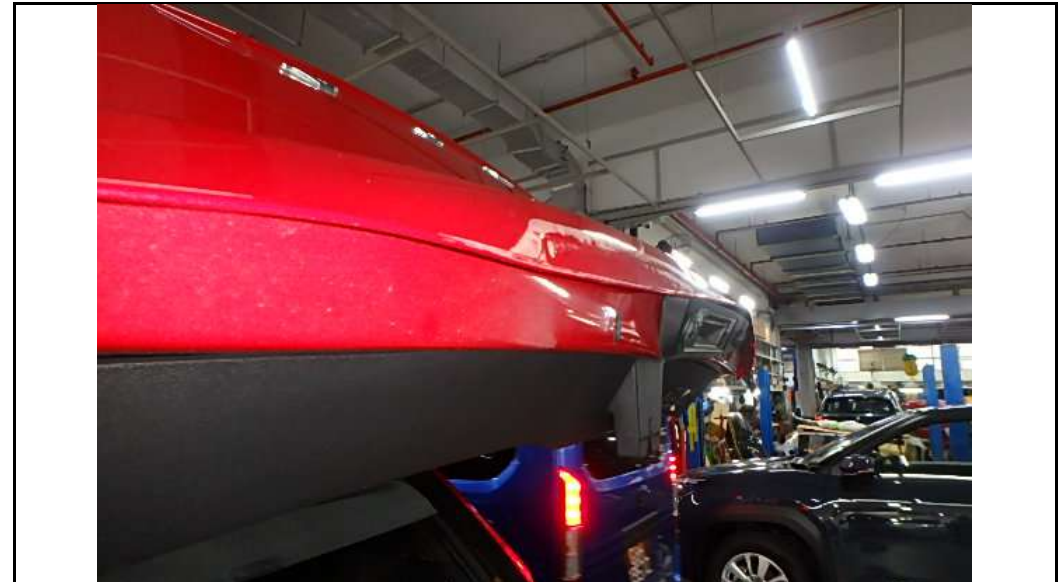
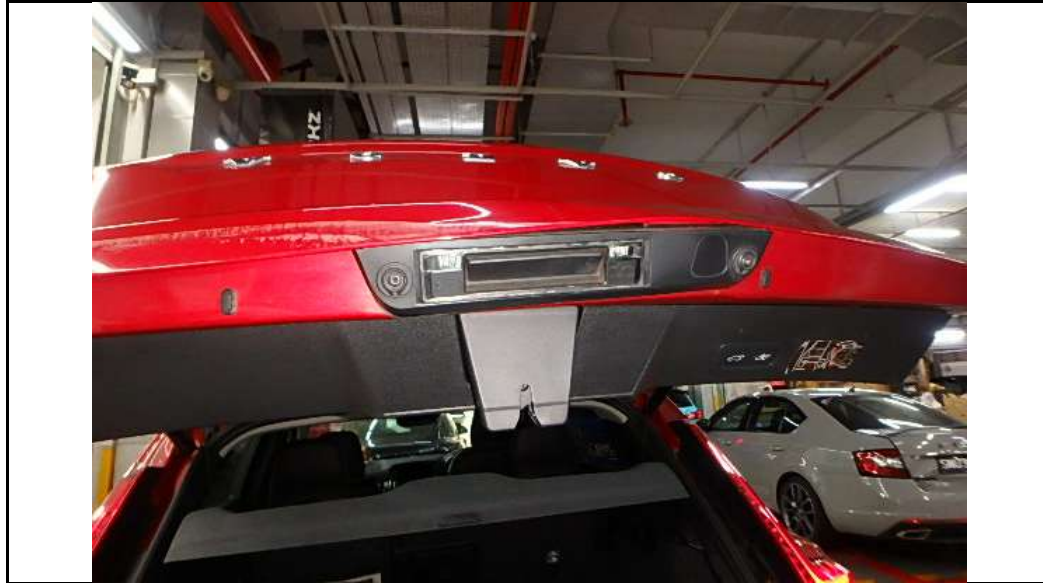
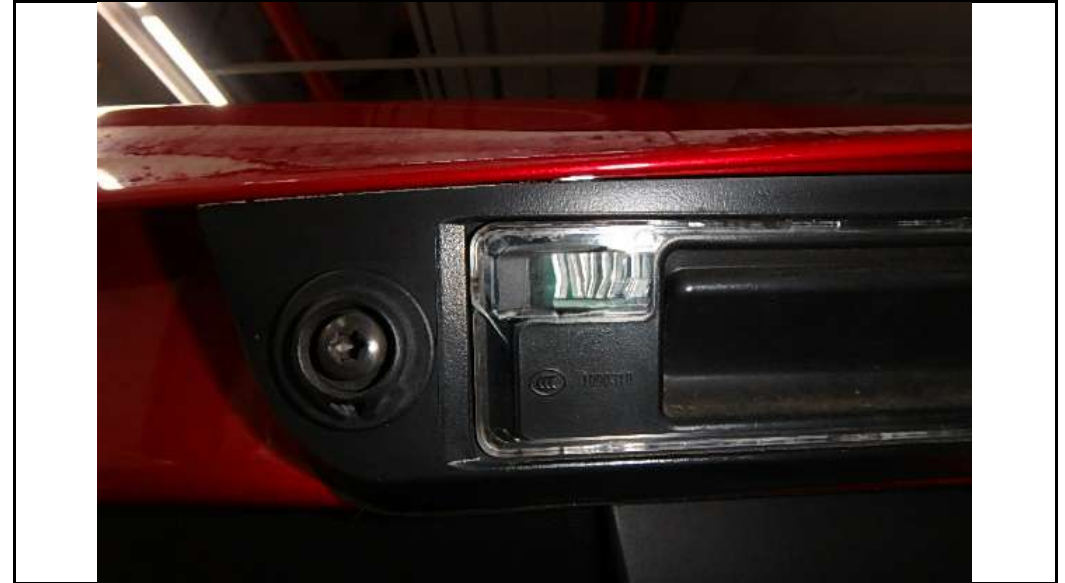
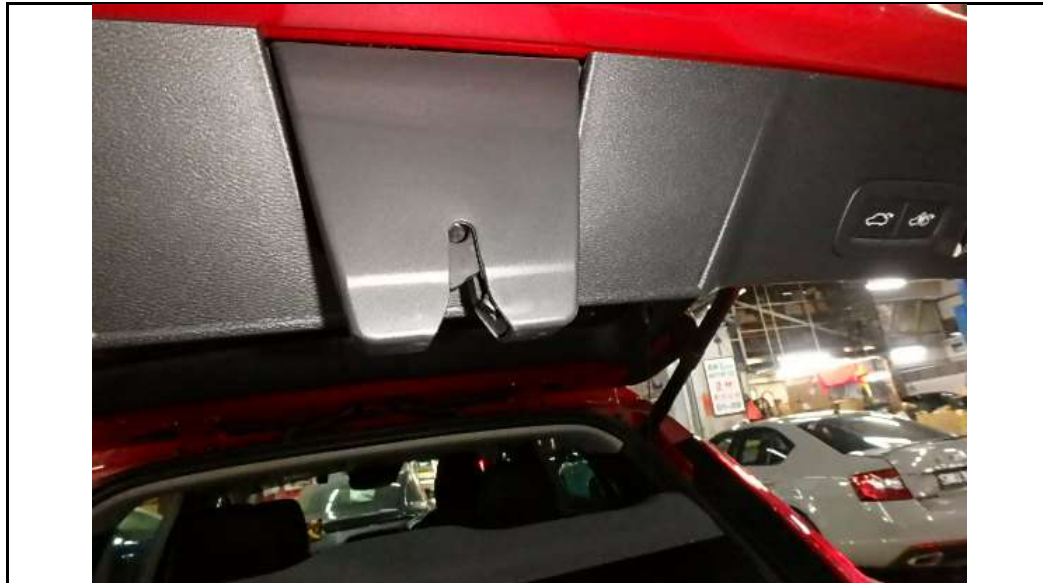
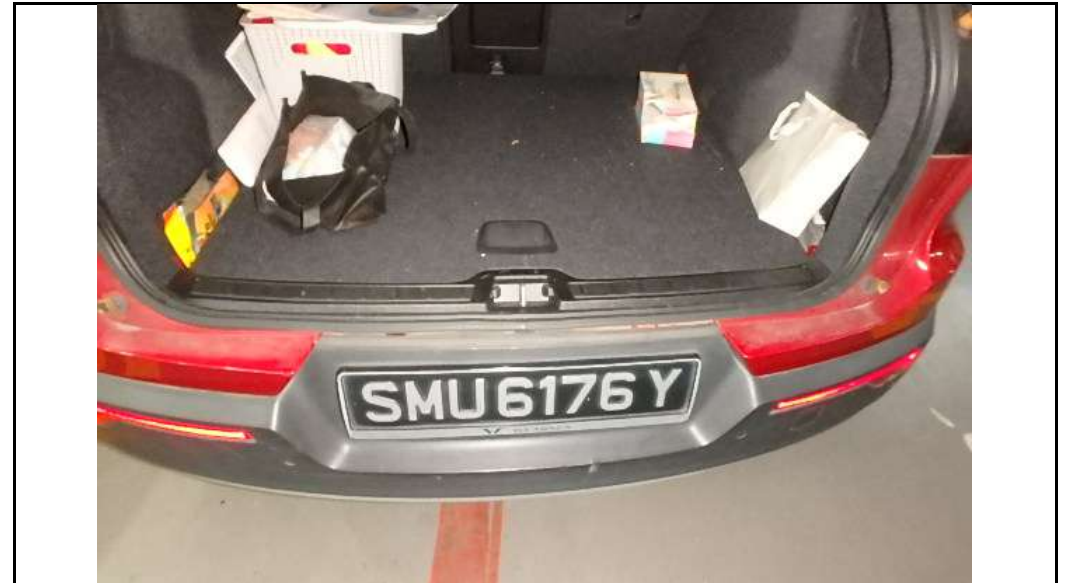
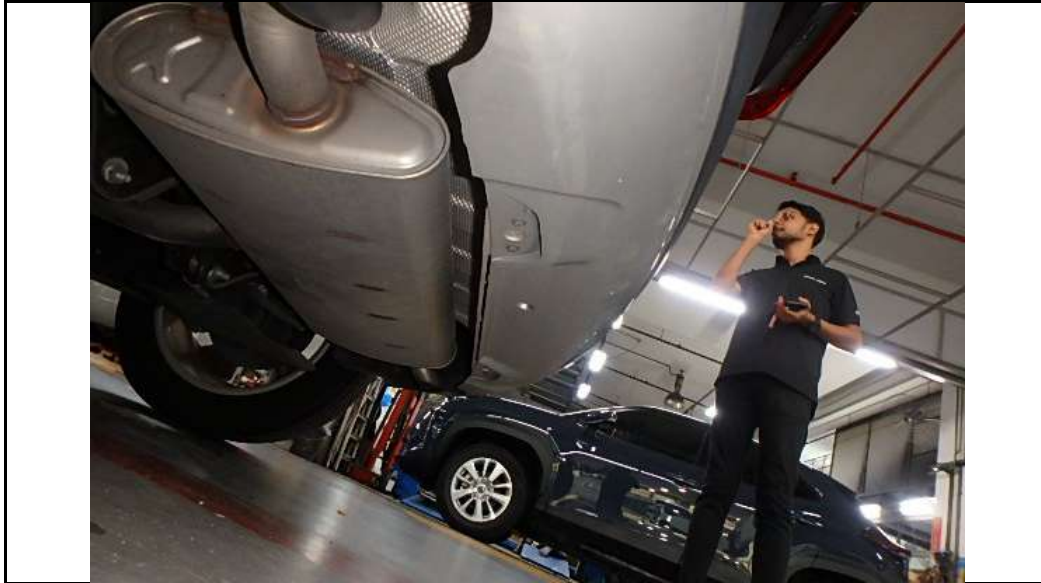
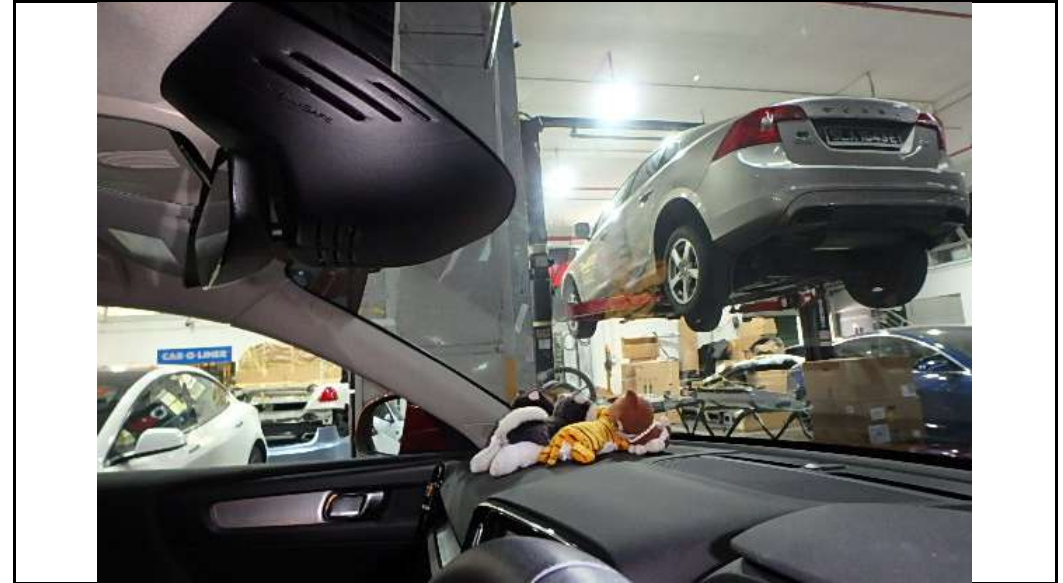
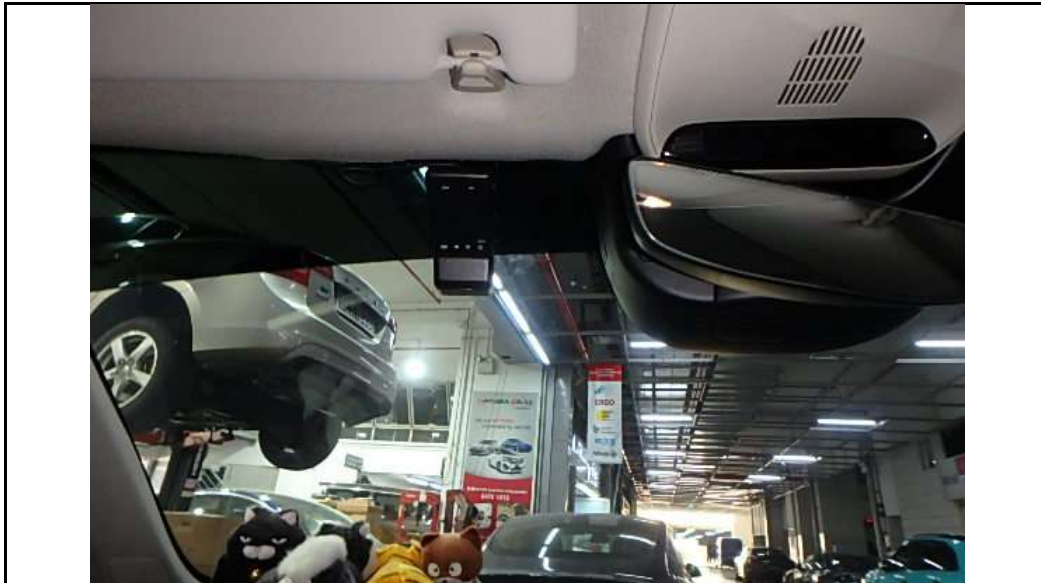
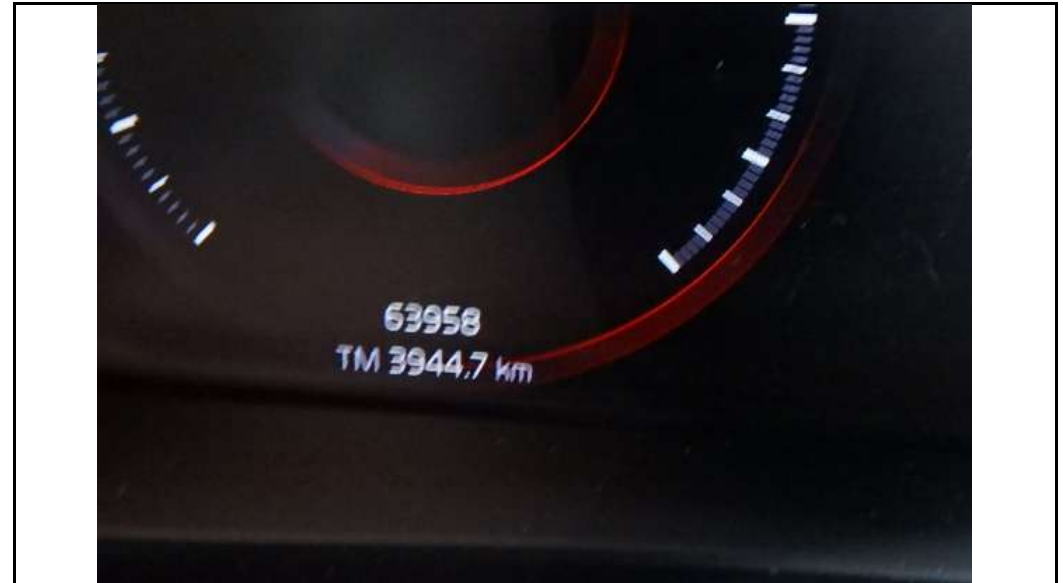
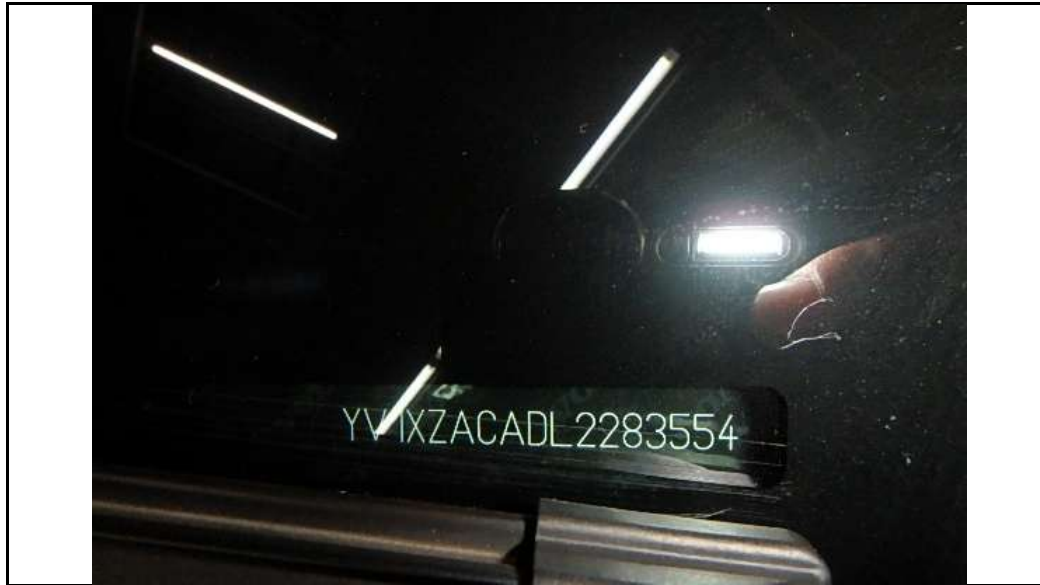
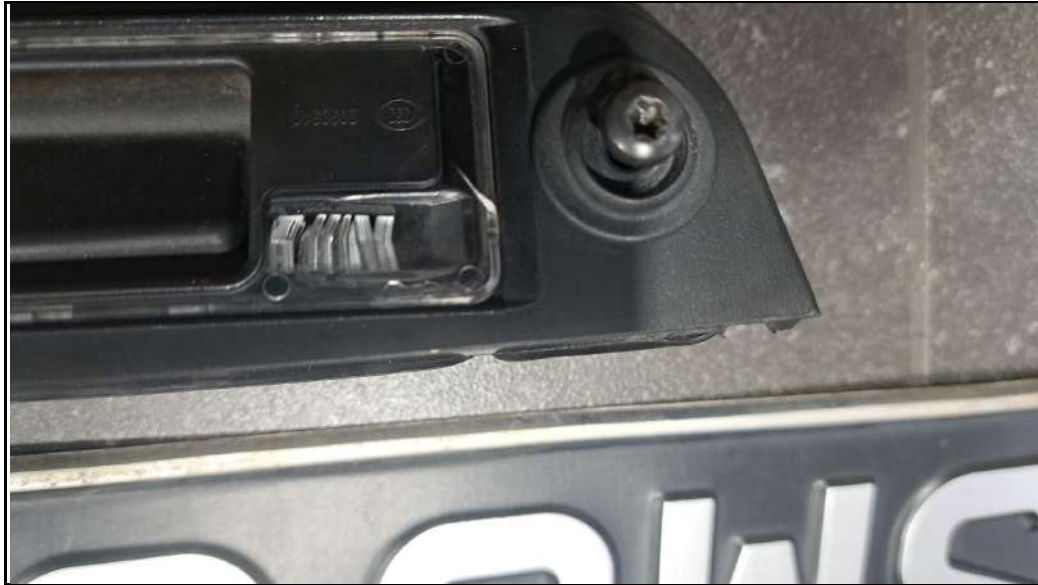
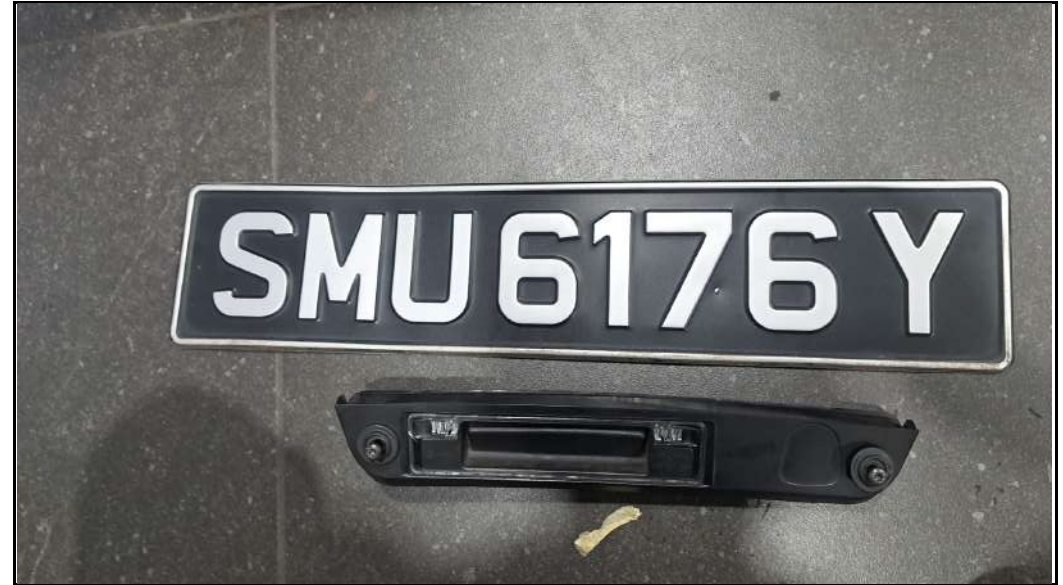
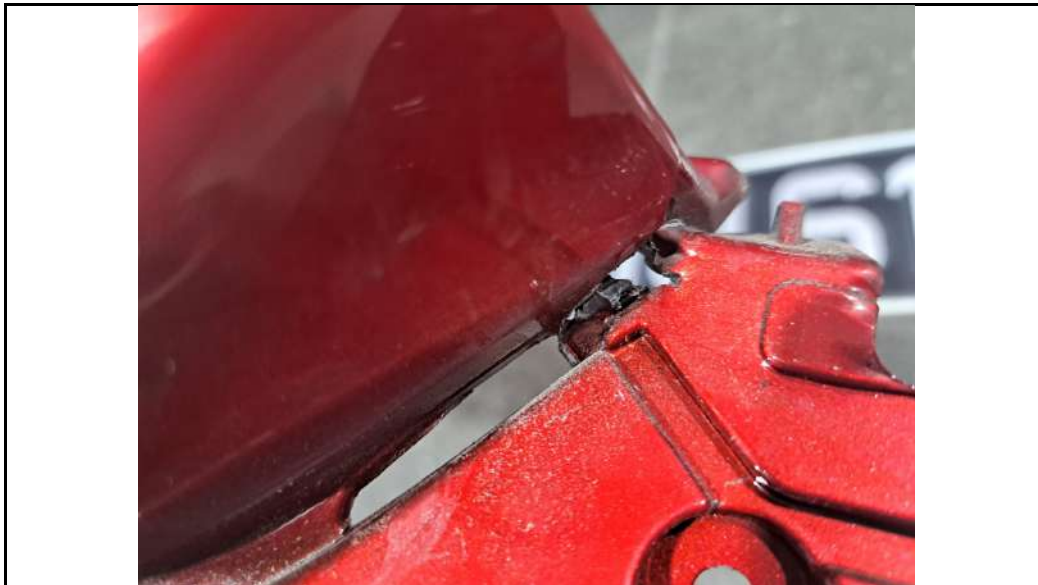
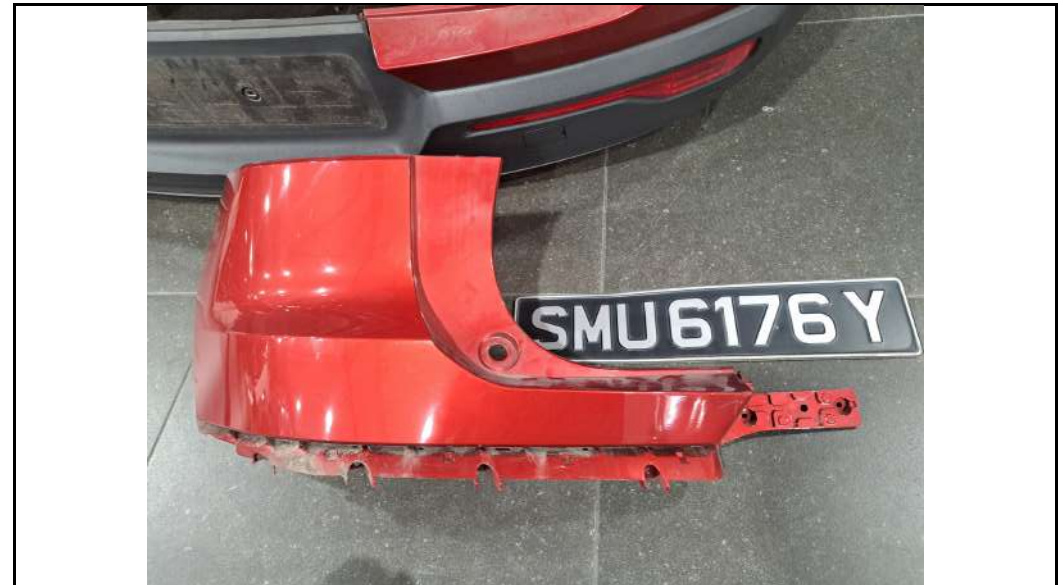
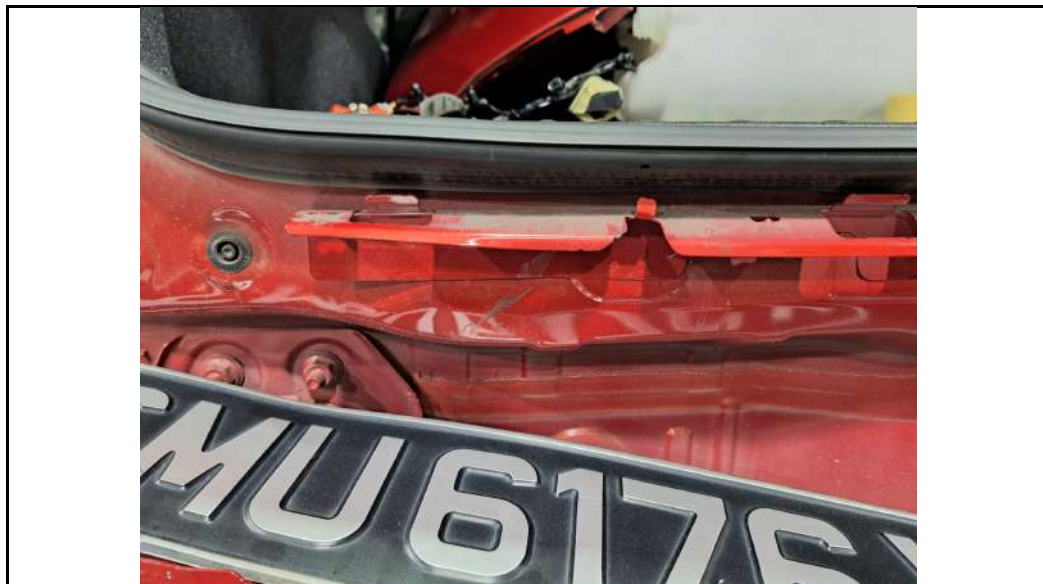
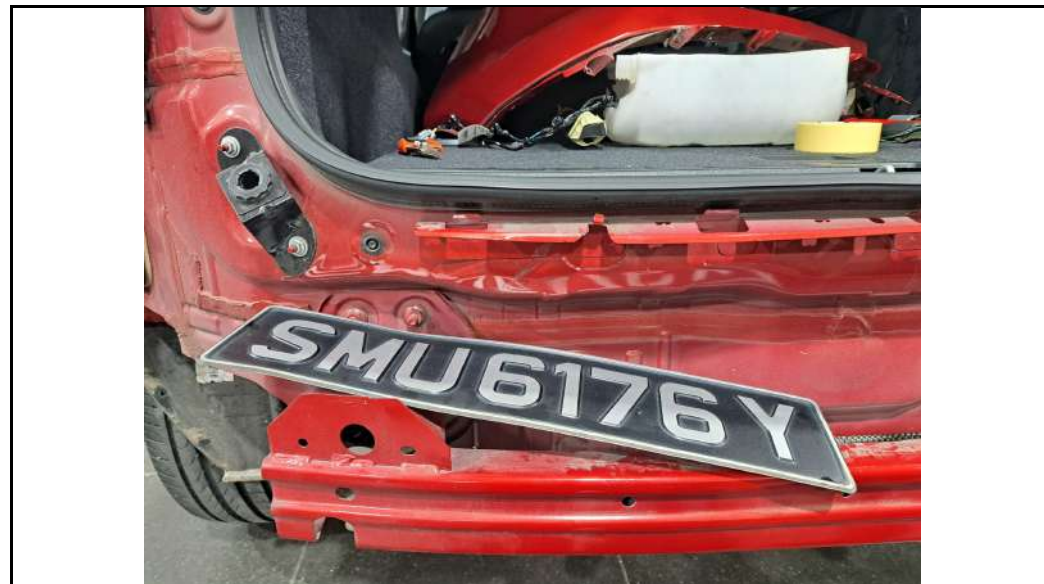
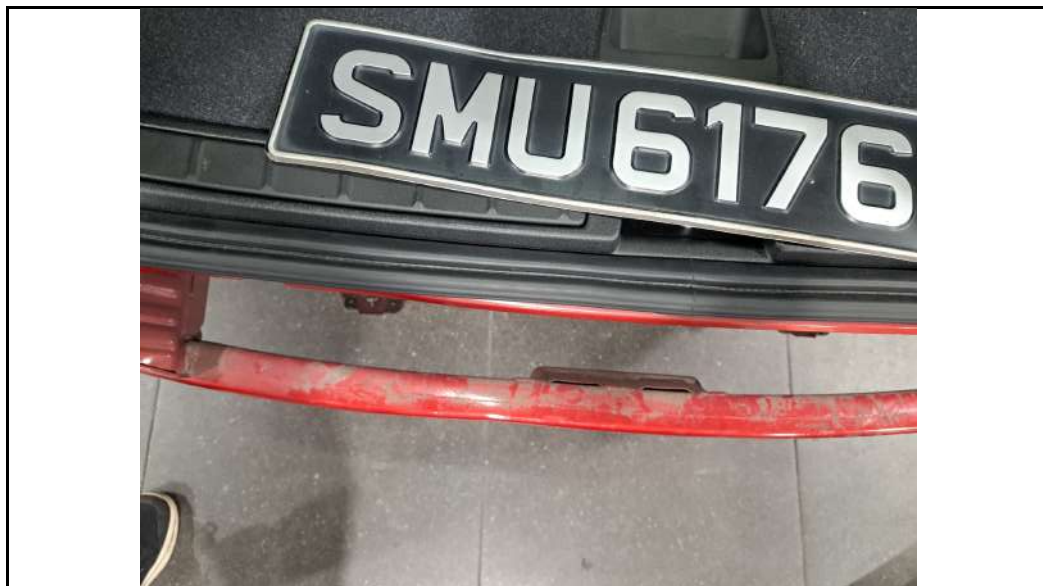
**PHOTOGRAPHS FOR VEHICLE NO. : SMU 6176Y**

| REPLACEMENT OF PARTS | | | | |
|---|---|---|---|---|
| 1 | RR BOOT | BENT | \$2,700.00 | \$2,512.00 |
| 1 | RR BUMPER - COMPLETE | BUCKLED/DENTED | \$1,995.00 | \$1,995.00 |
| 1 | RR ULTRASONIC SENSOR | MISSING | \$349.00 | \$349.00 |
| 1 | RR BUMPER REINFORCEMENT | BENT | \$1,440.00 | \$1,280.00 |
| 1 | RR BOOTLID SWITCH OPENING HANDLE (ADDITIONAL) | DENTED | \$780.00 | \$682.00 |
| 1 | RR LH BUMPER TOP MOLDING COVER (ADDITIONAL) | MTG CRACKED | \$420.00 | \$420.00 |

| Labour | | | | |
|---|---|---|---|---|
| | TO REMOVE, REPLACE, REPAIR, READJUST & REFIX RR AFFECTED AREAS | | \$800.00 | \$550.00 |
| | TO REMOVE, PUTTY, REPAIR, SAND AND RESPRAY AFFECTED AREAS | | \$660.00 | \$660.00 |

| | RECOMMENDED COST OF LUMP SUM REPAIRS<br>(TO ITS PRE-ACCIDENT CONDITION) | | <b>\$6,900.00</b> |
