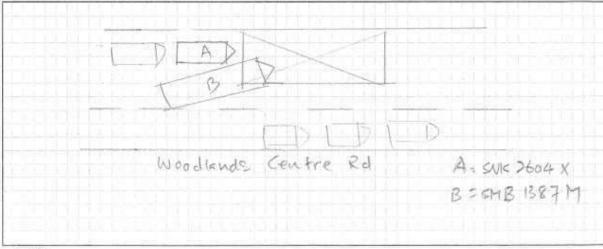
Sketch Plan

On the evening of 1st Nov 2024 near woodland strain station drop of point at around 1930 his, as I was forming on the extreme loft lane and my relicie was stationary walting pattently behind the ye now Box just beside the bus stop for my turn to proceed to the proper drop of point, a SMRT BUS (SMB 1387 M) drivers by Mr. Ma Hang Loong IIc are S825616 H recklessly cut into the lane that I was in from the lane on my right and hit and damaged my car arther right side while doing so. Despite my repeated afterpts to warm him by pressing my car horn several times, there were no aftempts by him to stop his bus immediately but instead continued to move forward and but into the bus stop. As a result of his care less and rections action, whe and my 3 pax were shocked and transactional by what happened. Besides my vehicle, as black may by what hand side.	cribe Circumstance of the Accident
	On the evening of 1st Nov 2024 Near Woodland strain station drop of point at around 1950 his, as I was forming on the extreme left lane and my relicie was stationary walting pattently behind the ye have box just beside the bus stop for my turn to proceed to the proper drop of point, a SMRT BUS (SMB 1387M) drivers by Mr. Ma Hang Loong He are \$823566 H recklessly cut into the lane that I was in from the lane on my right and hit and damaged my car anthe right side unite doing so. Despite my repeated attempts to warm him by pressing my car horn several times, there were no attempts by him to stop his bus immediately but instead continued to move forward and but into the lass stop. As a result of his care less and rections by what happened. Besides my vehicle, as black may by what happened.
