LKK Auto Consultants Pte Ltd

ADJUSTMENT ON REPAIR COST FOR VEHICLE NO. SMW 9532Y

PHOTOGRAPHS FOR VEHICLE NO. : SMW 9532Y

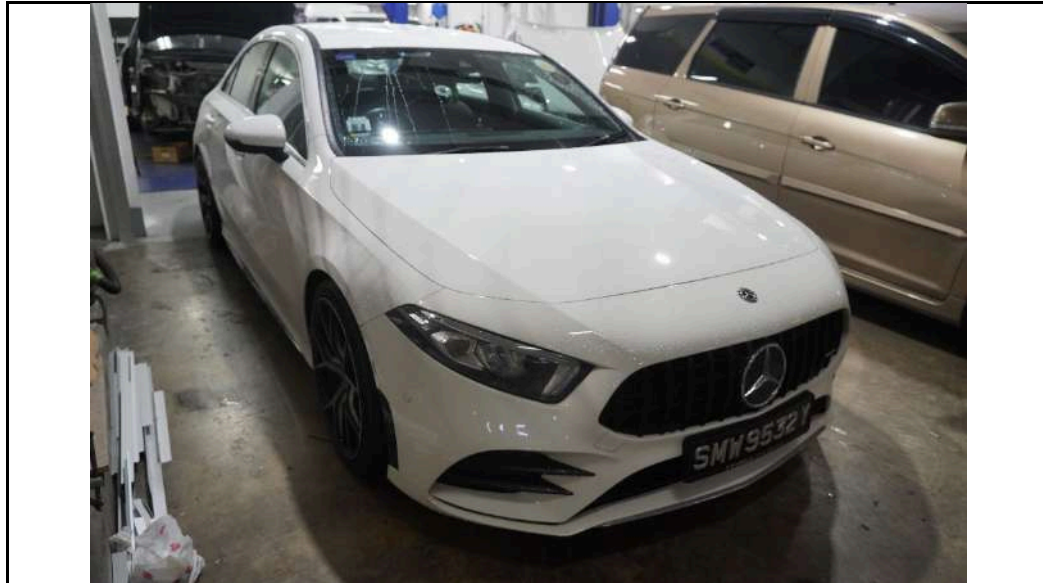
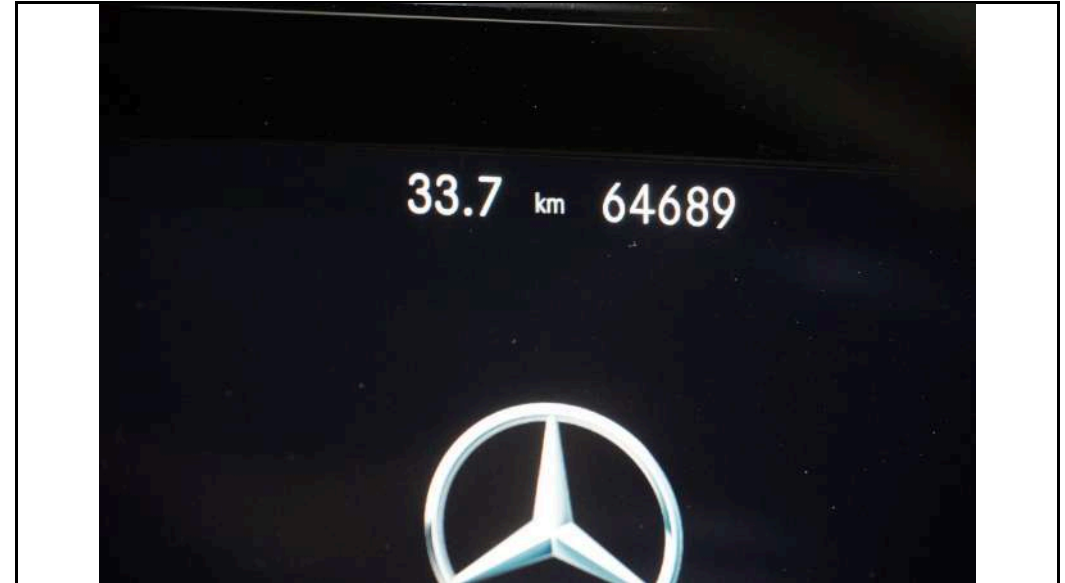
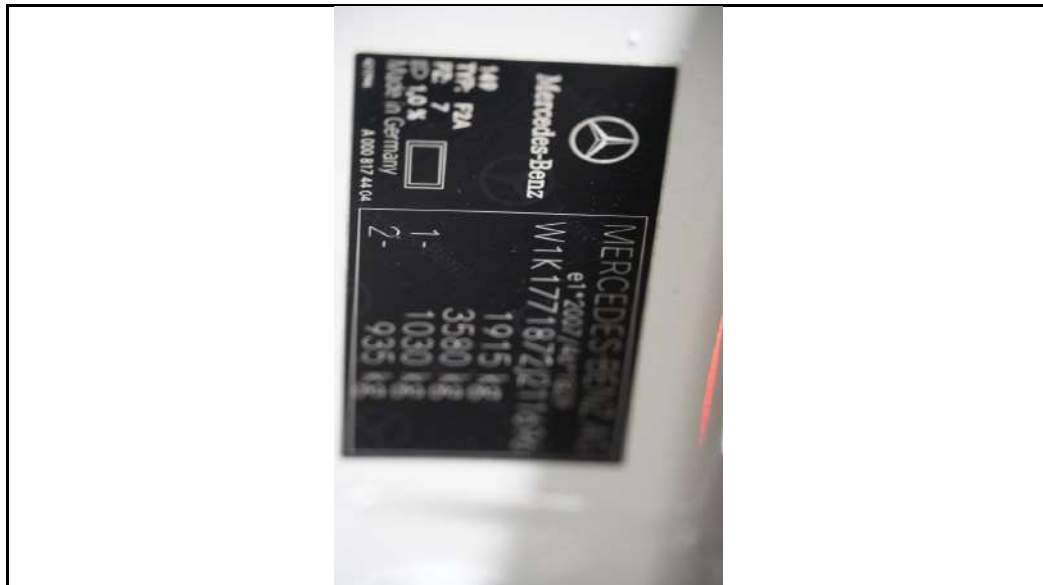
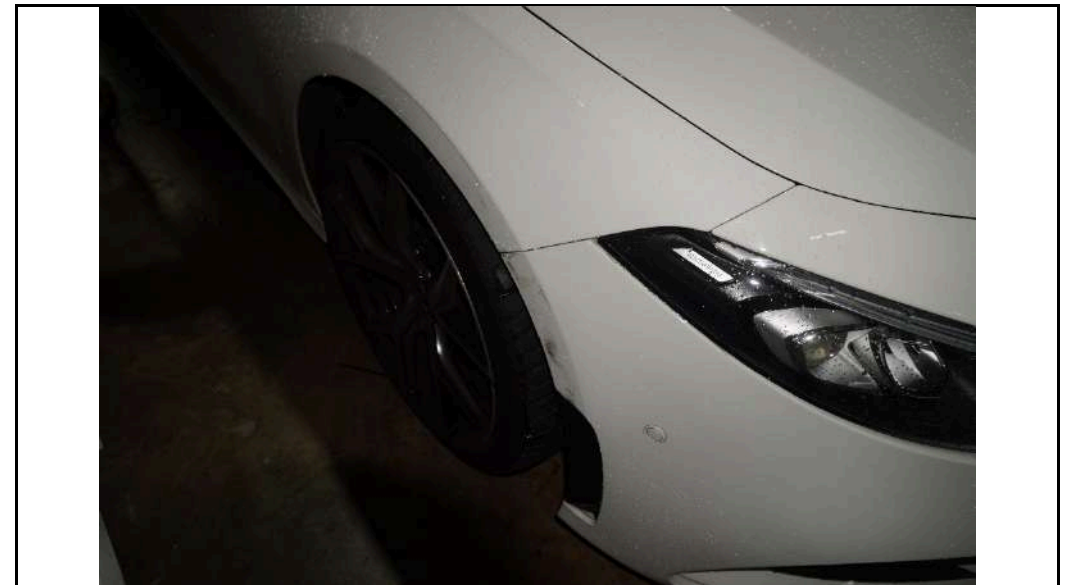
4. Description of Damages				
	THE VEHICLE SUSTAINED DAMAGES AT THE FRONT O/S PORTION. DAMAGES SEE DETAILS.			
5. General Information				
	Accident Date	22/06/2024	Inspection Date	01/07/2024
	Survey held at	AUTO UNITED SG PTE LTD 1 KAKI BUKIT AVENUE 6, #01-92, AUTOBAY@KAKI BUKIT, SINGAPORE 417883		
5a. Remarks				
	A)THE INSPECTION WAS CONDUCTED ON A"WITHOUT PREJUDICE" BASIS. B)IN ACCORDANCE TO YOUR INSTRUCTIONS, WE HAVE NOT AUTHORISED REPAIRS.			
5b. Estimate Days of Repair				
	ESTIMATED NORMAL PERIOD FOR REPAIR:		5 Working Days

Qty	Description of Parts	Condition	Estimate By Workshop (\$)	Our Adjusted (\$)
	<u>REPLACEMENT OF PARTS</u>			
1	FRONT BUMPER	TORN	1,341.00	1,341.00
1	FRONT BUMPER SIDE HOLDER	NOT NECESSARY	96.00	-
1	FRONT BUMPER SENSOR	NOT NECESSARY	289.00	-
1	HEADLAMP	NOT NECESSARY	3,301.00	-
1	FRONT FENDER	TO REPAIR SEE LABOUR	815.00	-
1	FRONT DOOR WING MIRROR	CUT	893.00	893.00
1	FRONT DOOR WING MIRROR COVER	TO REPAIR SEE LABOUR	101.00	-
1	FRONT DOOR WING MIRROR GLASS	NOT NECESSARY	373.00	-
1	FRONT DOOR WING MIRROR SIGNAL LAMP	CUT	239.00	239.00
1	FRONT LOWER ARM	NOT NECESSARY	825.00	-
1	FRONT KNUKLE ARM	DAMAGED	1,310.00	1,159.00
1	FRONT WHEEL HUB C/W BEARING	DAMAGED	635.00	540.00
1	FRONT SHOCK ABSORBER	NOT NECESSARY	790.00	-
	LESS 10% DISCOUNT		-1,100.80	-417.20
			9,907.20	3,754.80
1	FRONT WHEEL RIM (SN)	CUT	1,580.00	1,080.00
	LESS 10% DISCOUNT		-158.00	-
			1,422.00	1,080.00
	<u>SPECIAL NETT ITEMS</u>			
1	SET FRONT BUMPER CLIPS (SN)	NECESSARY	50.00	50.00

1	SET FRONT BUMPER SIDE GARNISH (SN)	CUT	150.00	80.00
1	FRONT TYRE (SN)	NOT NECESSARY	280.00	-
			480.00	130.00
	<u>LABOUR</u>			
	PANEL BEATING, REMOVE AND REFIT PARTS. INCLUSIVE OF THE REPAIR OF FRONT FENDER AND FRONT DOOR WING MIRROR COVER.		1,000.00	400.00
	SPRAY PAINTING TO AFFECTED AREA.		1,000.00	500.00
