TAX INVOICE

2. Vehicle Particulars & Condition				
	Make & Model	TOYOTA CAMRY	c.c	1998
	Engine No.	HIDDEN	Year of Reg.	2016
	Chassis No.	MR053DK5100104960	Colour	BLACK
	Odometer	138678 KM	Steering	IN ORDER
	Brakes	IN ORDER	Modification	SPORTS RIM
	General	GOOD

4. Description of Damages				
	THE VEHICLE SUSTAINED DAMAGES AT THE FRONT AND REAR PORTION. DAMAGES SEE DETAILS.			
5. General Information				
	Accident Date	19/11/2024	Inspection Date	21/11/2024
	Survey held at	SM INTEGRATED PTE LTD 1 KAKI BUKIT AVE 6, BLK C #01-43 AUTOBAY SINGAPORE 417883		
5a. Remarks				
	A)THE INSPECTION WAS CONDUCTED ON A"WITHOUT PREJUDICE" BASIS. B)IN ACCORDANCE TO YOUR INSTRUCTIONS, WE HAVE NOT AUTHORISED REPAIRS.			
5b. Estimate Days of Repair				
	ESTIMATED NORMAL PERIOD FOR REPAIR:		6 Working Days

ADJUSTMENT ON REPAIR COST FOR VEHICLE NO. SNF 3859Y

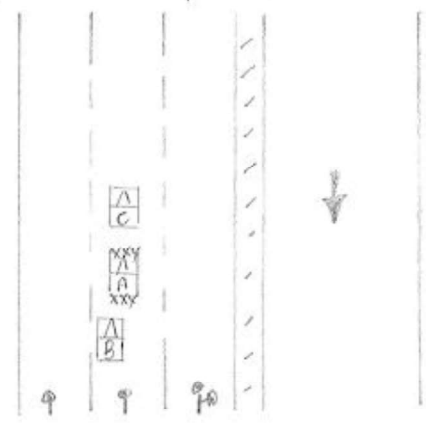
Driver's Signature (If driver is not the policyholder) / Date & Time	Witnessed by Reporting Centre Personnel
<p>Sketch Plan</p>

<div style="position: absolute; top: 100px; right: 100px;"> <p>A: SNF3859Y</p> <p>B: SHB5813H</p> <p>C: SNN5019A</p> <p>Yishun Ave 9 Towards Yishun Ave 1</p>

I was driving straight along Yishun Ave 8 towards Yishun Ave 1 at the center lane of 3 lanes.

While the vehicle "C" in front of me slowed down and stopped, I followed suit.

Suddenly, I felt an impact from behind. Veh "b" collided with the rear portion of my vehicle, causing my car to surge forward collided with Veh "C" rear portion and causing damage.

I alighted and realized there were a total of 3 vehicles involved.
