Vehicle No. GBA 7552Z

4.		Description	on of Damages				
	THE VEHICLE SUS	STAINED DAMAGES AT THE REA	AR O/S PORTION.	•			
	DAMAGES SEE DE	ETAILS.					
5.		General	Information				
	Accident Date	09/12/2024	Inspection Dat	е	12/12/2024		
	Survey held at	SE AUTOHUB PTE LTD					
		56 LOYANG WAY 04-04 LOYANG ENTERPRISE BUILDIN SINGAPORE 508775	NG				
5a.		Re	emarks				
		N WAS CONDUCTED ON A"WITH E TO YOUR INSTRUCTIONS, WI					
5b.		Estimate I	Days of Repair				
	ESTIMATED NORM	MAL PERIOD FOR REPAIR:		3 Worki	ng Days

## ADJUSTMENT ON REPAIR COST FOR VEHICLE NO. GBA 7552Z

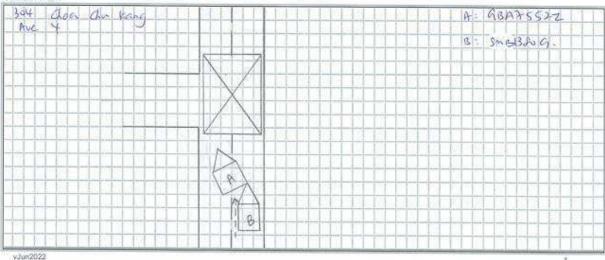
#### Sketch Plan

Describe Circumstance of the Accident
While I was parked in the left lane at the specified date and time, I was switching from the right
lane to the left lane, and the traffic light was red. Bus B was in the right lane, and I had been
parked in the left lane for almost a minute when suddenly Bus B collided with my right side. It took me a
few seconds to realize what had happened. I then got out of the car to check the damage to my vehicle
and found that the right side of my car was damaged. After communicating with the bus driver, he gave
me the hotline number for their company and asked me to contact them. After taking photos of the
scene, I got back in my car and left. Shortly after leaving, I started feeling pain in my back, so I
went to see a doctor.

On the above mentioned date time and location, I was driving my lorry and stopped at the traffic light at the T junction of 304 Chao Chu Kang Ave 4. A bus then hit me from behind causing a impact. I strain my back as a result and was given 3 days MC by CGH. My passenger also sprain his chest and given 2 days MC.
