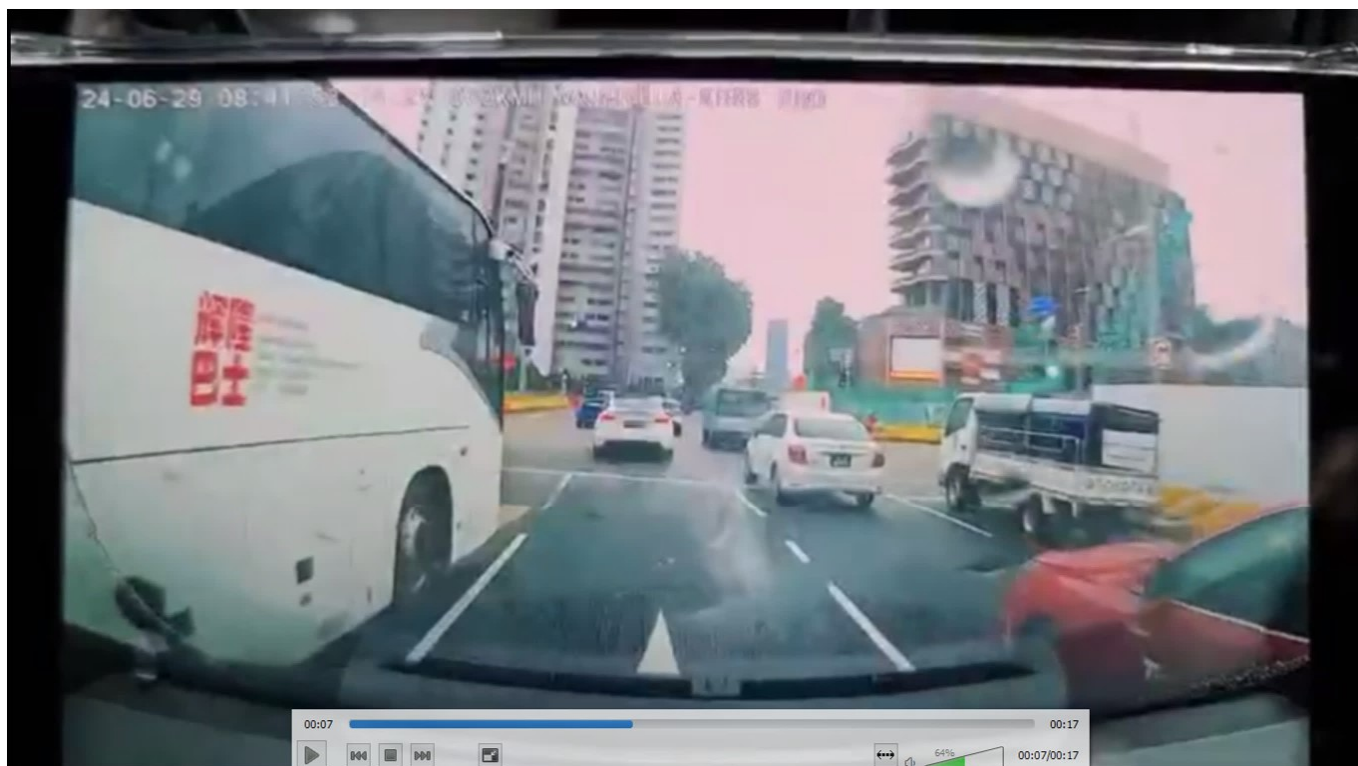
3rd party was driving on the 3rd lane(going straight only) from the left while OI bus was on the left side of 3rd party. OI's lane can turn left and go straight.

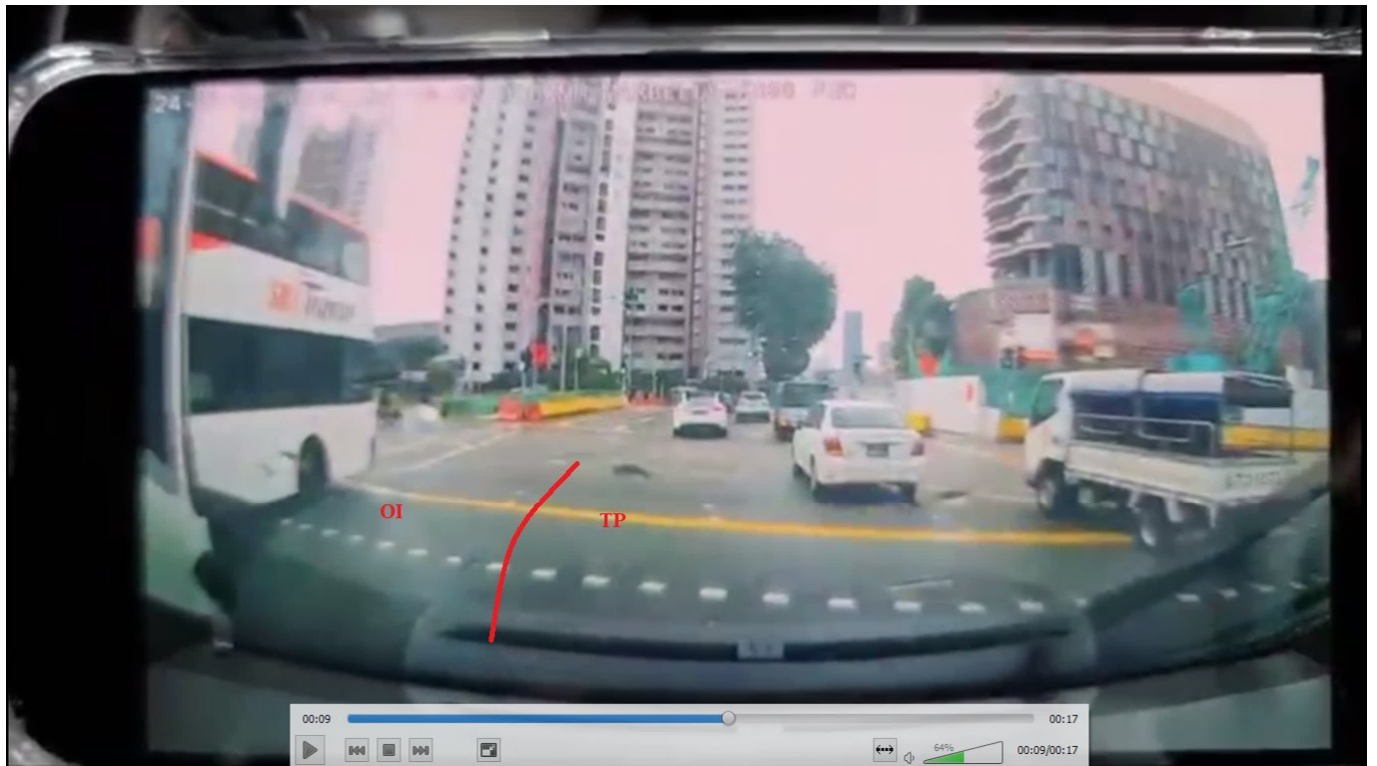
While crossing junction, OI should keep to left as per road marking.

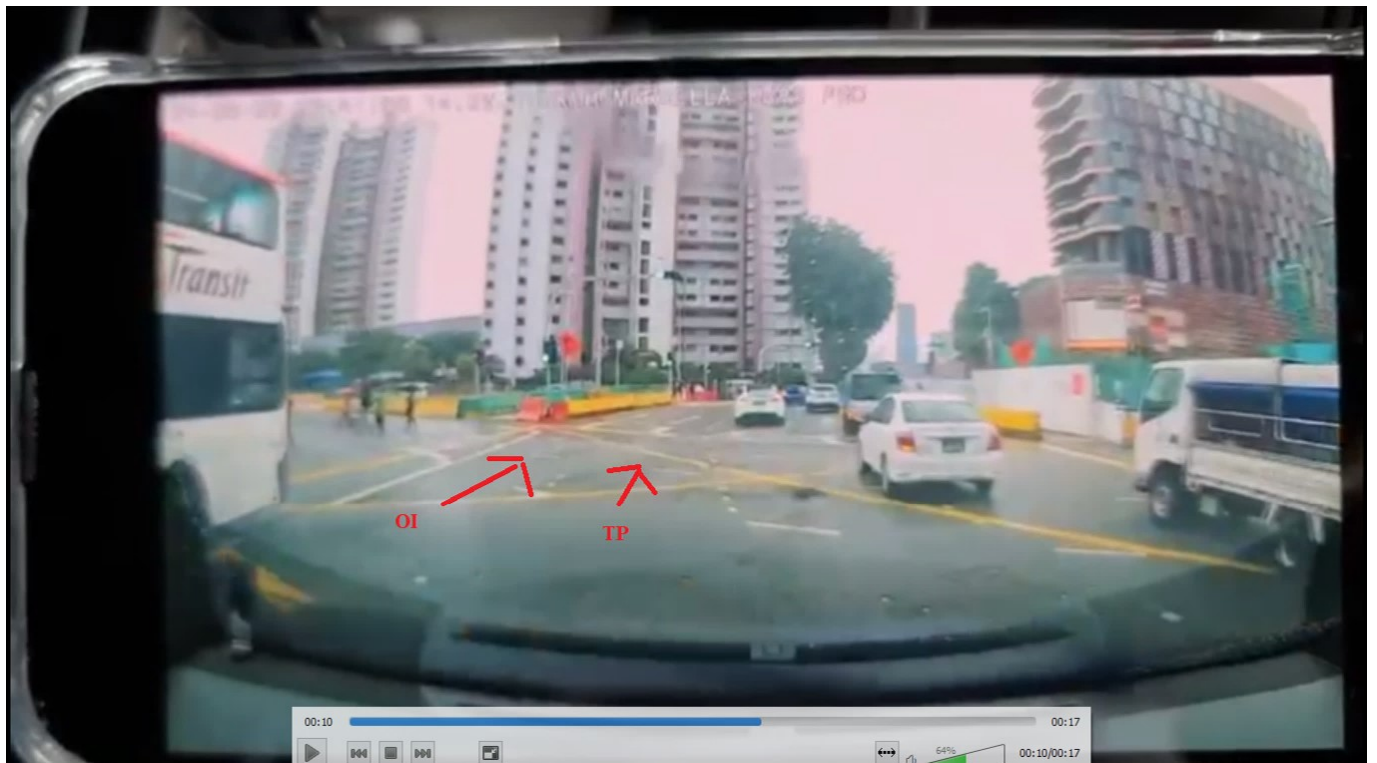
From video, 3rd party was driving within his lane and there is a jerk on his car while crossing the junction.
