1. Policy Particulars :- THIRD PARTY CLAIM			
Insured Veh.	SKX 8789Z	Veh. Inspected	SKF 3645H
Policy No.		Coverage (\$)	0.00
Claim No.		Excess (\$)	0.00
Assign From		Assign Date	17/05/2016

Model : VOLKSWAGEN SCIROCCO 1.4L AT TSI 1372Q5

**ACCIDENT INVOLVING SKX 8789Z AND SKF 3645H ON 14.05.2016 ALONG
BISHAN STREET 13 JUNCTION INFRONT OF BISHAN BUS INTERCHANGE**

VEHICLE DAMAGE INSPECTION REPORT

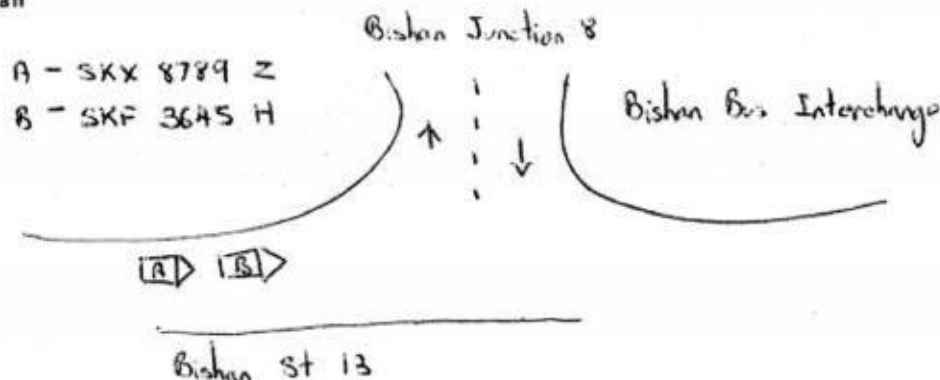
Sketch Plan

Type Of Accident Collision- Head to Rear (Insured Hit TP)

PP Stopped down the vehicle and pushed the brakes but as it
was raining heavily the car skidded and scratched the
car in front.
