SLM5182P

Make: Subaru XVc.c. 1600Colour: whiteA/C: Insured / Std / NI / NASp. Reading: 2905T/Radio: Insured / Std / NI / NA

D.O.I. 20-06-17Survey held at N/SDes. of Damages: Frt / Rear / O/S / N/S / U/C / Rooftop or _____The U/C / Chassis frame / Body Structure affected due to collision.

VEHICLE DAMAGE INSPECTION REPORT

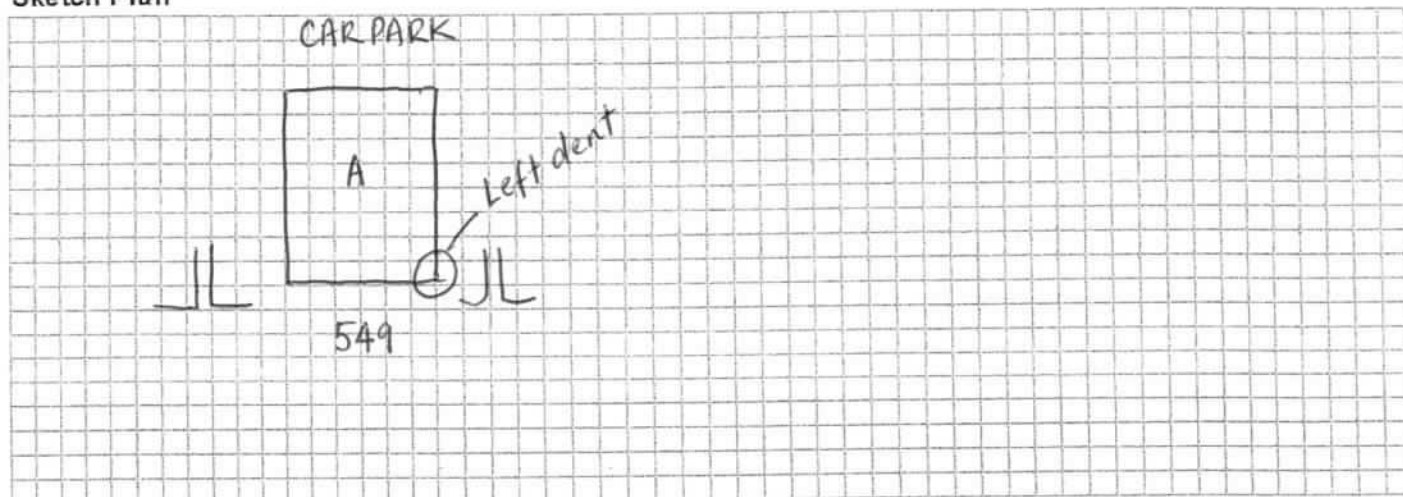
Sketch Plan

A: 8LM 5182P

B: SJF 7803D

Car was parked at Bukit Batok West Ave 5 MSCP at Lot no. 549. Owner found note left at the wiper. Discovered dent at front left bumper at 8.32 pm on 2 June 2017.
