ACCIDENT INVOLVING EE 3 G & YN 2478 Y ON 10 SEPTEMBER 2017

Preliminary Advice

VEHICLE DAMAGE INSPECTION REPORT

Our File No: CS/MSG17017706/ARBN2

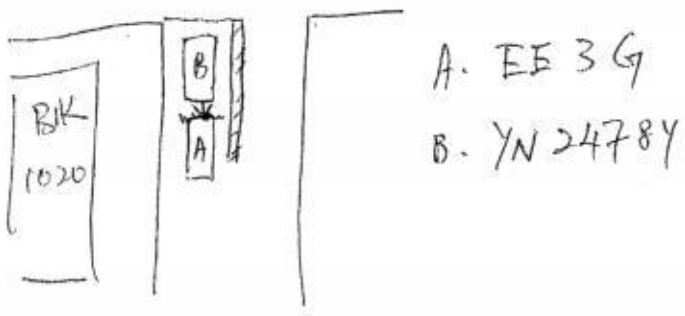
Sketch Plan

I AM STATIONARY MY CAR BEHIND (YN2478Y). LORRY REVERSE AND HIT ONTO MY CAR (EE3G).

I stationary my car behind (YN 2478Y) lorry reverse and hit on my car (EE3G).

Location: Blk 1020 Tai Sang Ave car park exit.
