ACCIDENT INVOLVING YM 329M & YL 2159D ON 12/09/2017

**PRELIMINARY INVESTIGATION
REPORT (PIR) INVOLVING CIVIL
RESOURCE (CR) VEHICLE YM
329M AND CR VEHICLE YL 2159D
AT SIMPANG TRAINING AREA
ON 12 SEPTEMBER 2017 AT
ABOUT 1210HRS**

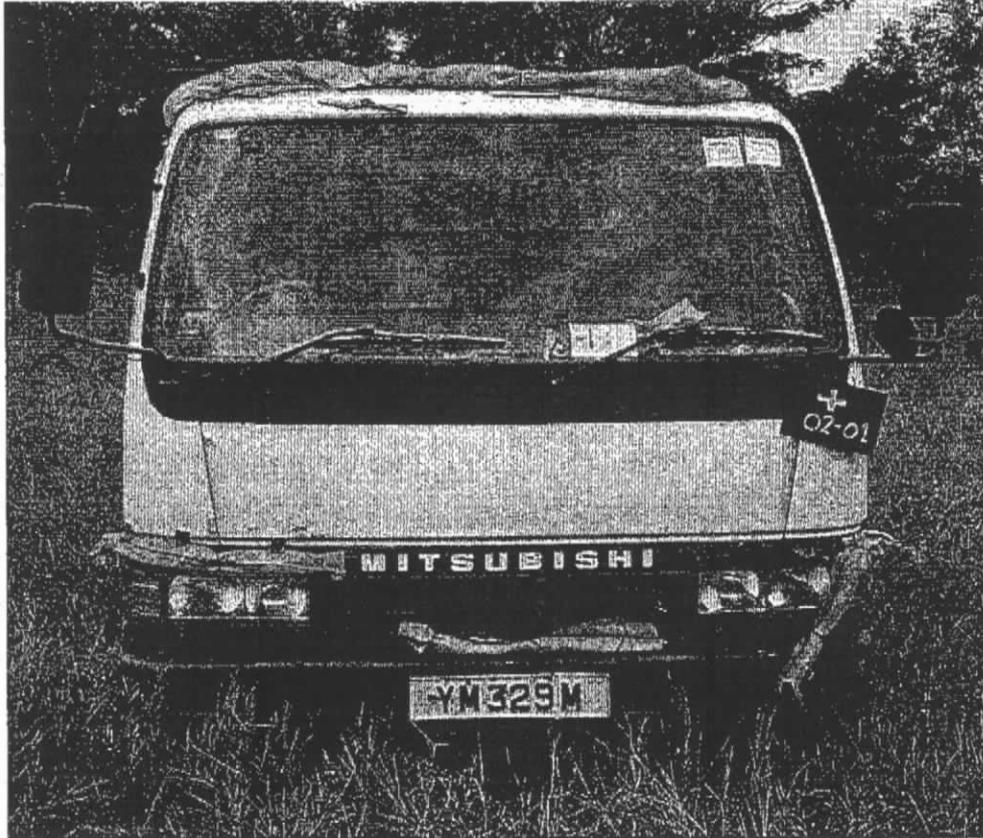
10. YL 2159D sustained a slight dent on its front bonnet from the contact. YM 329M is observed to have no visible damages.

Front view of YM 329M

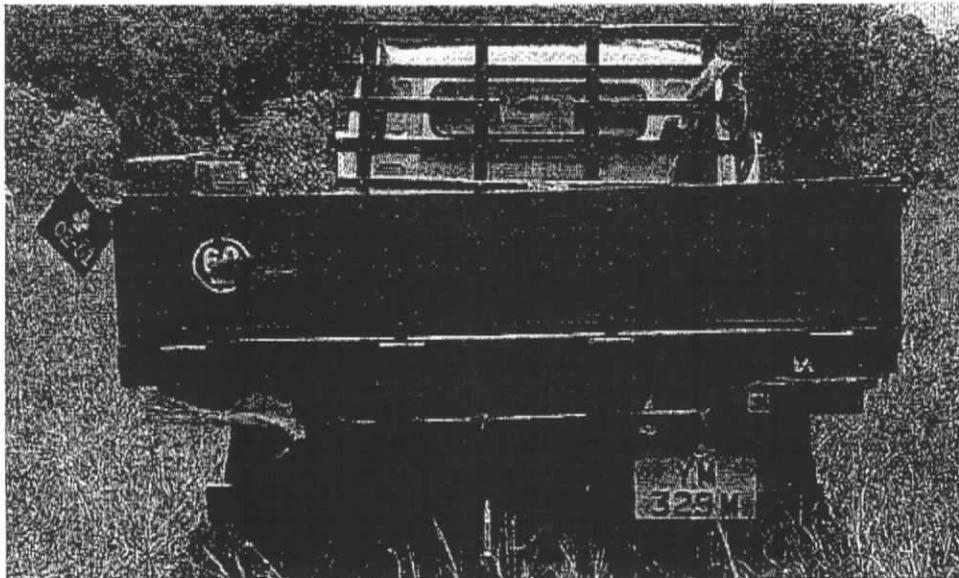
Back view of YM 329M

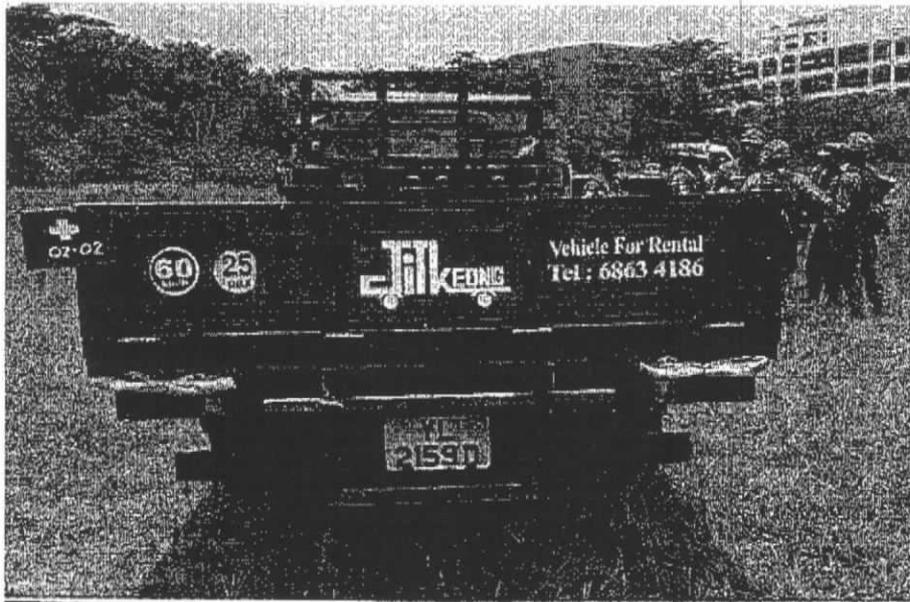
Back view of YL 2159D

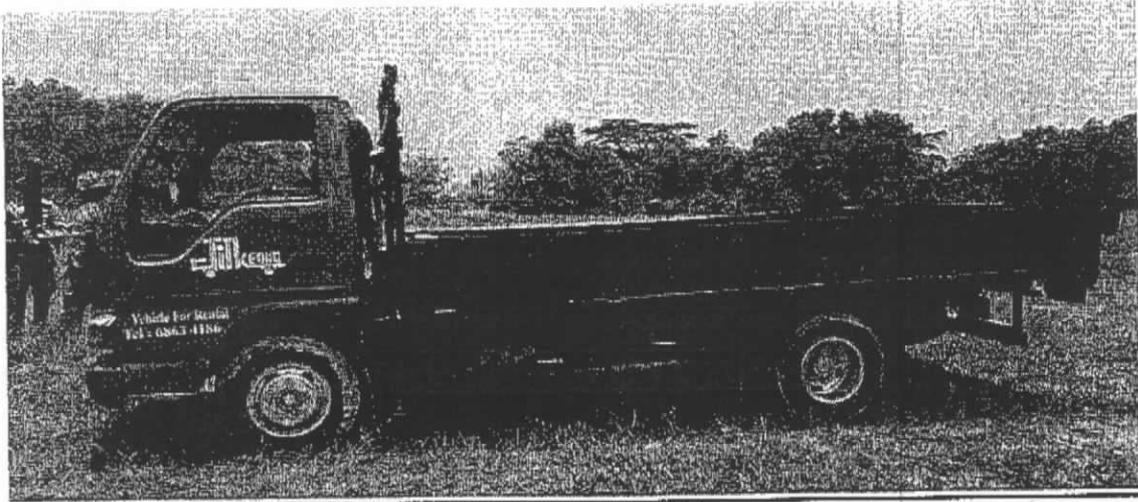
Left side view of YL 2159D

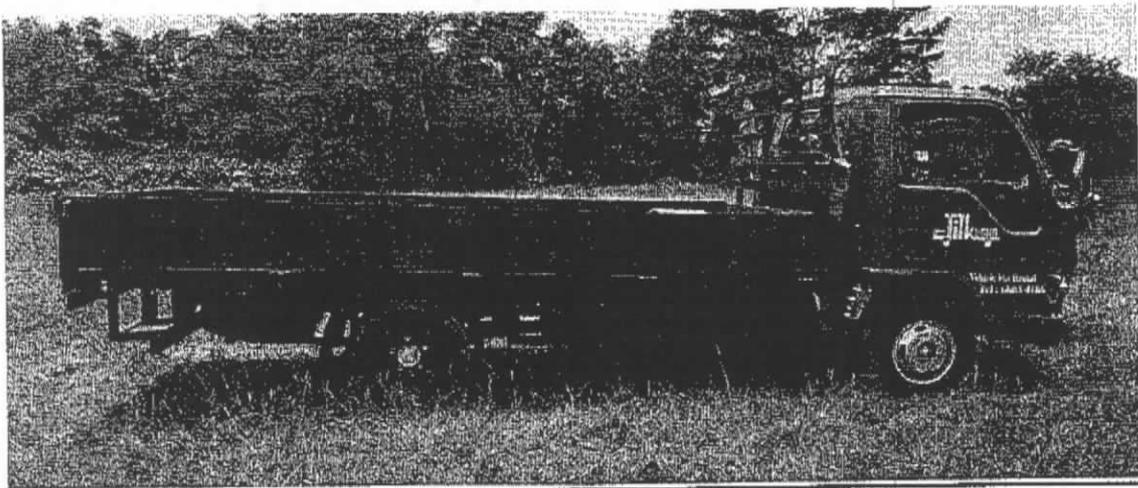
Right side view of YL 2159D

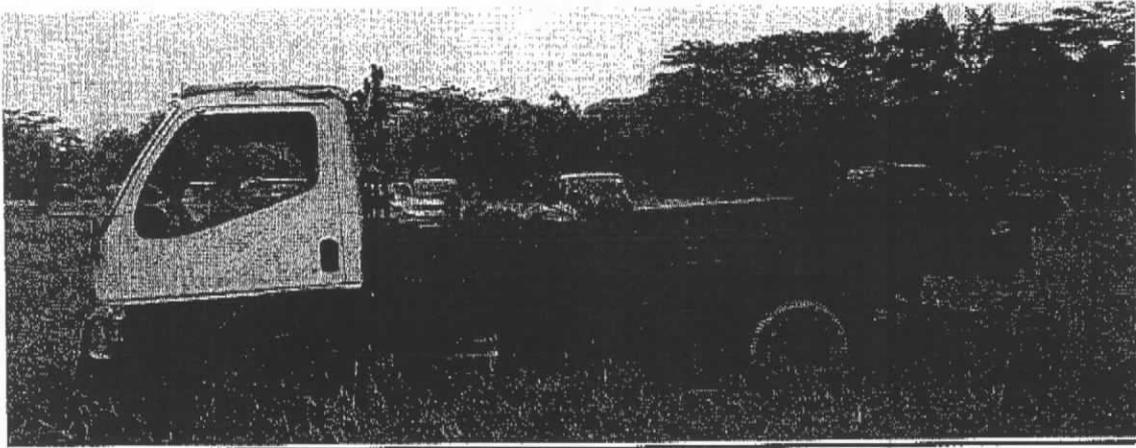
Left side view of YM 329M

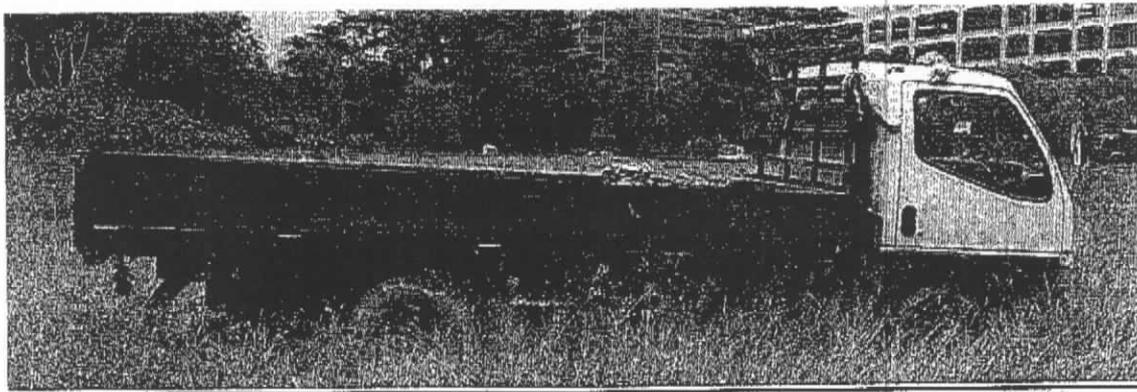
Right side view of YM329M

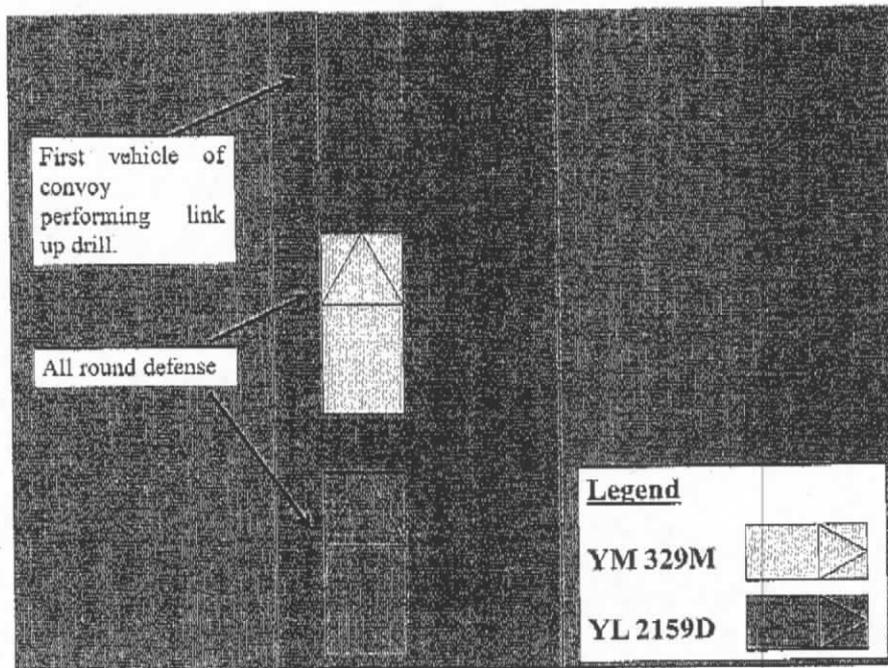
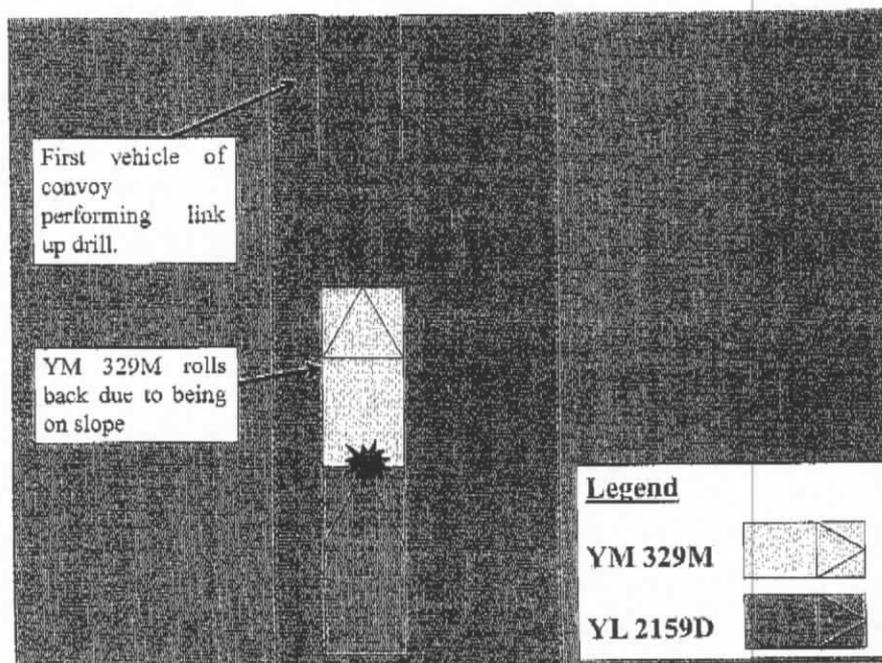
Schematic Diagram of Incident

4. The ground in which CPL MUHAMMAD HAZIQ's vehicle was stopped at had a slight incline.
5. During the halt, the convoy was required to perform all round defence within the area. CPL MUHAMMAD HAZIQ, from his statement, had engaged his handbrake prior to dismounting the vehicle.

6. No wheel choke was placed after CPL MUHAMMAD HAZIQ had dismounted his vehicle and performed the all round defence.
7. During the all round defence was being performed, CR vehicle YM 329M rolled backwards and contacted CR vehicle YL 2159D, which was parked behind it.

1. Despite CPL MUHAMMAD HAZIQ stating that he had engaged the handbrake prior to performing his all round defense, it is deduced that the handbrake was not engaged fully.

2. It is recommended that ALTC to refresh and enforce for all NS GTC that the teachings of putting on wheel choke for all peacetime training. Commanders from Delta GTC and trainers from ALTC are recommended to conduct checks on parked vehicles during link up drill to ensure that all wheel chokes are placed properly.

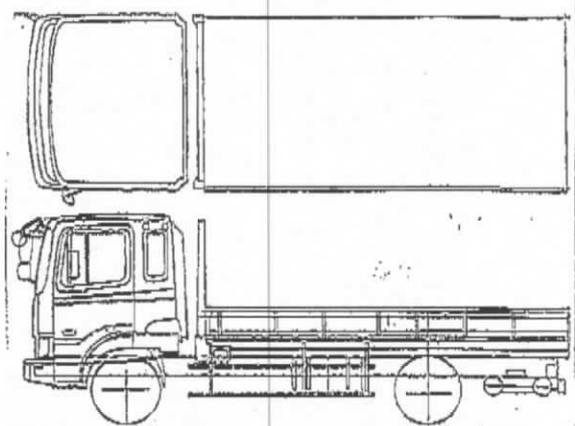
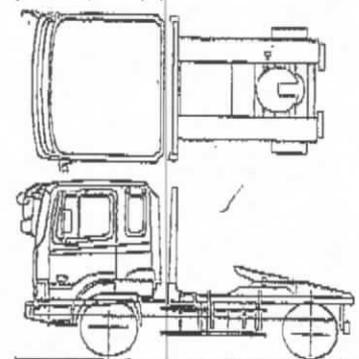
YL2159D

X - Accident hit rear truck

- not full hand brake

- front panel damage

- reverse ~~part~~ and hit front panel

- front vehicle reverse and knock the vol (YL2159D)
