OD/TP Re-inspection / Evaluation  
 To Inspect Vehicle No: SKW 903T Insured: GBF 2585K  
 at Workshop m/s Eng Soon Tel: 6760 6271  
 of 3939 Woodlands Road  
 Policy No: 2900 6428 MKC Claim No: 535302  
 Sum Insured: \_\_\_\_\_ Excess: \_\_\_\_\_  
 Make of Veh: \_\_\_\_\_ D.O.A. 31.10.2017  
 (Client's Record)

**ACCIDENT INVOLVING SKW 903 T & GBF 2585 K ON 31 OCTOBER 2017**

### VEHICLE DAMAGE INSPECTION REPORT

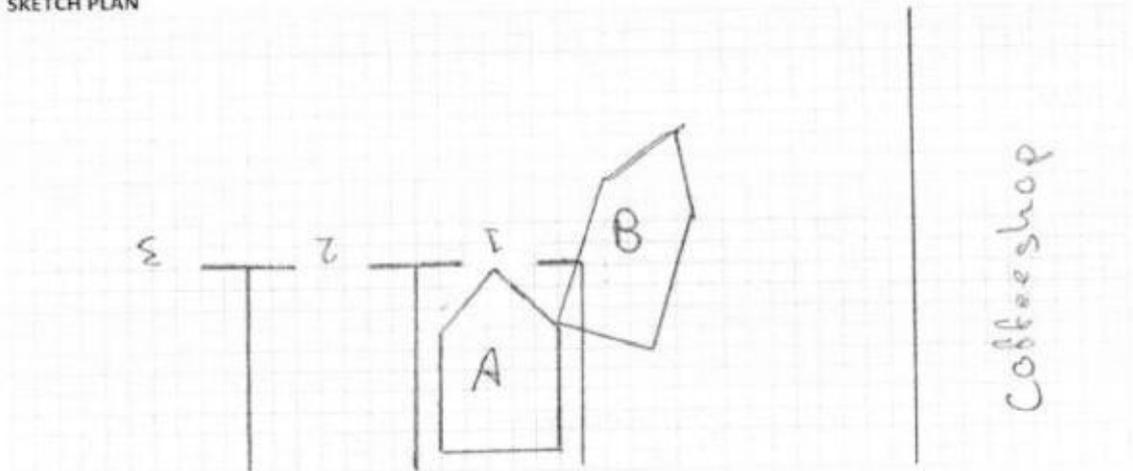
SKETCH PLAN

On 31/10/17, My Car was parked stationary at 21 Tuas Ave 13, inside the parking lot.

The Lorry of GBF2585K had reversed and hit my car, causing damages to my side tender, (driverside), side mirror (driverside) and driver's door.
