SKW 6217B - CS3 / AIG 7021591 / Sb - D.O.A. : 9/11/2017

Veh No: SKW6217B.

**- FW: PRE-REPAIR INSPECTION - ACCIDENT INVOLVING OUR INSURED
VEHICLE SLE7682S AND SKW6217B ON 9/11/2017**

VEHICLE DAMAGE INSPECTION REPORT

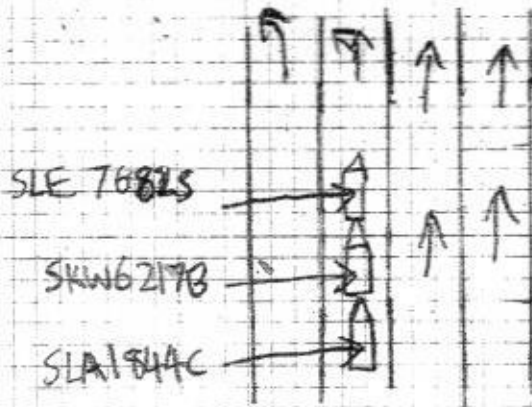
SKETCH PLAN

I WAS TRAVELLING ALONG BKE GOING TOWARDS PIE(CHANGI) ON THE 3RD LANE, THE VEHICLE INFRONT OF ME BRAKE AND I FOLLOWED TO BRAKE AND STOPPED, ALL OF A SUDDEN, I FELT A GREAT IMPACT COMING FROM BEHIND MY VEHICLE AND MY VEHICLE WAS BEING PUSHED FORWARD AND THUS THE FRONT PORTION OF MY VEHICLE HIT ONTO THE REAR PORTION OF THE VEHICLE INFRONT OF ME. I THEN ALIGHTED TO CHECK AND REALISED THAT IT WAS A CHAIN COLLISION INVOLVING 4 VEHICLES (INCLUDING MINE). I AM FEELING A STIFF N AND BODY PAIN, I WILL BE CONSULTING A DOCTOR LATER. MY VEHICLE SUSTAINED SERIOUS DAMAGE TO THE REAR PORTION AS COMPARED TO THE FRONT PORTION. ATTENDED BY : SUSAN
