LKK Auto Consultants Pte Ltd

Ref : CS3/MSG16022477/qb-1

Insured Veh.	SLC 1832B	Veh. Inspected	SGS 5356H
Policy No.	MSD/VPCP/16-001051	Coverage (\$)	0.00
Claim No.	MSC/V/16-001646	Excess (\$)	0.00
Assign From	MERIMEN (IRENE TAN)	Assign Date	20/11/2017

Automobile Inspection Report

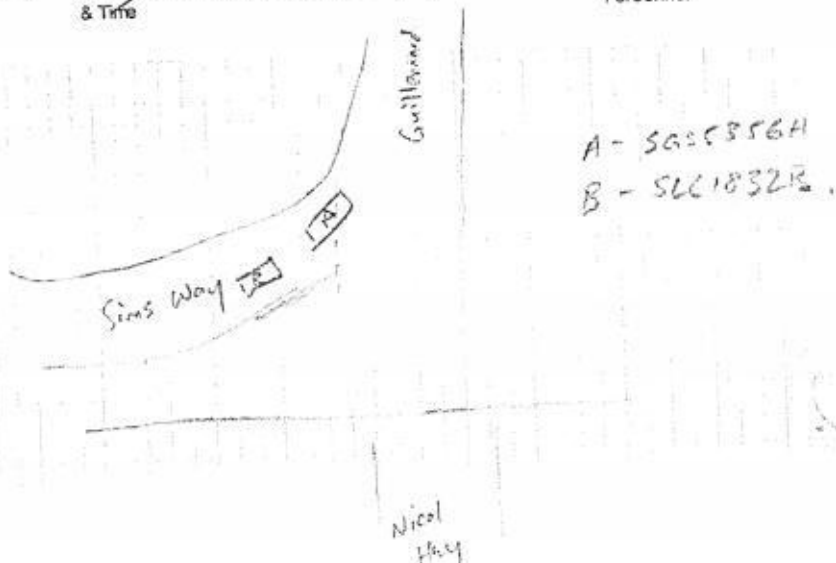
Accident Sketch Plan Pg.1

At about 2135hrs, I was driving along Sims way filtering to Guillemard road. I was heading to Geylang Lor 30, sending a passenger to her destination.

As I was turning left to filtering left to Guillemard road, I saw a vehicle coming from the right and therefore stop behind the line. The vehicle, a dark grey Toyota Altis, GLC1P32B, hit my car from the rear.
