## ESTIMATE REPAIR BILL FOR HYUNDAI 130 WAGON REGN NO: SHD 1658 E

- 2	Odometer	699250	Steering	IN ORDER
	Brakes	IN ORDER	Modification	STANDARD ALLOY RIM
	General	FAIR		
		Con	ditions of Tyres	
		Size	Make	Balance
	R/H Front Tyre	185/65 R15	MAXXIS	7 mm
	L/H Front Tyre	185/65 R15	MAXXIS	7 mm
	R/H Rear Tyre	185/65 R15	MAXXIS	7 mm
	L/H Rear Tyre	185/65 R15	MAXXIS	7 mm
He	Description of Damages			
	THE VEHICLE SU	STAINED DAMAGES AT THE ETAILS.	N/S REAR PORTION.

### ADJUSTMENT ON REPAIR COST FOR VEHICLE NO. SHD 1658E

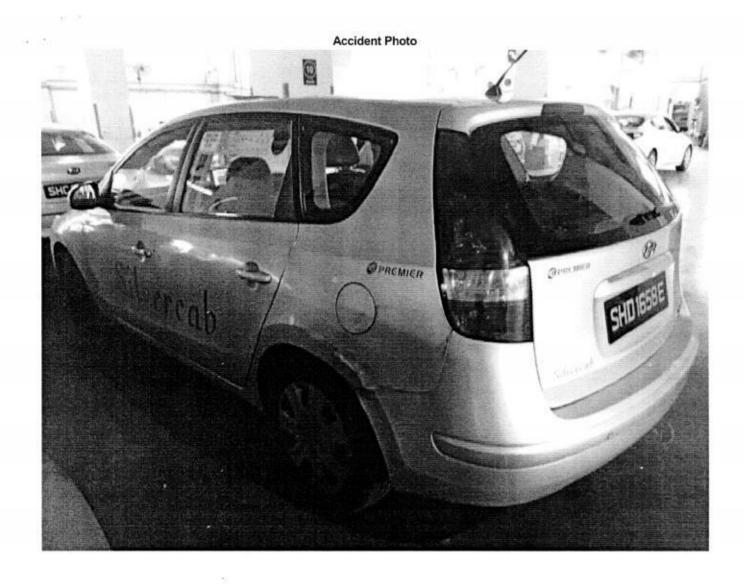
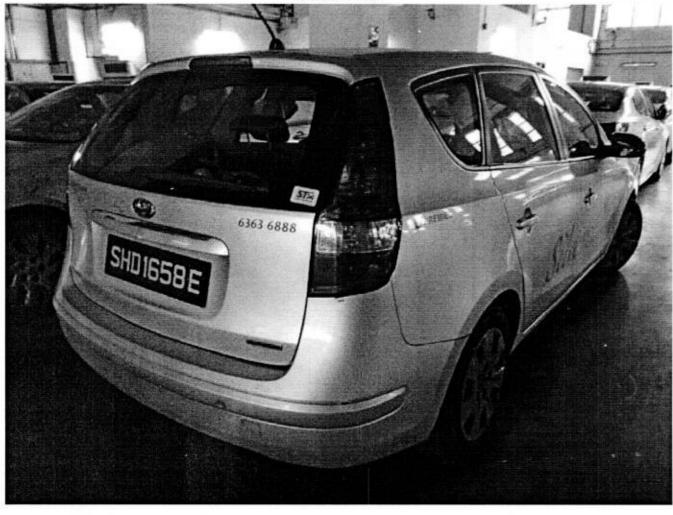
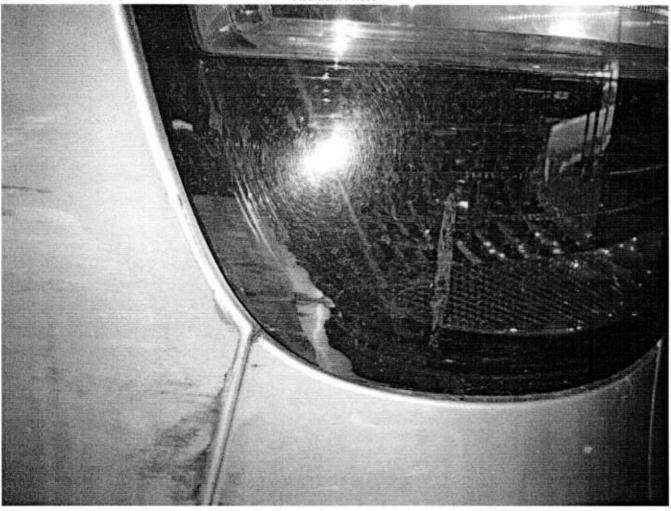
I assessed that my rear bumper left portion was badly dented in. The white Subaru's rear bumper was badly smashed and debris were scattered on the ground. The lorry's front left bumper portion was also broken and dented.

Qty	Description of Parts	Condition	Estimate By Workshop (\$)	Our Adjusted (\$)
	REPLACEMENT OF PARTS			
1	REAR BUMPER	DEFORMED	447.00	447.00
1	REAR BUMPER INNER SPONGE	SERVICEABLE	129.00	10-
1	REAR BUMPER BEAM	SERVICEABLE	270.00	-
1	REAR BUMPER TOW HOOK CAP	SERVICEABLE	38.20	85-
1	REAR BUMPER BEAM LOWER BRACKET-CENTRE	SERVICEABLE	13.70	
2	REAR BUMPER BEAM LOWER BRACKET-RH & LH @\$16.20	SERVICEABLE	32.40	22-
2	REAR BUMPER BEAM O/S & N/S UPPER BRACKET @\$13.70	SERVICEABLE	27.40	-
2	REAR BUMPER O/S & N/S SIDE BRACKET @\$16.00	SERVICEABLE	32.00	
2	REAR BUMPER O/S & N/S SIDE UPPER BRACKET @\$15.20	SERVICEABLE	30.40	-
2	REAR BUMPER O/S & N/S UPPER BRACKET @\$13.30	SERVICEABLE	26.60	
1	REAR LICENSE PLATE LAMP	SERVICEABLE	60.00	
1	REAR N/S FENDER	TO REPAIR SEE LABOUR	1,736.30	
1	REAR N/S FENDER INNER SHIELD	SERVICEABLE	120.00	-
1	N/S TAIL LAMP	GRAZED	477.50	477.50
	LESS 20% DISCOUNT		-688.10	-184.90
	1952 PGB (SENUNCON) CON (SENUNCON) (SOI)		2,752.40	739.60

RECOMMENDED COST OF LUMP SUM REPAIRS		1,400.00
(TO ITS PRE-ACCIDENT CONDITION)
