To Inspect Vehicle No: GY 8020A Insured: GT 2975K

4. DESCRIPTION OF DAMAGE

At the time of inspection observed that this vehicle had sustained damages to the Right side front portion

VEHICLE DAMAGE INSPECTION REPORT

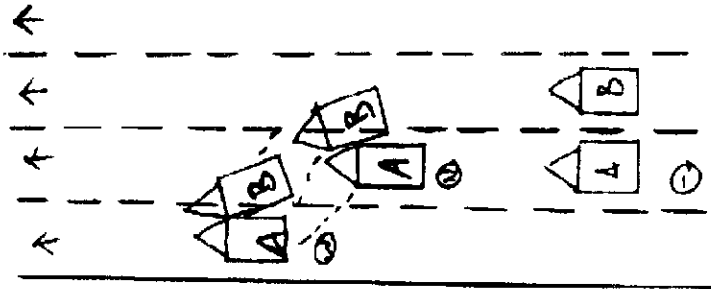
SKETCH PLAN

PIE TOWARD CHANGI AIRPORT AFTER KILLANG EXIT

VEHICLE A (GT297SK)

VEHICLE B (GT297SK)

ON THE STATED DATE AND TIME ON THE STATED
VEHICLE, I VEHICLE A (GT297SK) WAS TRAVELLING STRAIGHT
ON MY LANE, SUDDENLY VEHICLE B (GT297SK) CUT INTO
MY LANE AND HIT ONTO MY VEHICLE FRONT RIGHT PORTION, AND
PUSH ME TO NEXT LANE
